## HERITAGE STATEMENT

### FOR REFURBISHMENT WORKS TO

### 11 RAILWAY VIEW ROAD, CLITHEROE

Revision B 02.11.22

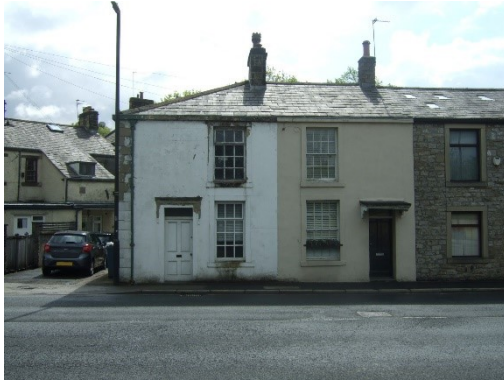
- 2.3 The simple façade is punctuated with a pair of narrow timber window openings providing light to the living room and bedroom above. These windows are not original and we would estimate their age to be around 1960. Although replicating the traditional glazing bar patterns one would expect for this period of property, they are in fact top hung hinged casements.

- 2.8 The render to both elevations appears to be a hard cement-based product with evidence of cracking to the surface finish.
- 2.9 Unusually, the demise of 11 Railway View Road only extends to  $\frac{3}{4}$  width of the northern gable end with the final  $\frac{1}{4}$  occupied by 13 Railway View Road.

*Picture 4 – West elevation along Railway View Road*

- 3.7 Existing top hung casement windows to the west (front) elevation will be removed and replaced with Accoya factory finished single glazed sliding sash windows. Refer to application drawings 5561 (PL) 02B & 03A for details.

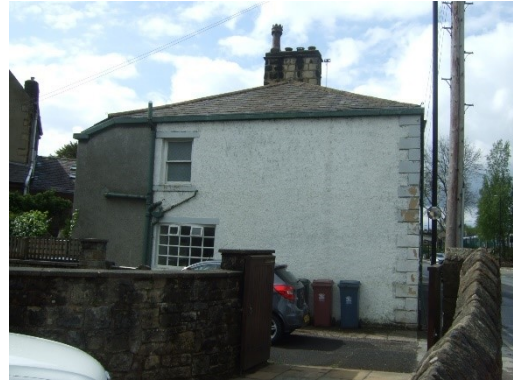
- 2.7 The northern elevation is more utilitarian in appearance with two windows; the ground floor bowed window being a C20 intervention whilst the first floor sliding sash window appears to be original. The render finish is also less ornate on this elevation being standard roughcast render with a paint finish and no applied coursing.

*Picture 5 - North elevation*

- 3.8 The opaque sliding sash window to the northern elevation will be retained and renovated / decorated.
- 3.9 The bow fronted window to the kitchen will be removed and replaced with new single glazed sliding sash windows incorporating weatherseals for improved thermal and acoustic comfort.

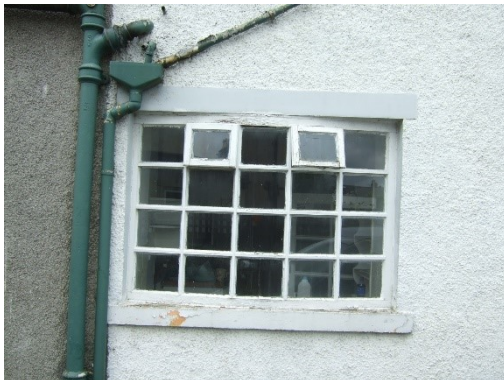
*Picture 6 - Bow window to kitchen*

- 4.6 The existing building is in need of renovation and repair. The windows in particular require replacement. The current arrangement, with the exception of the bathroom window to the northern elevation, are C20 interventions with top hung casements. The bow window to the kitchen in particular appears incongruous and causes visual HARM.

- 4.8 The bow window on the north will be replaced with a pair of vertical sliding sash windows with central mullion. We cannot be entirely sure of the original window configuration to this opening but rather than major structural intervention, the use of a double sliding sash restores the verticality and proportions associated with this age of property.

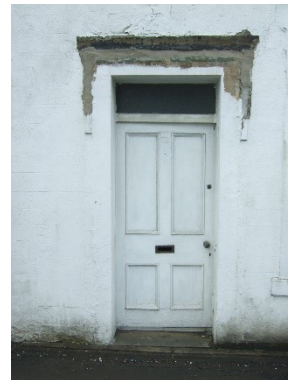
- 2.2 The timber hood referenced in the Listing has fallen off the building due to rot but has been retained. Unfortunately, the timber hood is in very poor condition and beyond repair therefore an exact replica has been manufactured copying details, size etc.

- 2.4 A 4 panelled timber door, assumed to be original, with glazed fan light over provides the only access into the property.
- 2.5 As noted in the Listing, the property has rusticated quoins and stone surrounds to the windows and doors. These appear to have been painted with a modern plastic based paint which is flaking and in poor condition generally.

*Picture 7 - Original front door with hood missing*

- 3.5 The replica timber hood will be reinstated over the door to match the retained feature at #13.
- 3.6 The existing door will be retained, repaired as necessary and re-decorated.

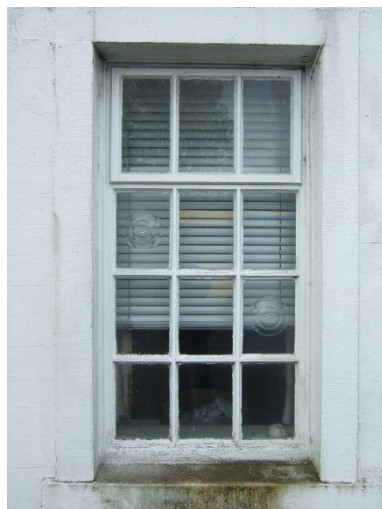
*Picture 8 - Mock sash window with top hung casement*

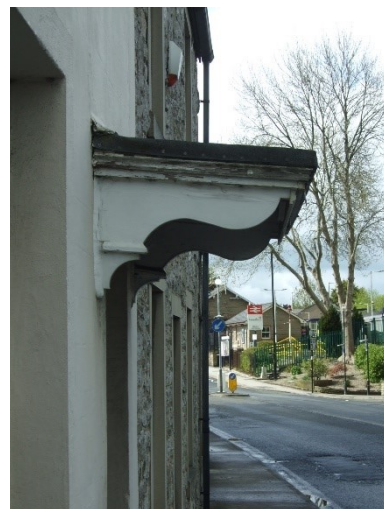
*Picture 9 - Timber hood to #13*
