Project details

Job no.	LTC115
Site	Talbot Hotel, Talbot Street, Chipping, PR3 2QE
Client	Sunderland Peacock & Associates Ltd.
Arboriculturist	Jennie Keighley PhD MSc MArborA
Local authority	Ribble Valley Borough Council
Issue date	2 February 2022

BS5837 Tree Survey Schedule

Tree Survey Plan

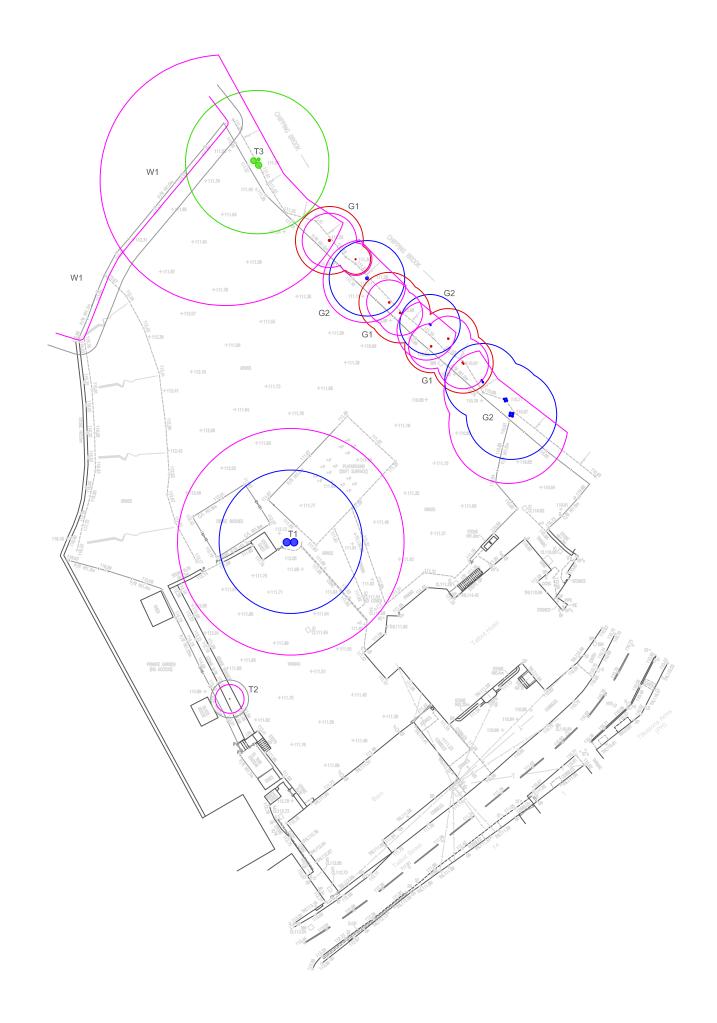
Date: February 2022
Scale: 1:500 at A3
Drawing: LTC115-TSP

Tree Survey Schedule Summary Species Cat. ID No. Sycamore T1 В Cherry T2 C Sycamore T3 Α ≈ 7no. ash G1 U ≈ 5no. sycamore G2 В W1 Various C
