METHOD STATEMENT

Proposal: Listed Building Consent for the retention of unauthorised works, namely removal of ground floor wall and subdivision of first floor room with new partition wall, new doors and door fittings to facilitate relocation of bathroom from ground floor to first floor. Also proposed is infilling of holes left by removal of pipework, replacement of window head and sills, replacement of windows to rear elevation, alteration of first floor rear window, replacement of existing rear door and installation of mechanical extraction to bathroom

Address: Primrose Cottage 4 Main Street Bolton by Bowland BB7 4NW

Application no: 3/2023/0270

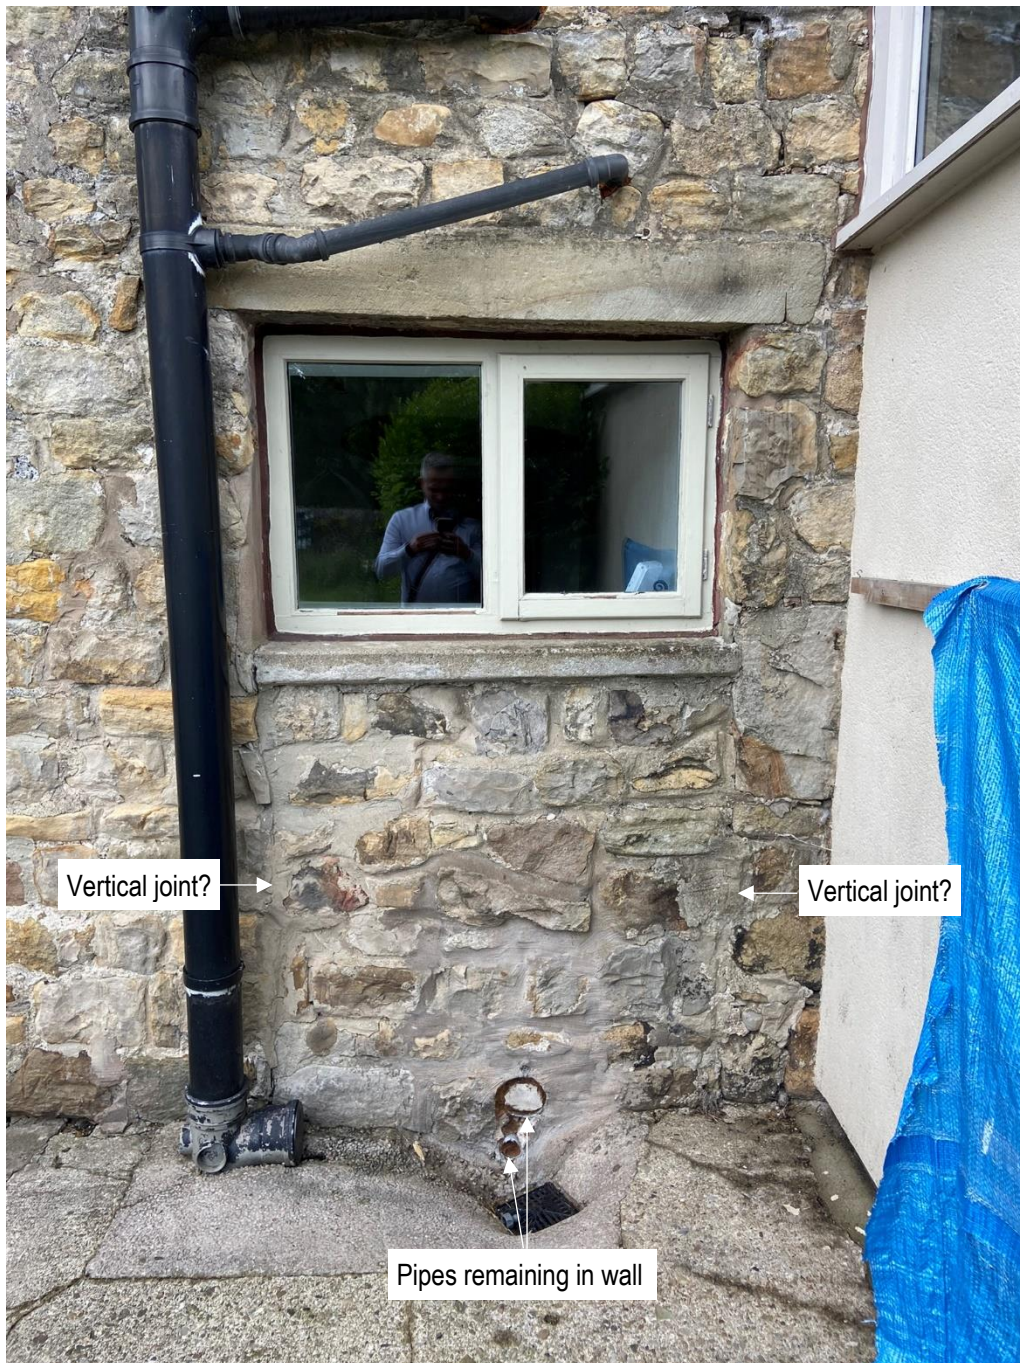
Photo 1

- Redundant pipework appears to remain in the wall and has been infilled with a portland cement based mortar (see photo 1).
- Near vertical joints indicate the window above was once a door opening. The majority (if not all) of the infill is pointed with a mortar mix that is likely to be portland cement based. It is also possible that the stonework to this infilled panel is bedded on a mortar mix that is portland cement based.

- Carefully hack out redundant pipes and surrounding portland cement based pointing, using hand tools.

- Infill hole with surplus stone created by work no. 9, bedding with matched lime based mortar. See below for mortar specification.
- Repoint where surrounding Portland cement based pointing has been removed. See below for mortar mix and repointing method.

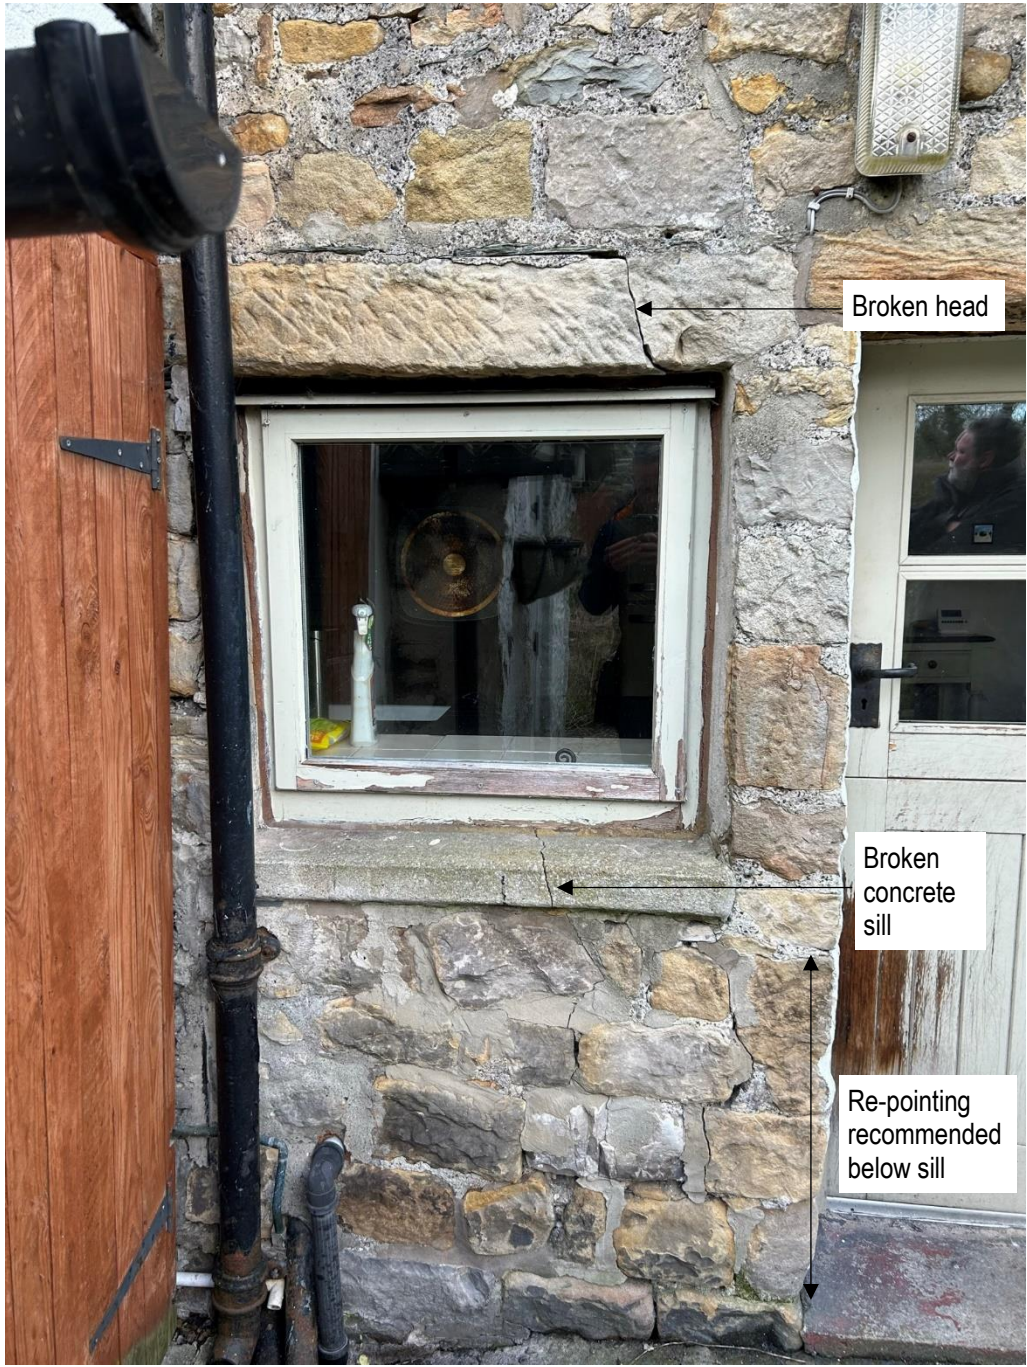
- The window head is broken and requires replacement (see photo 2).
- It has a punched face with tool marks at an angle of 45 degrees from the vertical. This indicates that it might be older than other windows opening to this elevation, which have smoother and more regular stone heads and sills (where not concrete).

Broken head

Broken concrete sill

Re-pointing recommended below sill

- Mason stone head out of matching stone, including punch marks at an angle of 45 degrees from the vertical. Do not overwork stone to try create an artificially aged and weathered appearance. Rather it should be legible as a sensitive stone repair/replacement.
- Carefully prop stonework to avoid or minimise any further movement.
- Carefully remove existing window.
- Carefully hack out broken stone head and replace, bedding with the matched lime based mortar. See below for mortar specification.
- Repoint around new head and renew any surrounding pointing that becomes loose or missing, using lime based mortar. See below for mortar mix and repointing method.
- Refit new flush-fitting windows, in accordance with approved detail.

- Acquire simple sawn and square stone sills that match the unweathered colour and composition of the existing first floor bedroom/ shower room sill. Allow for overhangs to match bearings of above heads and to shed water clear of the building.
- Remove existing windows.
- Carefully hack out concrete window sills and replace with stone sills, bedding with matched lime based mortar. Ensure sills are set to fall and shed rainwater. See below for mortar specification.
- Repoint around new sill and renew any surrounding pointing that becomes loose or missing. See below for mortar mix and repointing method.
- The areas of portland cement based pointing below each window sill may be removed (if desired) and the stonework repointed with the matched lime based mortar.
- Refit new flush-fitting windows, in accordance with approved detail.
