Arboricultural Impact Assessment

Lantern Cottage
27 Pendleton Road
Wiswell
BB7 9DD

September 2023

Job no.	LTC198
Site	Lantern Cottage, 27 Pendleton Road, Wiswell, BB7 9DD
Client	Paula Davis
Architect	Zara Moon Architects
Arboriculturist	[REDACTED]
Local authority	Ribble Valley Borough Council
Date	28 September 2023
Issue	Final issue for planning

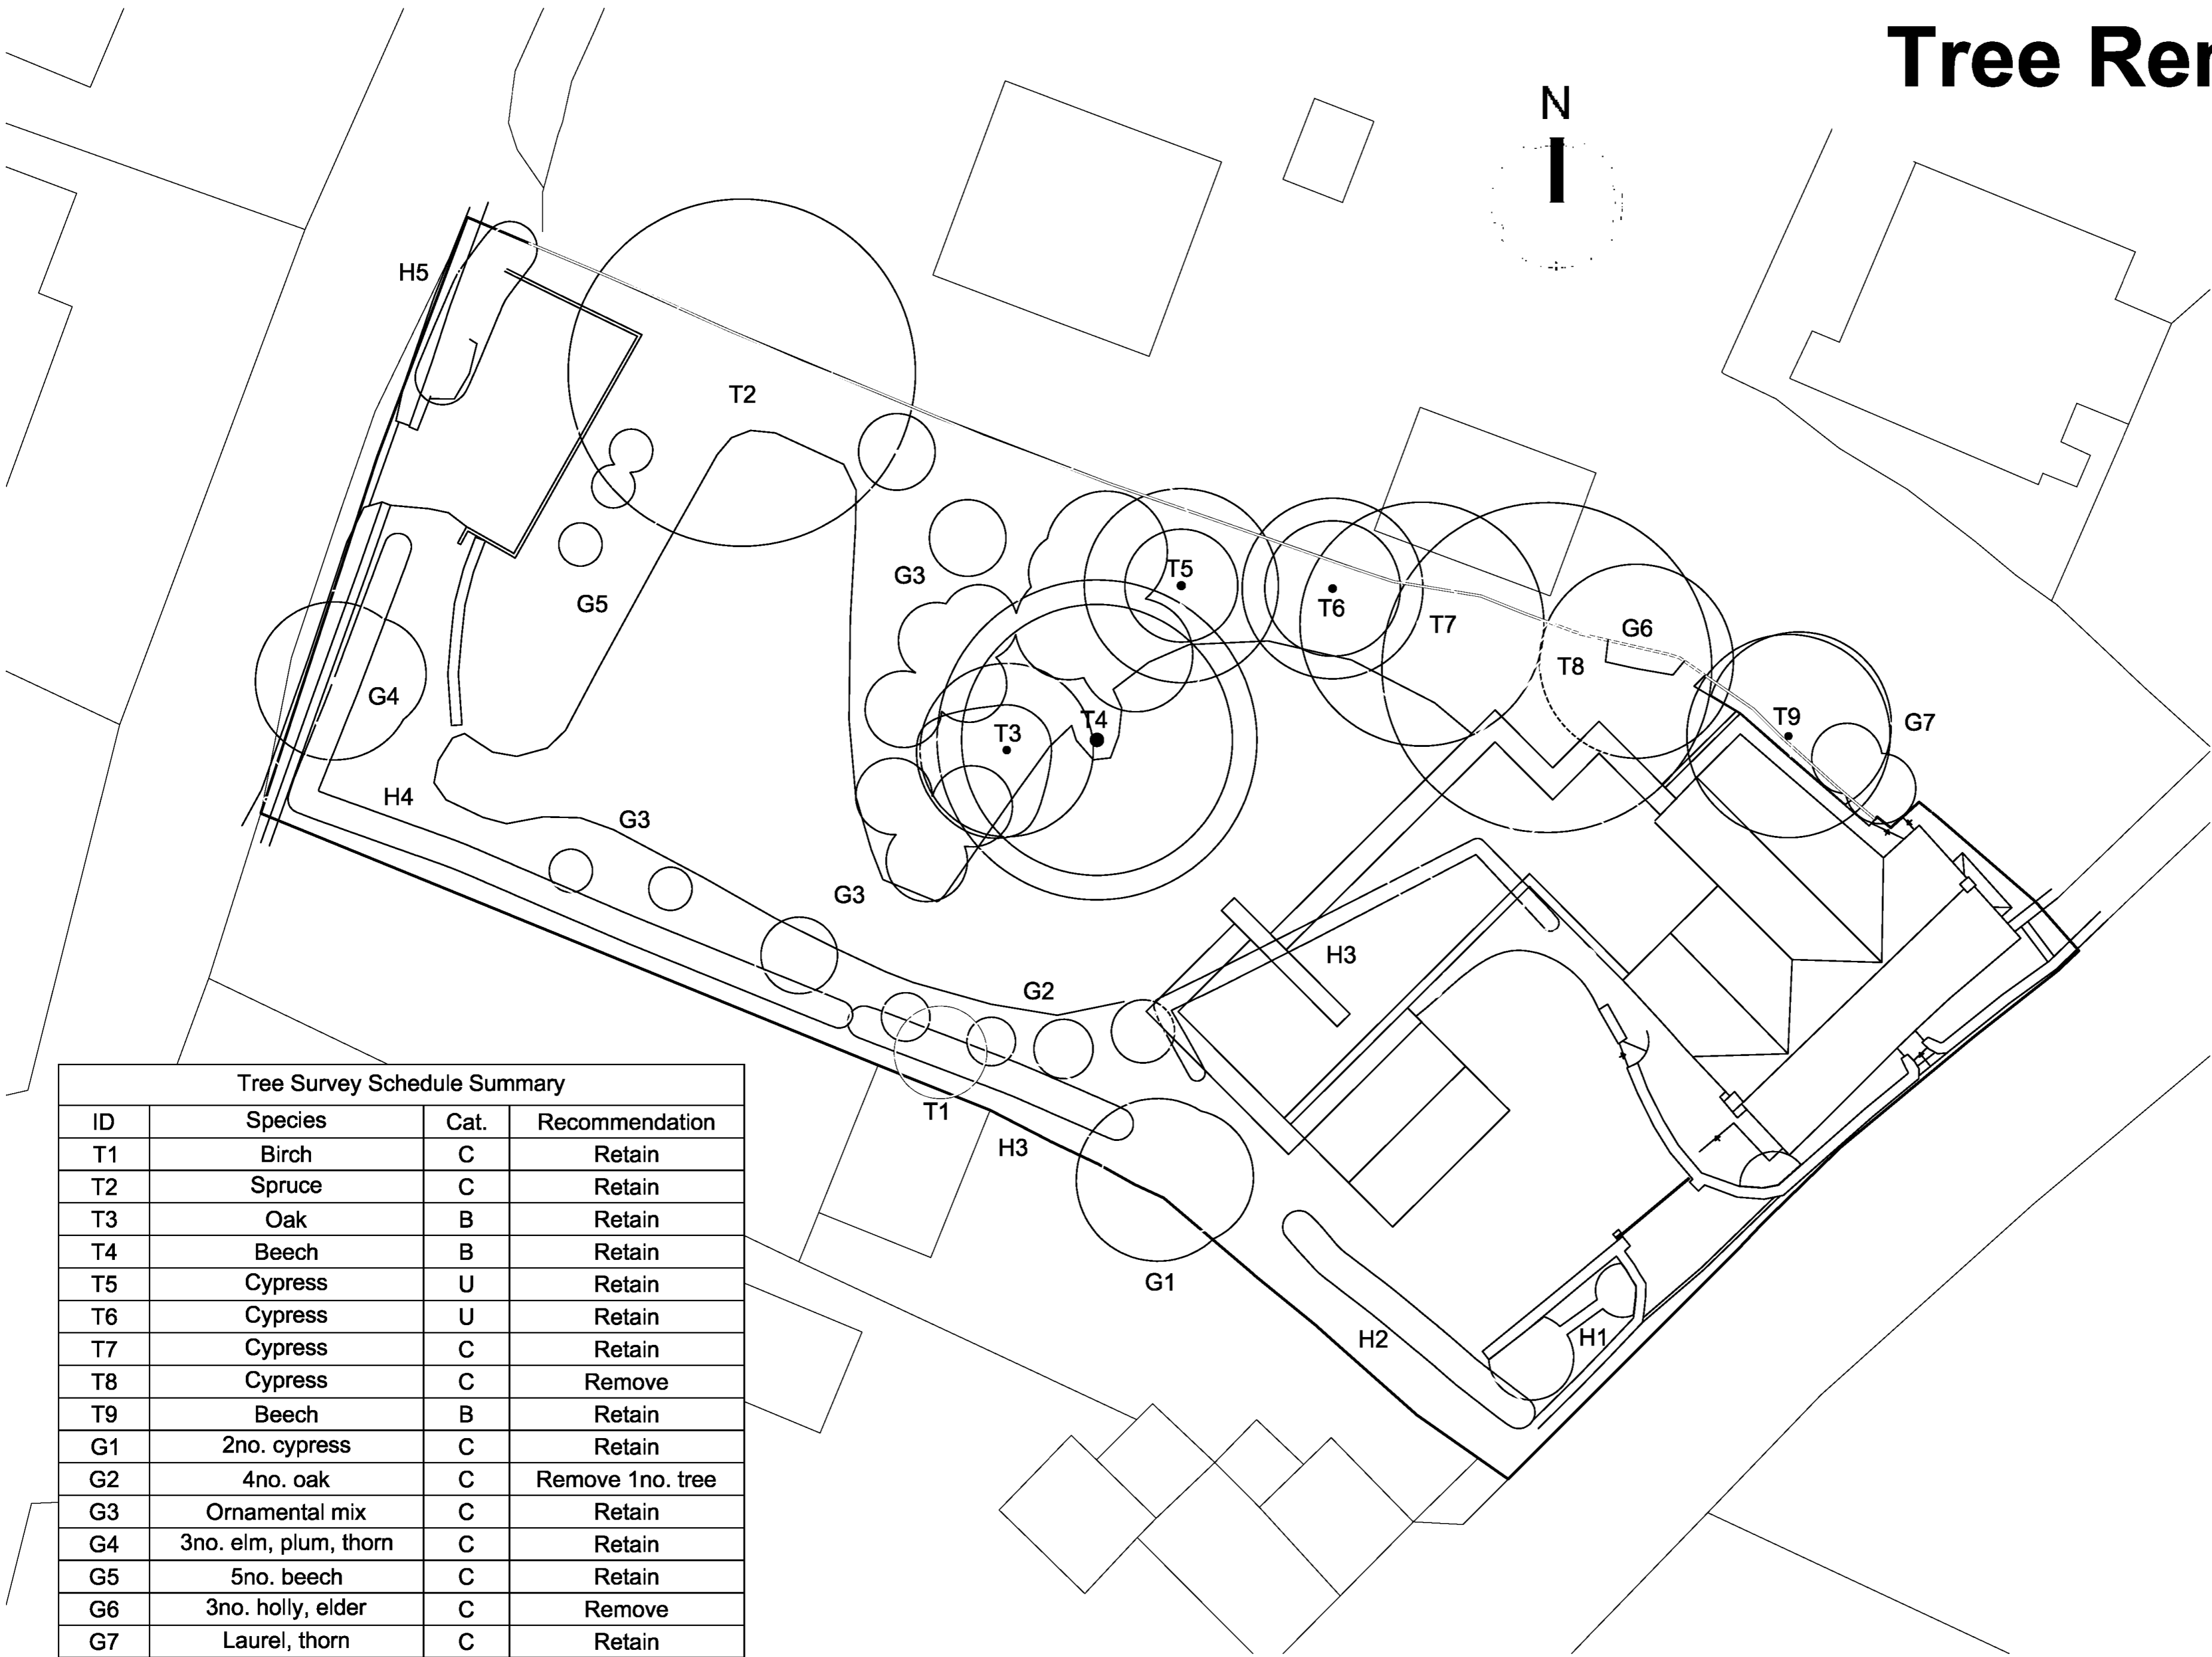
Tree Removal Plan

- 4.3 As shown on the appended tree removal plan and in Table 1, below, construction of the development as proposed will require the removal of five C-category trees and one section of C-category hedge.

ID no.	Species	BS5837 category	Recommendation
T8	Cypress	C	Remove in order to construct development as proposed
G2	Oak	C	Remove easternmost tree only in order to construct development as proposed
G6	3no. holly, elder	C	Remove group in full in order to construct development as proposed
H3	Beech	C	Remove easternmost hedge section in order to construct development as proposed
Total tree removals			5no. C-category trees 1no. C-category section of hedge

Tree Survey Schedule Summary			
ID	Species	Cat.	Recommendation
T1	Birch	C	Retain
T2	Spruce	C	Retain
T3	Oak	B	Retain
T4	Beech	B	Retain
T5	Cypress	U	Retain
T6	Cypress	U	Retain
T7	Cypress	C	Retain
T8	Cypress	C	Remove
T9	Beech	B	Retain
G1	2no. cypress	C	Retain
G2	4no. oak	C	Remove 1no. tree
G3	Ornamental mix	C	Retain
G4	3no. elm, plum, thorn	C	Retain
G5	5no. beech	C	Retain
G6	3no. holly, elder	C	Remove
G7	Laurel, thorn	C	Retain
H1	Ornamental mix	C	Retain
H2	Laurel	C	Retain
H3	Beech	C	Remove part
H4	Yew	C	Retain
H5	Native mix	C	Retain

4.5 The site can accommodate new tree planting in order to compensate for the development-related losses. The specification, delivery and aftercare of replacement tree planting can be secured by means of a suitably worded condition attached to a planning approval and should be implemented in accordance with the British Standard guidance BS8545 (2014) *Trees: from nursery to independence in the landscape - Recommendations*.
