HERITAGE STATEMENT

OUTBUILDING

ROCK HOUSE

29th September 2023

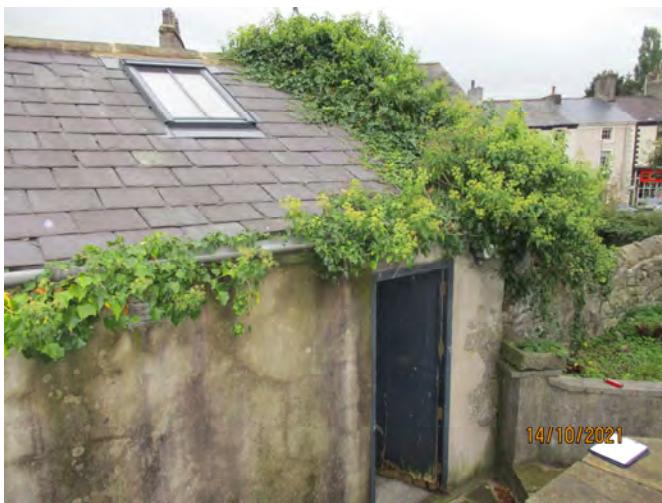
The lead lined gutter to the rear has been supplemented by a uPVC gutter and a substantial amount of water ingress is occurring in this location. As part of the roofing works the stone gutters are proposed to be re-lined with leadwork and all uPVC downpipes to be replaced with painted cast iron.

uPVC gutter to rear elevation

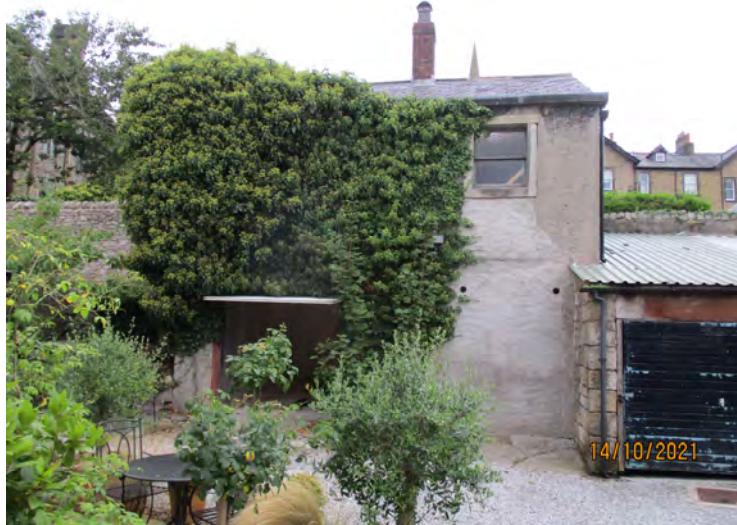
Widespread ivy growth to front elevation

6.4 The extensive ivy growth and roughcast render is proposed to be carefully removed to expose the limestone which will be re-pointed using lime mortar. The intention is for the external walls to achieve a finish as per the adjacent property, Crammond Coach House.

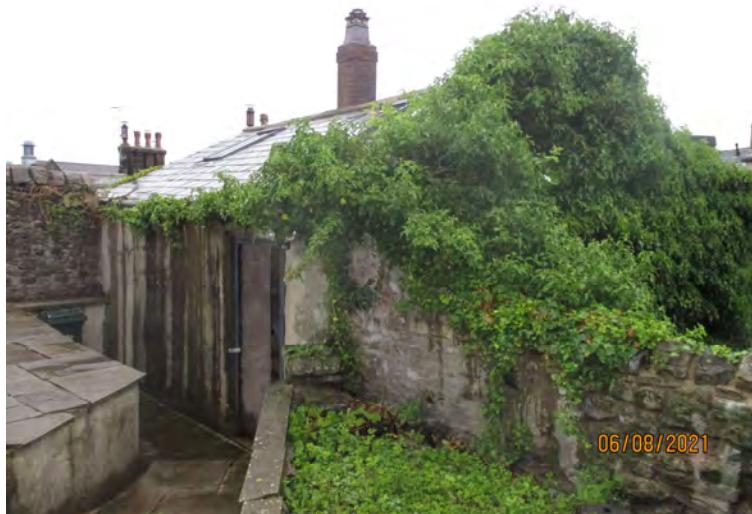
Widespread ivy growth to south west gable elevation
