Arboricultural Impact Assessment

Kemple Side
Clitheroe Road
Knowle Green
Preston
PR3 2YS

The post development survey for the creation of a garage

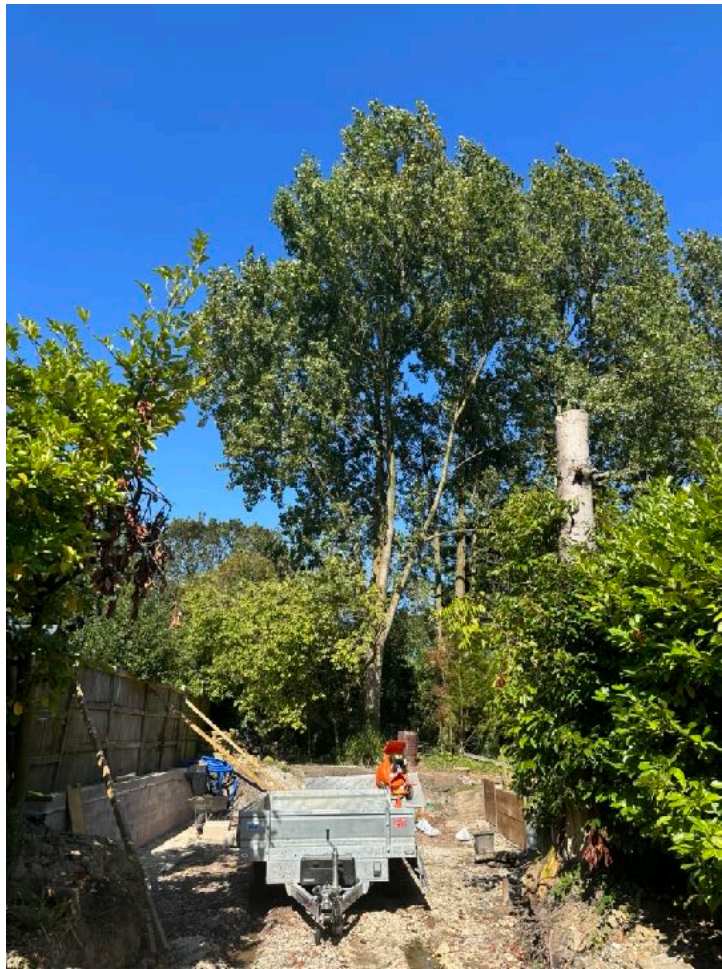
Overlooking the proposed development with the row of low quality trees in the foreground

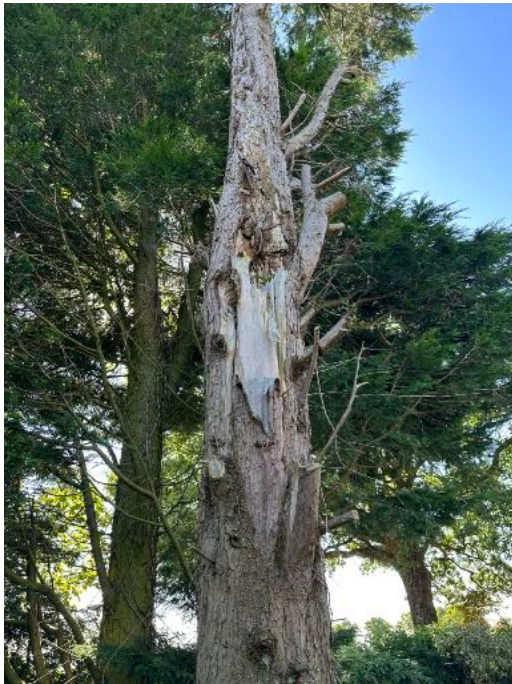
- T15 Conifer has already experienced failure of three limbs due to the aforementioned issue and is now full of decay with entire tree failure a likelihood.

Cavities on T15 conifer

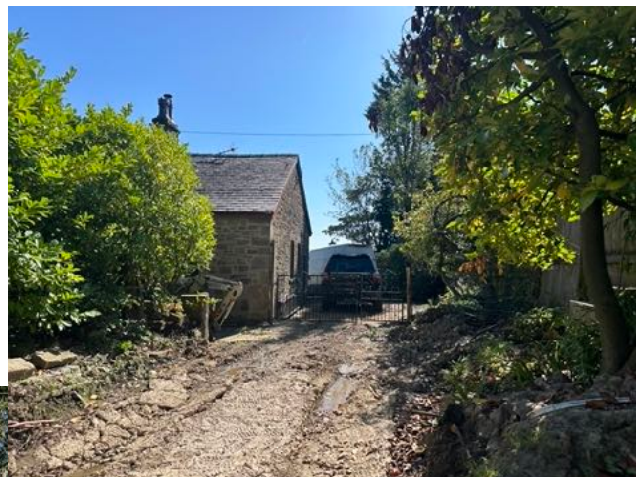
Right is looking south within the rear garden area where the existing surface is to be excavated where tree roots are located and have been excavated.

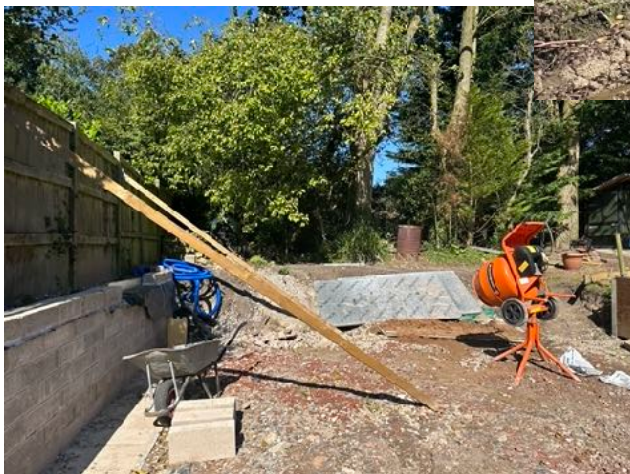
5.2.1 The development of the garage falls within the RPAs of T2 & T3 hybrid black poplar (*Populus x canadensis*).

Simply looking north at the row of poplars where the garage has encroach onto their RPA's which now needs protecting
