**ARBORICULTURAL REPORT
(BS 5837:2012)**

**LAND AT
NORTHCOTE ROAD
LANGHO
BLACKBURN
BB6 8BG**

May 2022

Job Number 4986

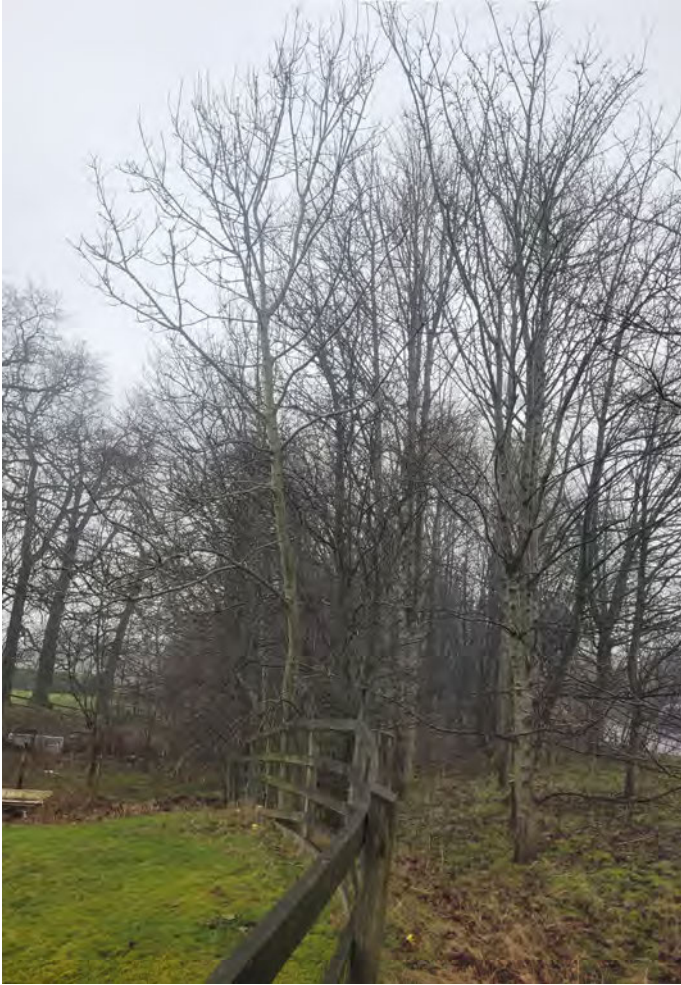
T13 - T16

- 5.2.3 The Oak trees T13, T15 & T16 have typical deadwood and broken branches present but are in good condition for their age and species. Some remedial works will be required in order to remove the most significant deadwood, which does not require consent under the TPO. None of the canopies are over the development so no pruning will be required in order to facilitate development.

Tree No.	Proposed Works
T1, T2, H1, T3, T11 & T12	Fell to ground level and remove stumps.
T13, T14, T15 & T16	Remove significant deadwood and broken branches.

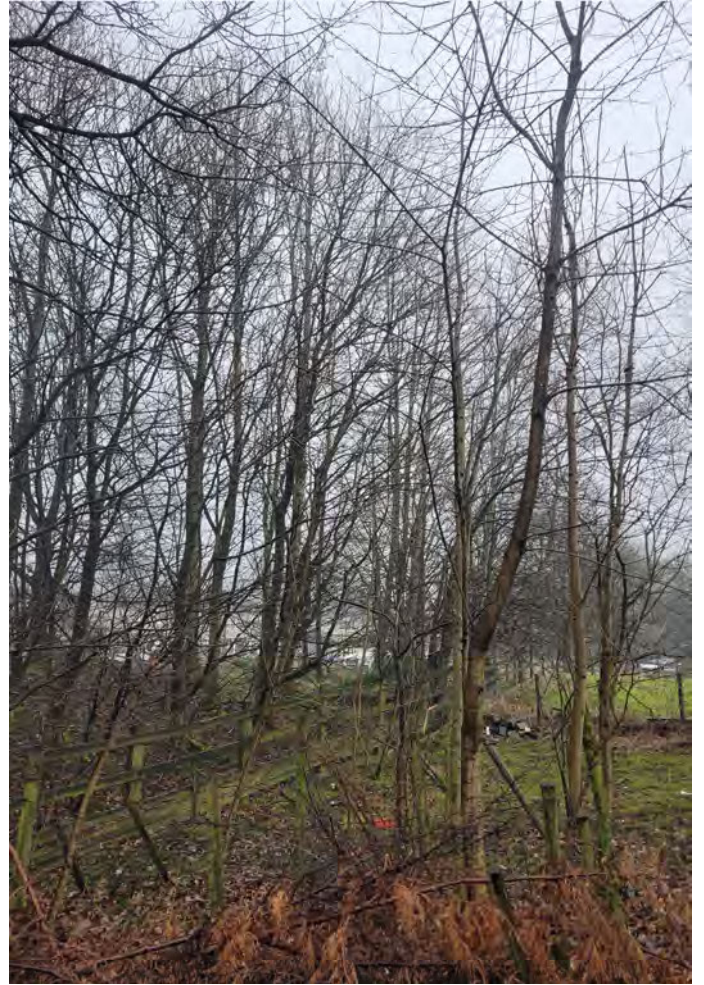
- 5.2.1 The above data table identifies that T18 is shown to have development within its shown Root Protection Area (RPA) due to new surfacing.
- 5.2.2 However, this intrusion is less than 20% of the overall RPA and far enough away from the buttress area not to cause too much root damage. This species is tolerant of some root intrusion and should not affect it long term. Some minor trimming back of foliage may be required for the new car parking space.
