Materials Specification

Pringle Homes
Crow Trees Farm
Crow Trees Brow
Chatburn
Clitheroe
BB7 4AA

May 2024

Listed Building Consent
Condition 3

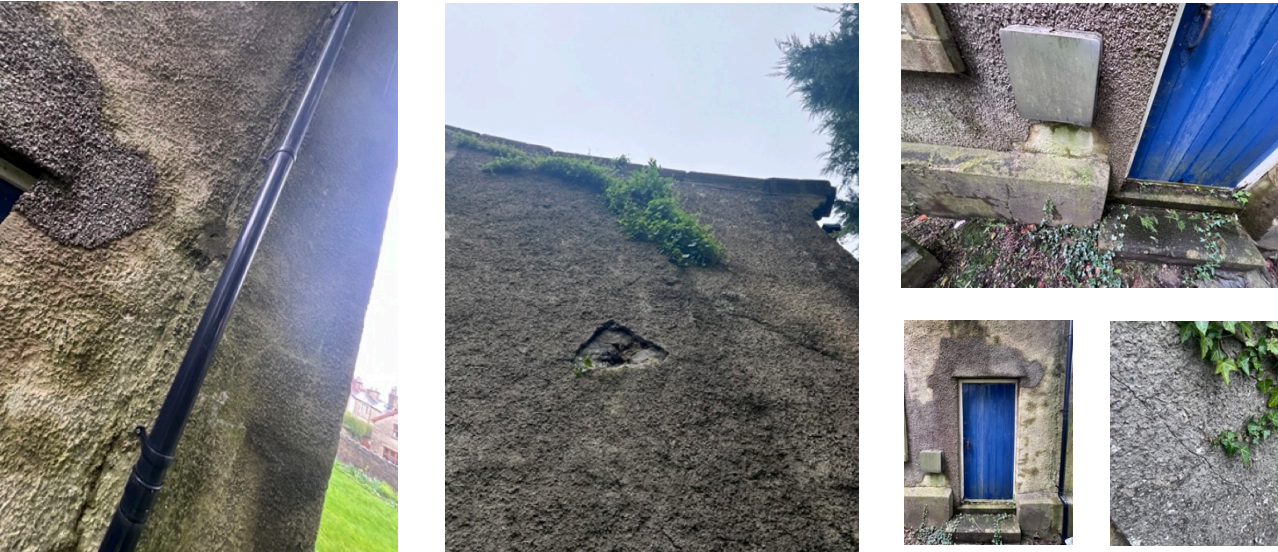
Fig: 3 Examples of deteriorating current cementitious render in extremely poor condition. Evidence of vegetation growing through the render in places along with substantial surface cracks.

Render: The use of an impervious Portland cement render (and/or application of an impervious paint) in place of a traditional lime-based covering restricts evaporation. This in turn has a detrimental effect on the substrate walls and the internal fabric of the building, with moisture content being forced back into the house rather than evaporating externally. Cement renders often fail in patches and detach from the wall which has occurred in a large number of places around the farmhouse. The cement render currently applied to the farmhouse has deteriorated severely, detaching from the walls in many areas and has plant life growing behind it in others. This needs removing and replacing with a breathable render that will preserve the longevity of the building fabric mimicking the style of a dashed render.

Render – Weber Monocouche chalk white

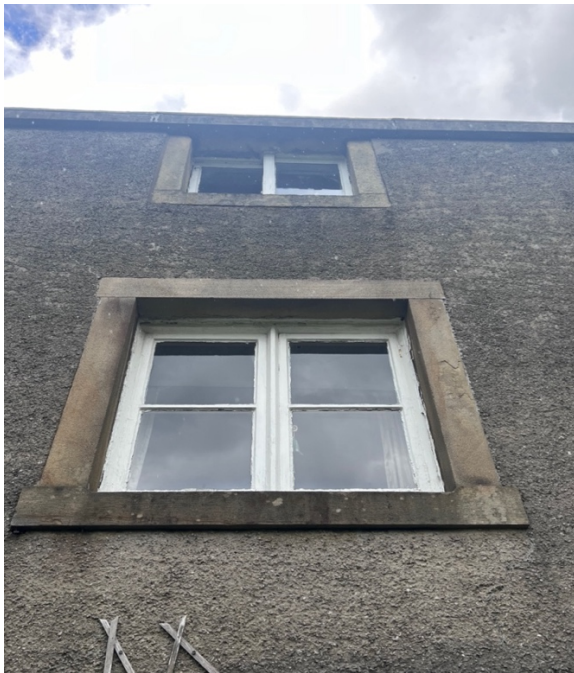
Fig: 4 Example of existing stone surround to be retained and cleaned

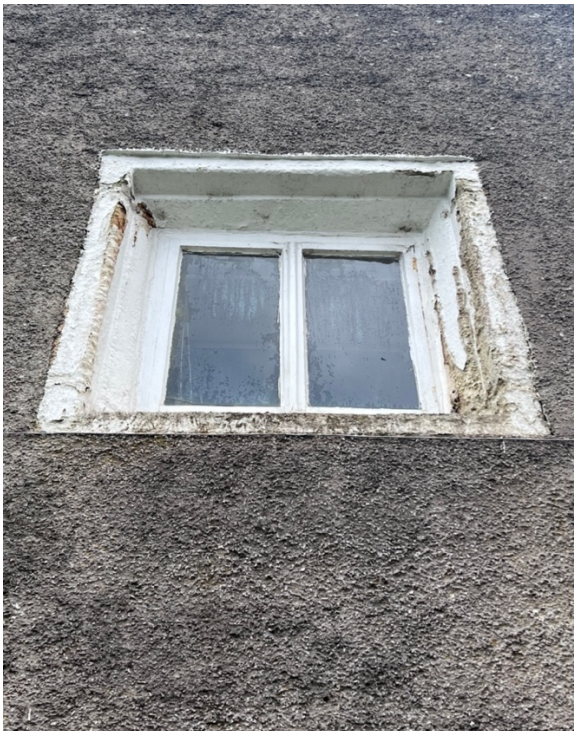
Fig: 5 Example of existing stone surround in extremely poor condition to be replaced with new natural stone to match profile/size

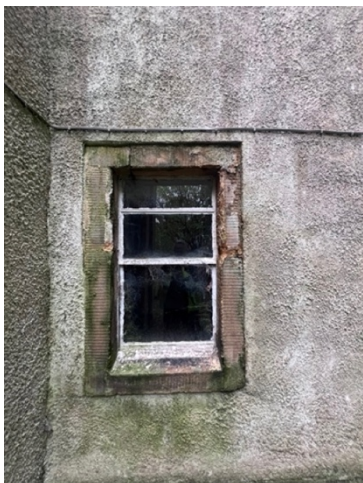
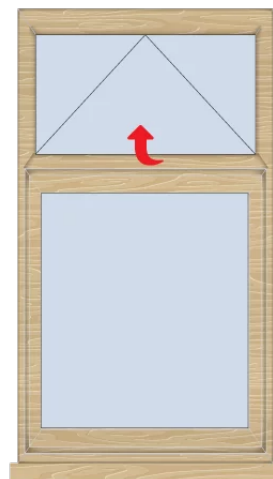
Fig: 7 Example of window in complete disrepair & example replacement in timber painted finish in RAL 7006 (Beige Grey)

- Have the window replaced by a newly manufactured wooden window of the same design as the original window if it is of a historic design. Or:
- Have the existing window refurbished if it is of historic importance. This would include making good the frames and fitting new seals, glass and fittings.
- Replacing any windows of inferior quality and of a modern design with wooden windows in keeping with the age of the building.
- All windows to be treated to give long-term protection against fungal and insect attack.

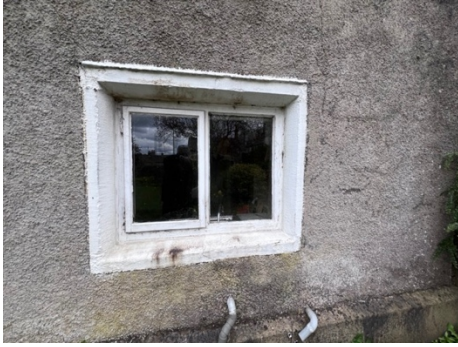
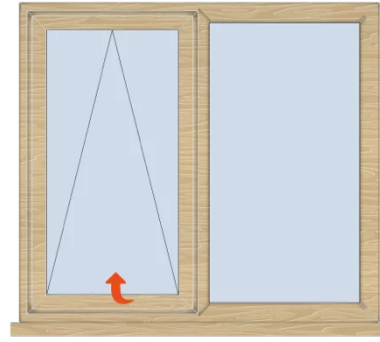
Fig: 8 Example existing window which appears to be circa 1980's/90's to be replaced for a more in keeping with original window in timber with painted finish RAL 7006 (Beige Grey)

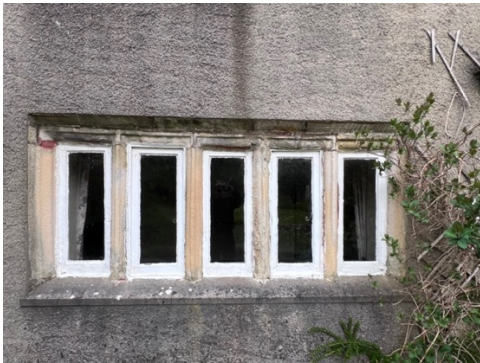
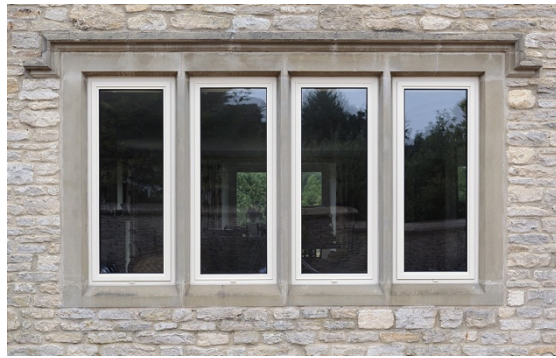
Fig: 9 Example original 17th century window to be replaced with Altherm Heritage (or similar) aluminium to mimic the original 17th century style, but offering modern energy efficiency finished in RAL 7006 (Beige Grey)

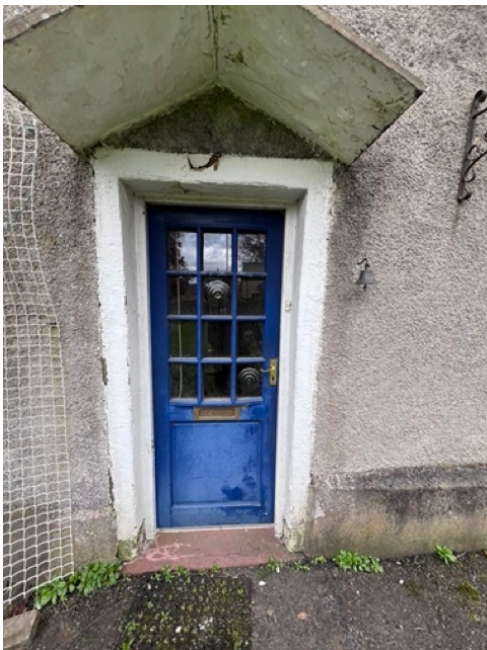
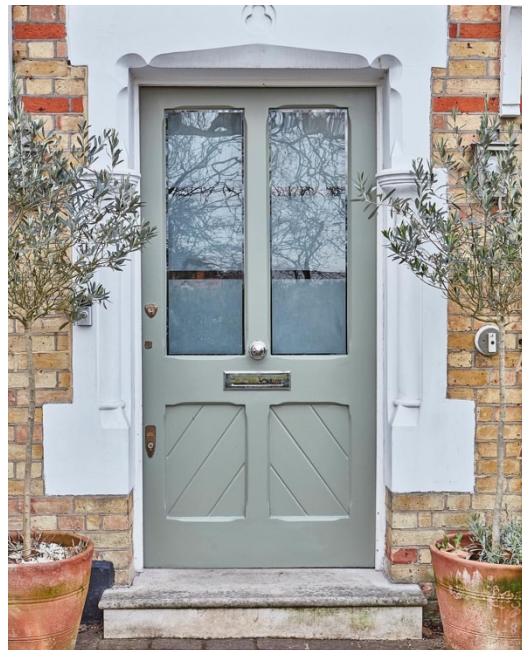
Fig: 10 Existing front door circa 1980's to be replaced for a more in keeping with original door in timber with painted finish RAL 7006 (Beige Grey)

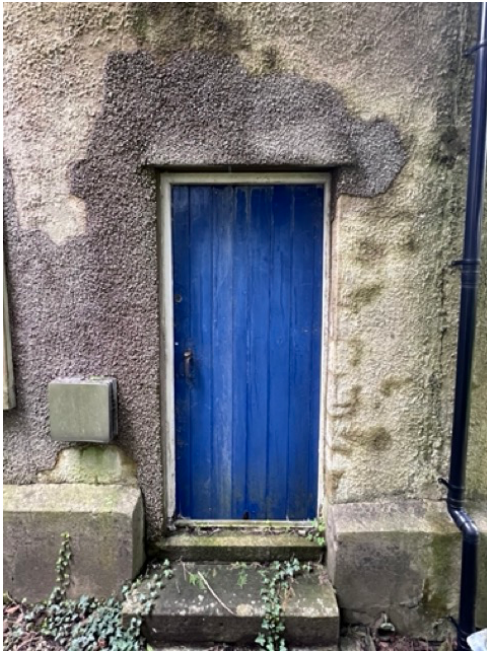
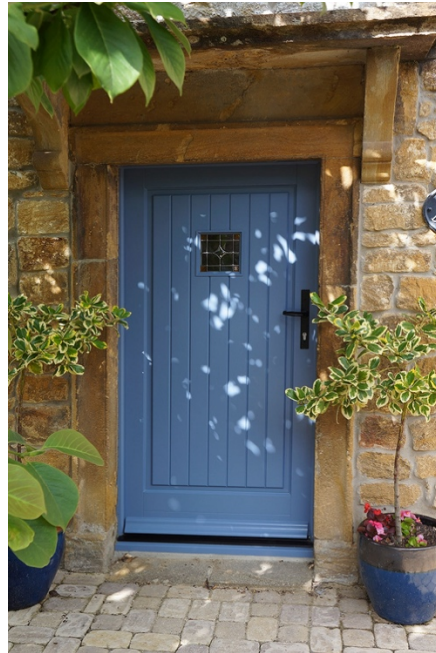
Fig: 11 Existing side door to be replaced with a more in keeping with original door in timber with painted finish RAL 7006 (Beige Grey)
