**HISTORIC BUILDING SURVEY REPORT:
CROW TREES FARM, CROW TREES BROW, CHATBURN, LANCASHIRE**

Planning References: 3/2022/0966 and 3/2022/0967

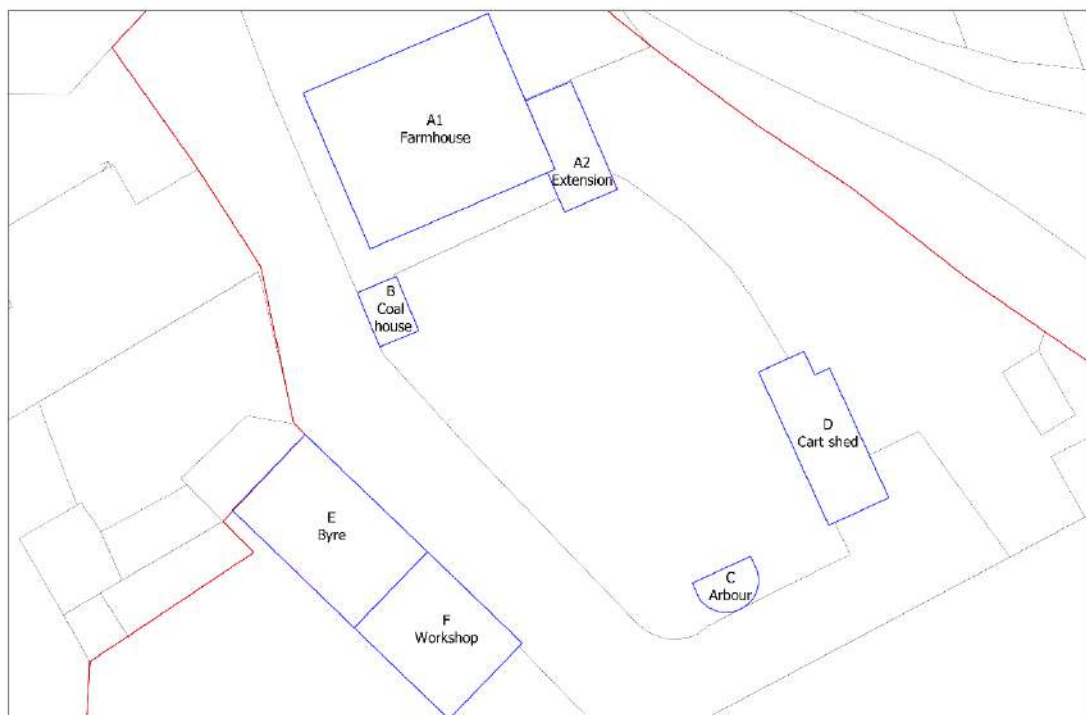
Plate 1: Block plan showing surveyed structures (base plan provided by the client)

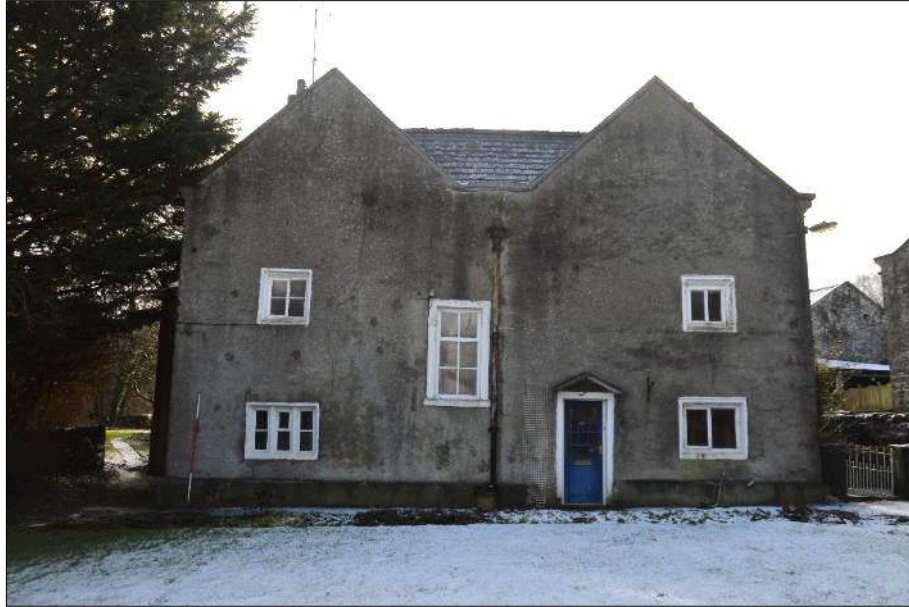
Plate 2 (shot 94): Northwest elevation of the farmhouse, looking south-southeast, 2m scale

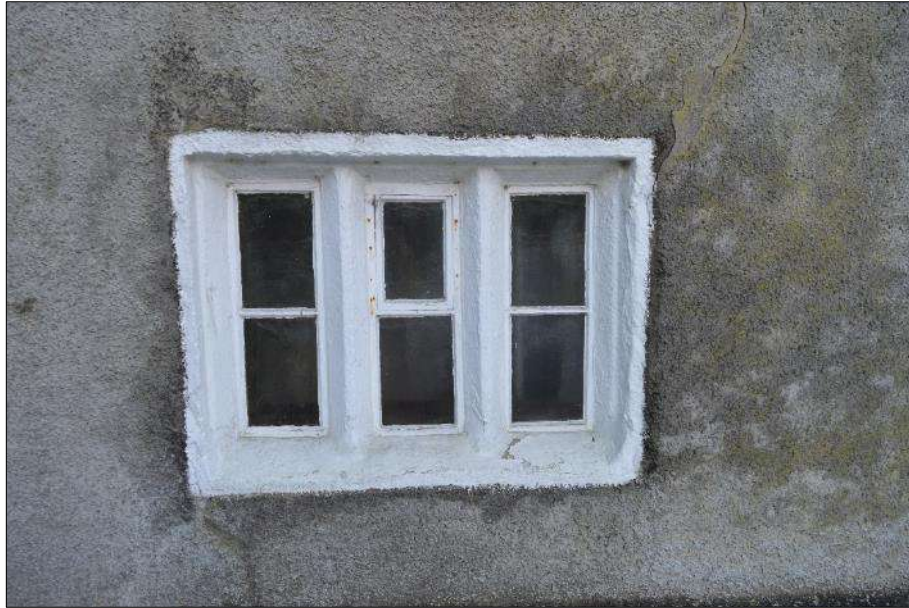
Plate 3 (shot 95): Small ground floor, mullioned window on the northwest elevation, looking south

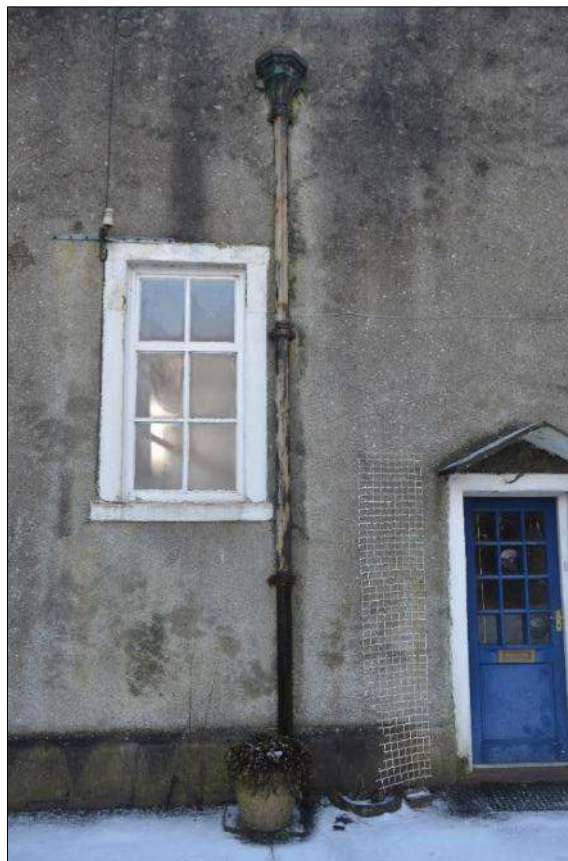
Plate 4 (shot 98): Close up of staircase window, cast iron gutter and entrance with plain canopy, looking south-southeast

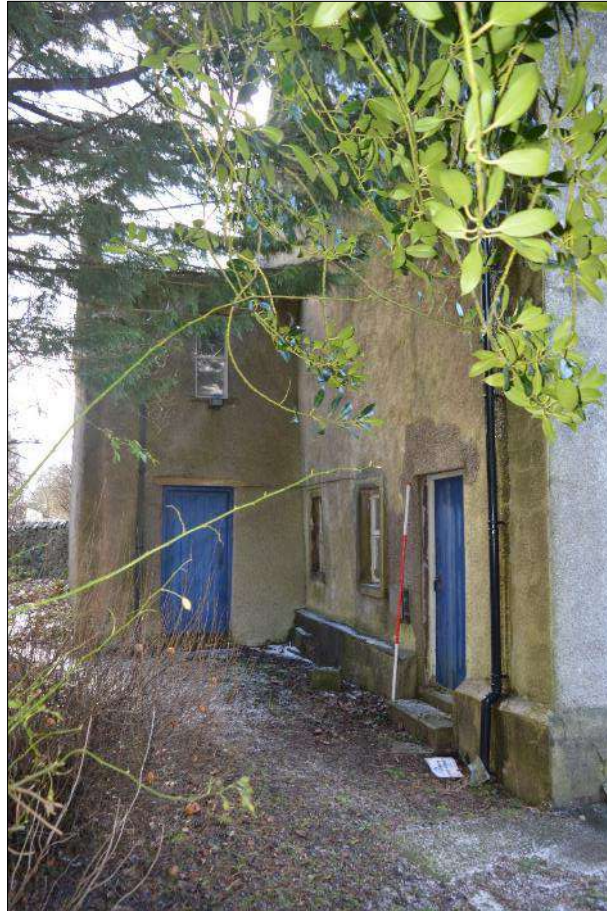
Plate 5 (shot 93): Northeast elevation abutted by extension A2 to the left, looking south, 2m scale

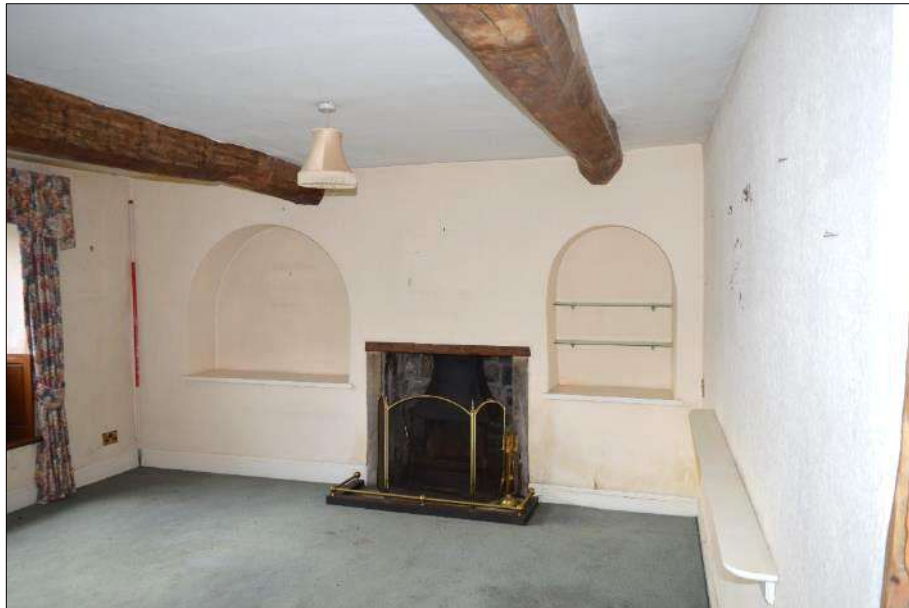
Plate 23 (shot 156): General view of the living room (1.2) towards the later wood burner and possibly later added niches, looking southwest, 2m scale

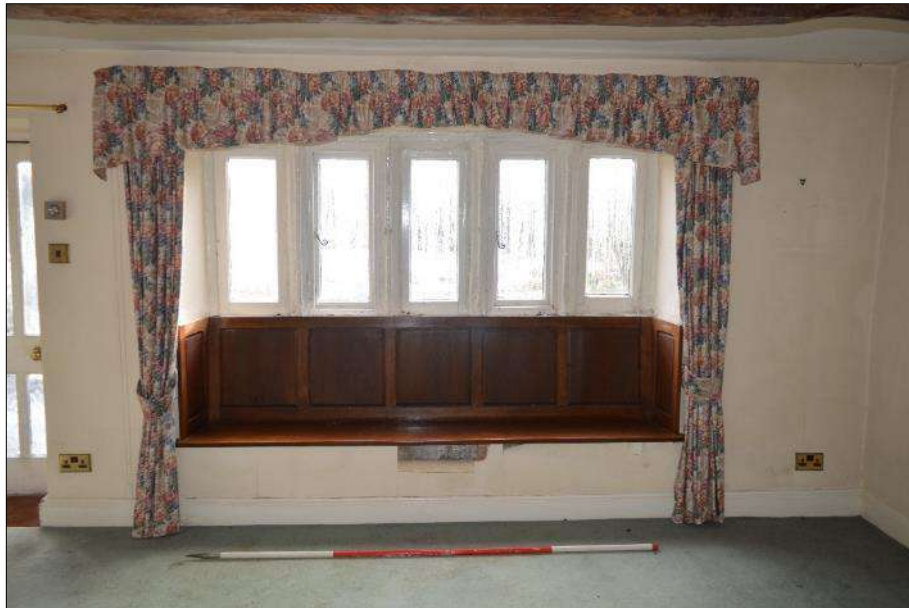
Plate 25 (shot 158): Arts and Crafts style window seat along the mullioned window, looking southwest, 2m scale

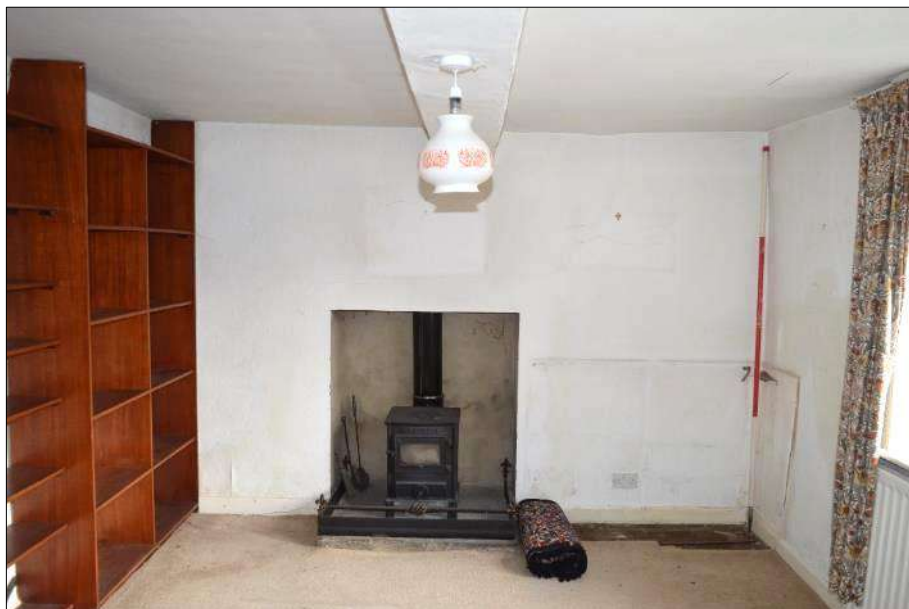
Plate 26 (shot 169): General view of sitting room (1.3) with wood burner in former fireplace, looking east-northeast, 2m scale

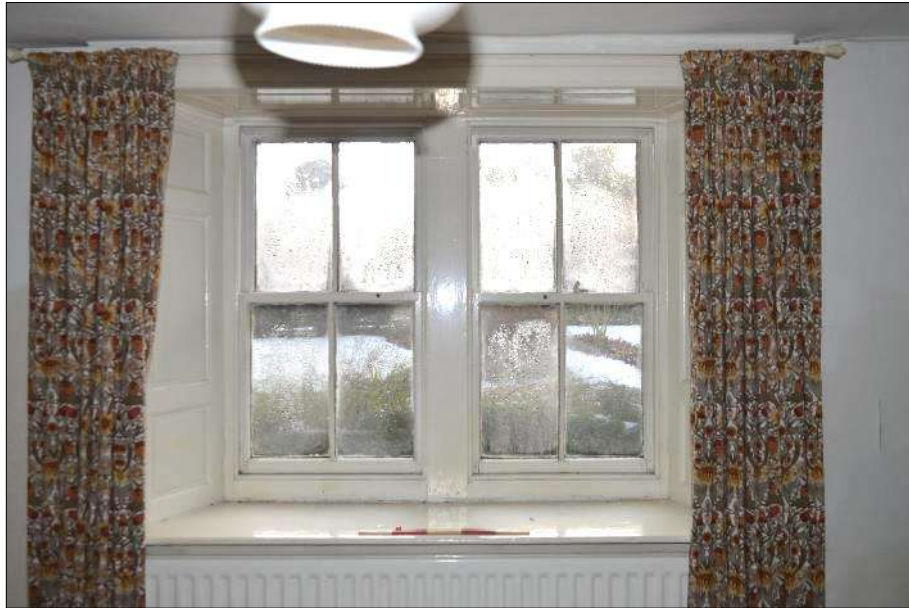
Plate 27 (shot 171): Close up of window with panelled shutters, looking south-southeast, 0.5m scale

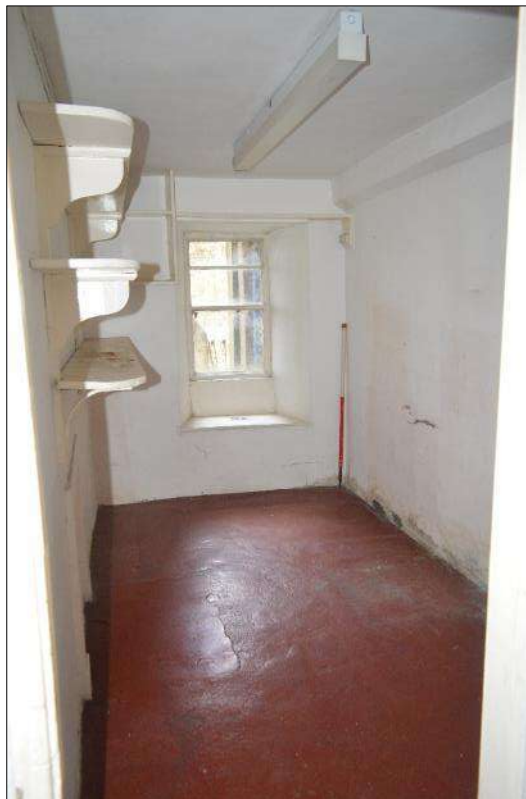
Plate 28 (shot 179): General view of small room (1.4), looking east-northeast, 1m scale

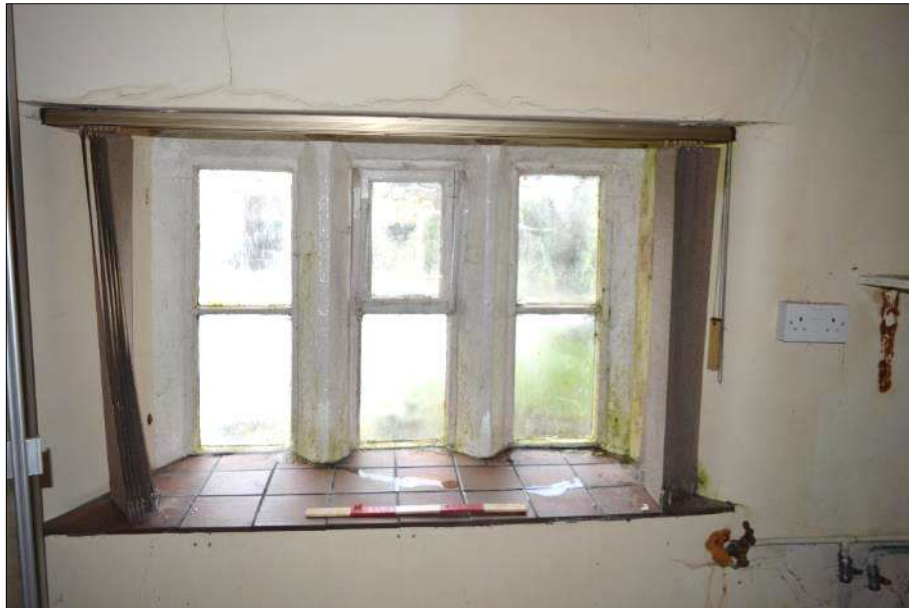
Plate 30 (shot 177): Mullioned window facing the road of Crow Trees Brow, looking north-northwest, 0.5m scale

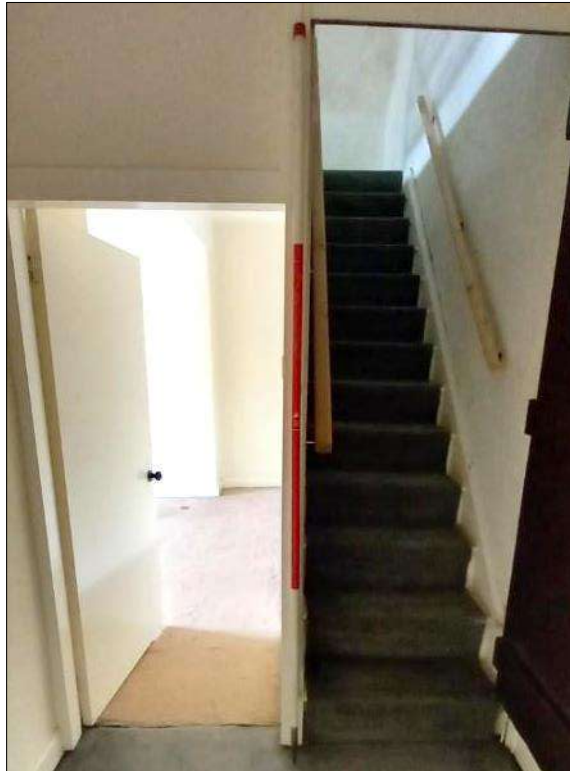
Plate 41 (shot 198): View of staircase to second floor, looking southwest, 2m scale

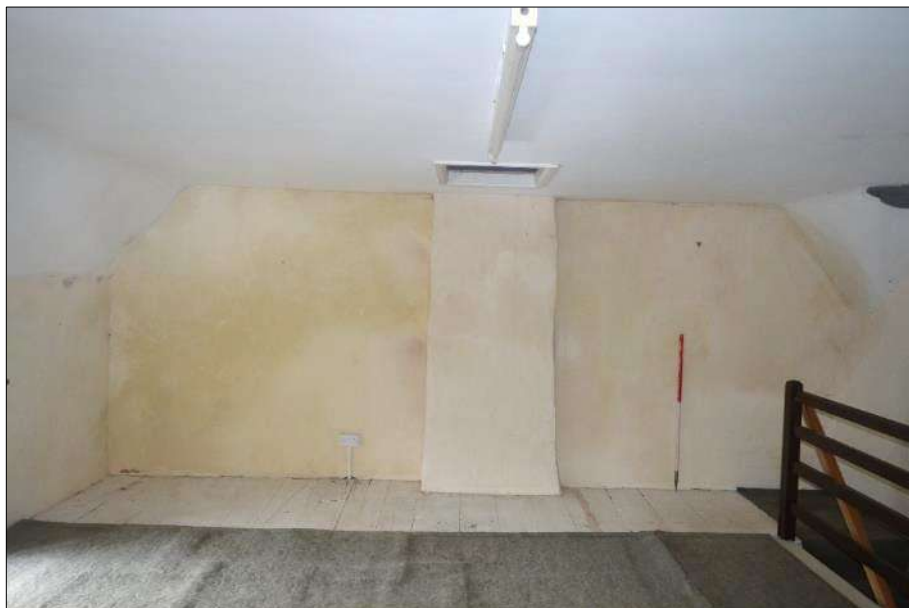
Plate 42 (shot 212): View of room (3.1) towards the chimney breast and modern roof hatch, looking southwest, 1m scale

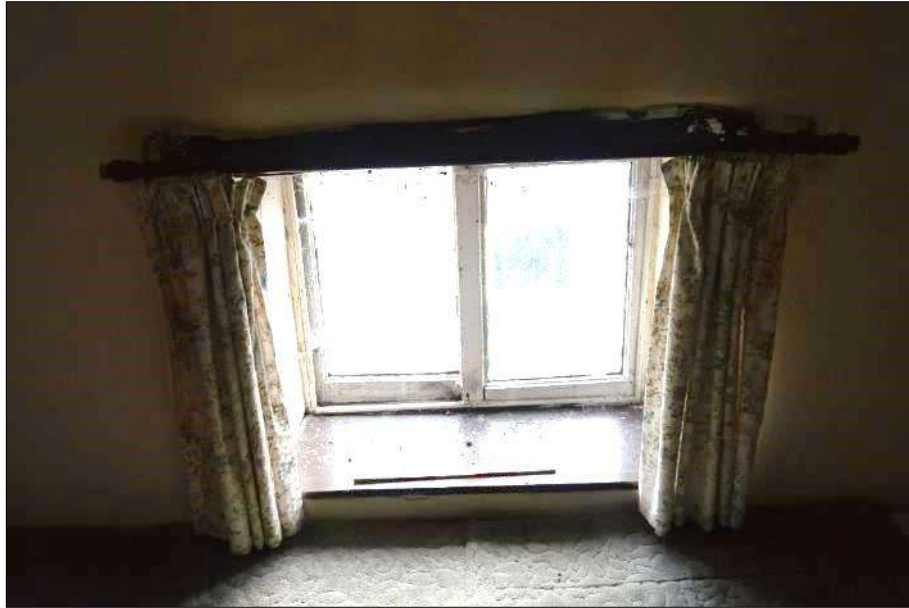
Plate 43 (shot 215): View of vertical sash in room (3.1), looking south-southeast, 1m scale

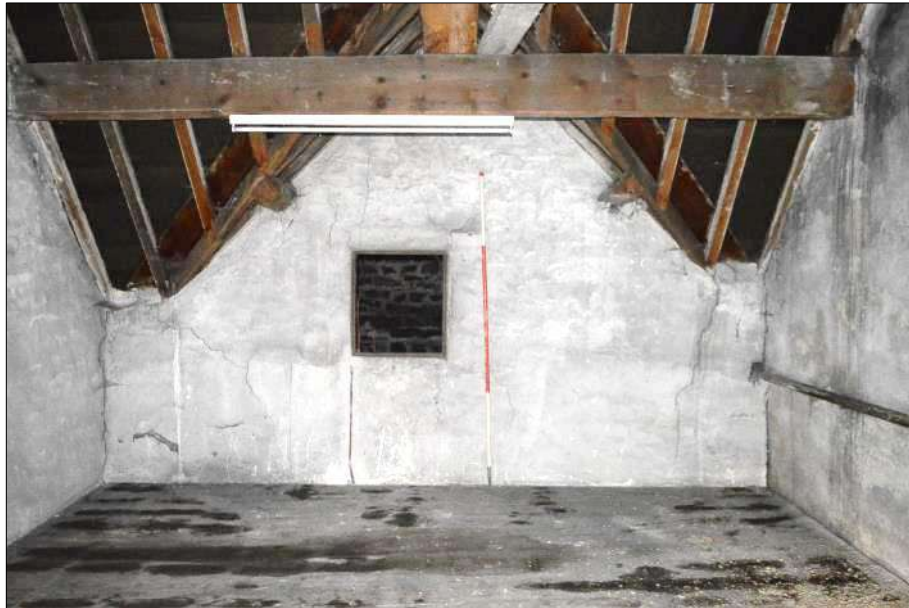
Plate 45 (shot 224): General view towards the northeast gable, looking north-northwest, 2m scale

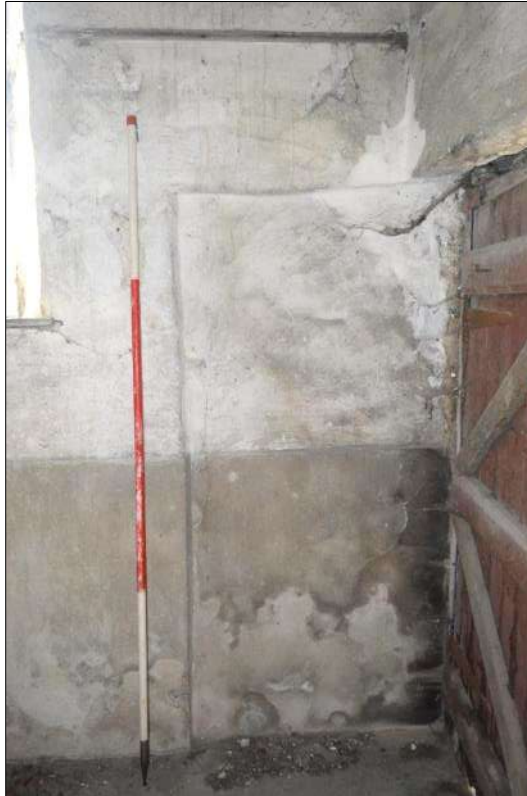
Plate 56 (shot 132): Recess to accommodate the door in the southeast wall, 2m scale

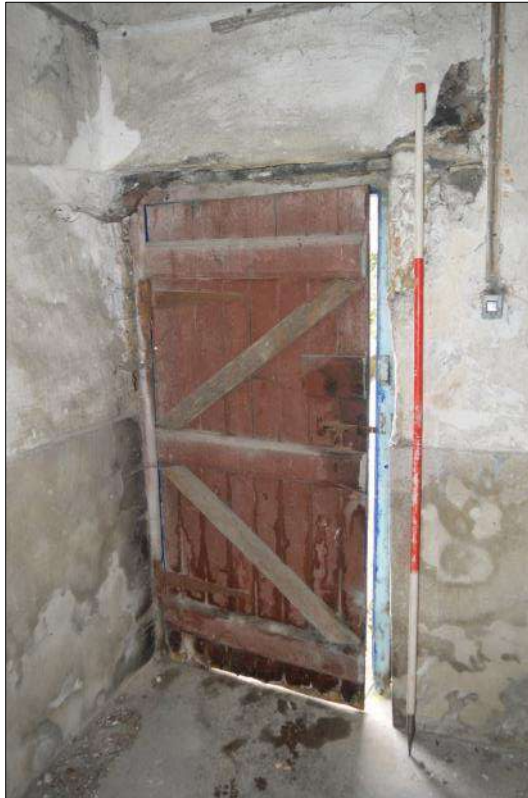
Plate 57 (shot 133): Close up of southwest plank and batten door, looking southwest, 2m scale

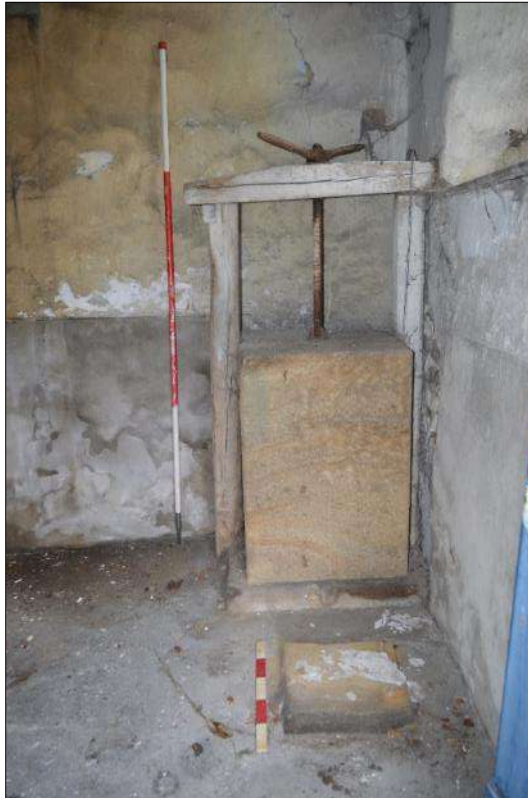
Plate 58 (shot 135): In situ cheese press and associated platform in front, looking east-northeast, 2m and 0.5m scales

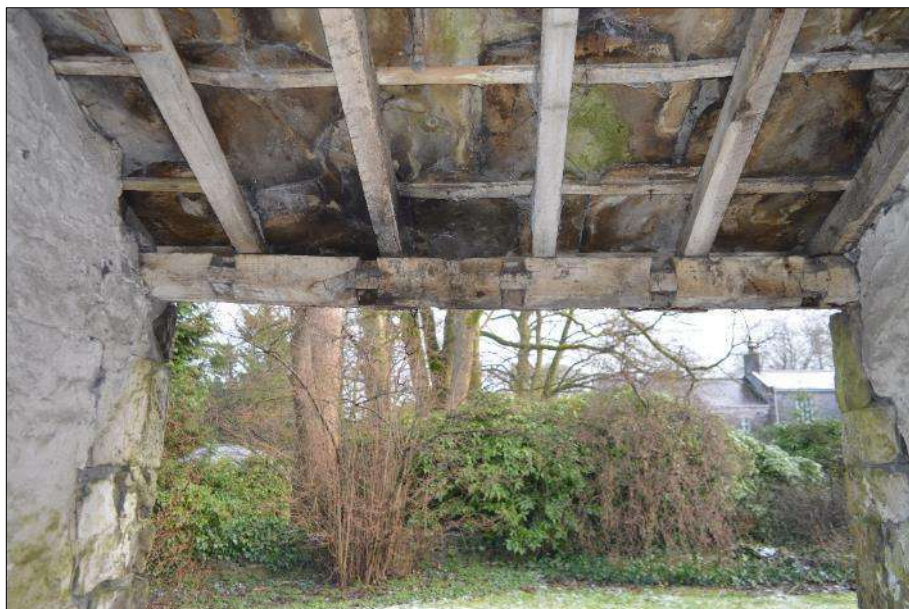
Plate 68 (shot 81): Reused main beam as wall plate, looking northeast

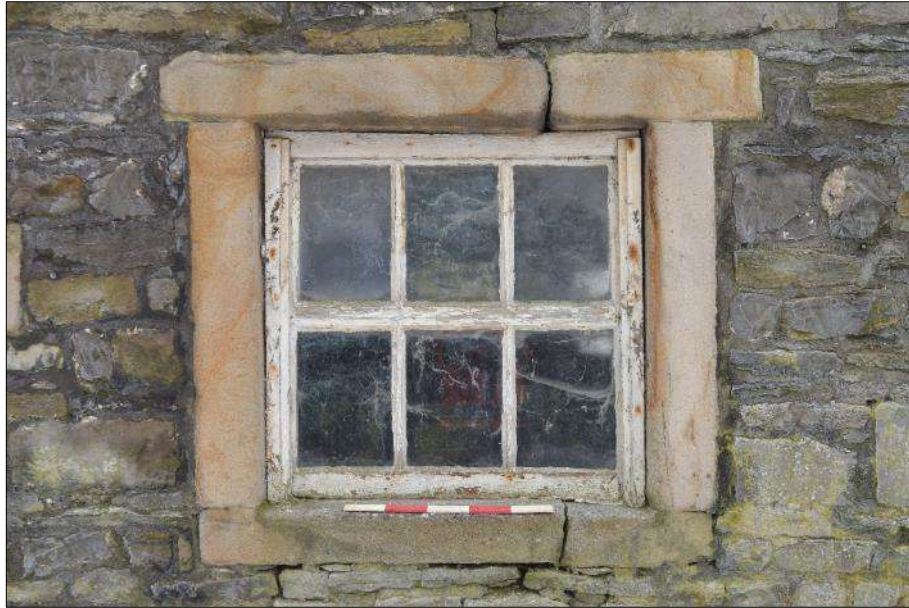
Plate 71 (shot 4): Timber window with top opening in with plain stone surround, looking southwest, 0.5m scale

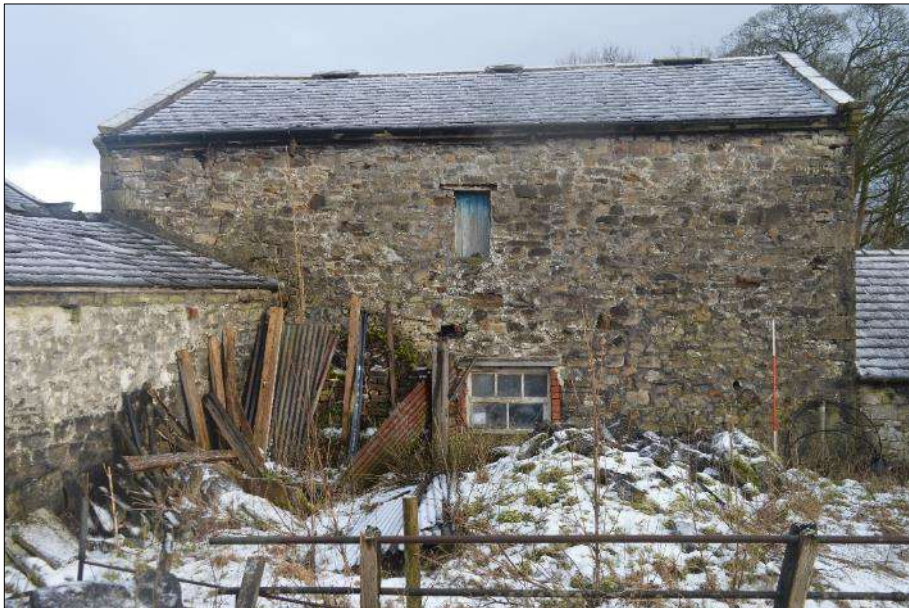
Plate 72 (shot 48): Southwest elevation, looking northeast, 2m scale

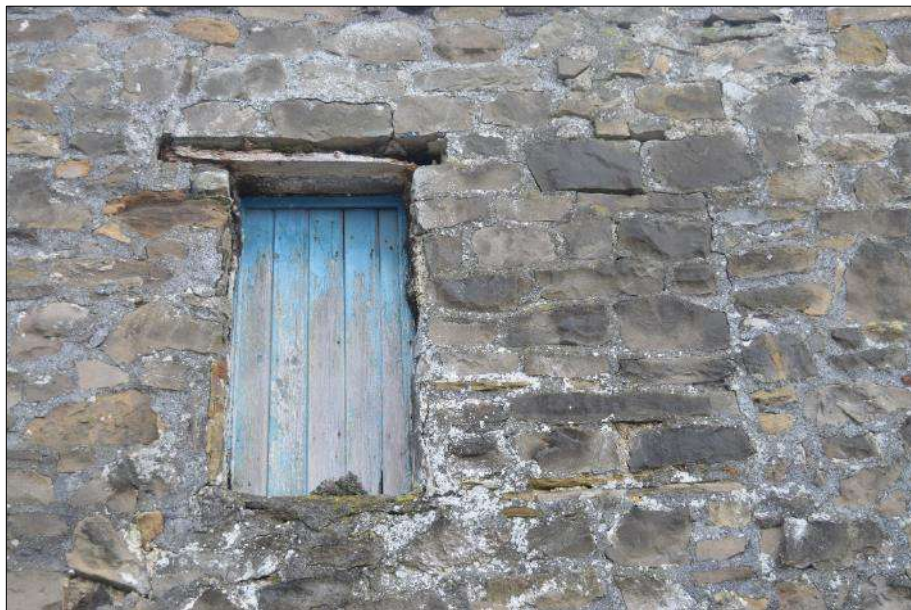
Plate 74 (shot 51): Reduced first floor opening, looking northeast

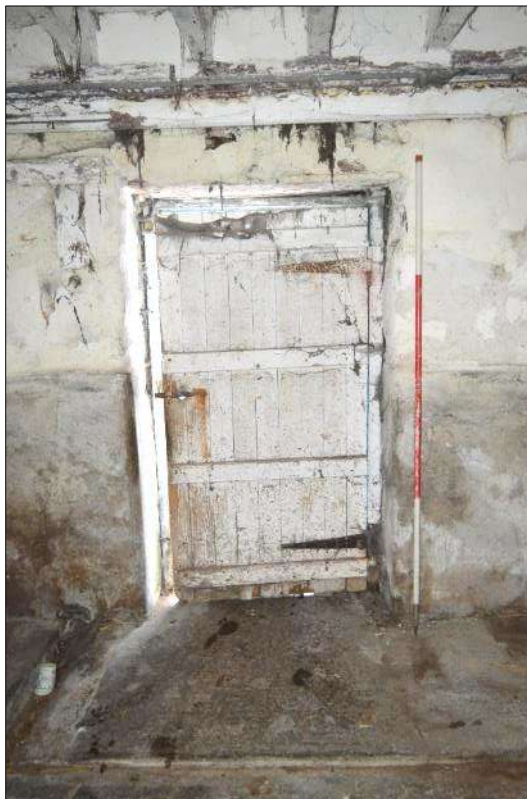
Plate 78 (shot 14): Close up of plank and batten door in later 19th century style, notice the small drainage channel to the left of the door, looking northeast, 2m scale

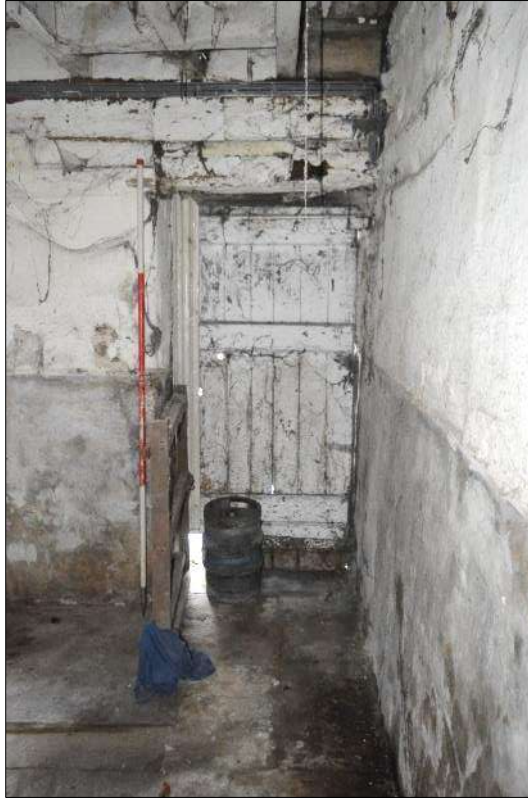
Plate 79 (shot 15): Early 19th century style plank and batten door with beaded narrow planks, looking northeast, 2m scale

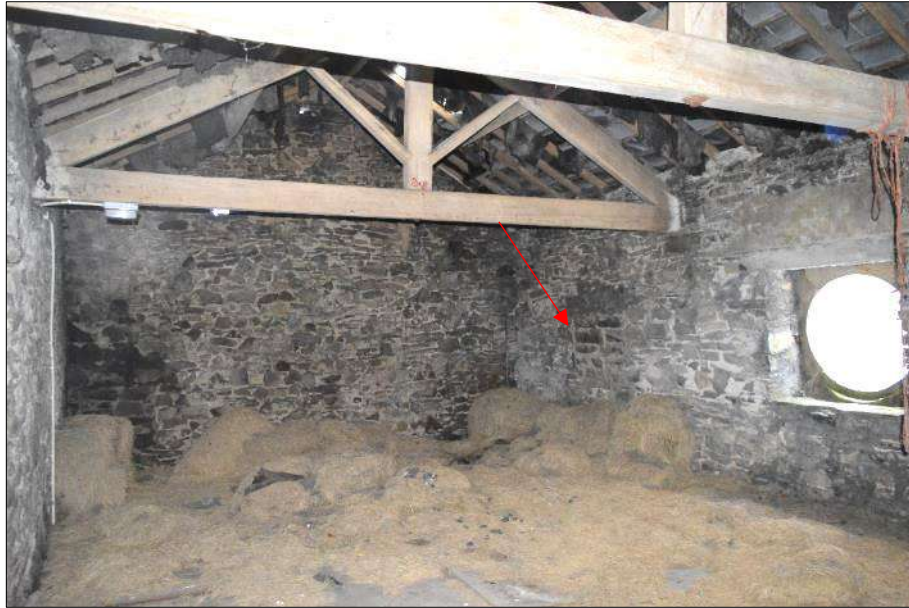
Plate 80 (shot 26): General view of the north half of the loft, arrow points to blocked window
