Written Stone Farmhouse, Longridge

BAT SURVEY REPORT

September 2024

Report Ref: 093_04

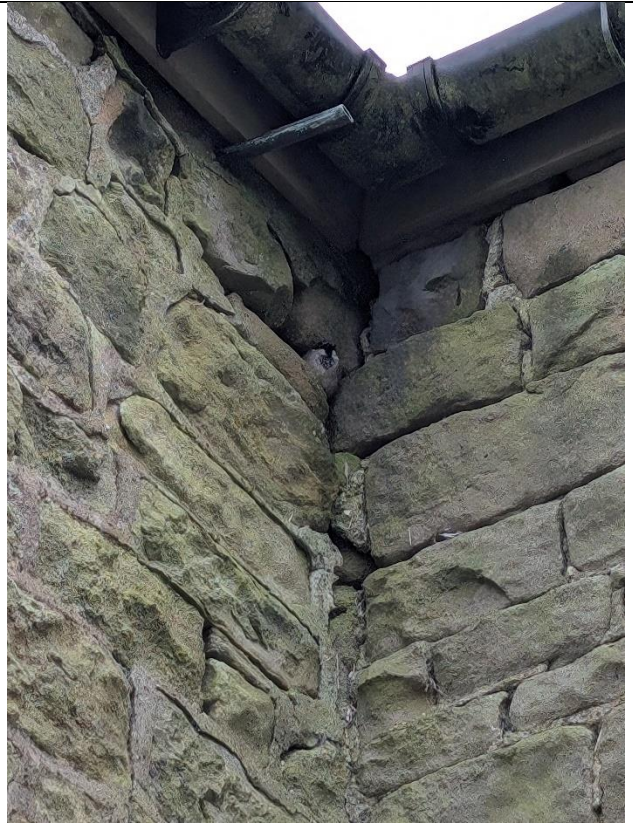
Photo 3.1.

During the preliminary bat roost assessment on 12th April, a male house sparrow was observed exiting a gap in the wall just below the roof eaves on the east elevation (see Photo 3.1 below). This was originally attributed to a nest site. No further evidence of nesting sparrows was observed in later visits. House sparrow is a 'red-listed' bird of conservation concern and a priority listed species. The house contains numerous features within the roof to support nesting birds.

House sparrow in cavity on east elevation.

The property owner is recommended to consider installing at least two-house sparrow boxes on the property or adjacent barns. Bird box models, locations and siting advice can be provided as a post-permission matter.

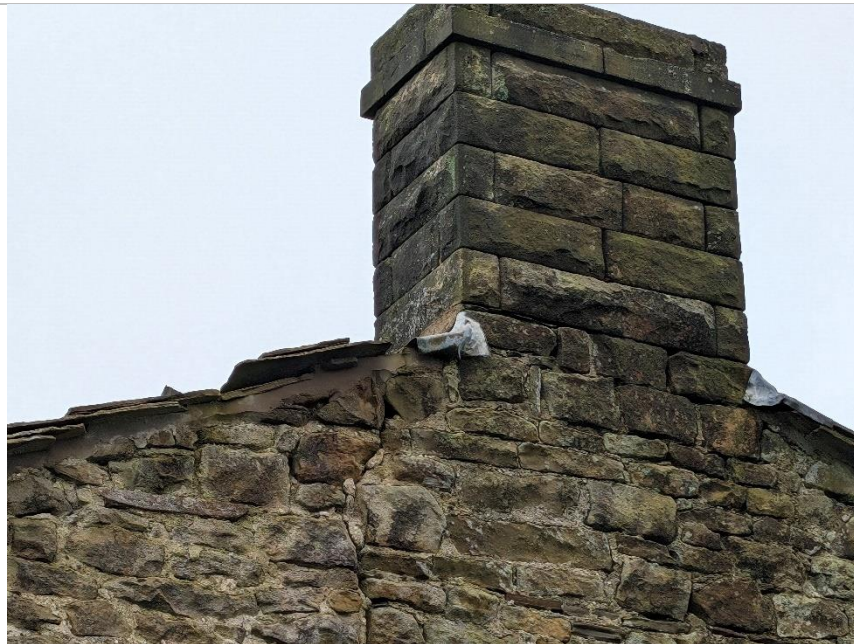
Photo 3

No bats or evidence of bats was recorded. In respect of the above-described roost features along with the property location and surrounding habitats, a **moderate roost suitability** category was assigned to the farmhouse. In summary, potential bat roost features comprised;

Gap in stonework, gaps under verge roof tiles and gaps under lead flashing.
