**Discharge of Conditions Statement following Planning
Permission under application number 3/2023/0287 and
Listed Building Consent 3/2023/0288**

Mr A Shorten
Bridge End Farm
Slaidburn
Clitheroe
BB7 3AH

HISTORIC BUILDING RECORD

Bridge End Farm, Wood House Lane, Slaidburn BB7 3AH

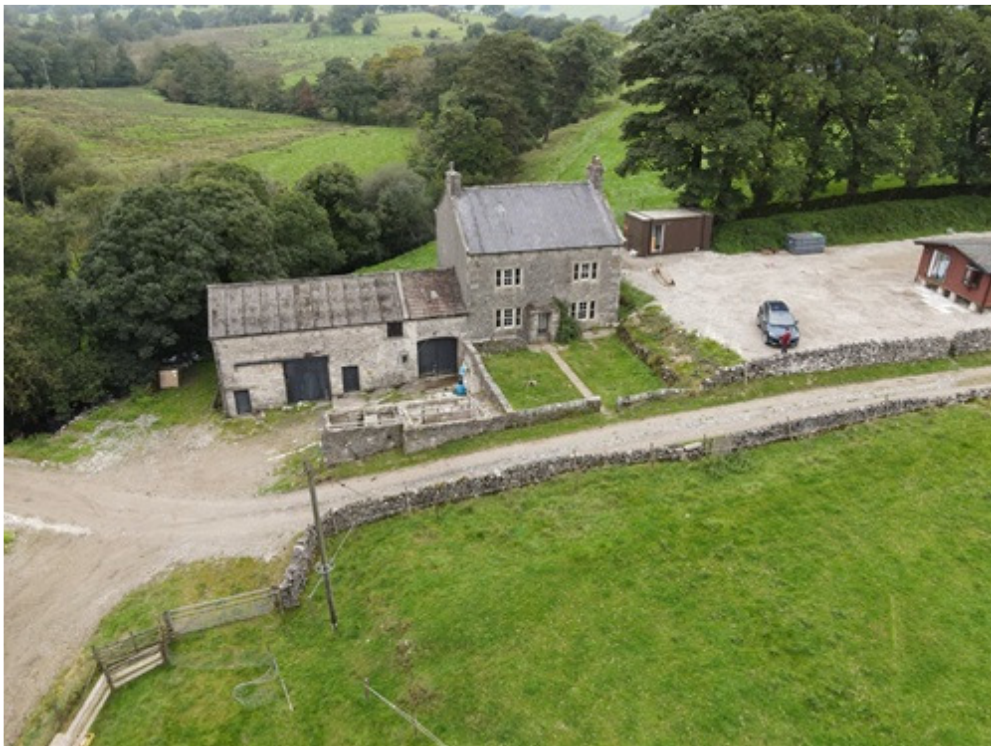
1. Aerial view from the south

The front wall of the house is regular coursed and knapped sandstone laid in lime mortar. The openings are plain with windows set between mullions (see photos 1,5)

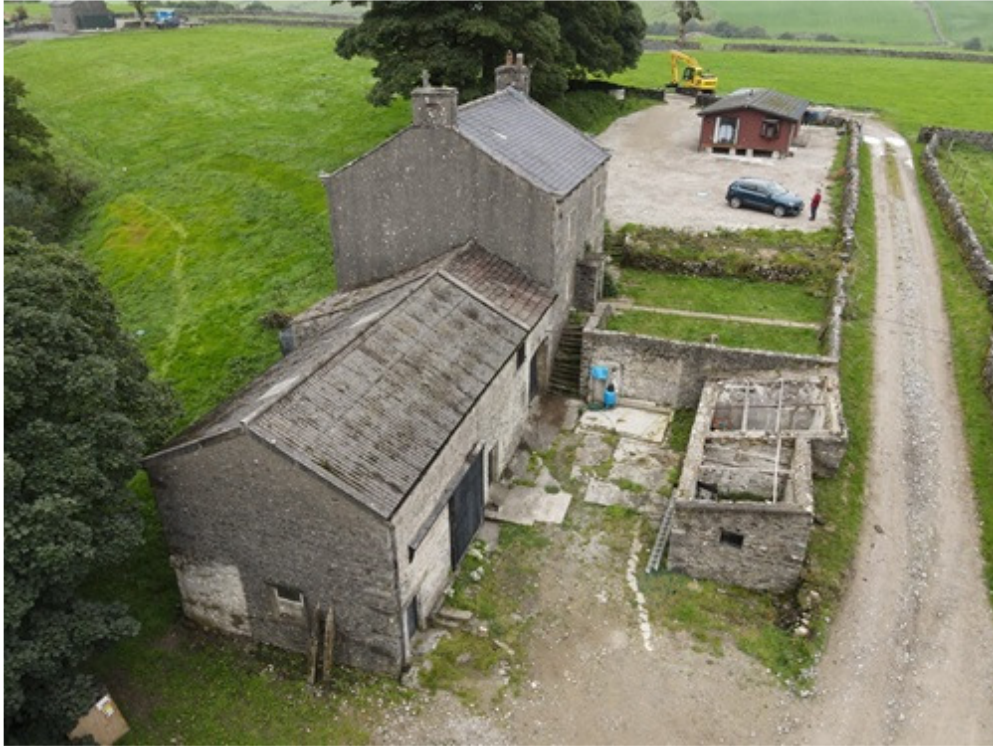
2. Aerial view from the west

The north elevation and west gable are rubblestone and were probably rendered originally (see photos 3,6,7,9); sand cement render remains on the west gable (photo 2).

The roof comprises corrugated mineral cement sheeting over modern purlins over original 18th century trusses in part (see photos 29,30). The walls are rubble stone with simple 18th century style lintels, reveals and cills. There are 19th century window insertions at the rear. The earth closet that formerly sat against the west gable is lost (photo 2).

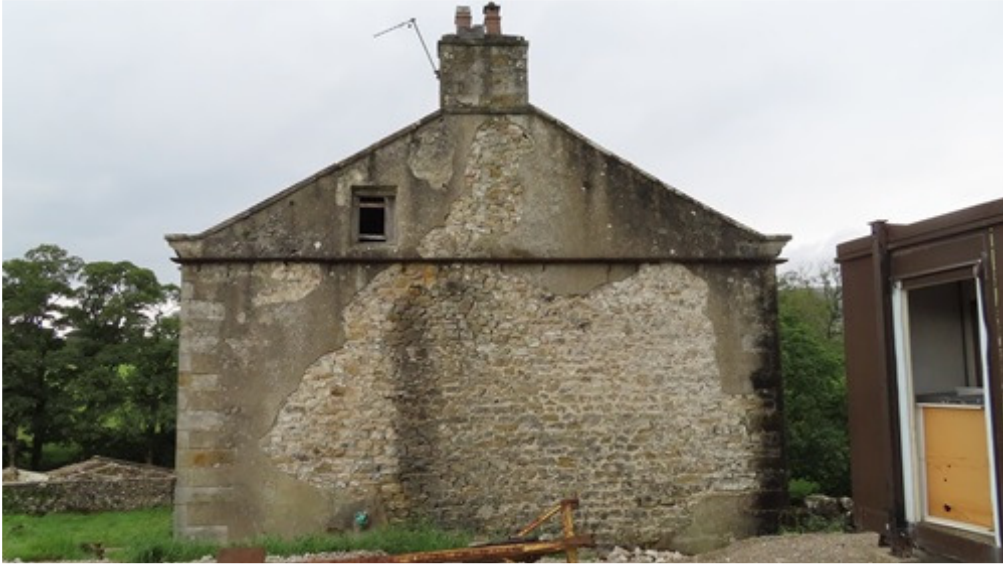
4. The east gable

The east gable is rubble stone with sand cement render (photo 4).

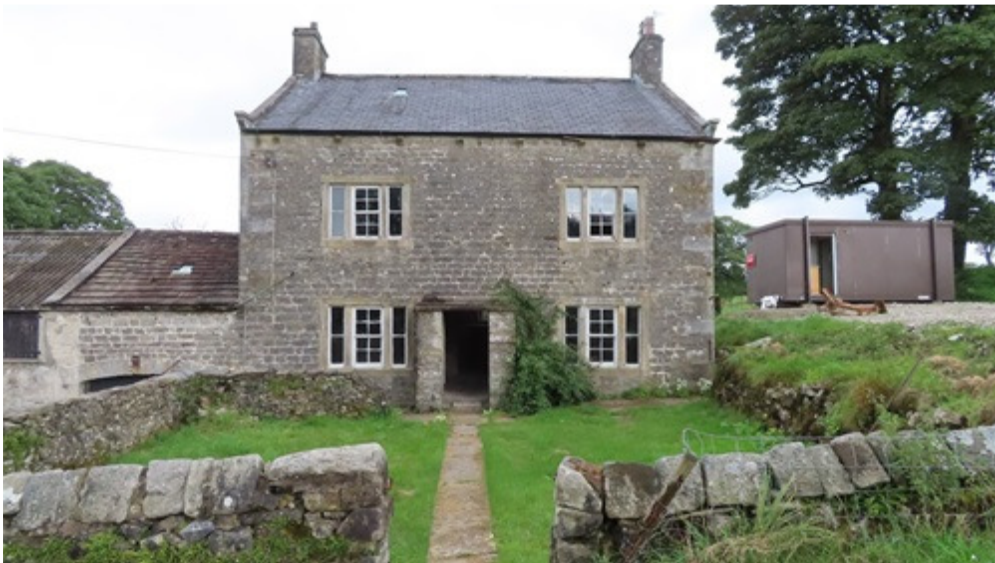
The features that pertain to this locality are the tripartite windows on the front elevation; R W Brunskill in “Vernacular Architecture – An illustrated Handbook” (2000 Edition) states that this style was common throughout the Pennines and Westmorland with central sliding sash and fixed side casements (Photo 5). The arrangement of the windows that light the staircase are also unusual in their ‘T’ arrangement (Photo 3) but both have been substantially altered with the insertion of larger glass panes and 2-over-2 style sash in the late 19th century.

Some unsympathetic alterations exist in the front and rear porches and improvised window arrangements at rear ground floor level (Photos 5 & 7).

5. The front (south) elevation

The original front door remains (photos 5, 10) with an ornate carved internal panel.

The front 4/4 sash windows remain between the front mullions but the margins have been altered to 2/2 arrangements (see photos 5, 15,16,41,43).

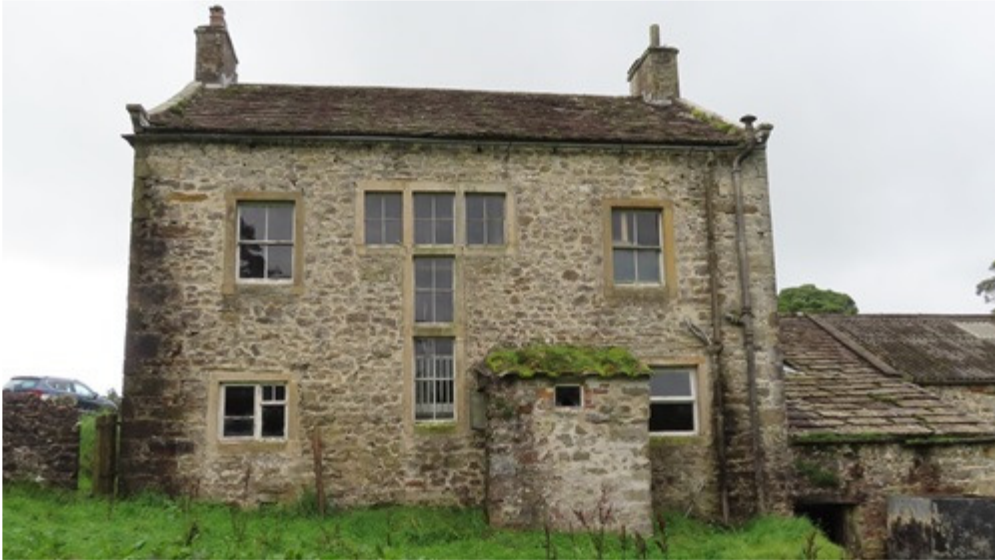
6. North elevation

The rear windows have been much altered also with late 19th C 2/2 sashes and casements (see photo 6,18,37,39).

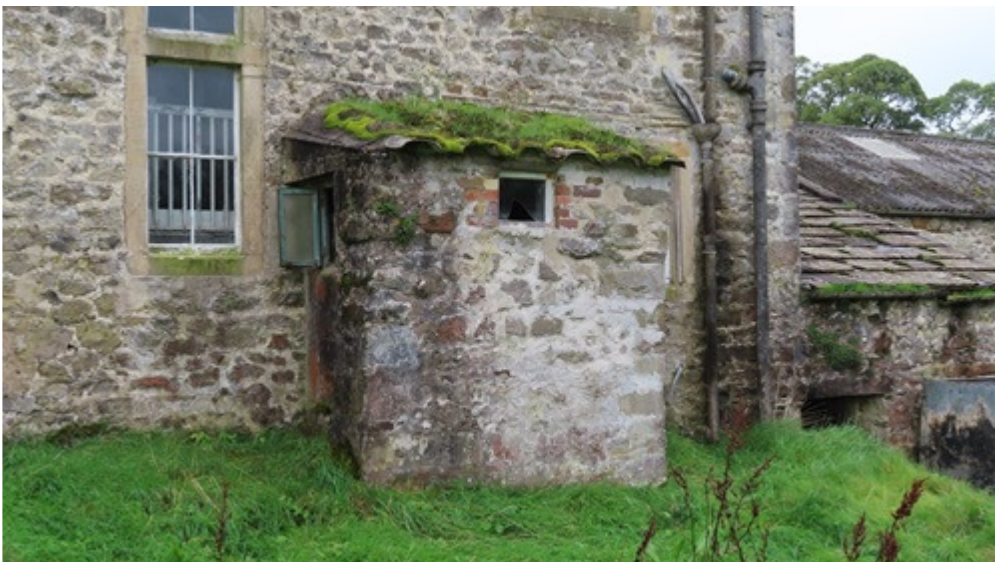
7. Improvised porch to north side

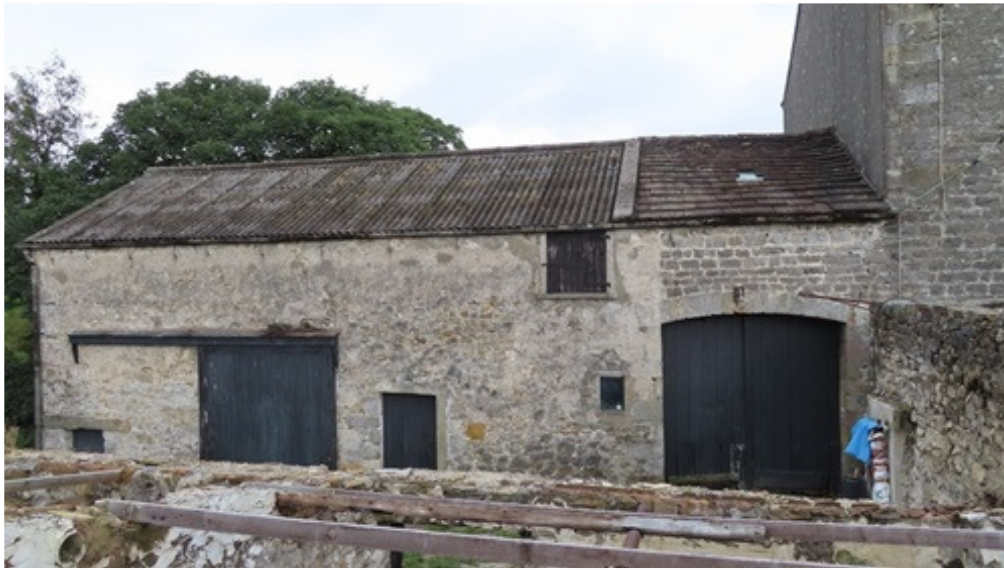
8. The south-facing trap house and barn; note that the masonry bonding of the house and trap house is continuous, indicating that they were built at the same time

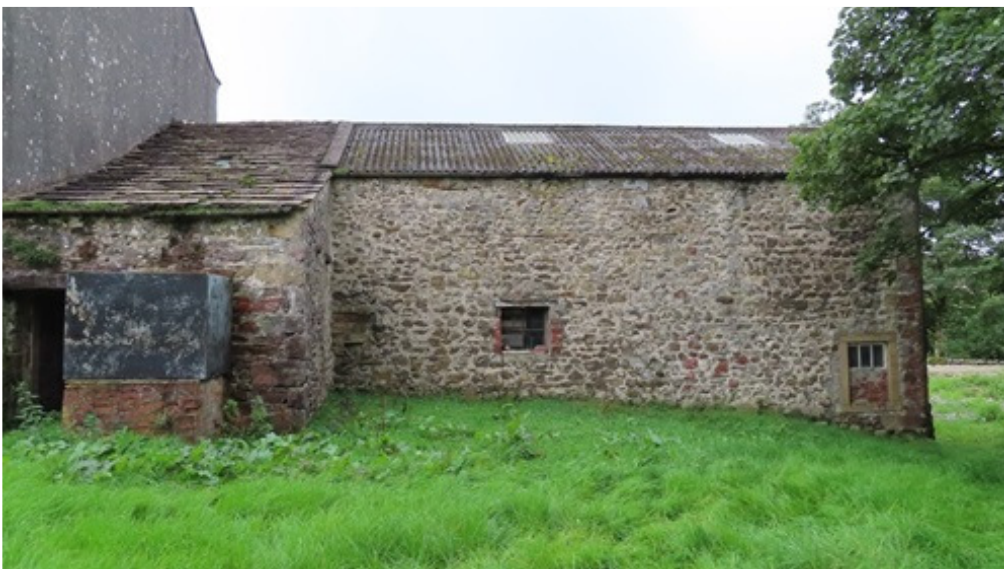
9. The rubblestone construction of the barn; note that the original roof finish is lost and has been replaced with corrugated mineral cement sheets, the original flag roof of the trap house remains

The barn has lost its flag finishes and is protected with corrugated mineral cement sheets.

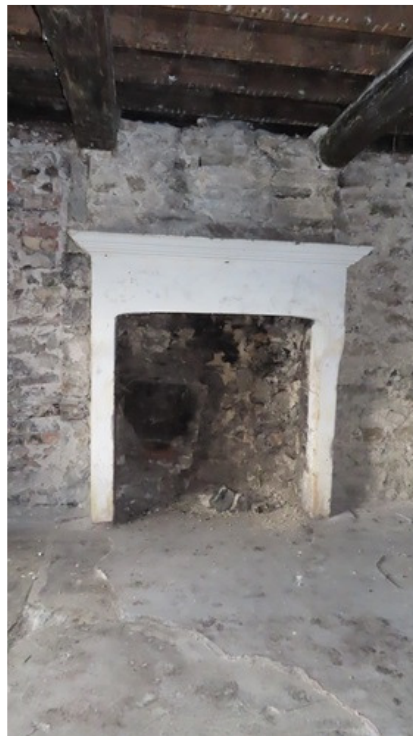
11.

All lathe and plaster ceilings have been removed (see photos 11,13,14,17,22,44,45).

The sole remaining fireplace is located in the front left reception room (photo 11); all others have been removed (photos 13,17,40,42).

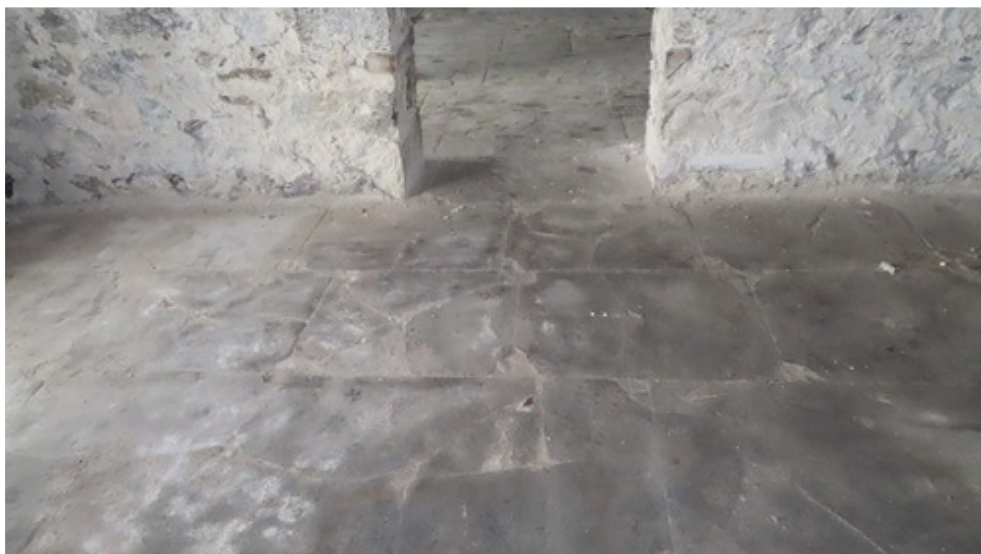
12.

At ground floor level the sandstone flags remain but are heavily fractured (see photos 12, 14). The timber floor in the rear right room is lost (photo 33).

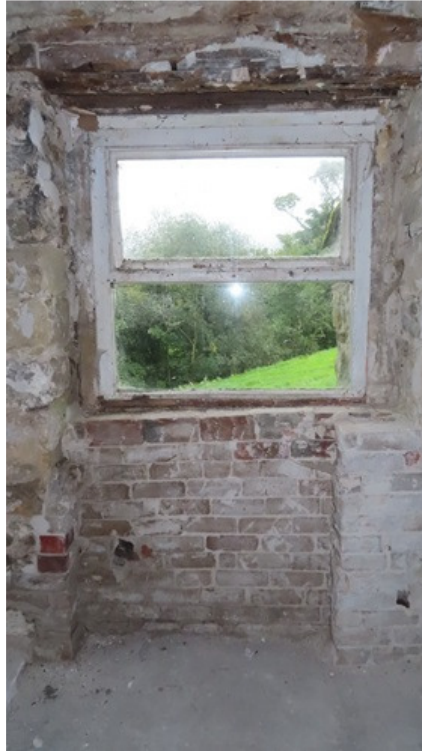
18.

The evidence of building styles dates the house and trap house to around 1800 with an earlier field barn circa 1750. Changes to the windows and rainwater goods indicate that the property underwent re-styling sometime toward the end of the 19th century. The evidence of post-1850 Imperial bricks around window openings reinforces this view (see photos 18,37,39).

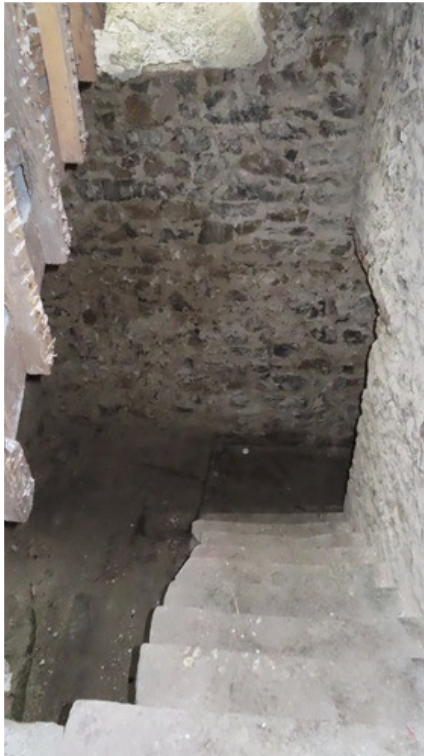
21.

The main timber stair comprises simple newel posts, handrails and spindles; the latter are missing at second floor level (see photos 20,21,34,35,46,47,53).

A simple stone stair leads to the basement at lower ground level; the balustrading is missing (photo 21).

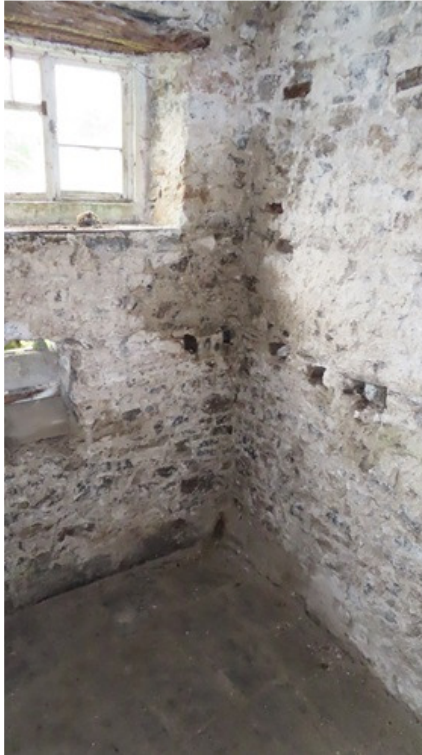
33.

The flags at lower ground level in the basement remain (photo 33).
