BAT PRESENCE / ABSENCE SURVEY

Black Moss Farm

Elmridge Lane
Chipping
Preston
Lancashire
PR3 2NY

Date: 9th September 2024
UES reference: UES03941/08

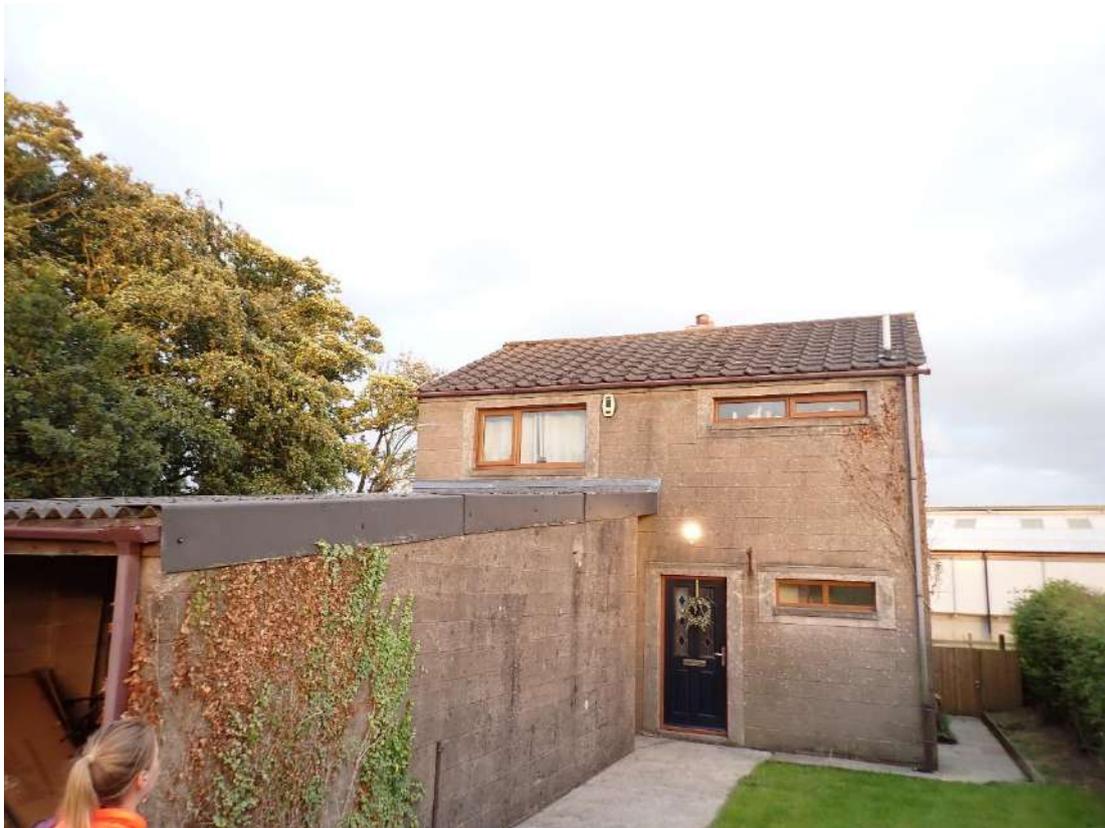
Photograph 6 - View of a missing section of bargeboard on the western aspect of Building 1.

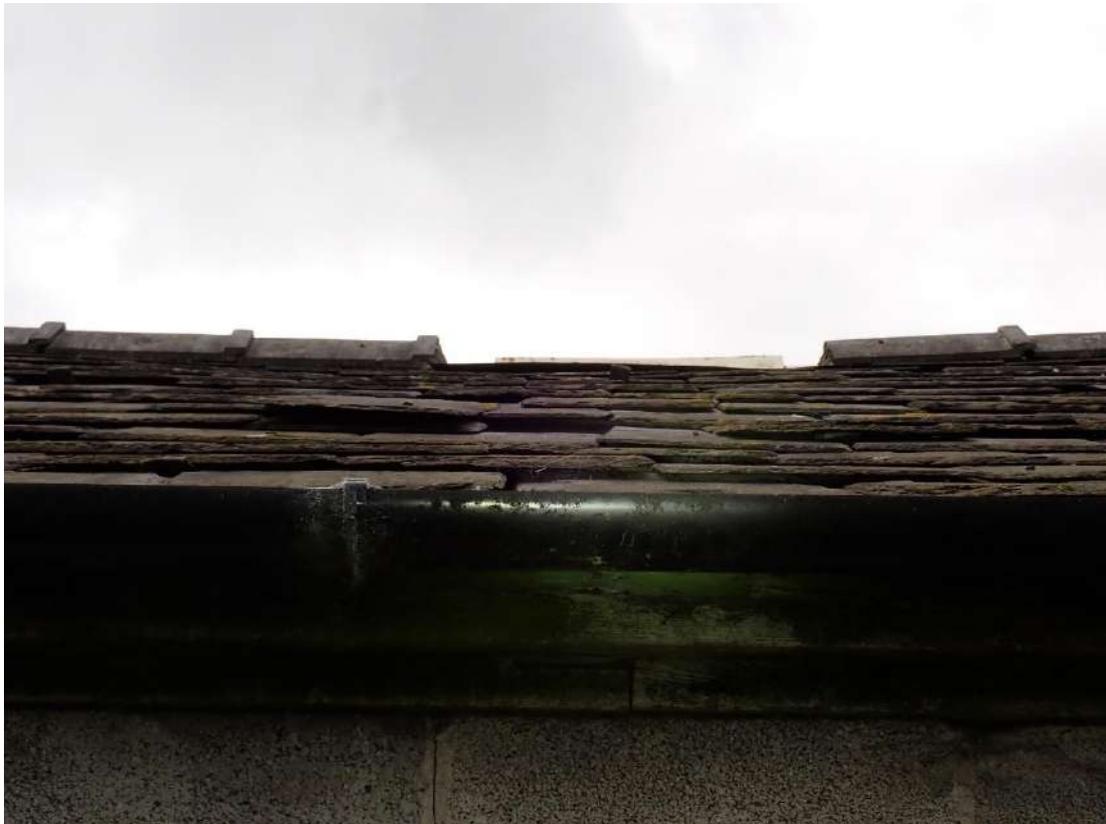
Photograph 11 – View of PRFs formed from raised roof tiles on the eastern section of Building 2.

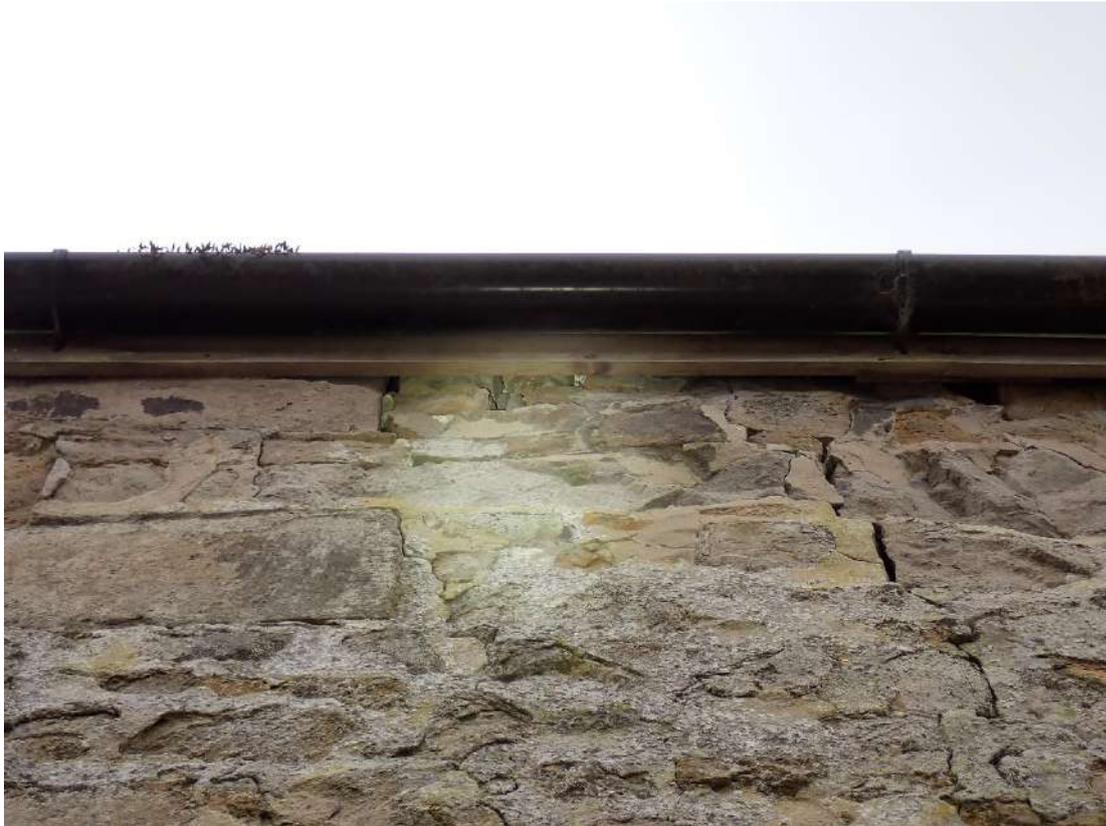
Photograph 12 - View of patches of raised roof tiles and missing ridge tiles on the roof of the eastern section of Building 2.

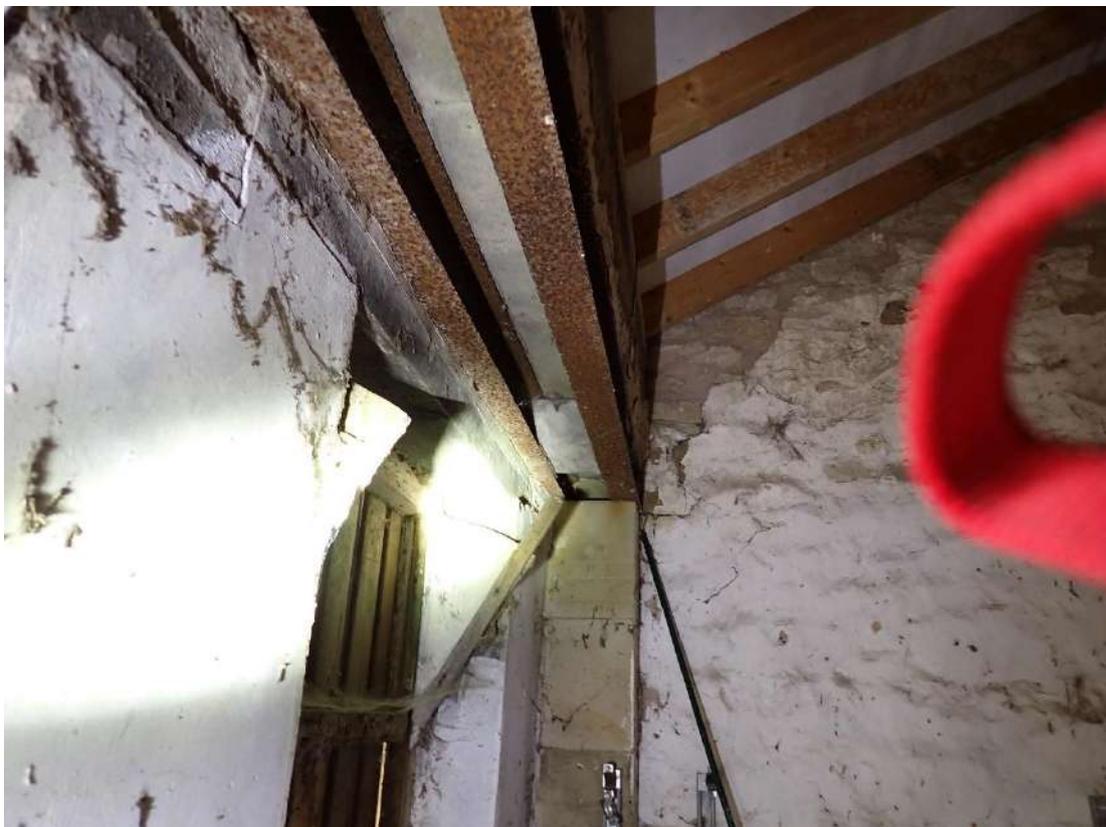
Photograph 13 – View of access points into Building 2 formed from missing mortar behind the fascia boards.

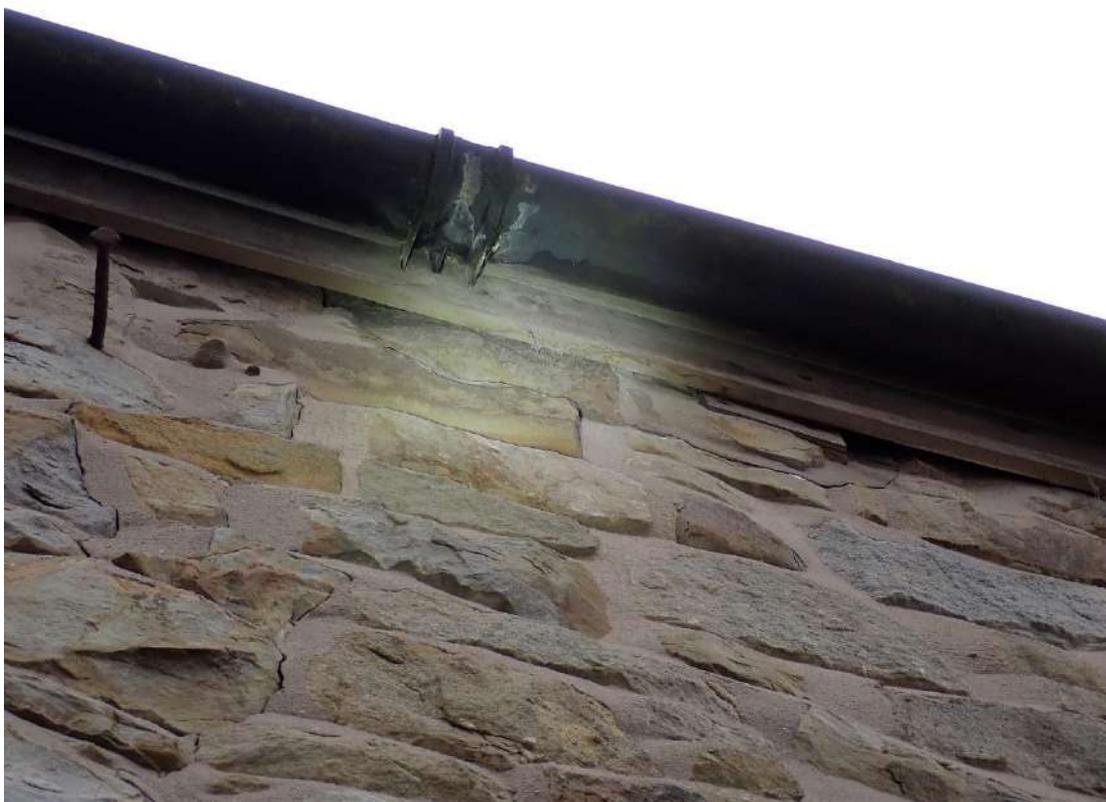
Photograph 23 – View of the gaps behind the fascia board on the southern aspect of Building 3.

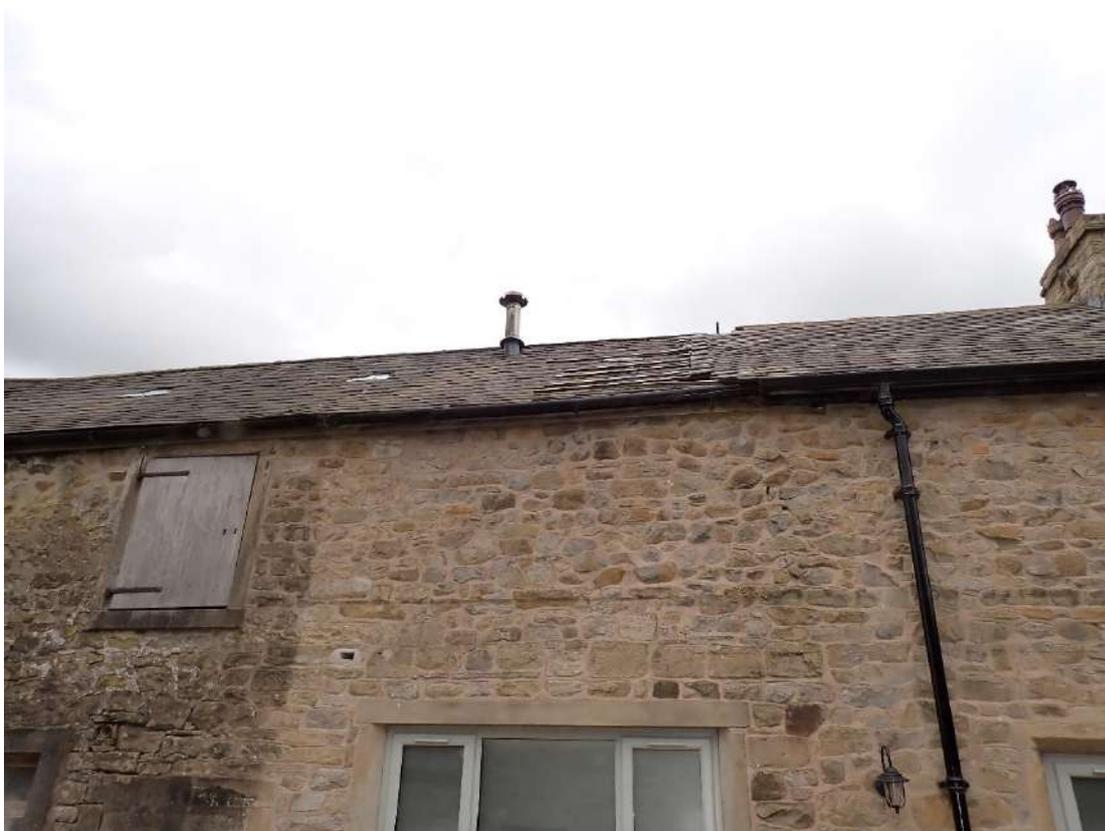
Bat droppings were found on the southern exterior wall of Building 3. No bat droppings or other field signs of bats were found during the external inspections of Buildings 1, 2 and 4.

Photograph 26 – View of the location where droppings were observed on the southern aspect of Building 3.

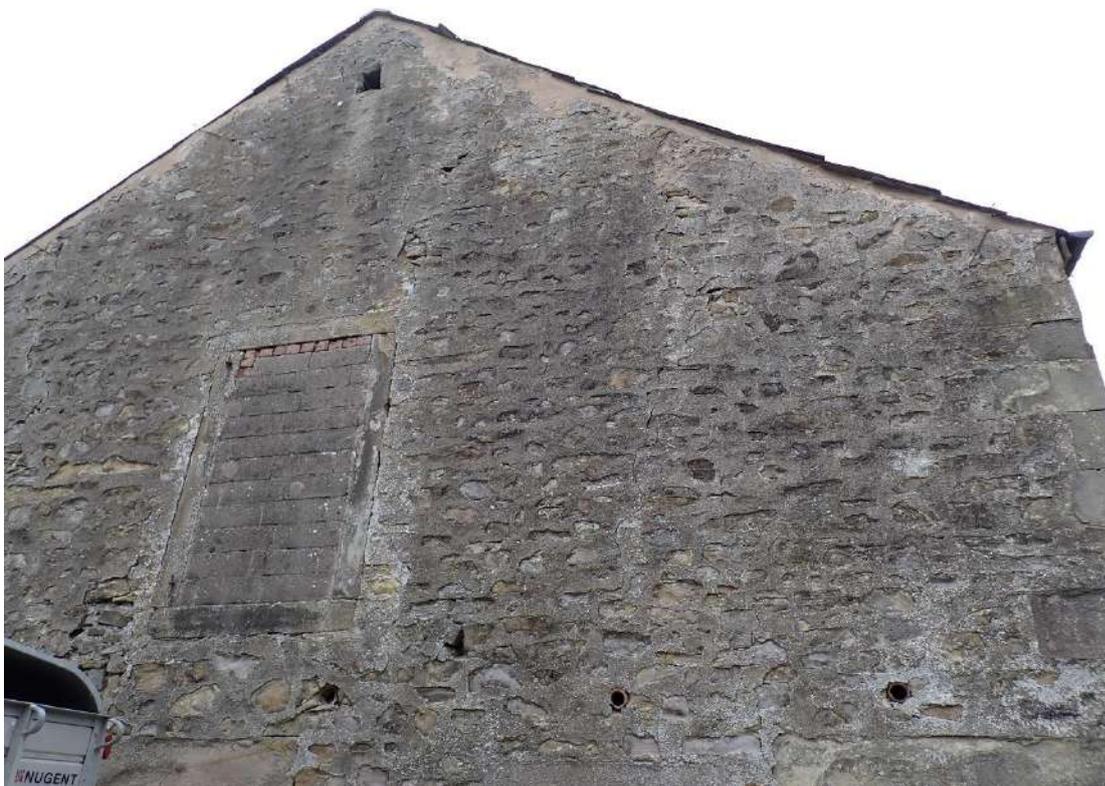
Photograph 27 – View of the PRF formed by cracks in the brickwork on the northern aspect of Building 3, where the newer extension meets the older barn.

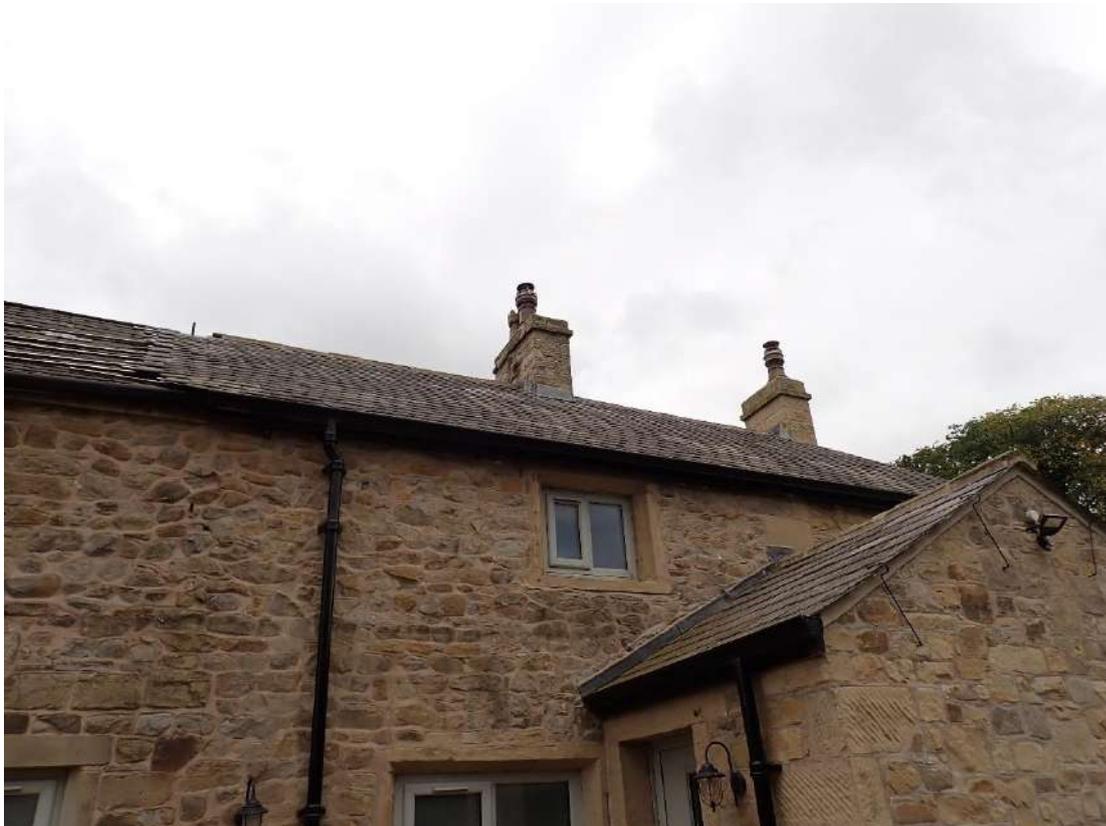
Photograph 29 – Close view of the PRF formed by the ventilation hole near the apex of the eastern gable end of Building 3.

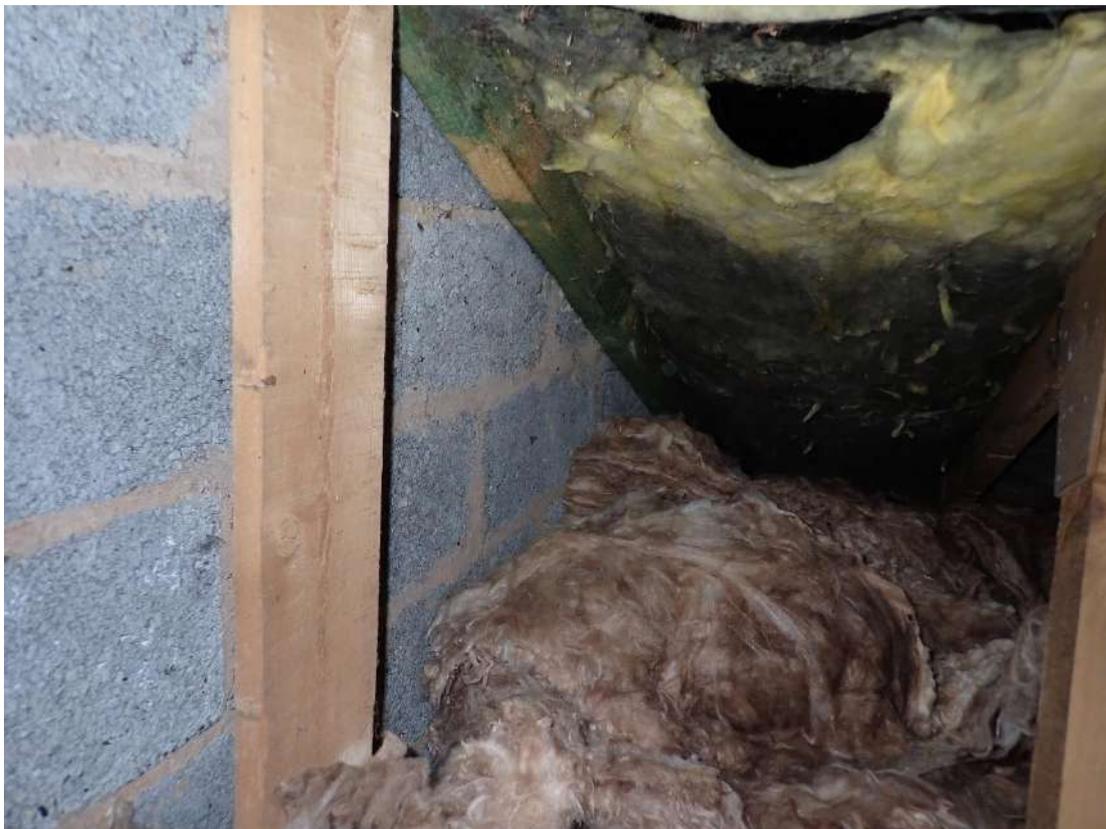
Photograph 35 - View of the gaps in the interior walls which allow access to the wall cavities.

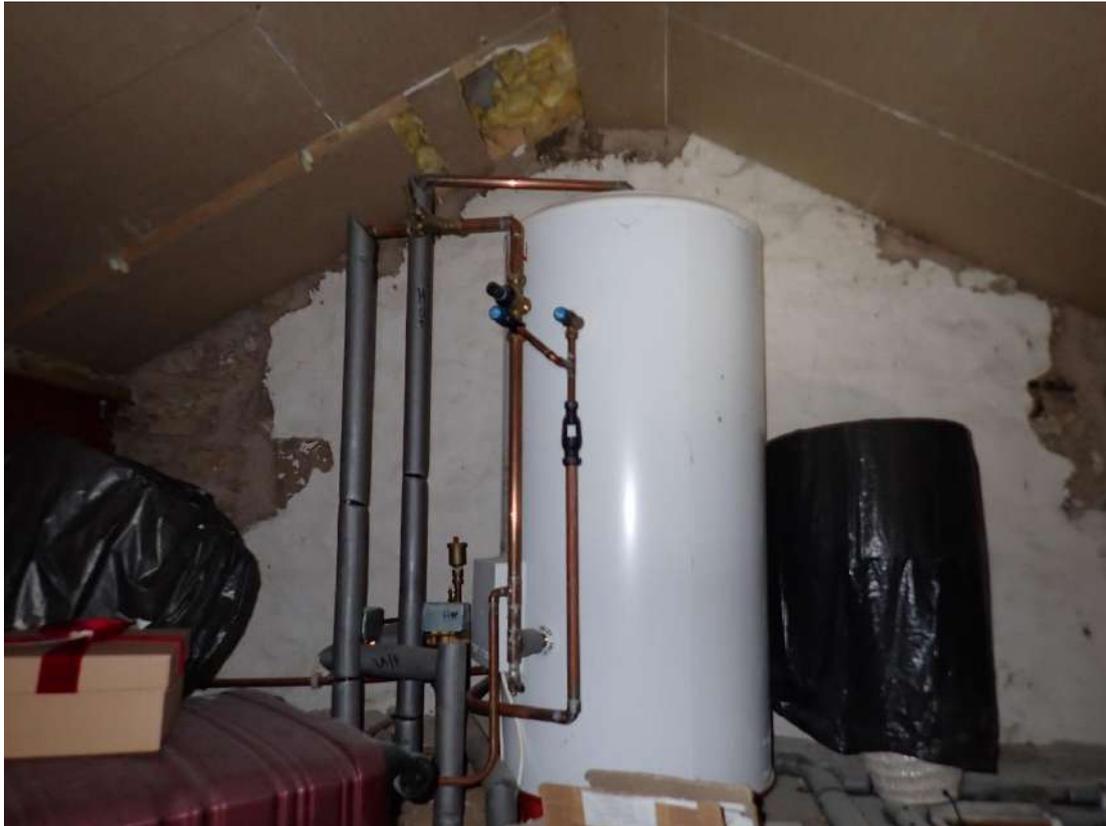
Photograph 36 - View of a hole in the mineral wool roof insulation leading to the underside of the tiles.

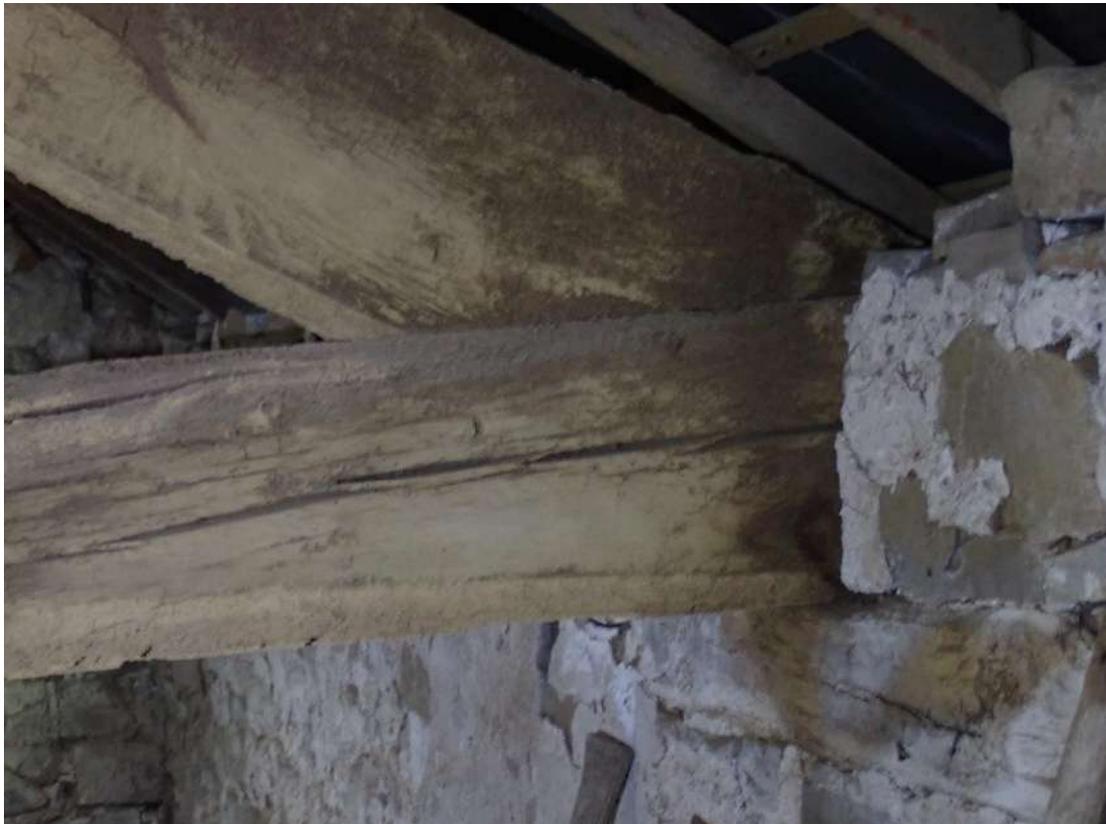
Photograph 59 – View of a PRF formed by ill-fitting joints in the timber structure of the barn section of Building 3.
