**United Environmental Services Ltd**

1 Booths Park,  
Chelford Road,  
Knutsford,  
Cheshire  
WA16 8QZ

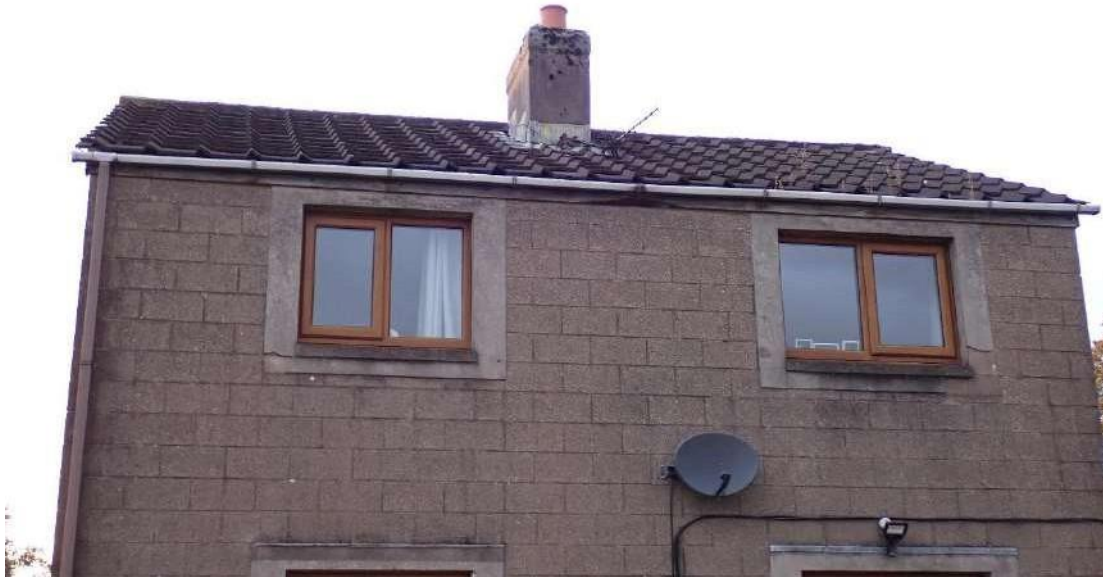
Photograph 3 – View of the PRFs formed from damaged fascia boards on the southern aspect of Building 1.

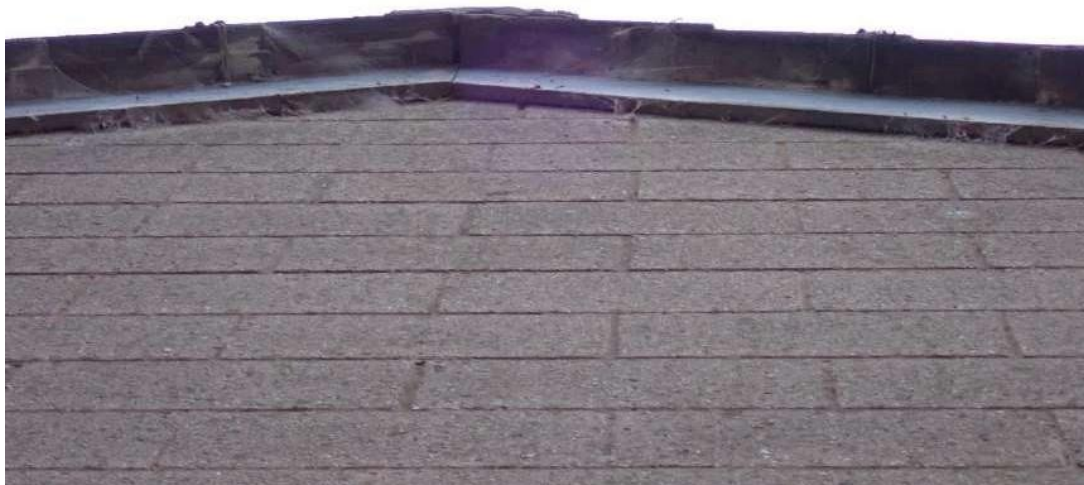
Photograph 4 – View of the gaps under the bargeboards on the eastern aspect of Building 1.

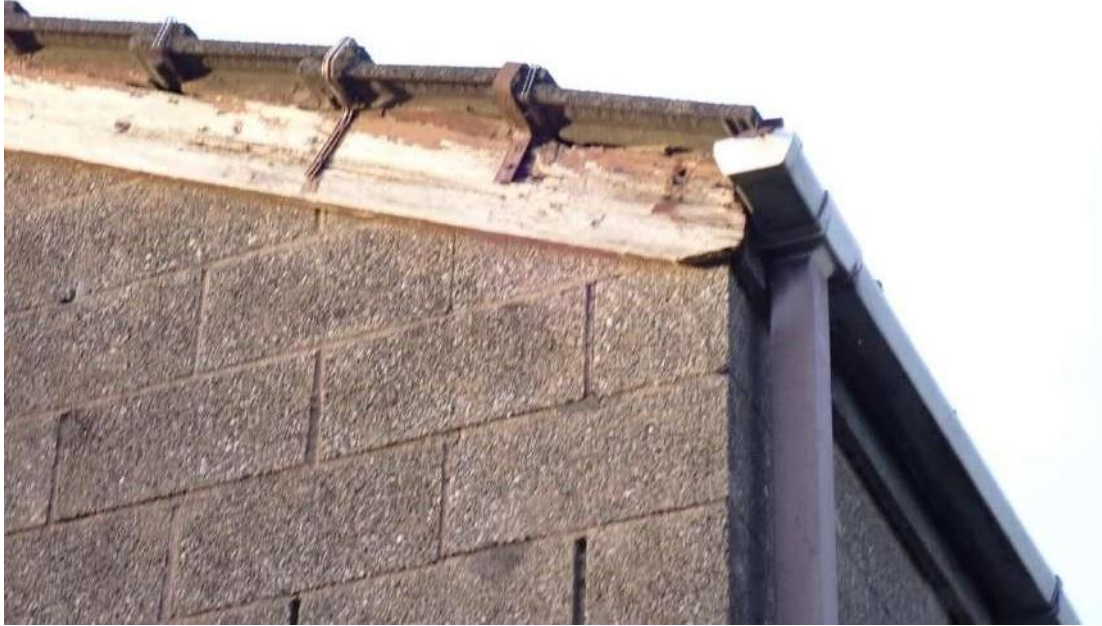
Photograph 5 – View of a damaged section of bargeboard on the western aspect of Building 1.

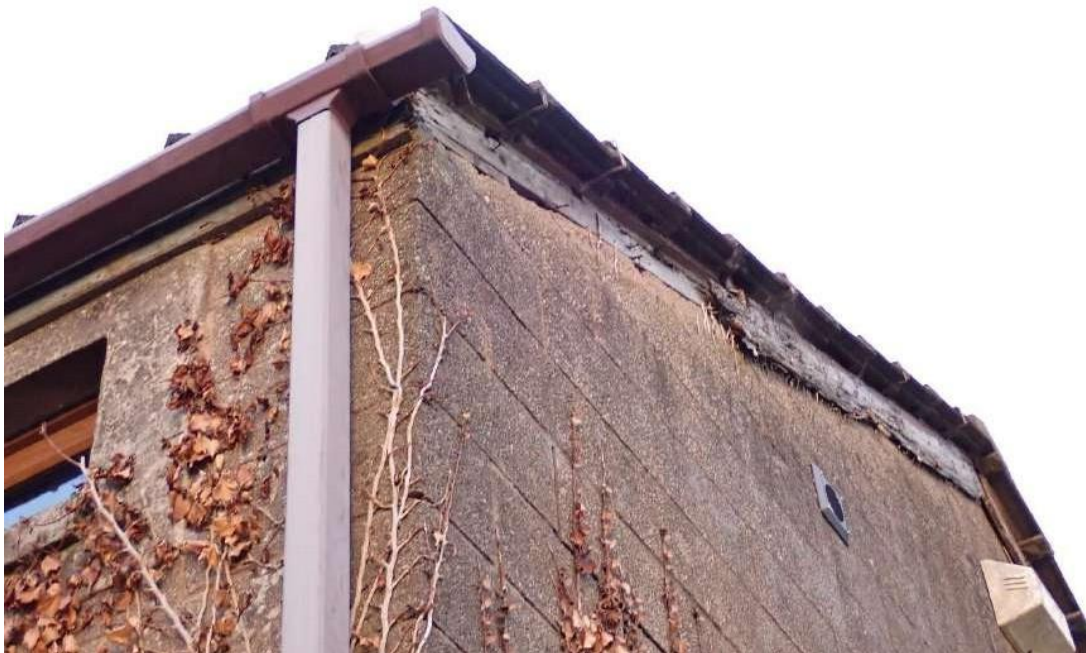
Photograph 6 - View of a missing section of bargeboard on the western aspect of Building 1.

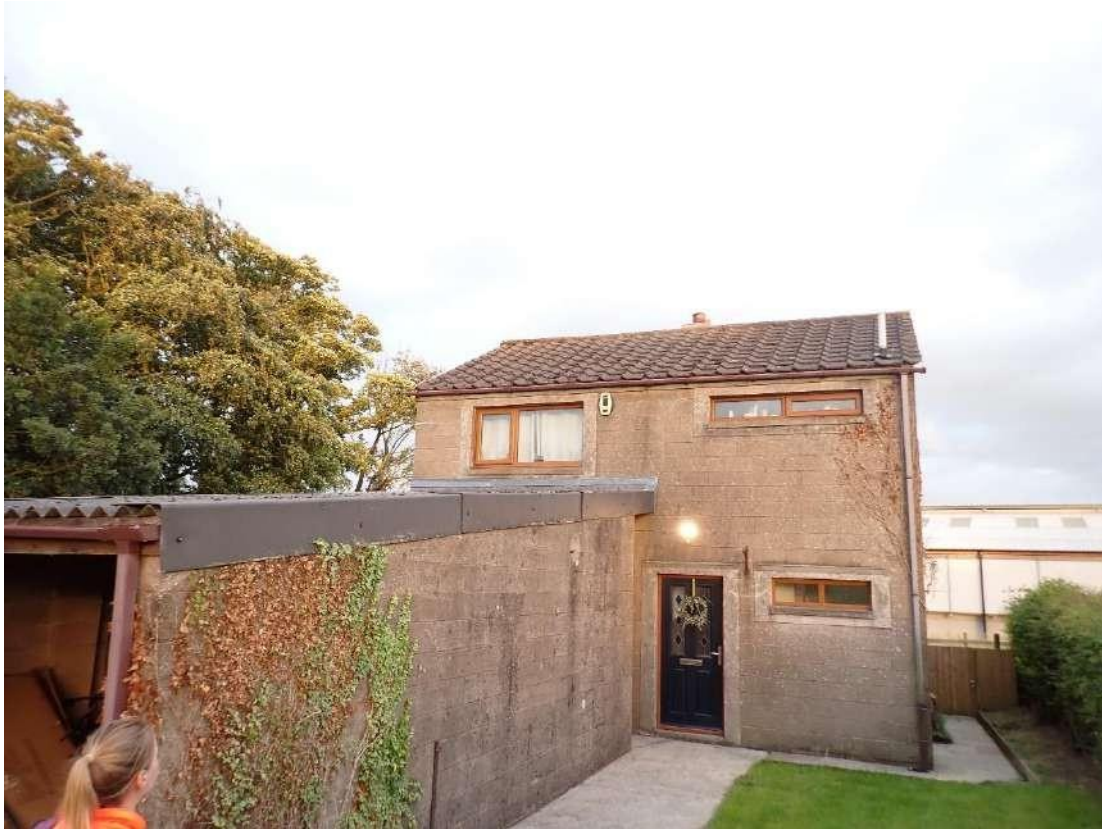
Photograph 7 – View of the northern aspect of Building 1 including the garage.

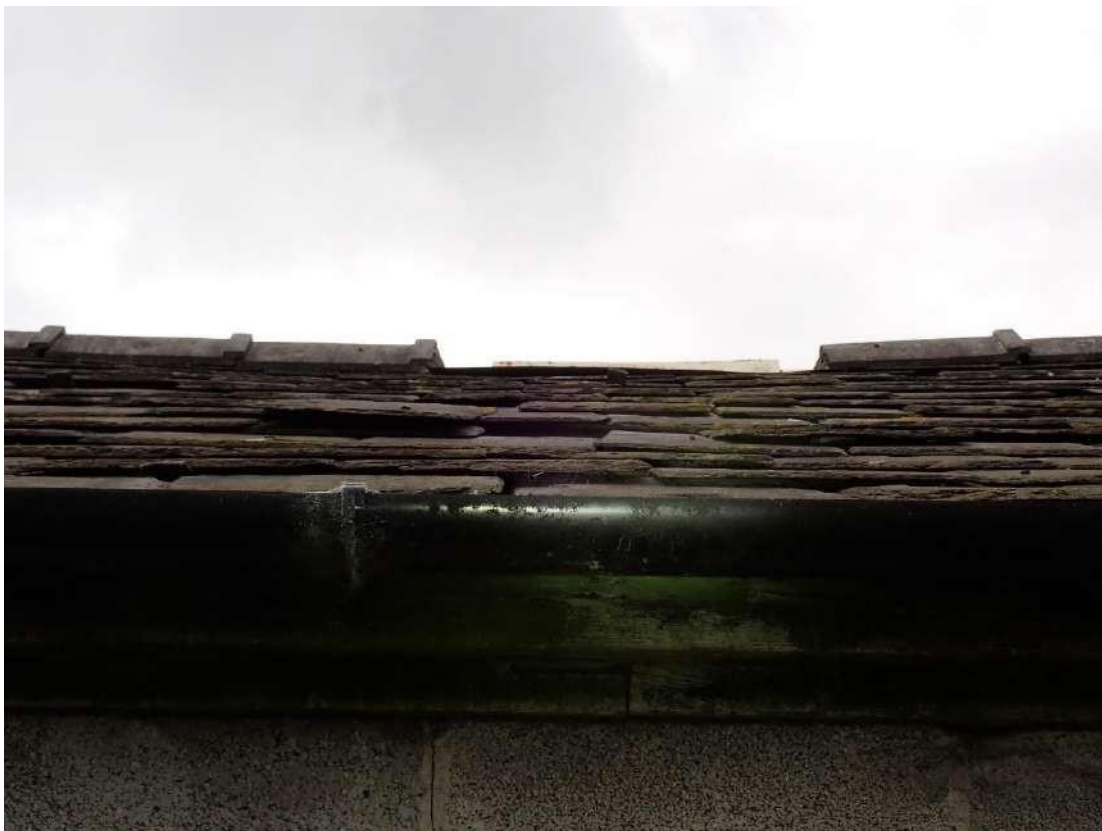
Photograph 12 - View of patches of raised roof tiles and missing ridge tiles on the roof of the eastern section of Building 2.

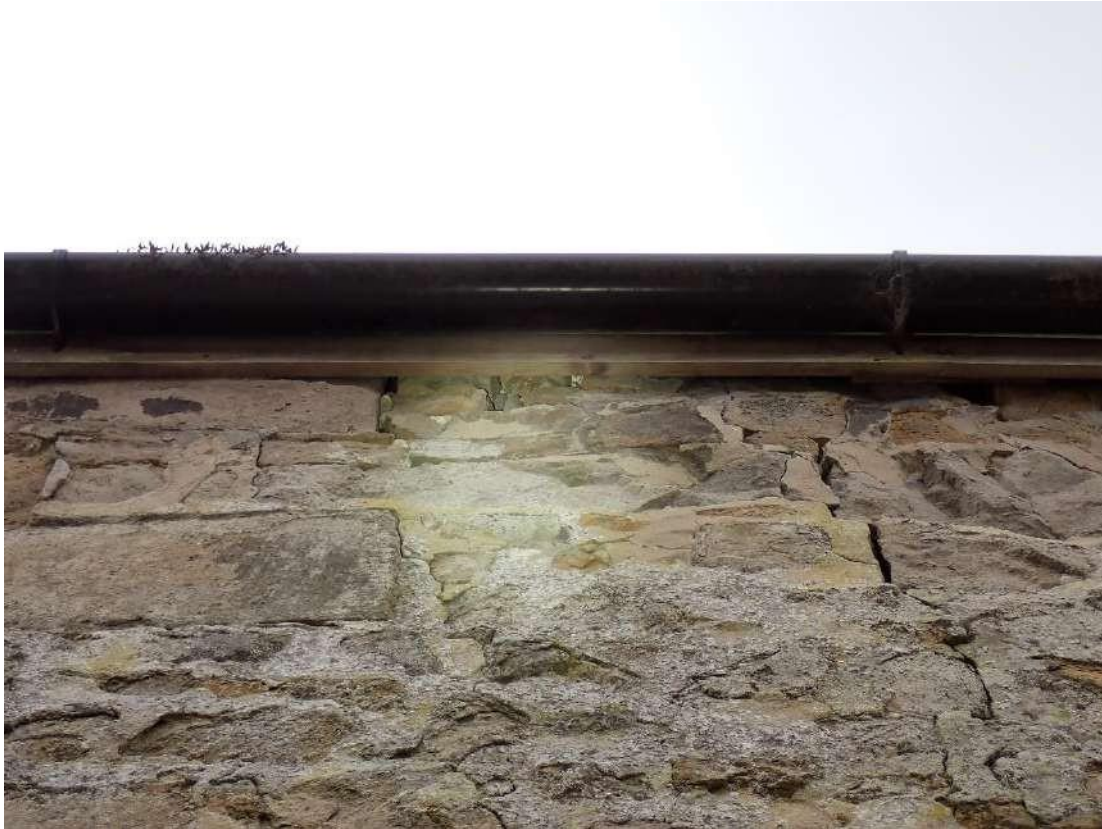
Photograph 13 – View of access points into Building 2 formed from missing mortar behind the fascia boards.

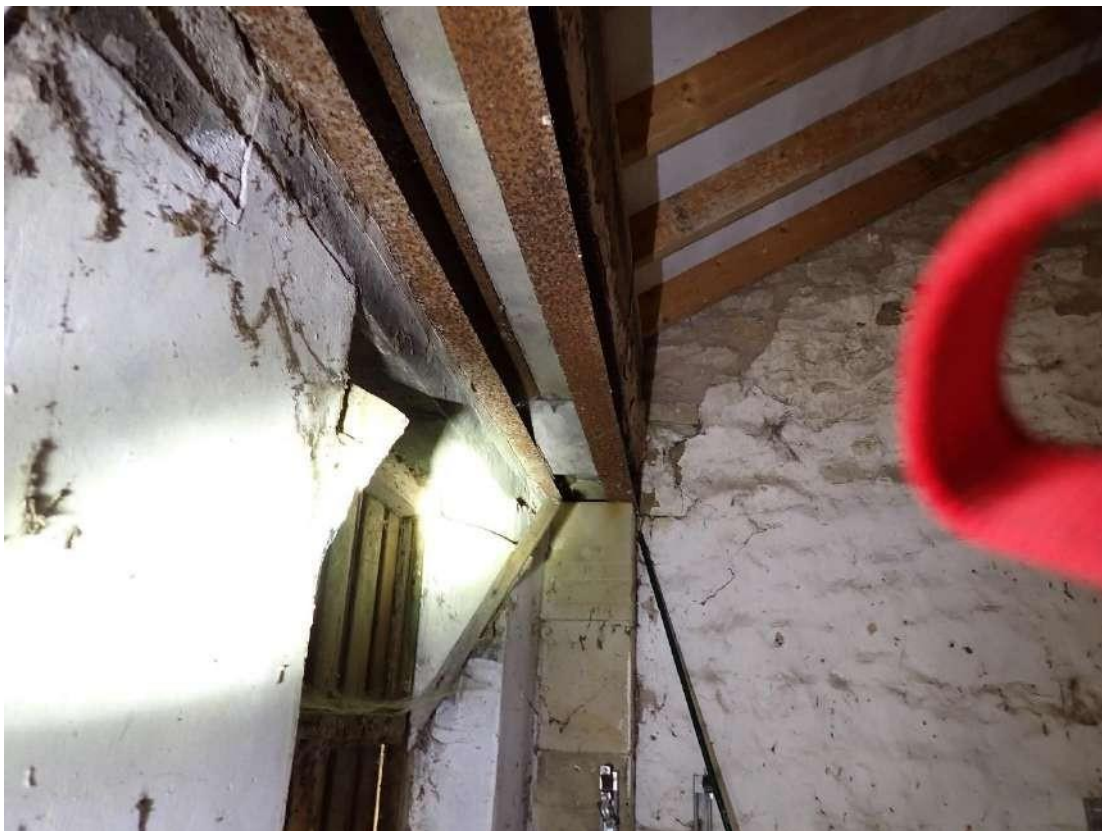
Photograph 14 - View of the wood and metal joists which comprise the eaves of the eastern section of Building 2.

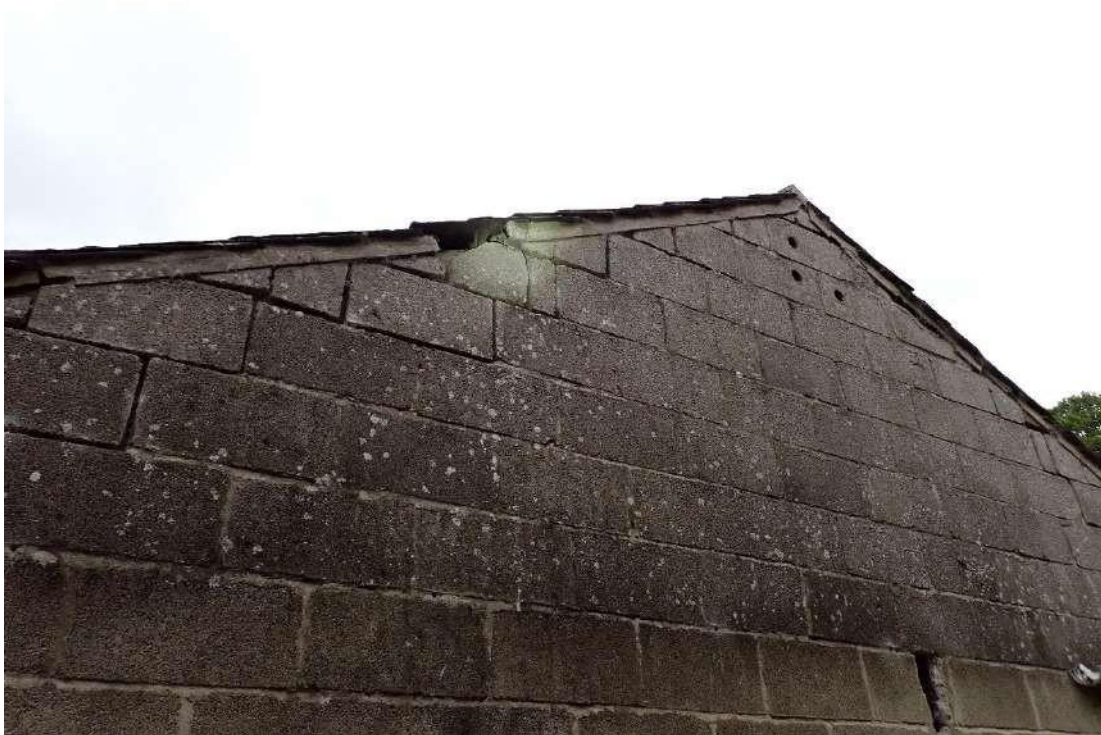
Photograph 15 – View of access points into the wall cavities of Building 2 via areas of damaged brickwork at the eastern gable end.

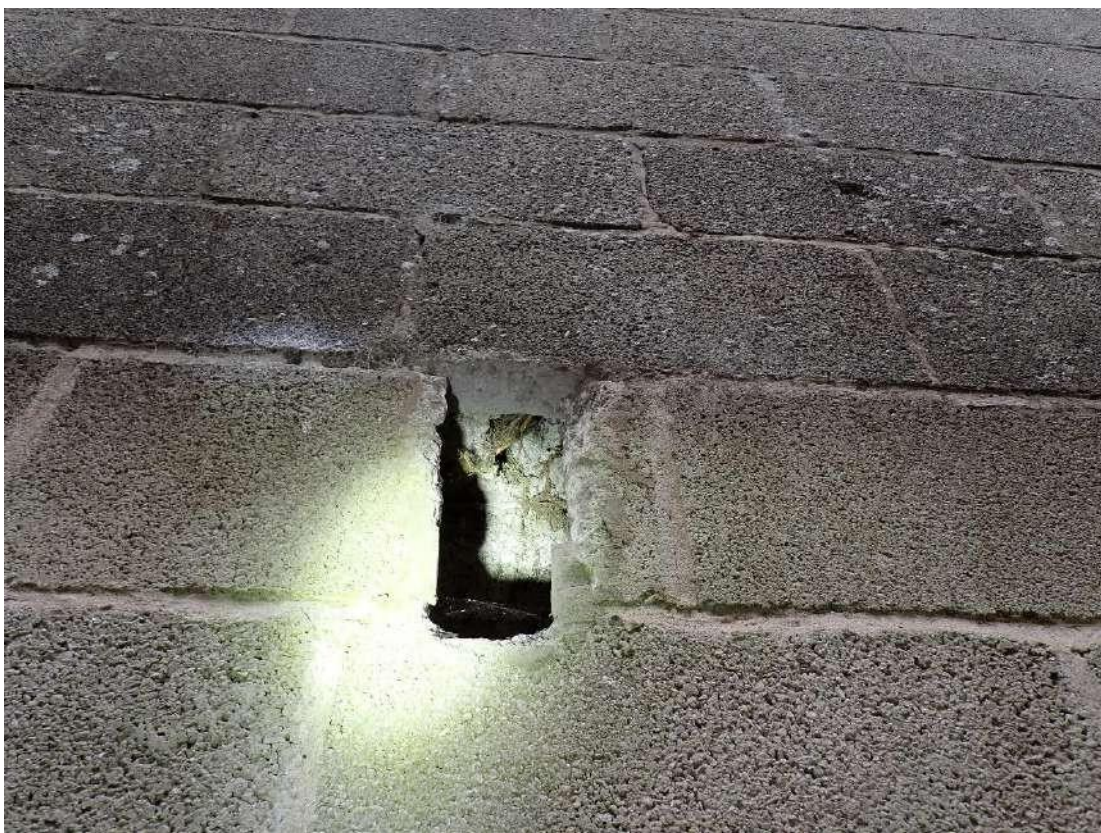
Photograph 16 – View of an access point into the wall cavity in the eastern section of Building 2, located on the eastern gable end.

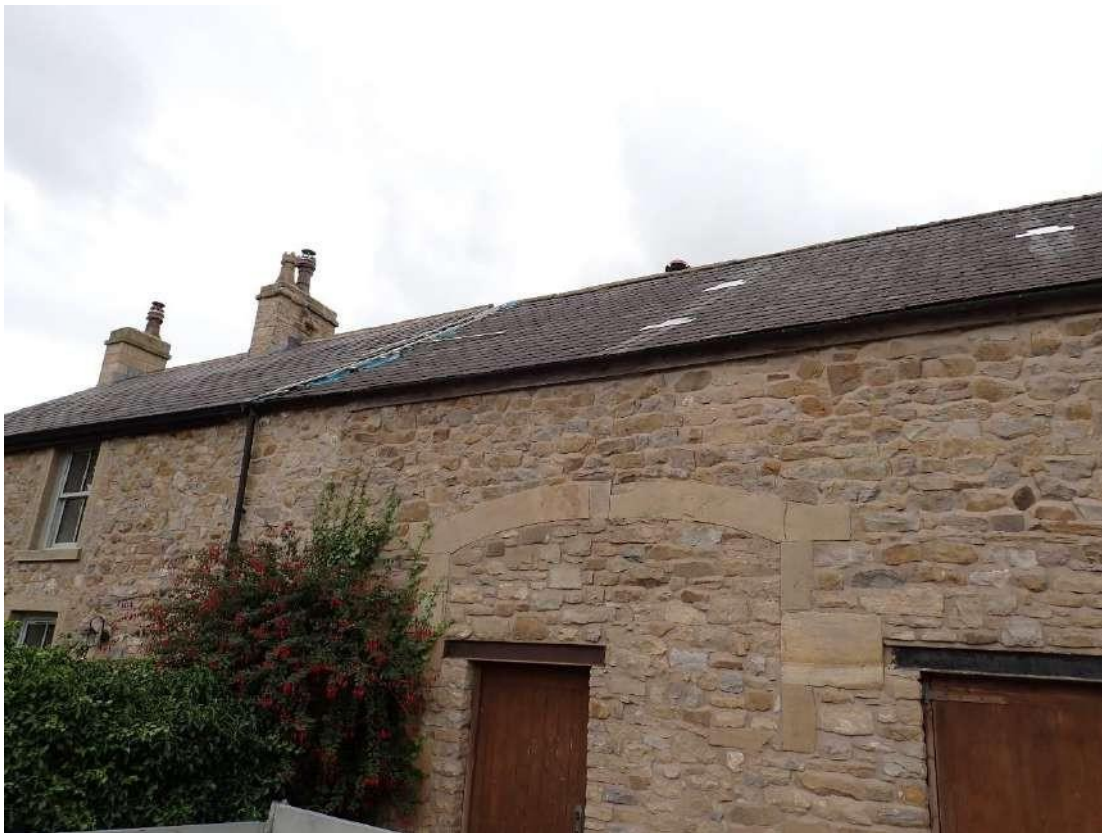
Photograph 22 – View of the southern aspect of Building 3 and the flashing around the chimneys and the skylights which is in good condition.

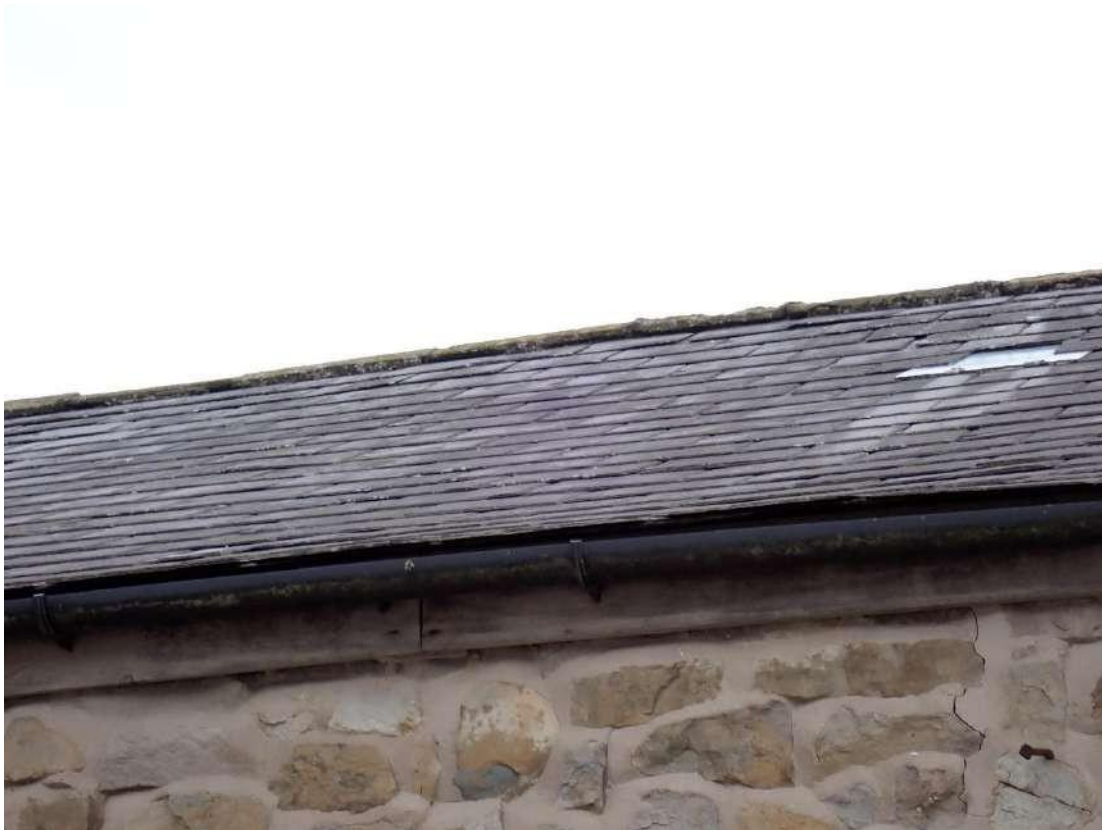
Photograph 23 – View of the gaps behind the fascia board on the southern aspect of Building 3.

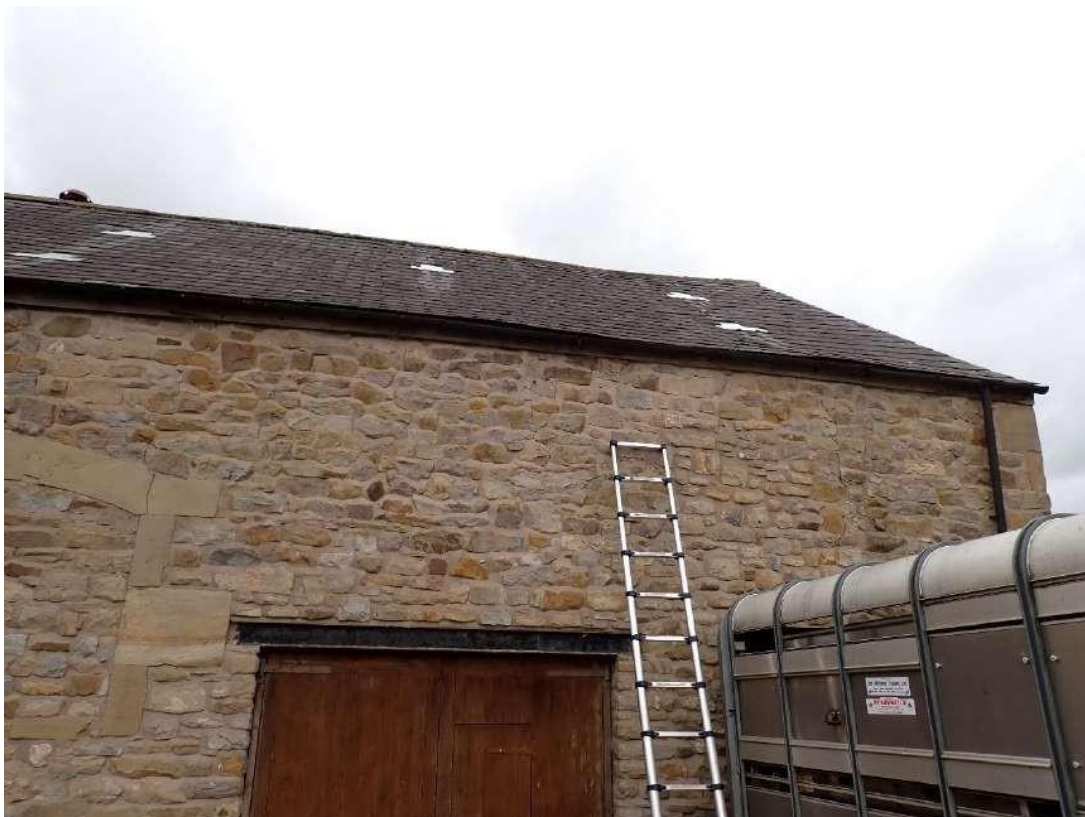
Photograph 26 – View of the location where droppings were observed on the southern aspect of Building 3.

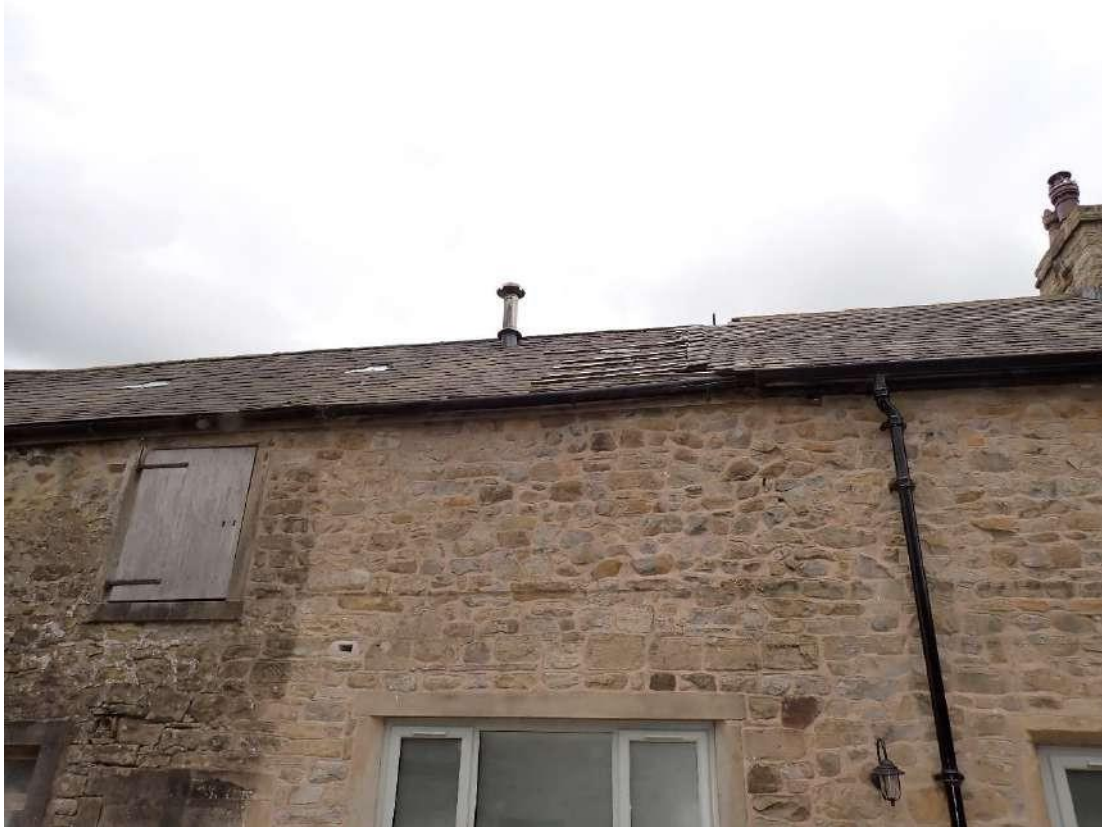
Photograph 27 – View of the PRF formed by cracks in the brickwork on the northern aspect of Building 3, where the newer extension meets the older barn.

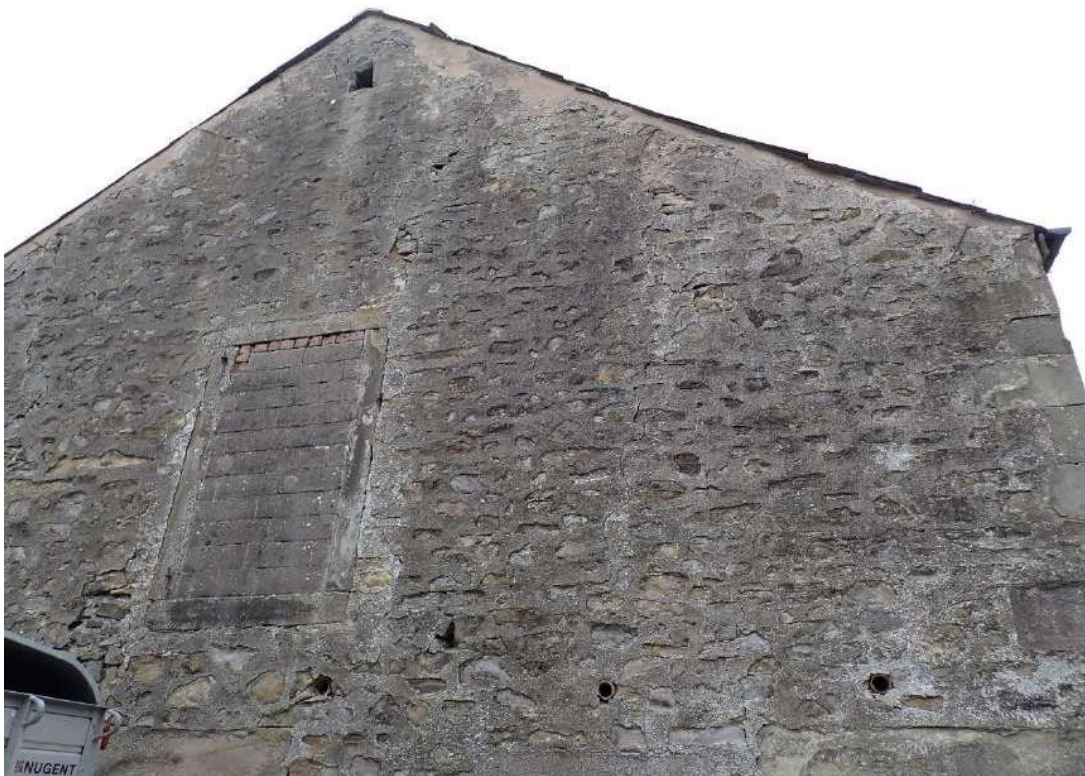
Photograph 28 – View of the PRFs formed from ventilation gaps on the eastern gable end of Building 3.

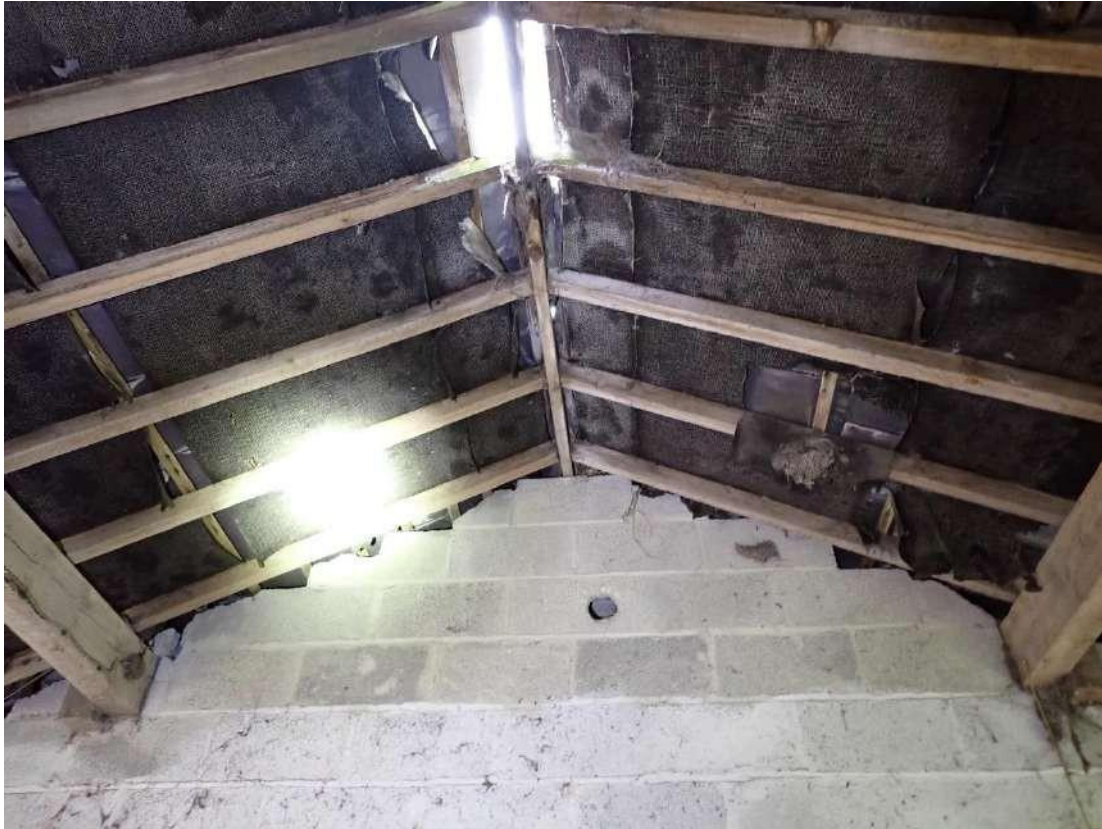
Photograph 43 - View of the damaged section of the bitumen lining of the middle room of the pig styes in Building 2.

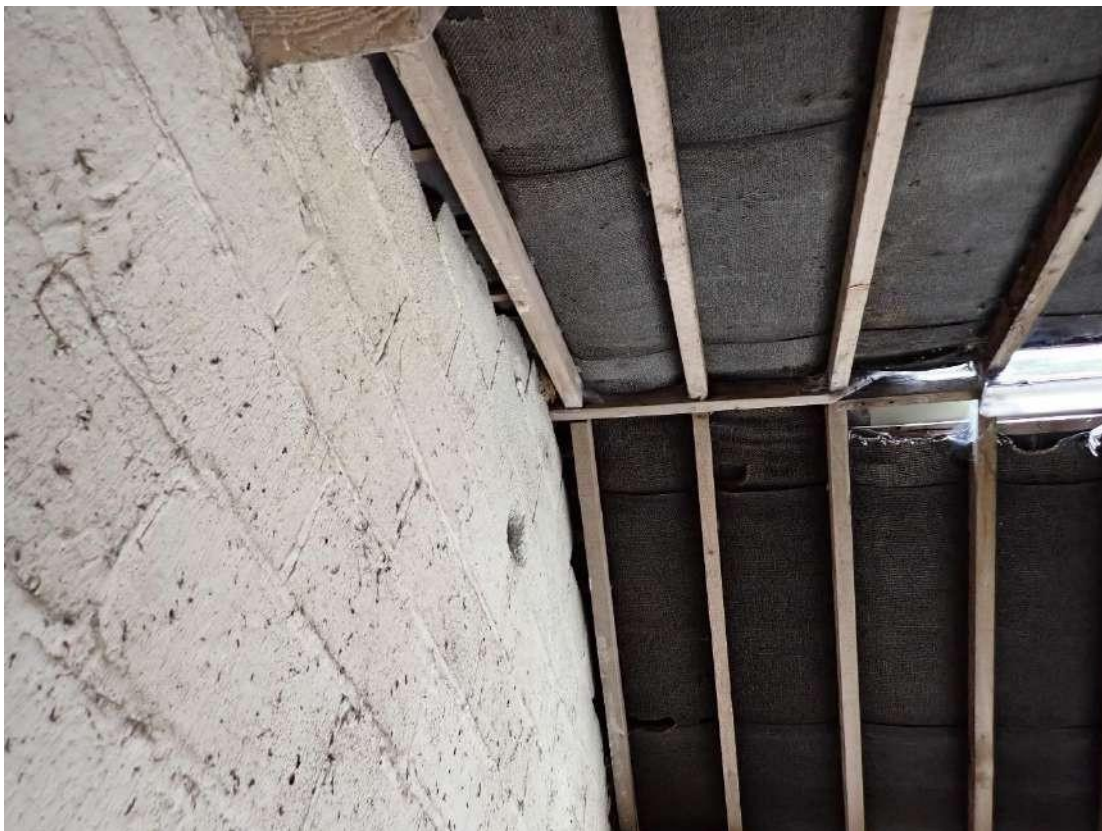
Photograph 44 – View of the gaps between the tiles and the bitumen lining forming PRFs in the middle room of the pig sty section of Building 2.

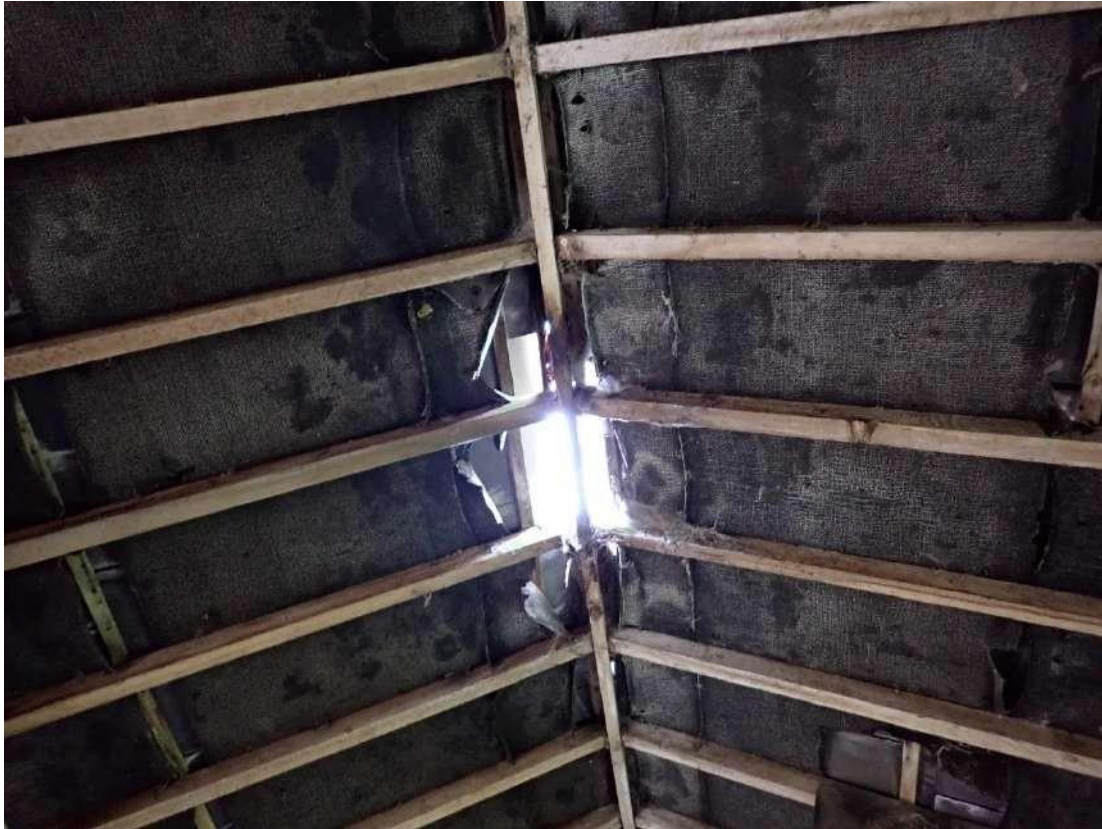
Photograph 45 – View of the damaged bitumen lining in the eastern room of the pig sty section of Building 2.

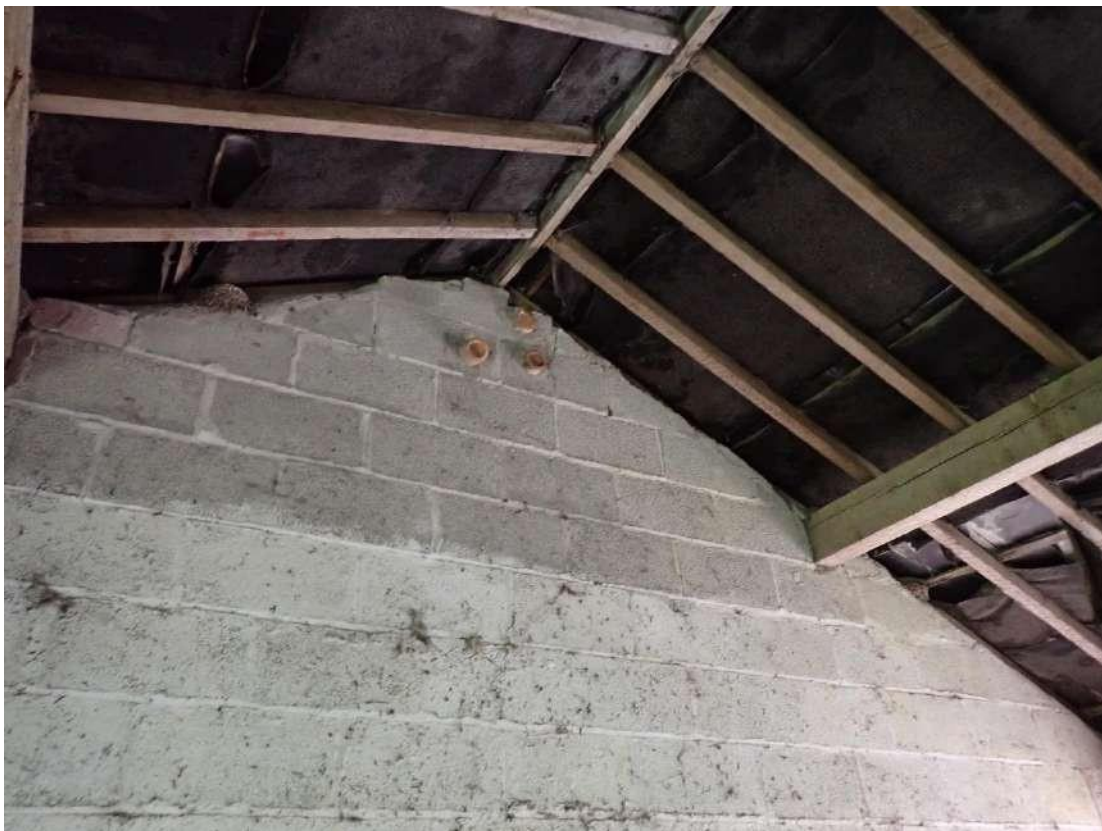
Photograph 46 - View of the damaged sections of the brickwork in the internal walls of the pig sty section of Building 2 leading to the wall cavity.

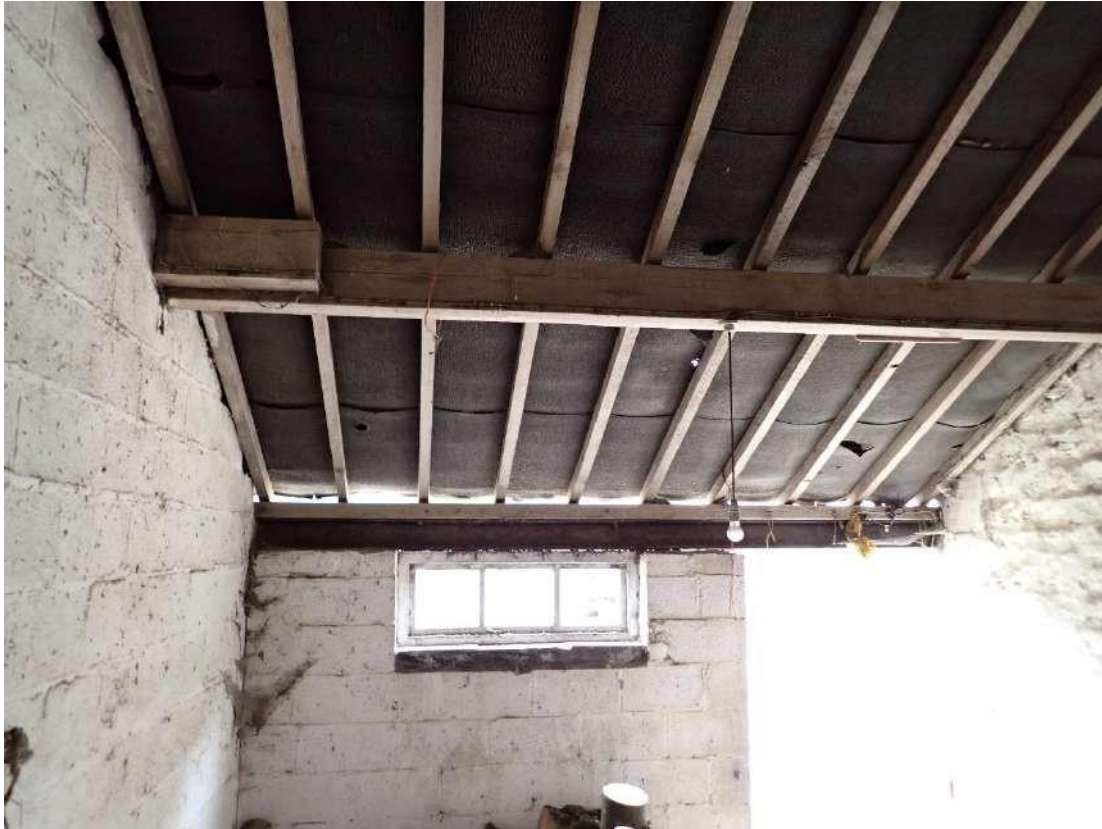
Photograph 47 – View of the gap in the wall above the final brick and the beam allowing access into the wall cavity of the eastern room of the pig sty section of Building 2.

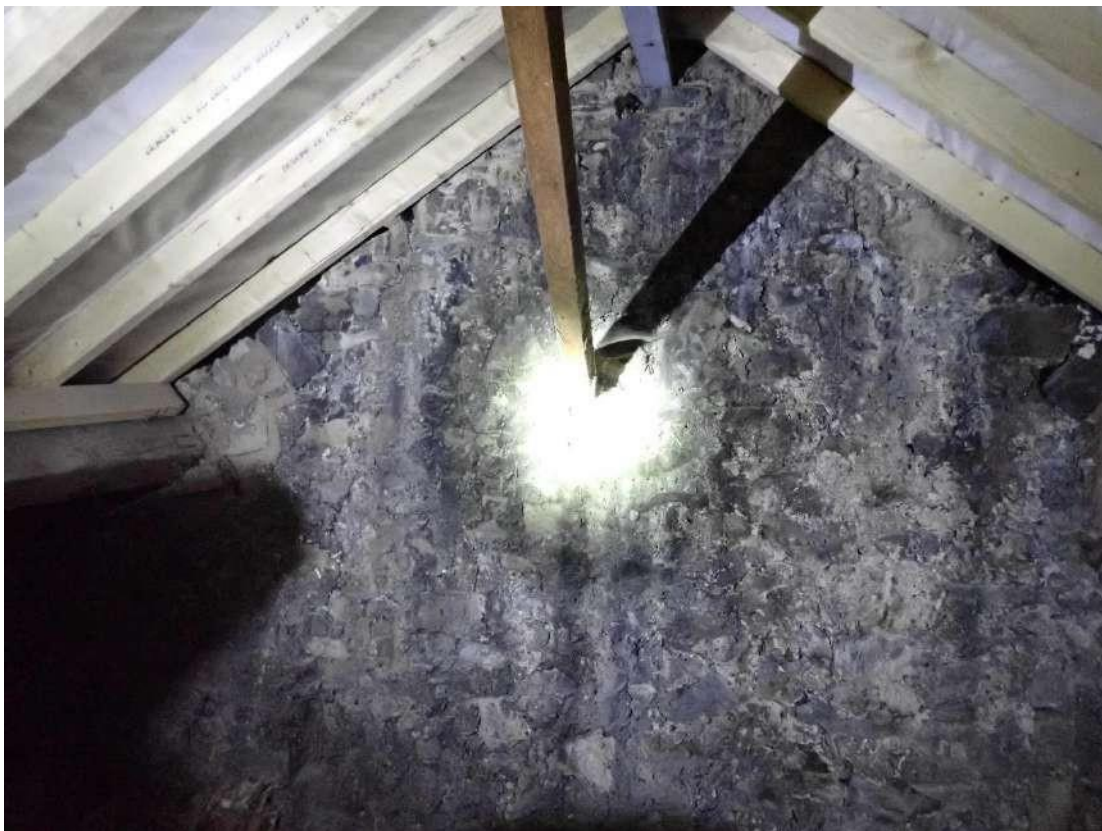
Photograph 54 – View of the numerous cracks and gaps in the internal walls allowing access to the wall cavity.

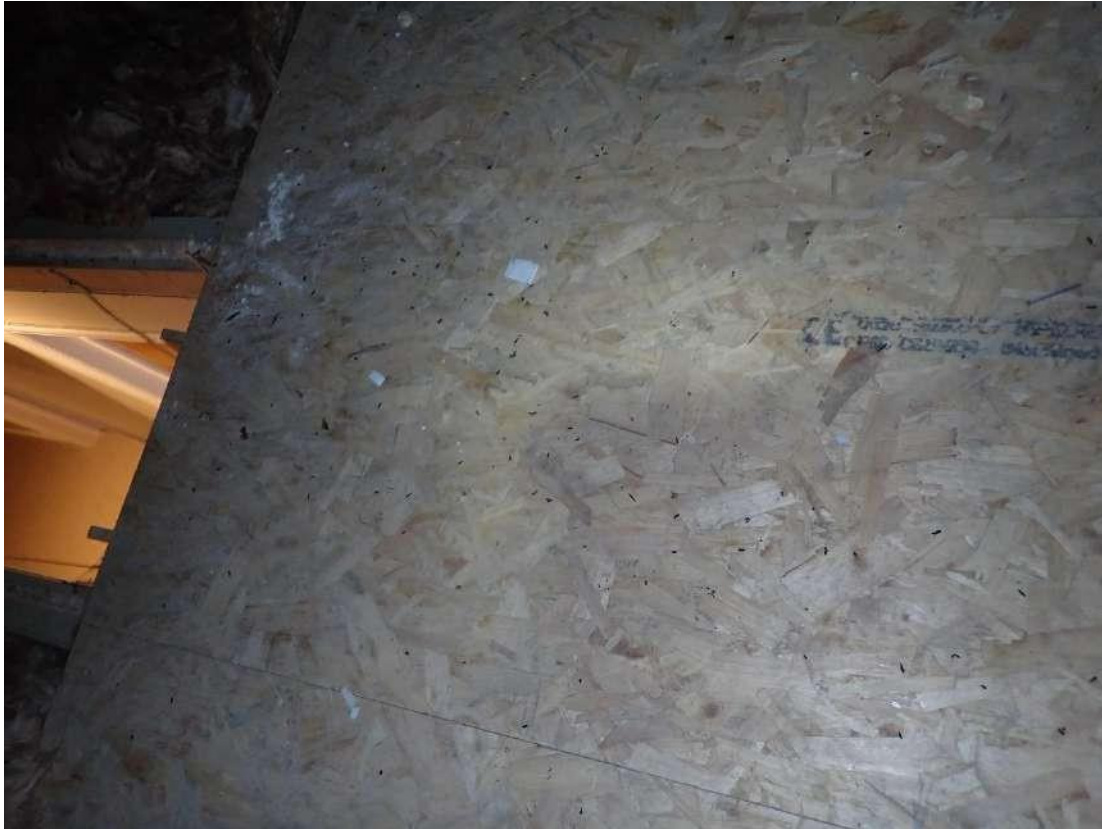
Photograph 55 – View of the numerous fresh bat droppings scattered over the chipboard lining the floor of the loft in the farmhouse of Building 3.

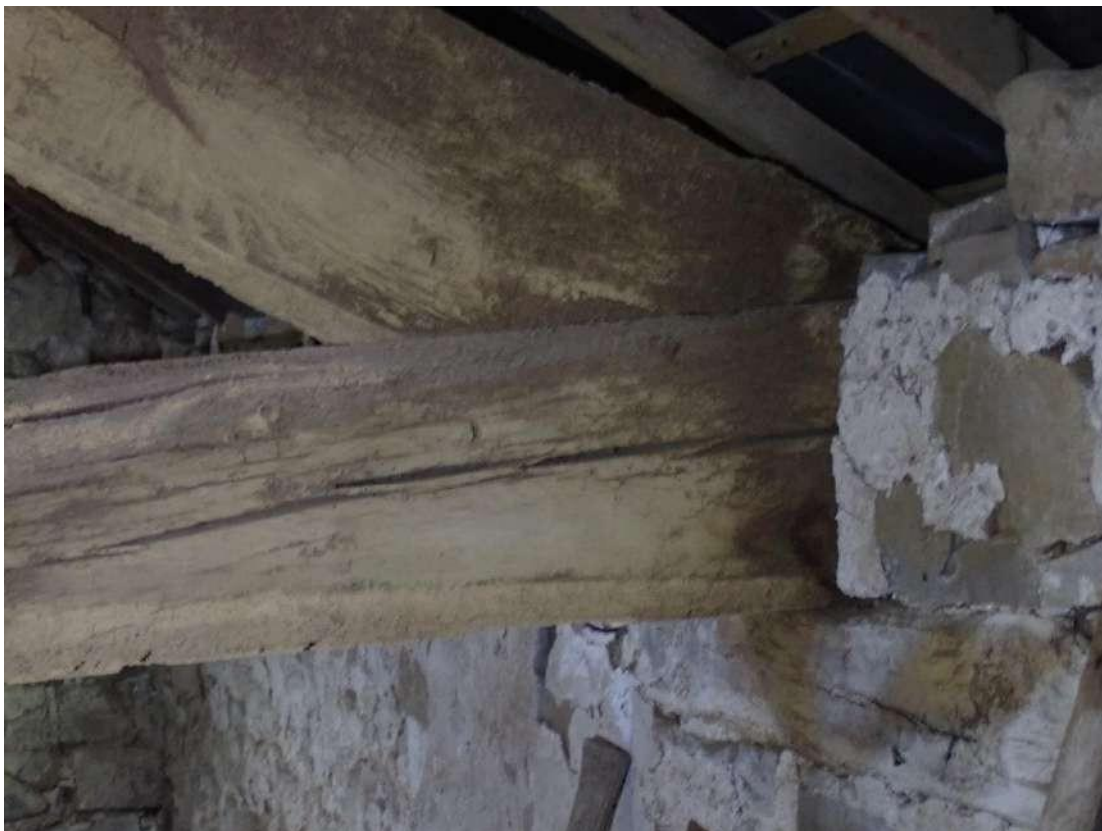
Photograph 60 – View of a PRF formed from cracks in the timber beams in the barn section of Building 3.

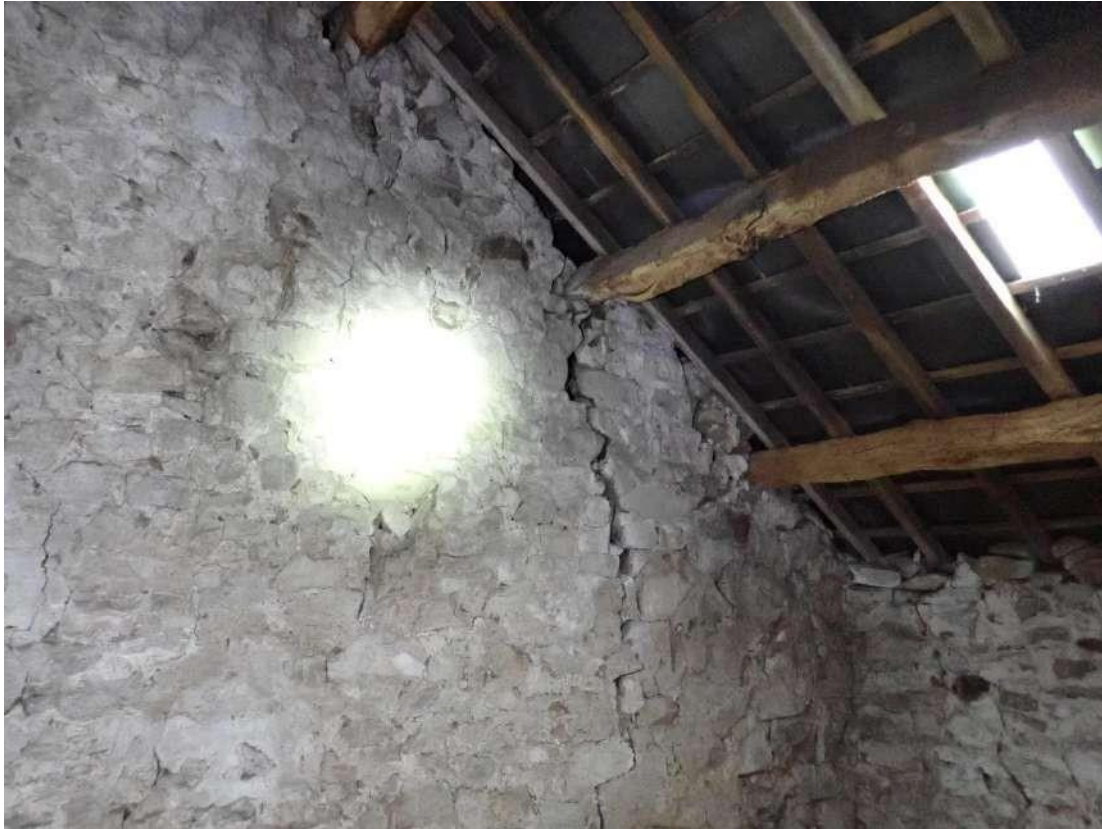
Photograph 61 - View of the cracks in the gable end and missing mortar at the wall plates in the barn section of Building 3.

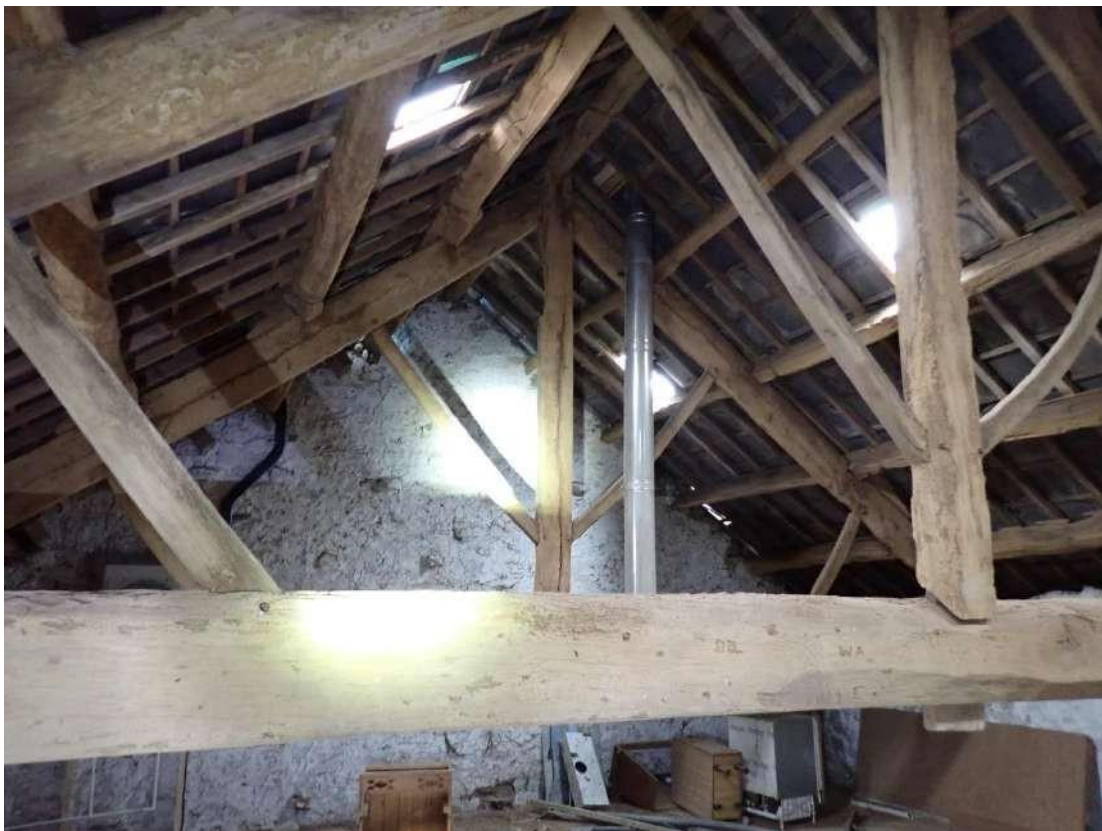
Photograph 62 – View of additional cracks and cavities of the gable end of the barn section of Building 3.

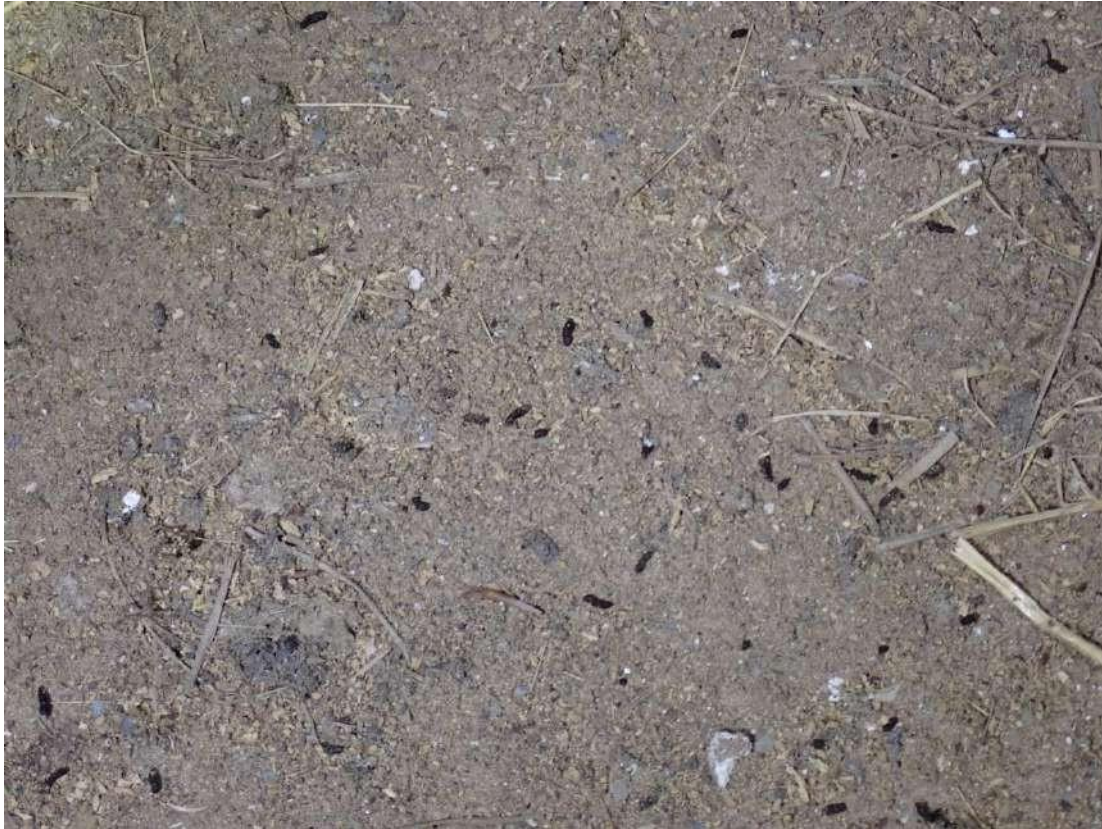
Photograph 63 – View of the bat droppings scattered throughout the first floor of the barn section of Building 3.
