**United Environmental Services Ltd**

1 Booths Park,  
Chelford Road,  
Knutsford,  
Cheshire  
WA16 8QZ

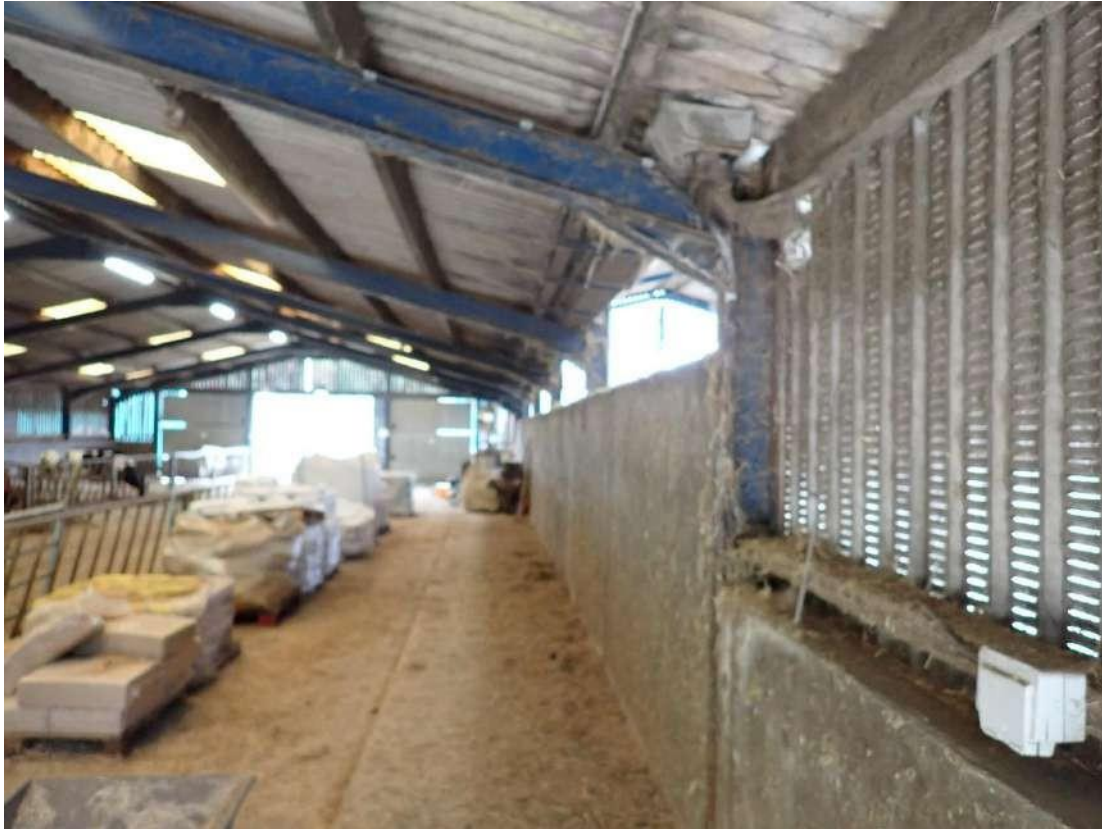
Photograph 67 – View of the interior of Building 4 showing the well lit and exposed conditions inside the building.

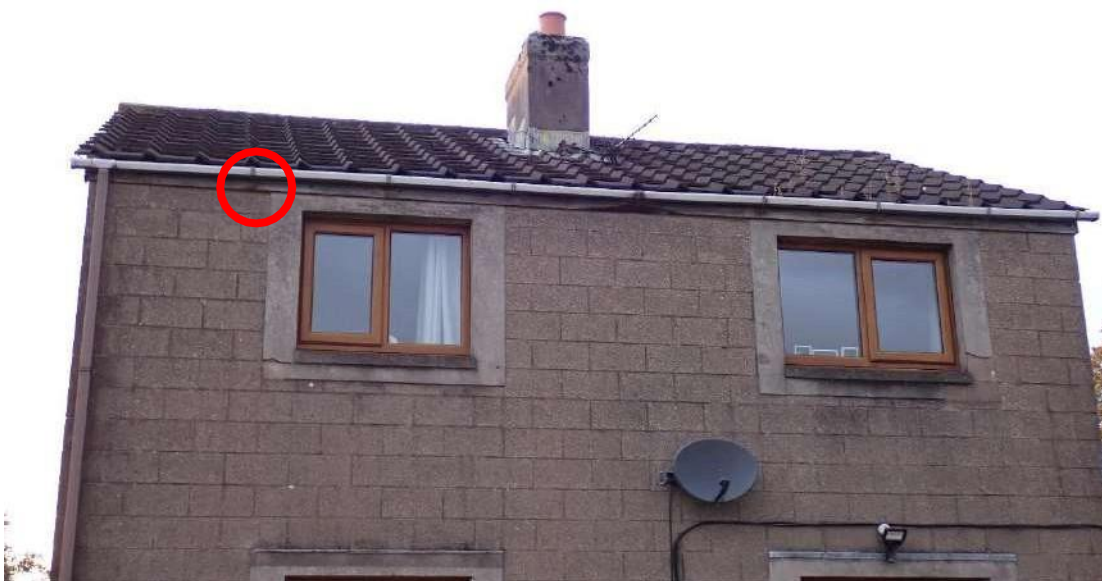
Photograph 68 – View of the southern aspect of Building 1 with Roost 1 circled in red.
