# ARBORICULTURAL IMPACT ASSESSMENT

Black Moss Farm  
Elmridge Lane  
Chipping  
PR3 2NY

### **Phase 3**

The demolition of existing structures, the development of an agricultural building and its associated infrastructure, an extension to a residential property

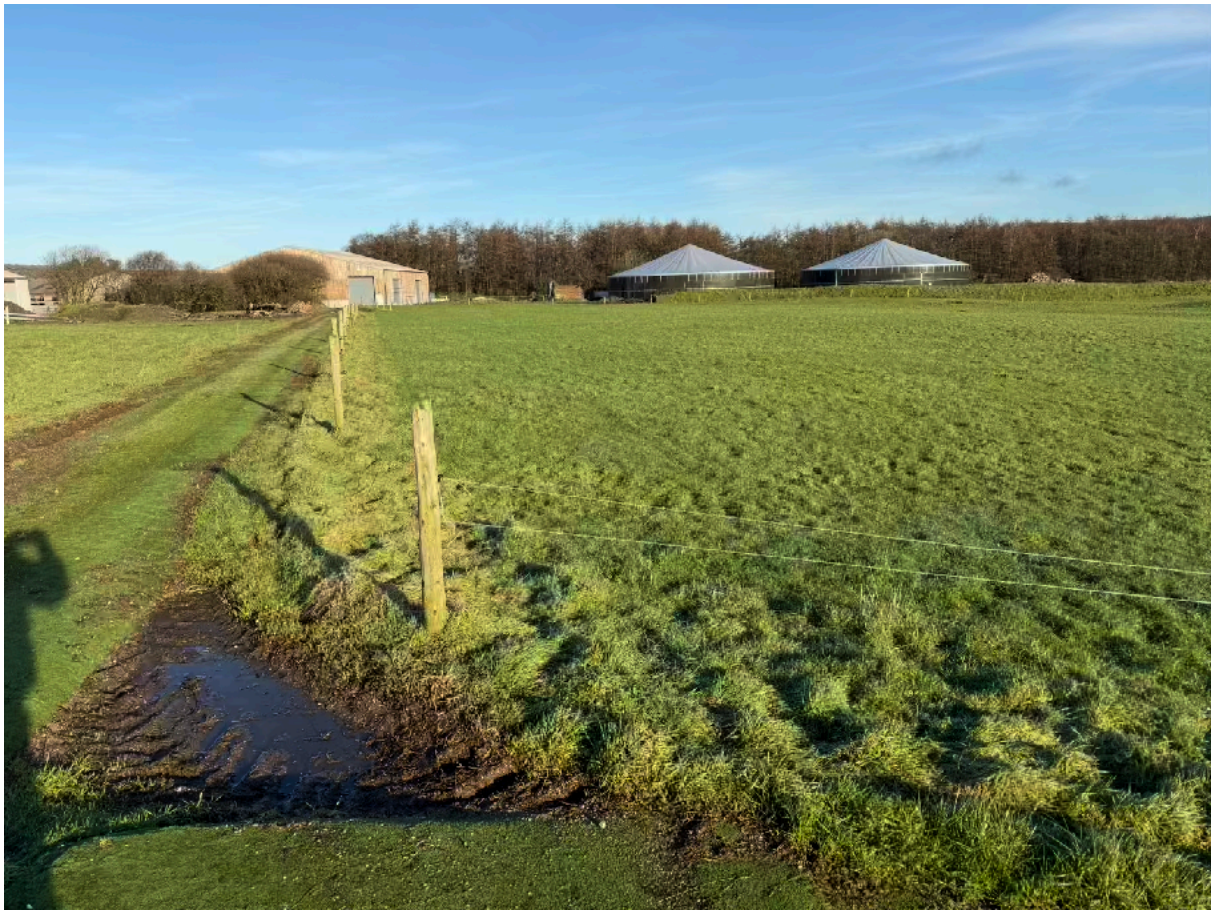
View of the trees with an overview of the site

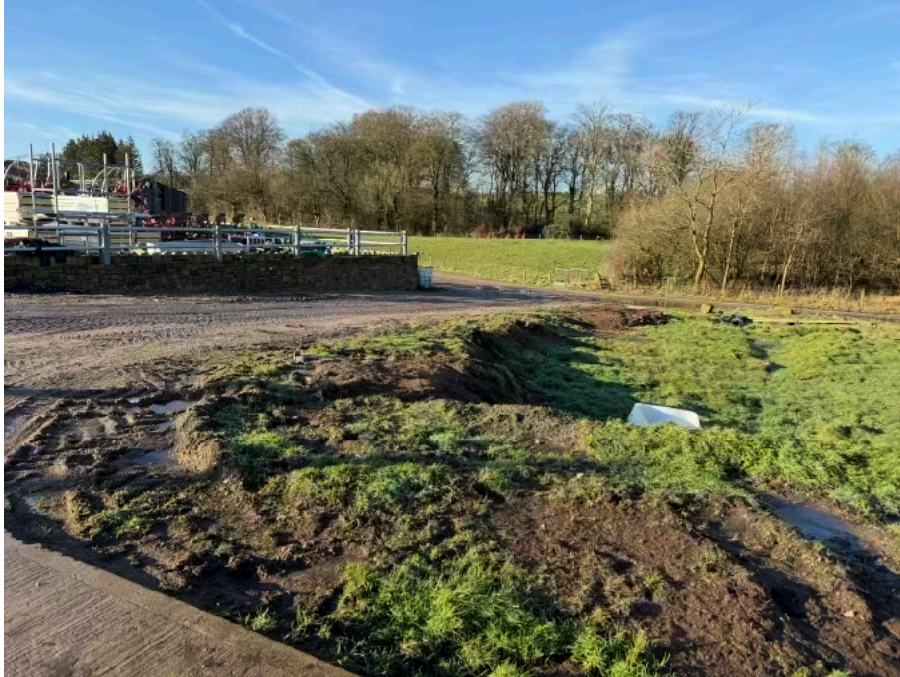
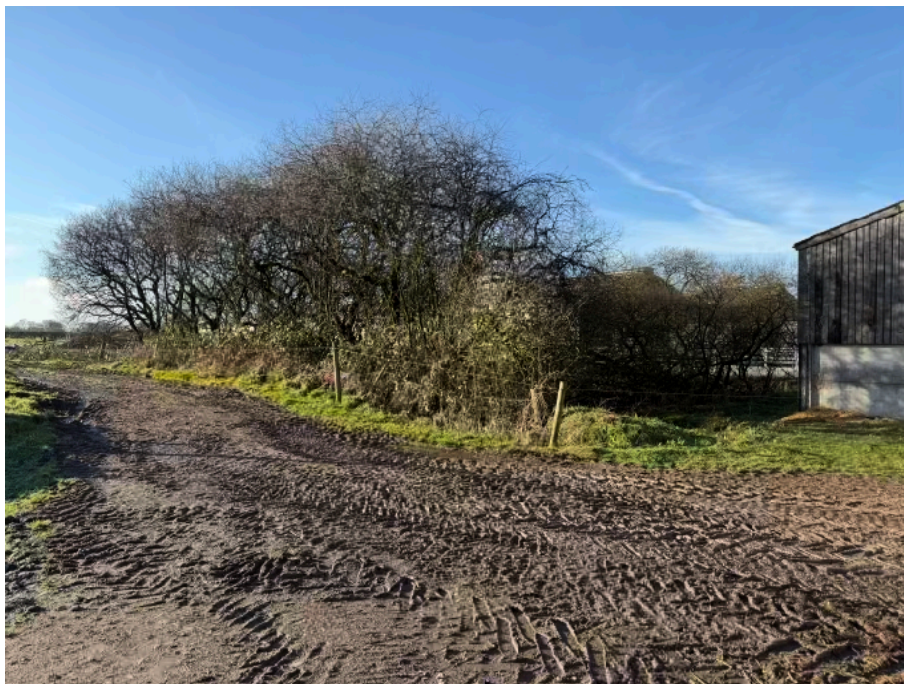
- 5.6.3 G2 is a wildlife haven with a pond located centrally. With demolition and development corridors potentially passing by the health of trees canoe adversely affected. Indirect damage could be caused by soil contamination through the mismanagement of building materials such as cement leaching into the soil profile during periods of heavy rain.

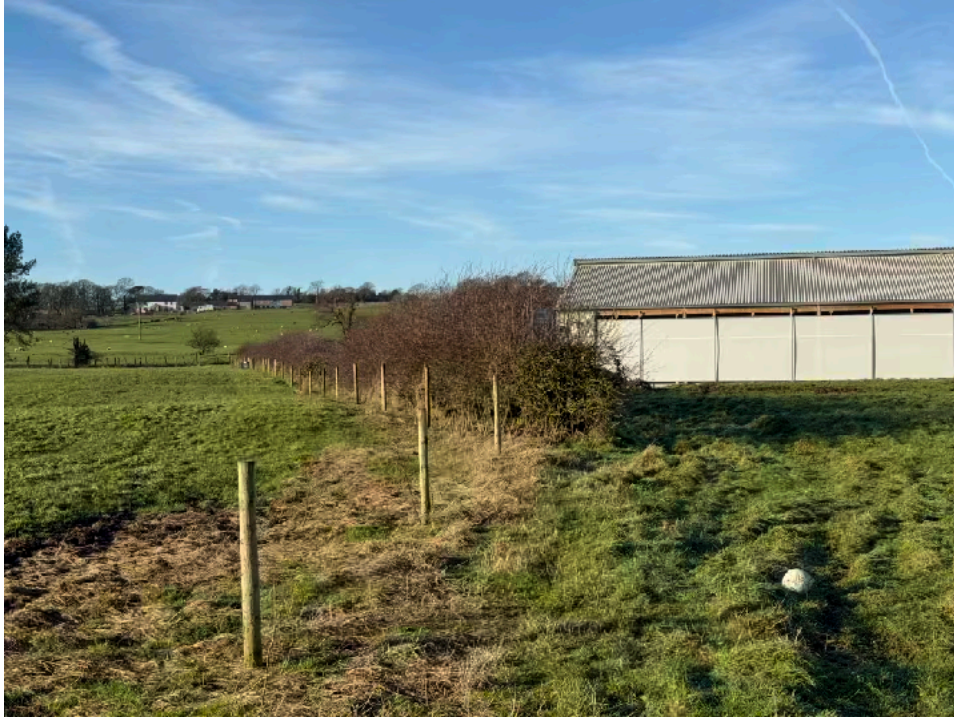
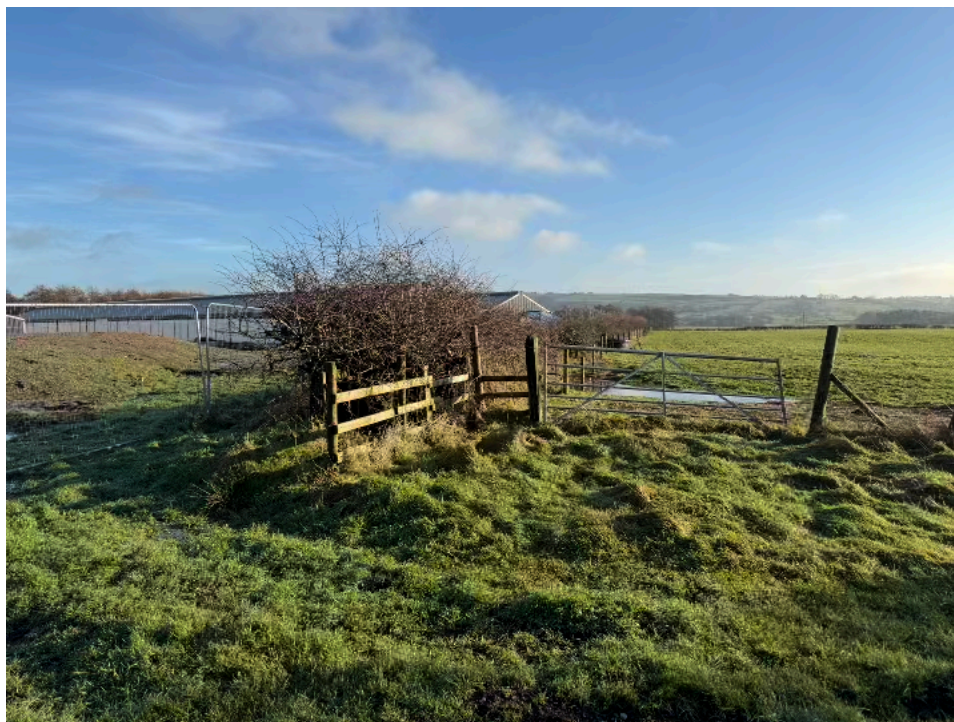
- 5.6.4 Below is looking north at H3 hawthorn (*Crateagus monogyny*) which is highlighted for removal to accommodate the proposed agricultural buildings and hardstanding areas. Bottom image is looking south at H5 hawthorn (*Crateagus monogyny*) which is highlighted for removal to accommodate the proposed hardstanding areas.

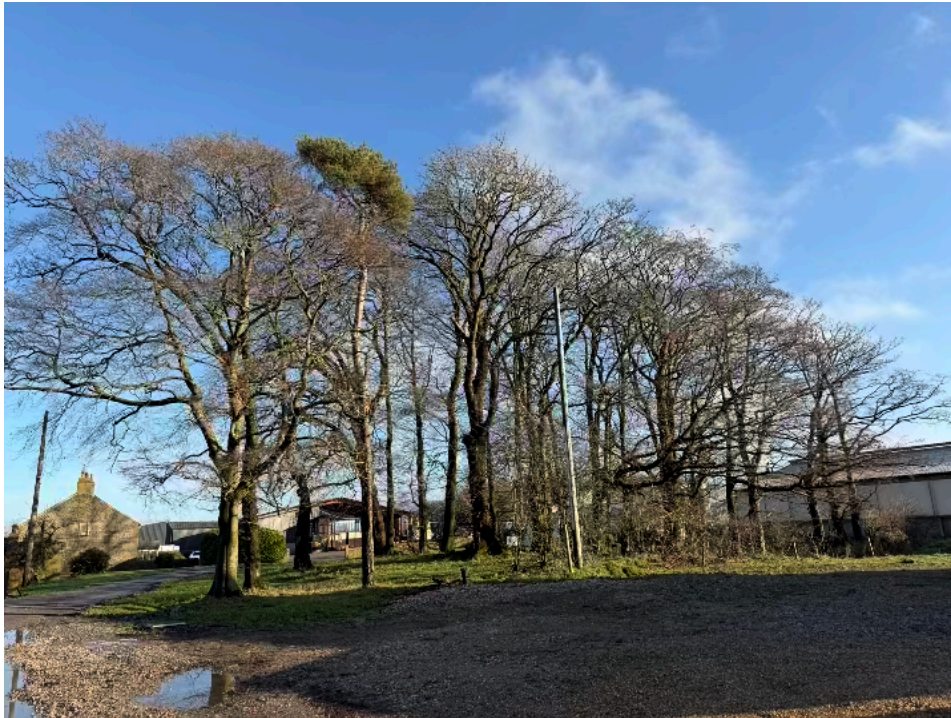
- 5.6.5 Below showing the woodland of W18 where trees are near to the proposed extension of the Farm Cottage, these have below ground constraints with regards to the indirect damage potentially caused by compaction and contamination.

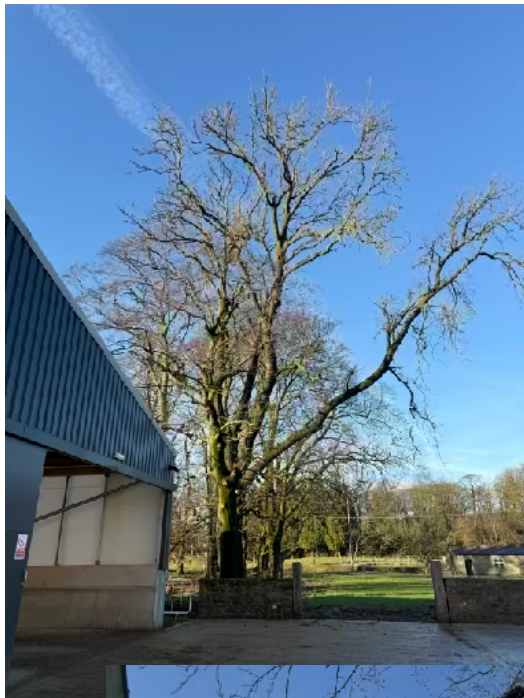
Left impart of G7 with a large mature ash suffering from ash dieback

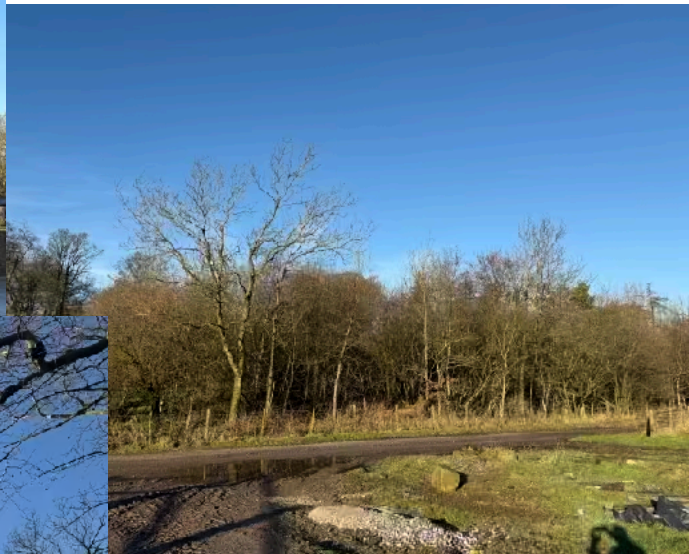
Below is W1 with hundreds of ash with ash dieback.

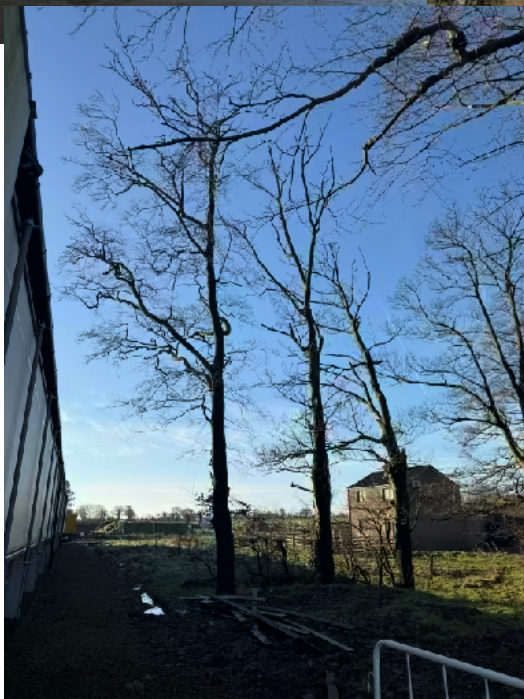
Bottom left are a group of trees G6 where soil mounding have caused irreversible stress and a high possibility of entire tree failure within the coming month onto the newly construction calving shed.
