# Arboricultural Impact Assessment (AIA) January 2025

**Report no.: TWR-0123**

Site Address: St Cecilia's RC High School, Chapel hill, Longridge, Preston, PR3 2XA

Report type: Arboricultural Impact Assessment (AIA)

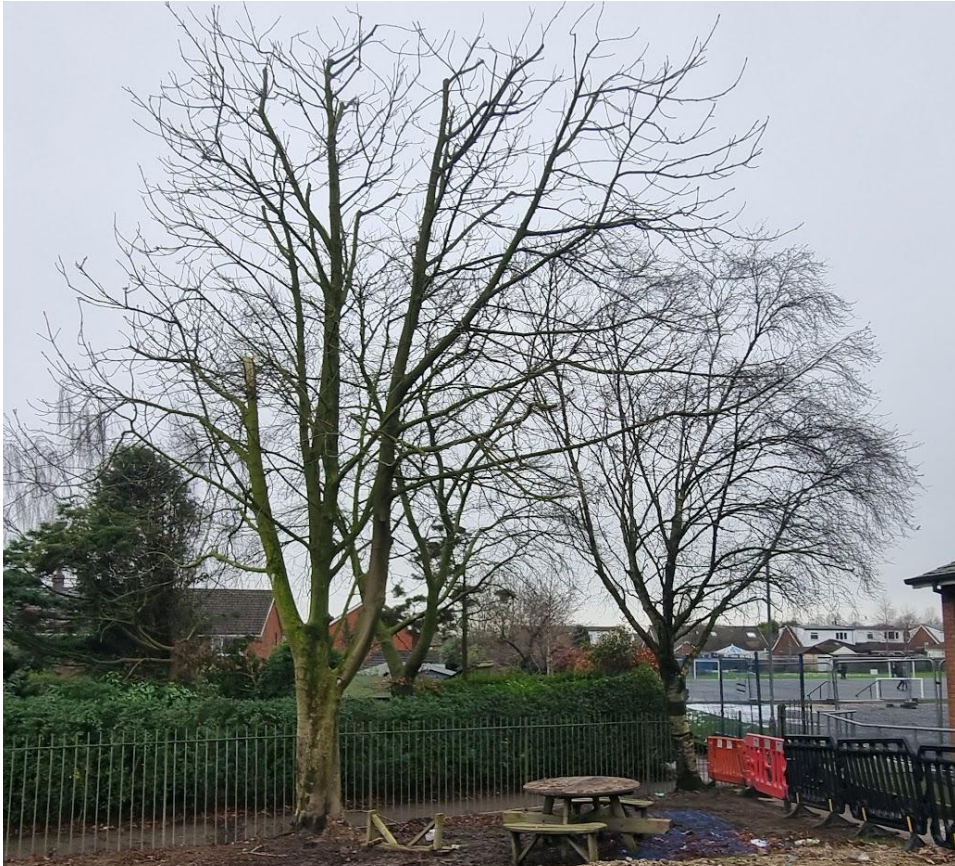
| | Species | | Condition | Category<br>(see reference 3.5) | Root Protection<br>Area (RPA)<br>(meters) | Comments |
|---|---|---|---|---|---|---|
| <b>T18</b> | Horse chestnut | <i>Aesculus hippocastanum</i> | Fair | B | 7 | # Storm damage<br># RPA previously encroached |

Picture 1: (from left to right) T18 Horse chestnut and T19 Silver birch.

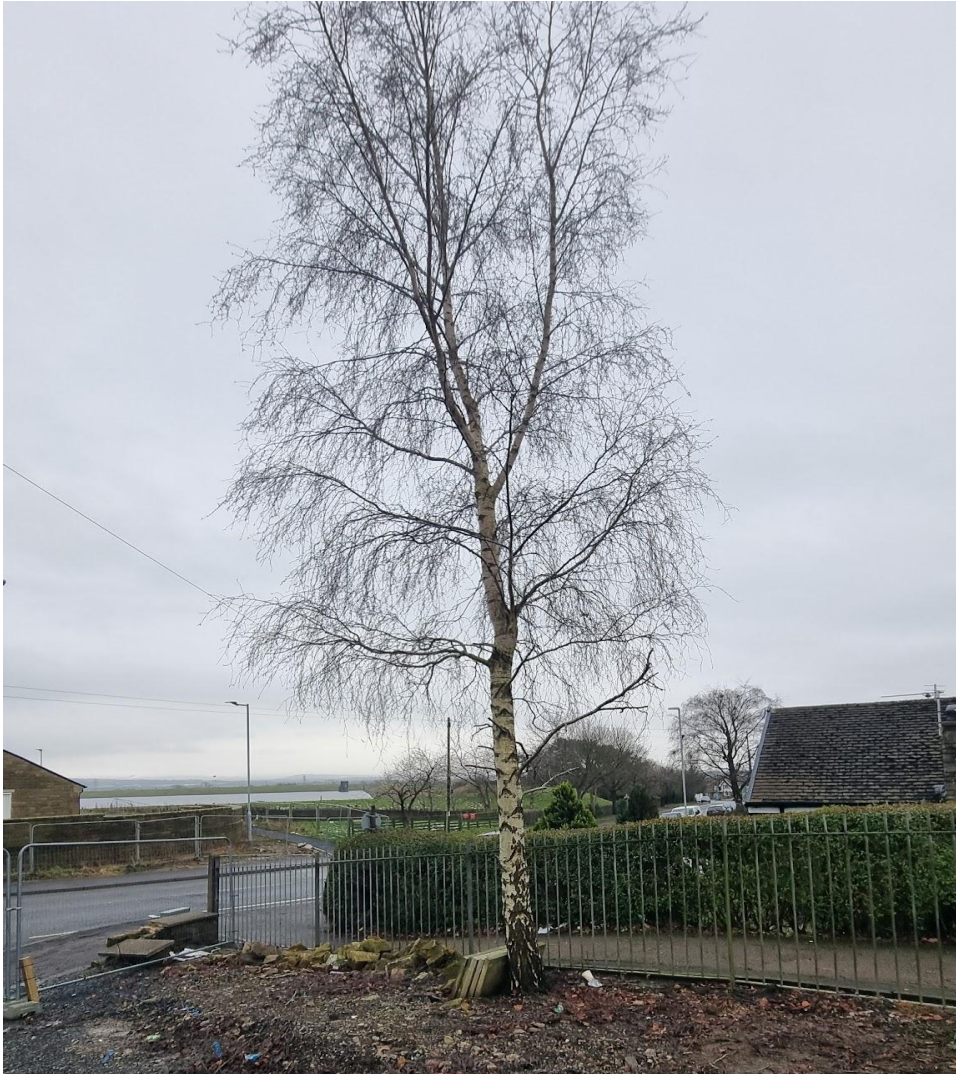
| | Species | | Condition | Category<br>(see reference 3.5) | Root Protection<br>Area (RPA)<br>(meters) | Comments |
|---|---|---|---|---|---|---|
| <b>T23</b> | Silver birch | <i>Betula pendula</i> | Good | B | 2.5 | n/a |

Picture 2: T23 Silver birch.

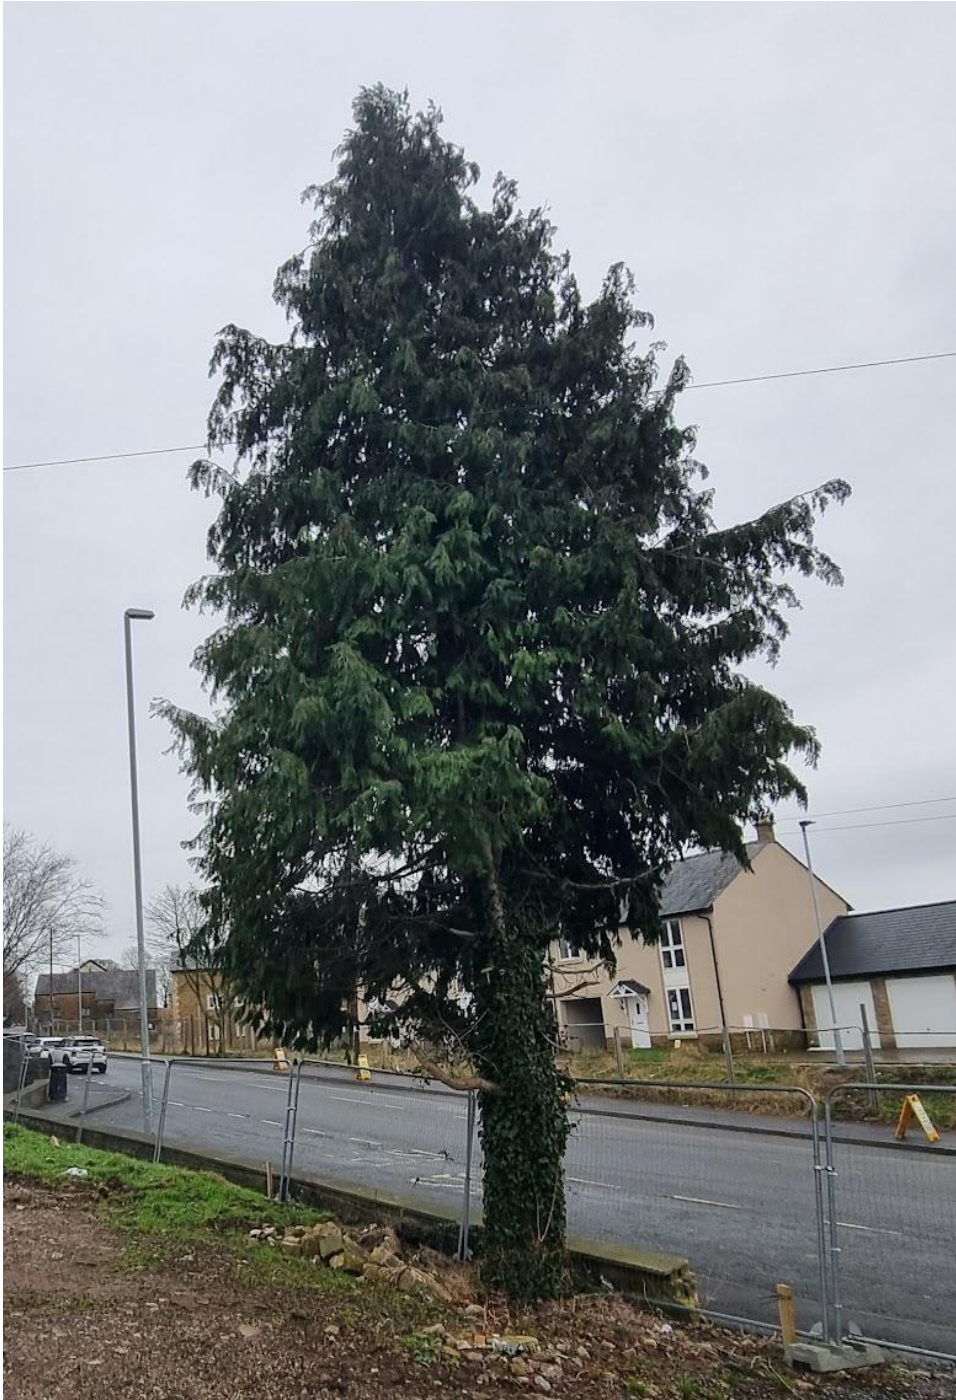
| | Species | | Condition | Category<br>(see reference 3.5) | Root Protection<br>Area (RPA)<br>(meters) | Comments |
|---|---|---|---|---|---|---|
| <b>T24</b> | Western red cedar | <i>Thuja plicata</i> | Good | B | 9 | # RPA previously encroached |

Picture 3: T24 Western red cedar

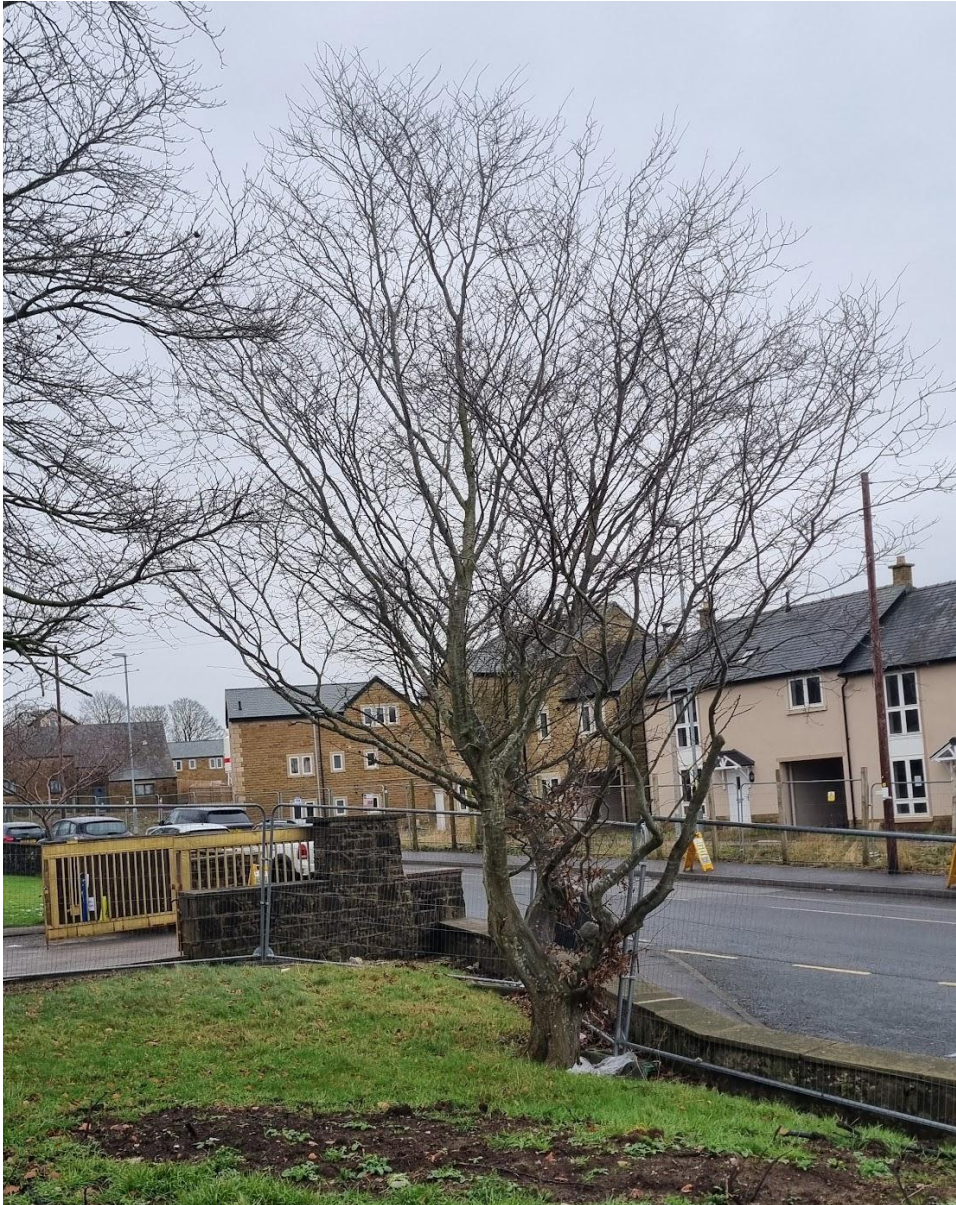
| | Species | | Condition | Category<br>(see reference 3.5) | Root Protection<br>Area (RPA)<br>(meters) | Comments |
|---|---|---|---|---|---|---|
| <b>T27</b> | Hornbeam | <i>Carpinus betulus</i> | Fair | B | 7 | n/a |

Picture 4: T27 Hornbeam.

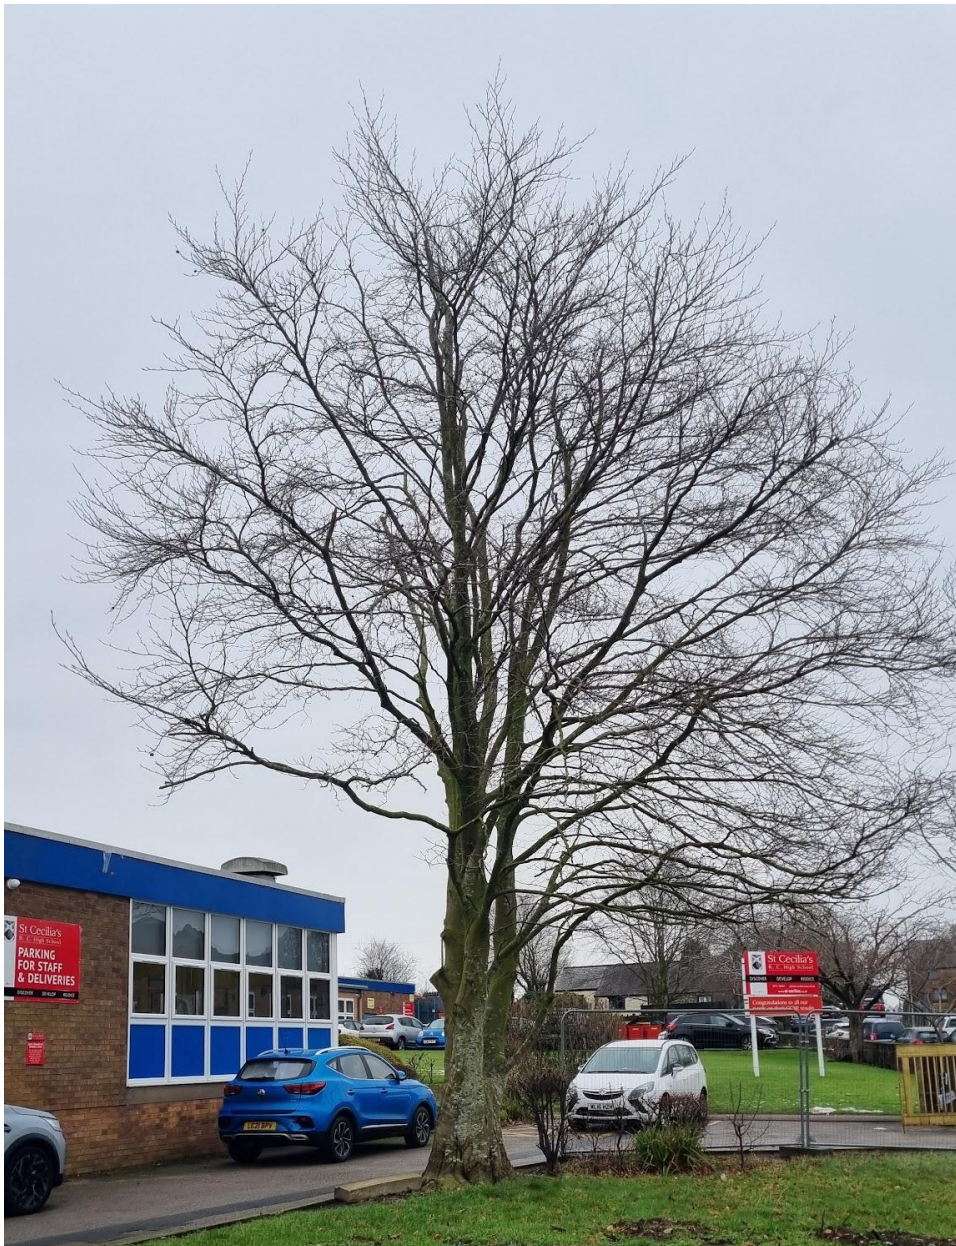
| | Species | | Condition | Category<br>(see reference 3.5) | Root Protection<br>Area (RPA)<br>(meters) | Comments |
|---|---|---|---|---|---|---|
| <b>T28</b> | Beech | <i>Fagus sylvatica</i> | Fair | B | 10 | # RPA previously encroached |

Picture 5: T28 Beech.
