ARBORICULTURAL REPORT
(BS 5837:2012)

LAND AT
NORTHCOTE ROAD
LANGHO
BLACKBURN
BB6 8BG

December 2024

Job Number 4986

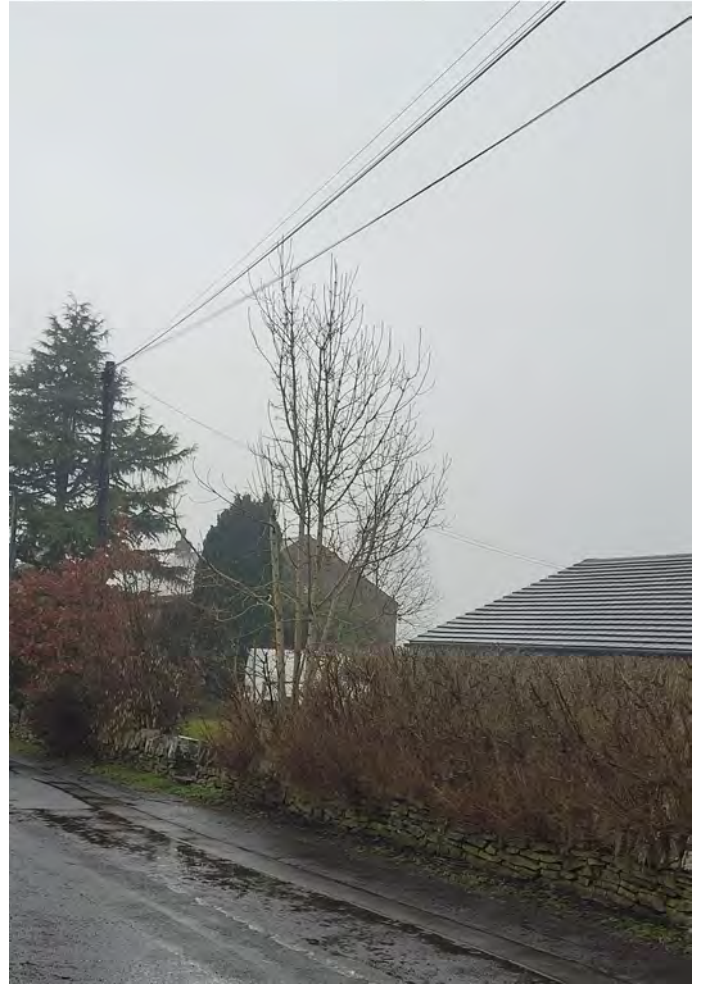
U – 3 trees (T1, T2 & T5)

Arboricultural Data Sheet: Land at Northcote Road, Langho, Blackburn, BB6 8BG															Date of Survey: 03/03/22		Weather: Inclement		Surveyor: PM	
Crown C = Crown Clearance; Cond R = Condition Rating; ERC (Yrs) = Estimated Remaining Contribution; TQRA = Tree Quality Category Rating; RPA (m ²) = Root Protection Area (m ²)															Recommended works should be carried out to the <i>British Standard Recommendations for Tree Work, BS 3998:2010</i>					
Tree No.	Species	Dbh (mm)	Height (m)	Age	Crown Spread				Crown C	Cond R	Observations and Comments	Preliminary Recommendations	ERC (Yrs)	TQC R	RPA (m ²)	RPA Circle Radius (m)				
					N	E	S	W												
T1	Ash	300	6	SM	2	3	2	2	1.8	B/C	A minor multi-stemmed specimen within hedge. Showing some signs of stress in crown, most likely due to Ash Dieback. Previously pruned from BT lines.	n/a	5-10	U	40.72	3.60				
T2	Ash	300	6	SM	2	3	3	2	2	B/C	A minor multi-stemmed specimen within hedge. Showing some signs of stress in crown, most likely due to Ash Dieback.	n/a	5-10	U	40.72	3.60

Tree No.	Proposed Works
T1, T2, H1, T3, T11 & T12	Fell to ground level and remove stumps.
T13, T14, T15 & T16	Remove significant deadwood and broken branches.
T16	Reduce the canopy on the development side by approximately 2-3m pruning to appropriate points whilst maintaining a flowing shape to the crown.

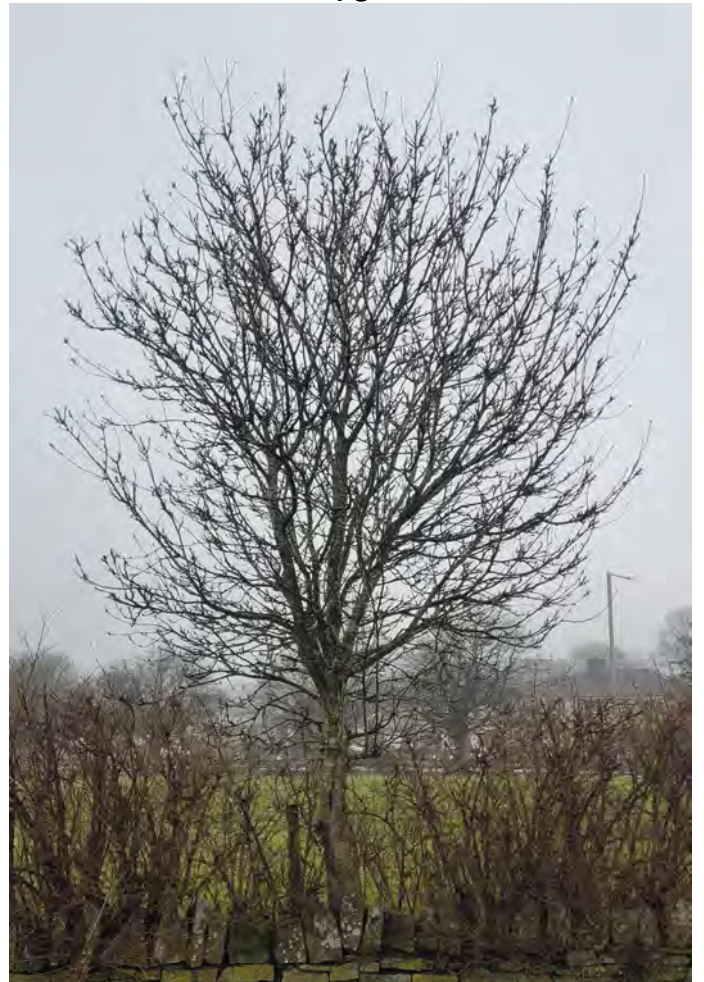
T3

C – 7 trees/groups (H1, T3, G1, T11, T12, T17 & T18)

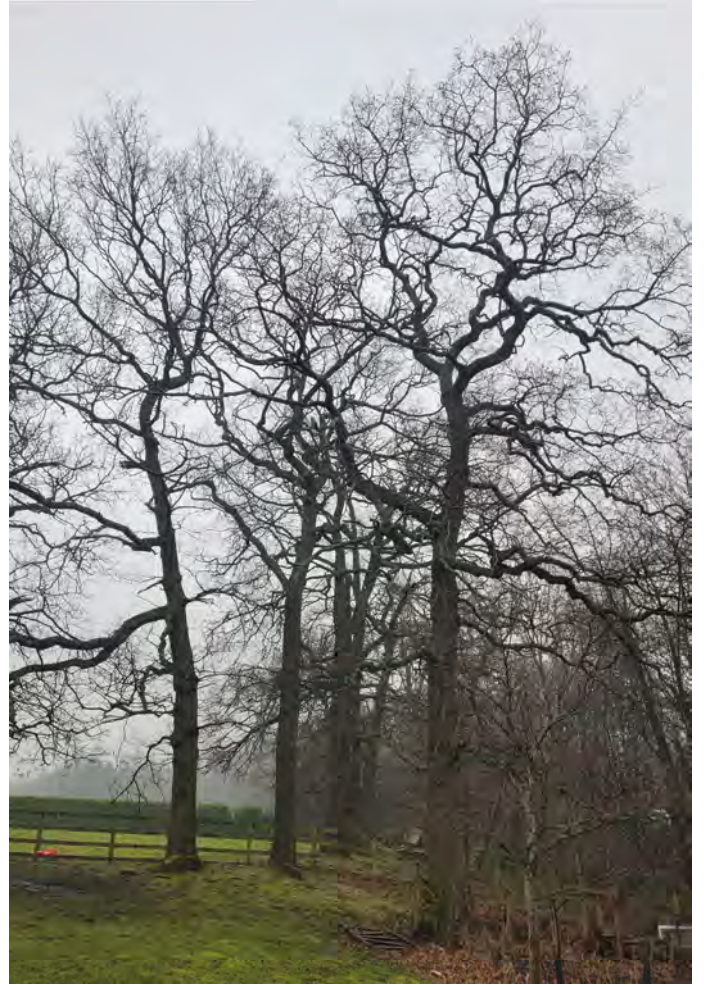
T13 - T16

- 5.2.4 The Oak trees T13, T15 & T16 have typical deadwood and broken branches present but are in good condition for their age and species. Some remedial works will be required in order to remove the most significant deadwood, which does not require consent under the TPO. None of the canopies are over the development apart from T16 so no pruning will be required in order to facilitate development.

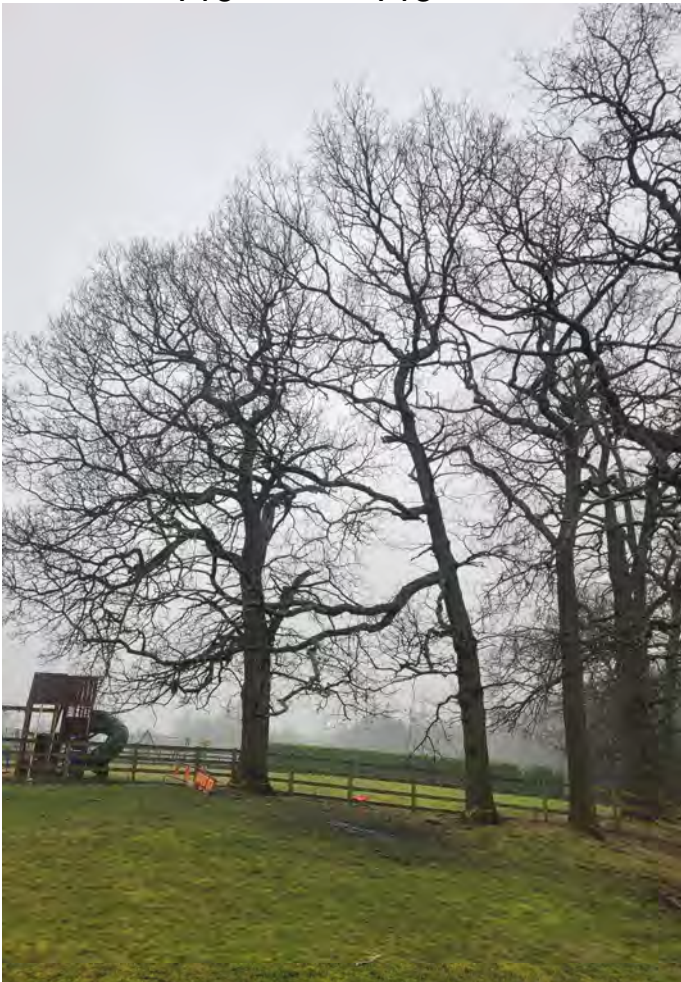
- 5.2.2 However, with regard to T16 (Oak) this intrusion is less than 10% of its overall RPA and far enough away from the buttress area not to cause any significant root damage. Provided this tree is appropriately fenced off it will suffer no adverse damage from the construction of the patio area. However, it will require some minor pruning works to facilitate the development.

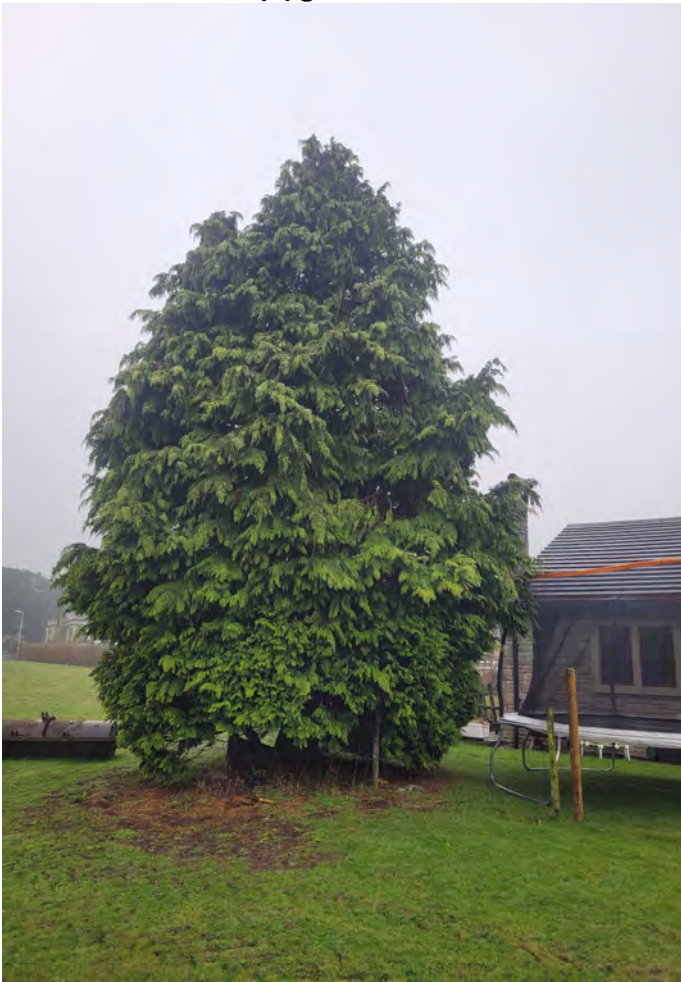
- 5.2.3 T18 (Lawson Cypress) is within the adjacent plot and the intrusion of the surfacing affects approximately 25-30% of its total RPA. This species is tolerant of root damage and should not affect it long term. Some minor trimming back of foliage may be required for the new car parking space.
