Preliminary Roost Assessment

Dilworth Cottage
Ward Green Lane
Longridge
PR3 2ZL

For
Ogden Design Consultants

Gritstone Ecology

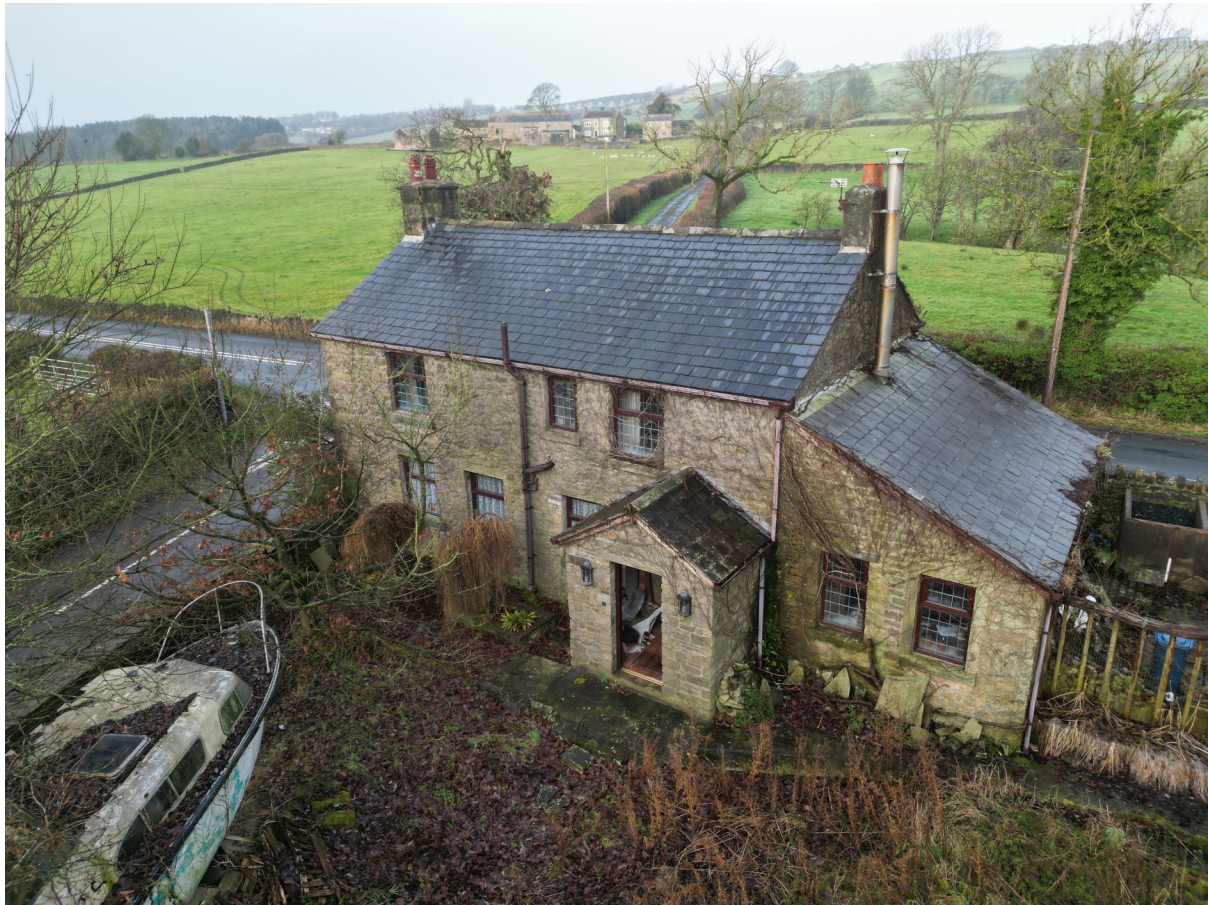
3.1a – The front (southern aspect) of the house.

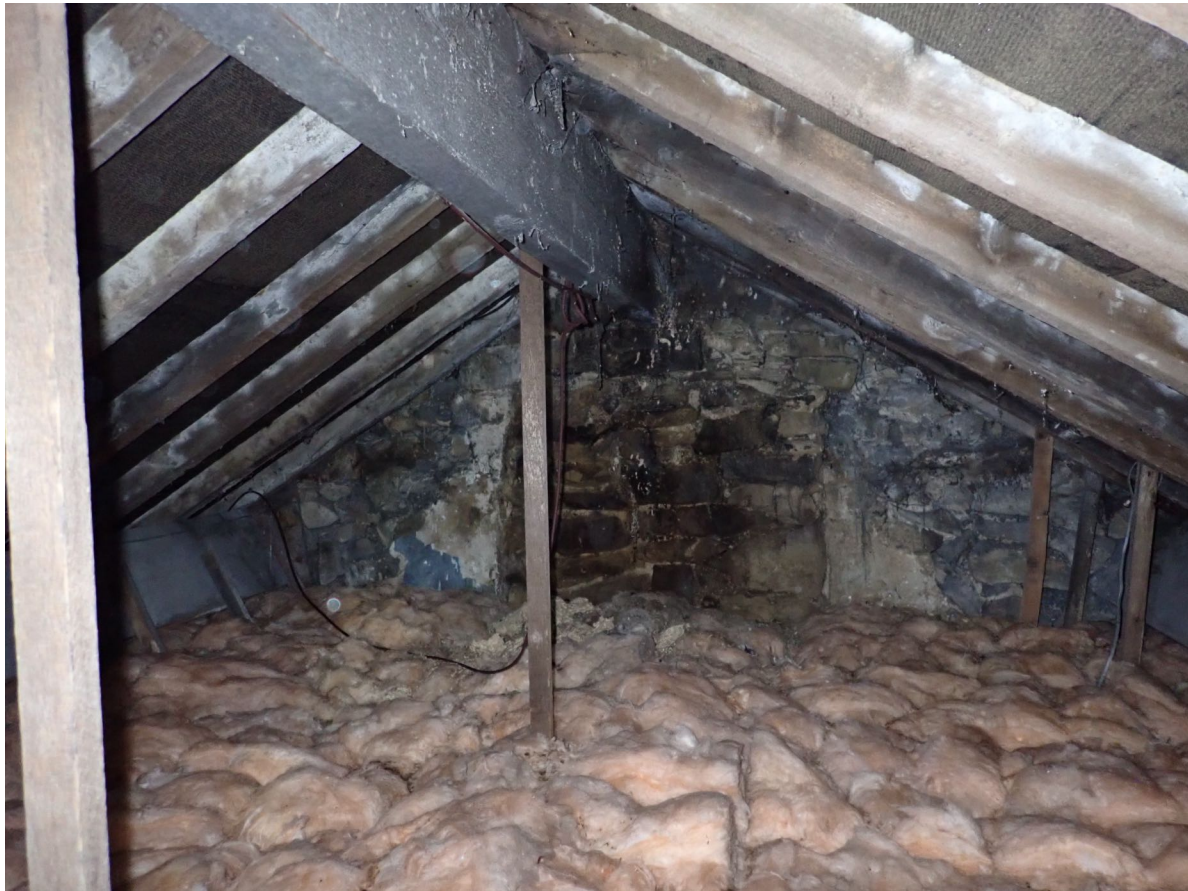
3.2a – A section of the roof void.

The roof has a timber rafter and purlin roof structure, lined with bitumen felt, and insulated with mineral wool between the ceiling joists. The roof lining is in good condition with no tears, or gaps. Timbers at the ridge, and the roof voids in general are filled with dusty cobwebs. Large numbers of mouse droppings were present in all roof voids.

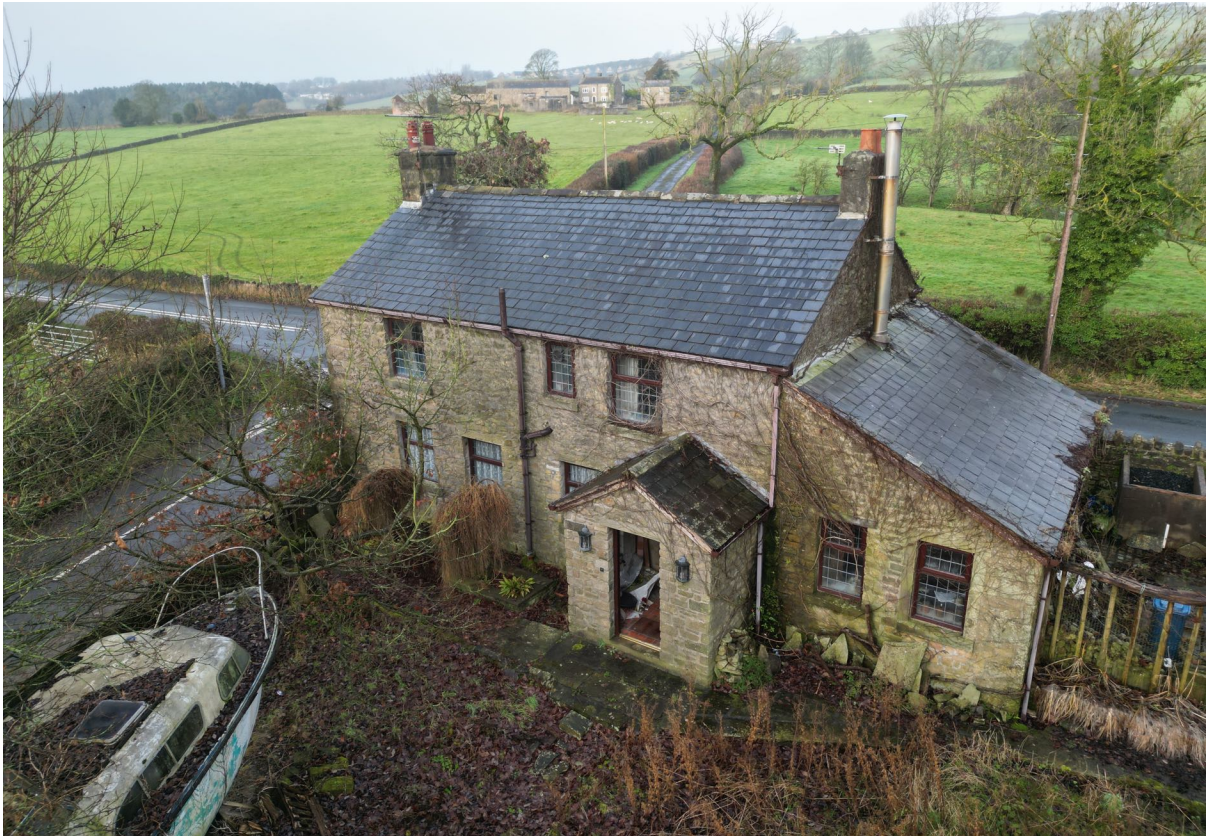
1 – The front of (south side) the house.

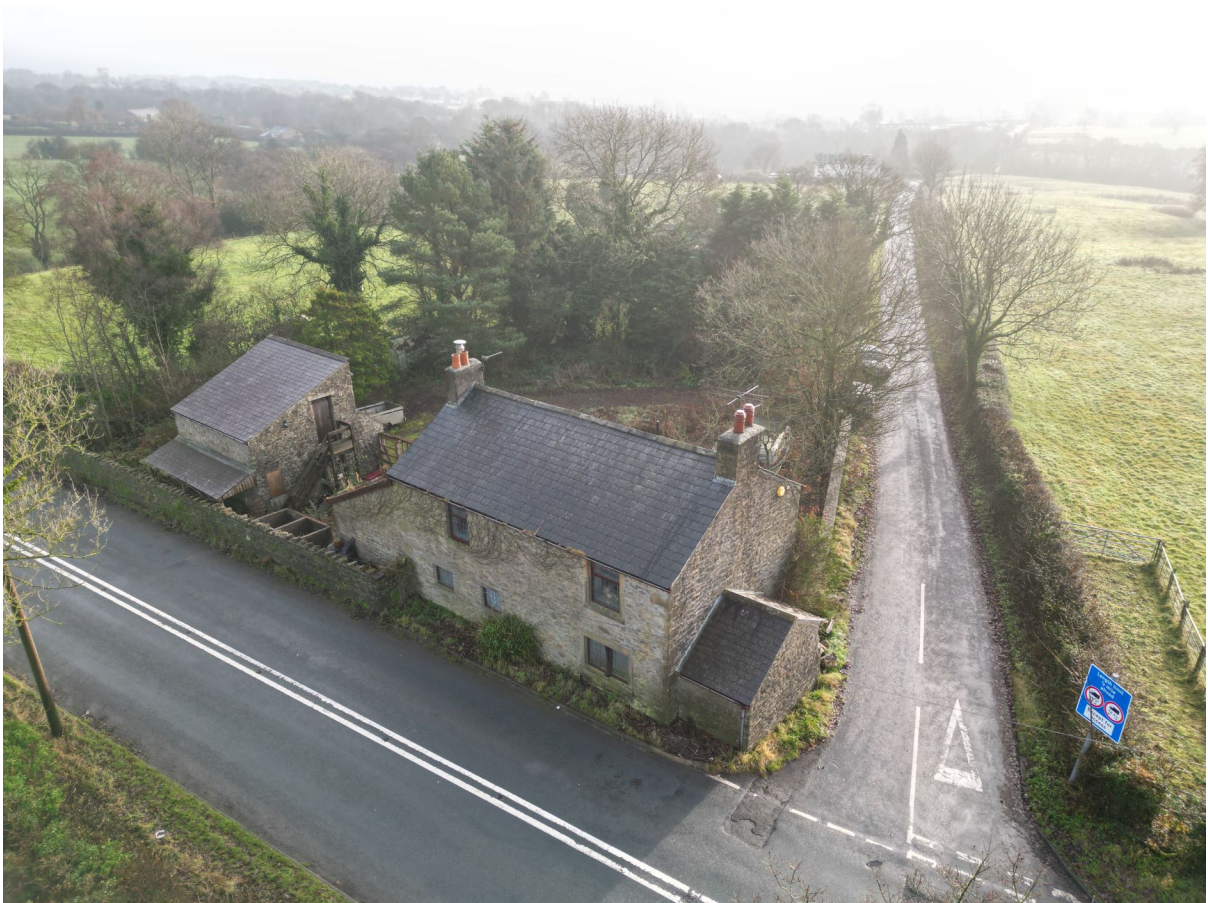
2 – The north side of the house (the garage to the left will not be affected).

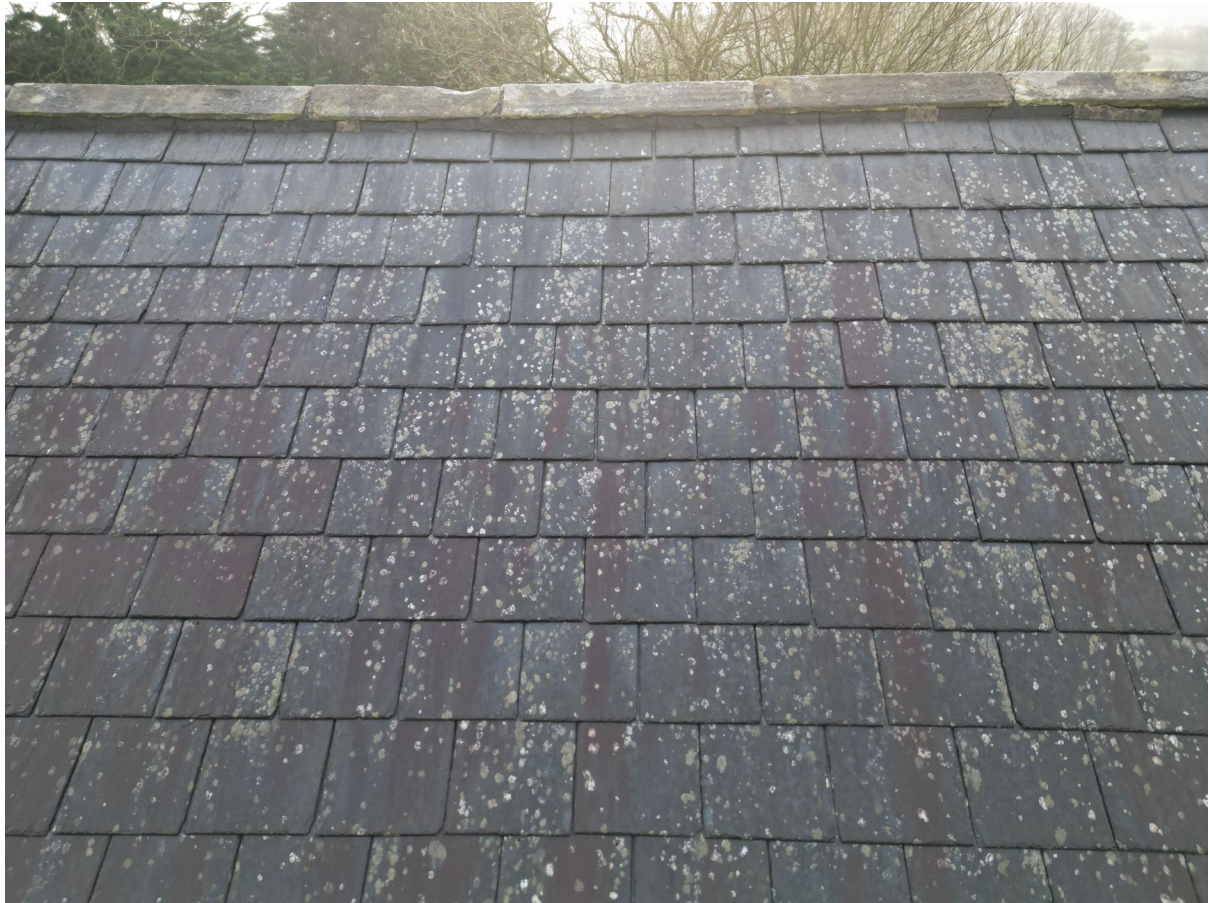
3 – Roof and ridge tiles are in good generally condition.

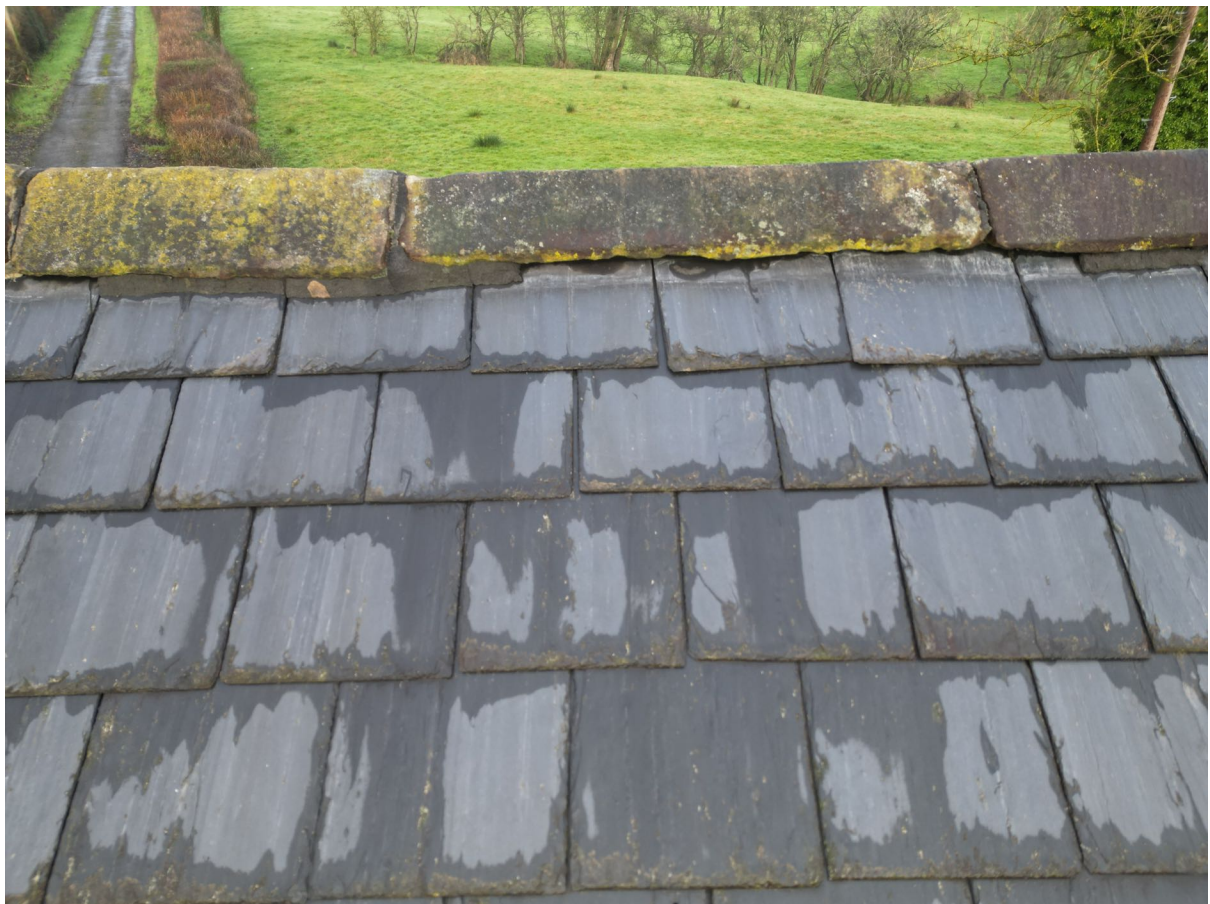
However, there are a number of features which could be used by roosting bats including: gaps in cement beneath ridge tiles, gaps between fascia boards and stonework at the eaves, and exposed cavities at the damaged store at the west gable.

Buildings immediately adjacent to good quality habitat are more likely to be used by roosting bats than those further away. The house has a number of features which could be used by roosting bats including; gaps beneath ridge tiles, and gaps behind fascia boards at the eaves. These are features which could be used by individual bats, or could give access to larger spaces such as roof voids.

4 – There are gaps under ridge tiles at various points on the ridge.

Bat emergence surveys are required during the active season for bats (May to September). The surveys are necessary to determine the presence or (likely) absence of bats in the building.

As the building has moderate suitability, two separate surveys are required. The surveys must be a minimum of three weeks apart. If bats are found roosting then a further survey will be necessary to determine the type of roost present.

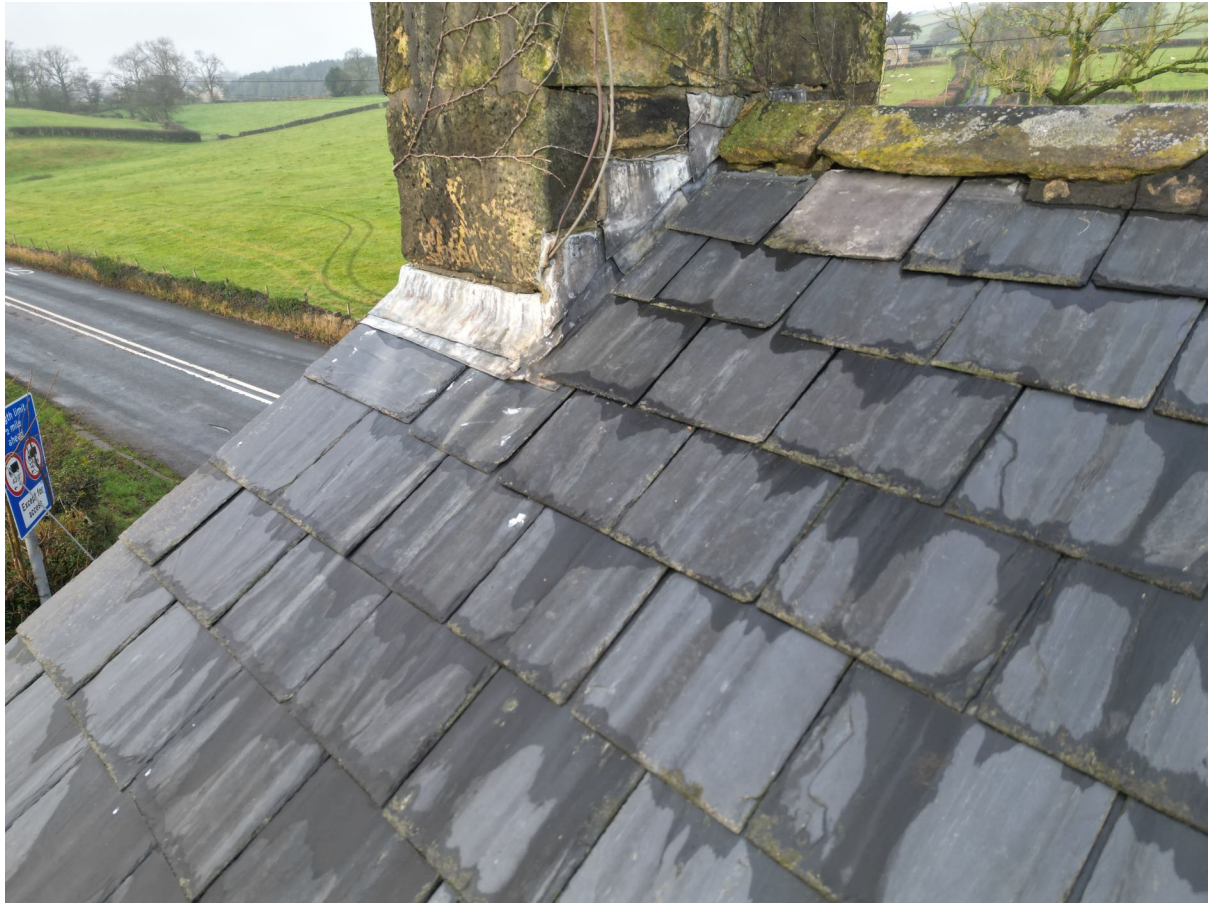
5 – Lead flashing is fitted tightly with no suitable gaps.

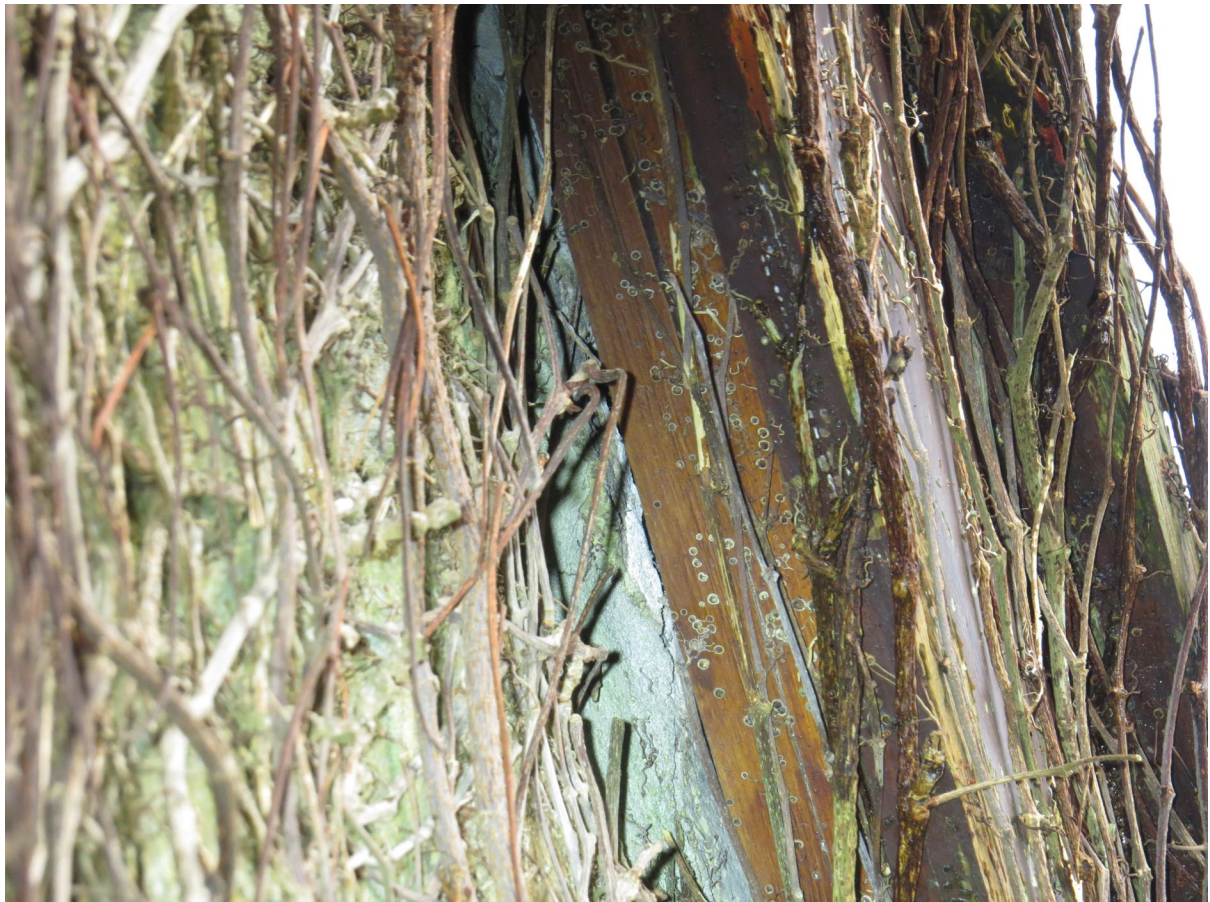
6 – There are gaps between fascia boards and stonework at the eaves.

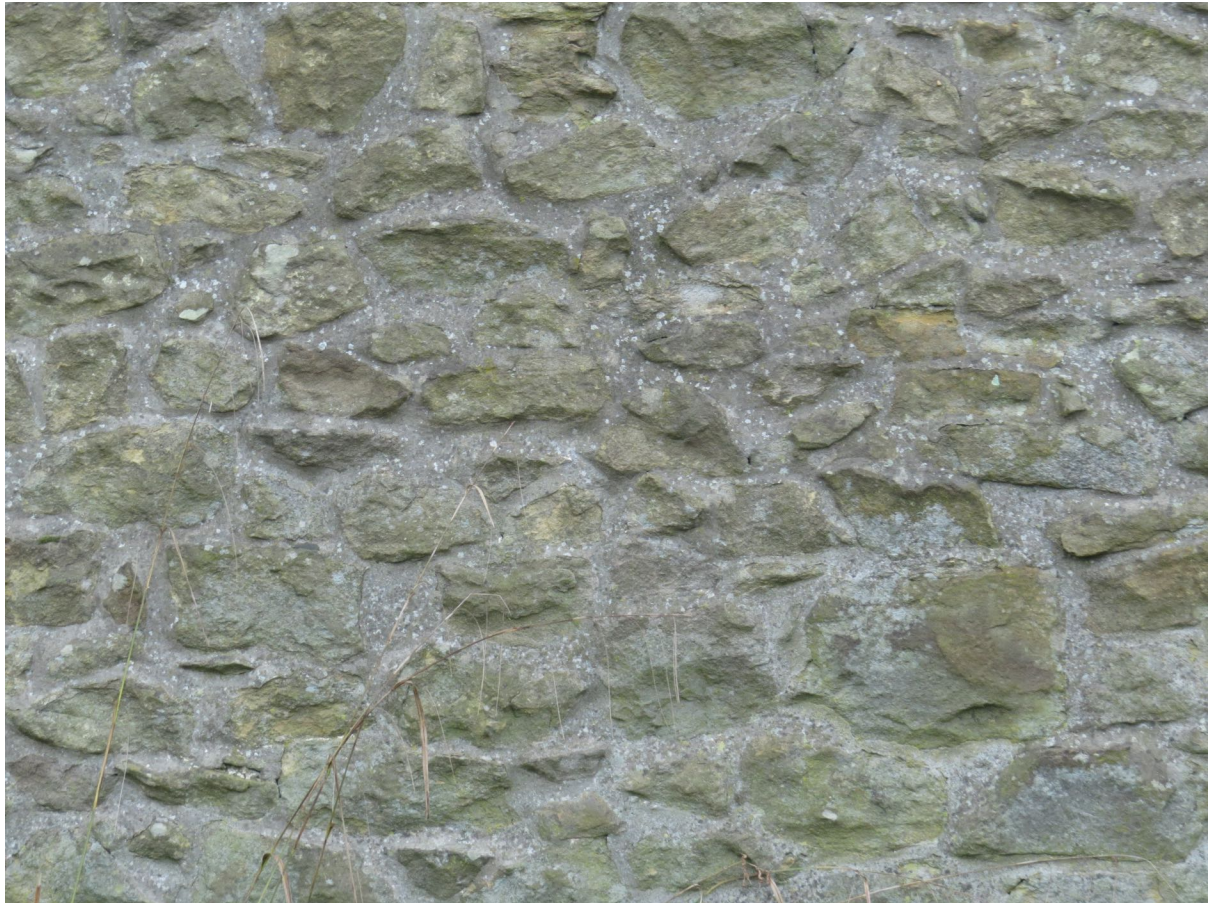
7 – Stonework and mortar is in generally good condition.

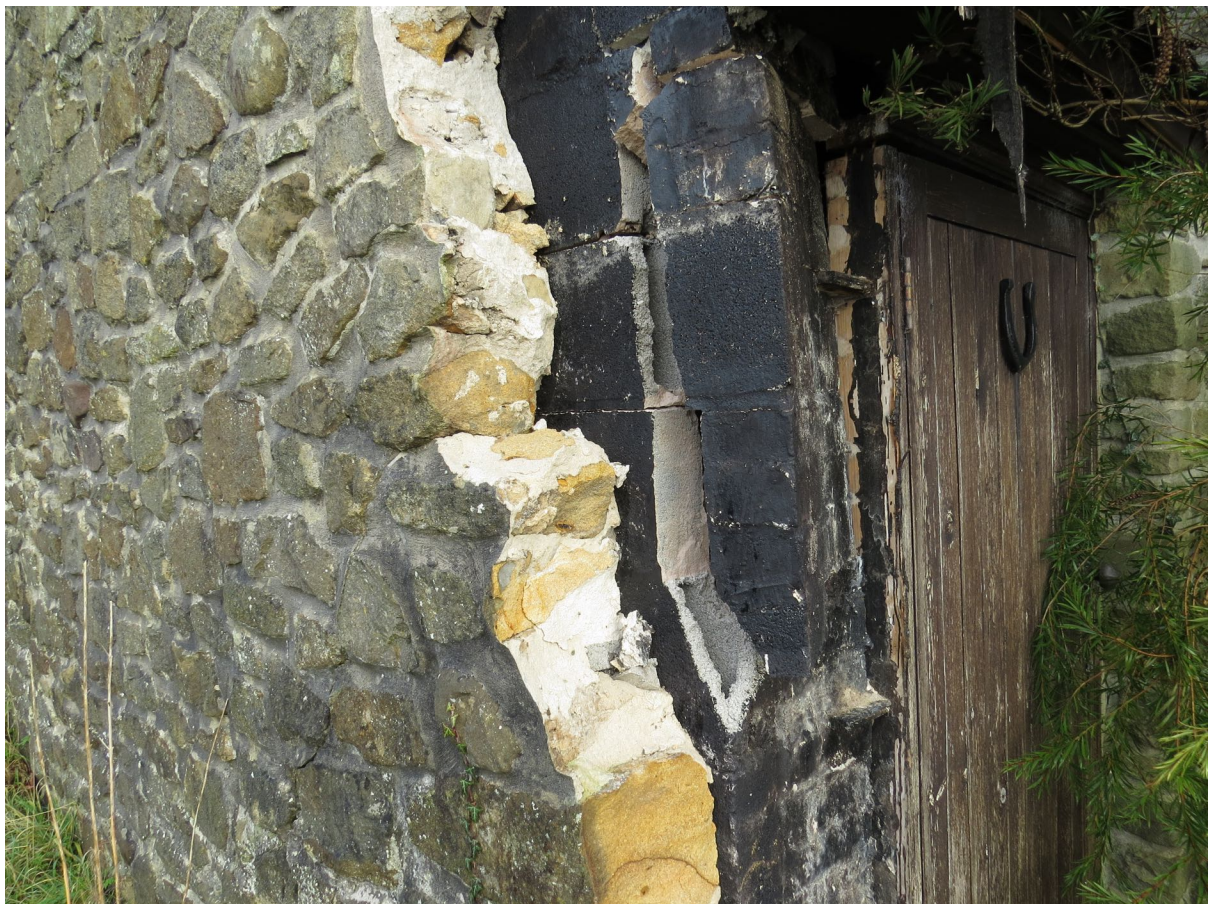
Walls are solid stone with no insulating cavity. In general the walls are in good condition, with no cracks, or missing mortar which could be used by crevice dwelling bats. However a damaged store at the west gable has exposed cavities, which could be used by roosting bats.

8 – A damaged store wall at the west gable has exposed the cavity in blockwork.

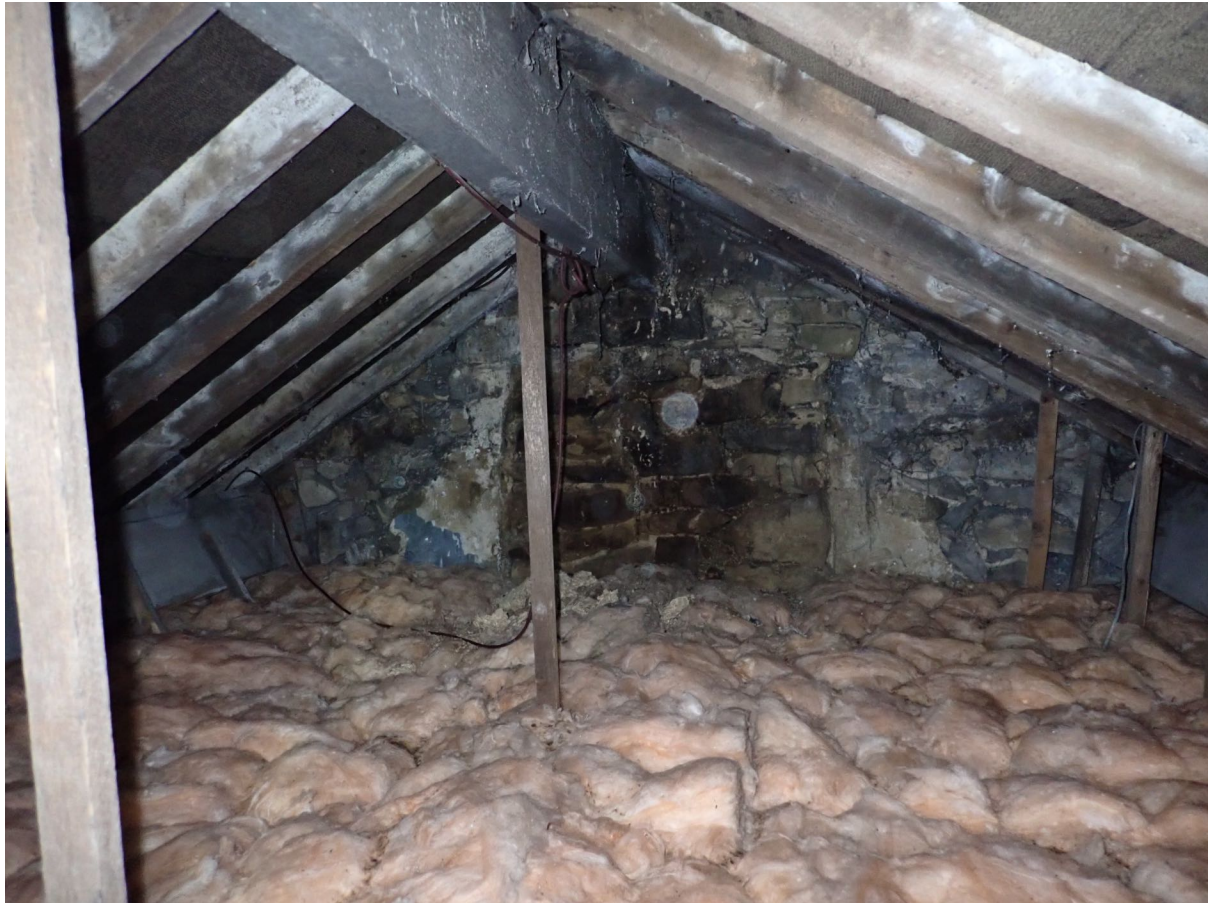
The building has four separate roof voids. The roof void of the house is split into two equal sections by a stone dividing wall; both sections were inspected. The roof void of the ground floor extension at the east gable end is divided into two sections by a stone dividing wall. Only the northern section was inspected as there is no access into the southern section. The roof voids are only accessed for essential maintenance work, and were undisturbed prior to the inspection.

9 – The house has four separate roof voids.

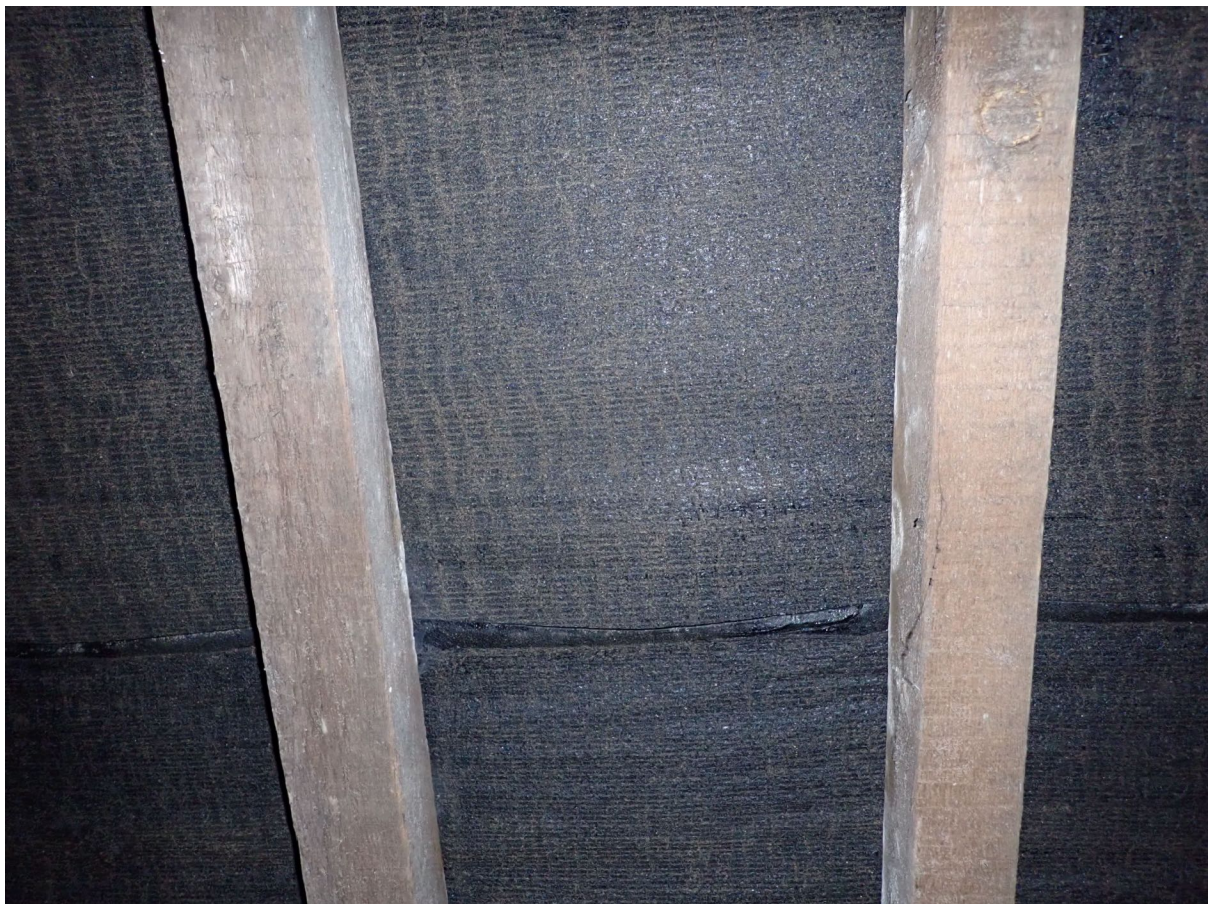
10 – Roof lining is in good condition with no gaps or tears.

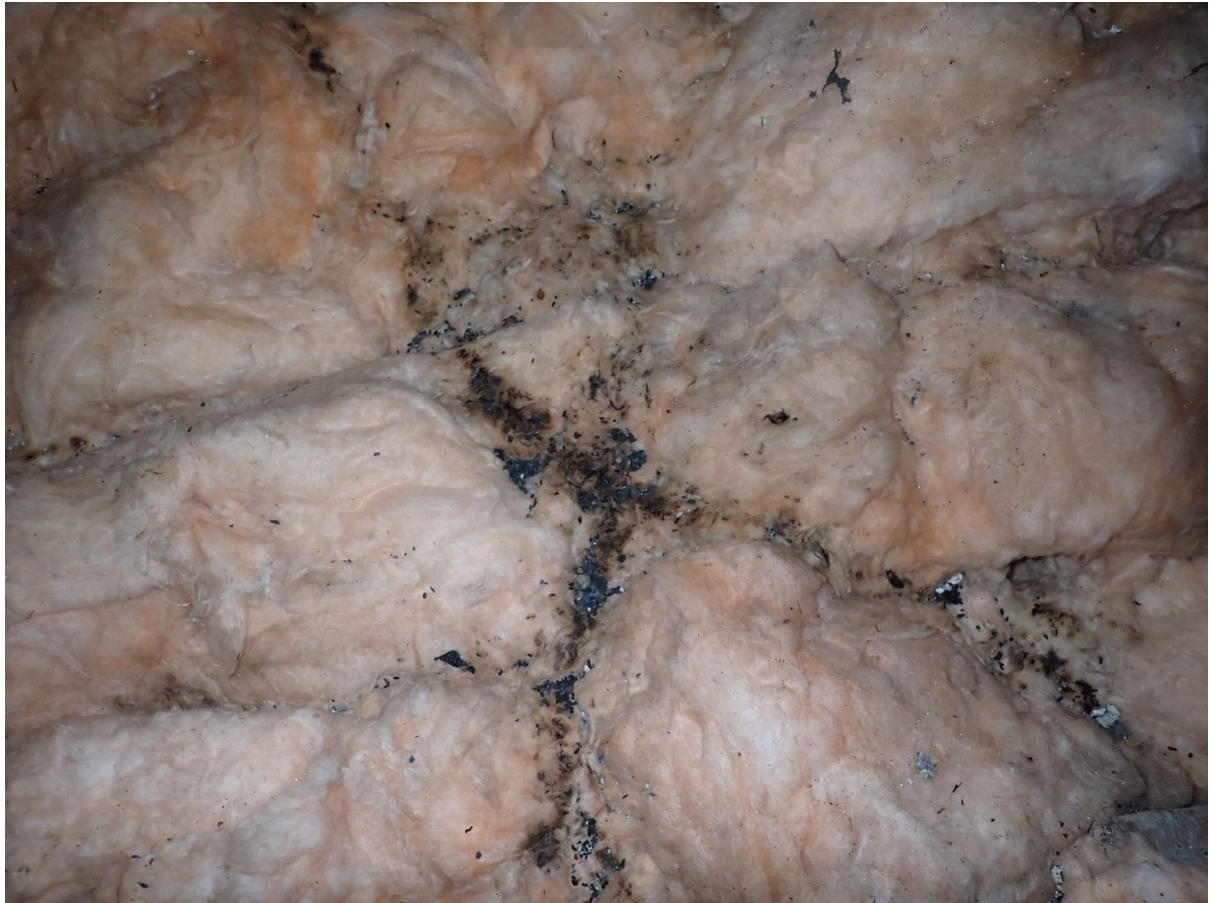
11 – Mouse droppings and runs were present in each of the roof voids inspected.

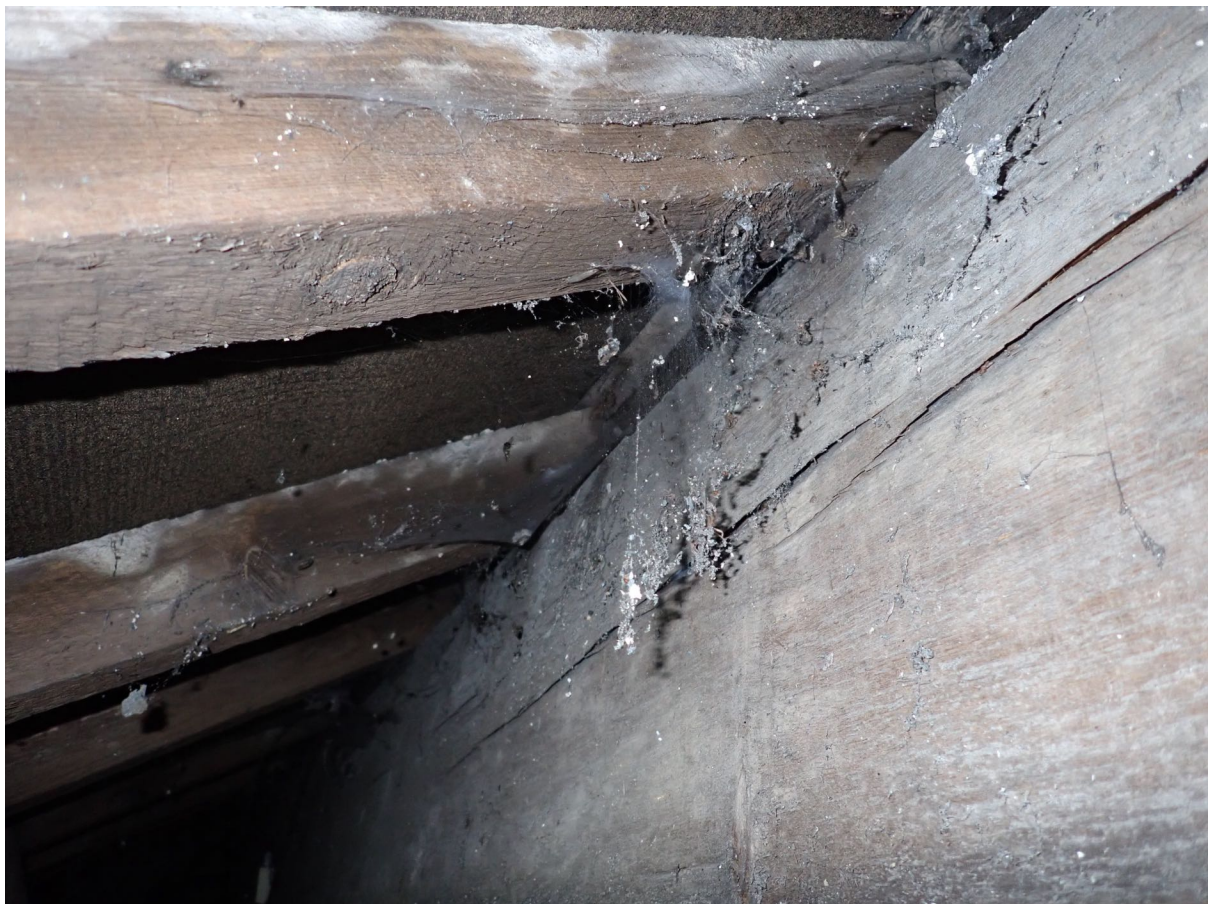
12 – Roof timbers are dusty and cobwebbed.
