# BOWLAND SURVEYORS LTD.

Heritage appraisal and heritage impact assessment for the replacement of internal timber stairs (retrospective listed building consent application).

24 January 2025 | Reference: 2024-77 | Version 3.0

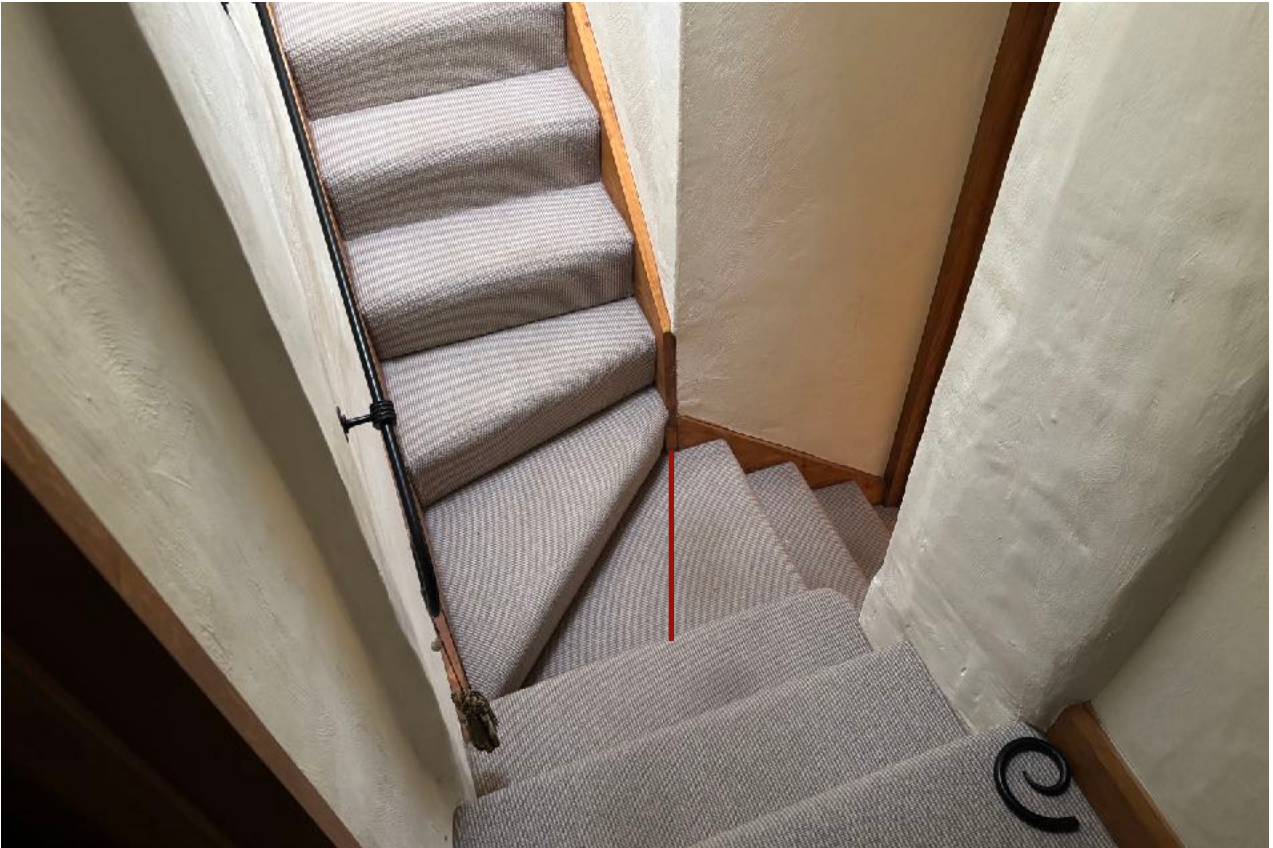
Figure 1: Replacement stair as seen from the bathroom doorway. The red line indicates the former position of a step (see figure 2). This has been removed and the steps reconfigured so as to form a small landing making use of the 'bathroom' steps safer.

5.3 The alterations therefore comprise the replacement of the entire stair with an almost like-for-like assembly, albeit with improvements to ensure that the riser heights and tread depths are equal. In addition, the bathroom steps now discharge onto a full step rather than across two steps on the main staircase as it did prior (please see figures 1 & 2). The lintel height of the doorway upon the stair was increased from 1550mm to 2000mm to improve access and thus safe passage. The timber-planked enclosure wall was replaced with a plasterboard-clad stud partition to improve acoustic resistance and provide robust support for the stairs. It is understood that the timber-planked enclosure was also in poor condition and of poor quality. The door at the bottom of the stair was re-used and the door under the stairs was installed along with the stairs.

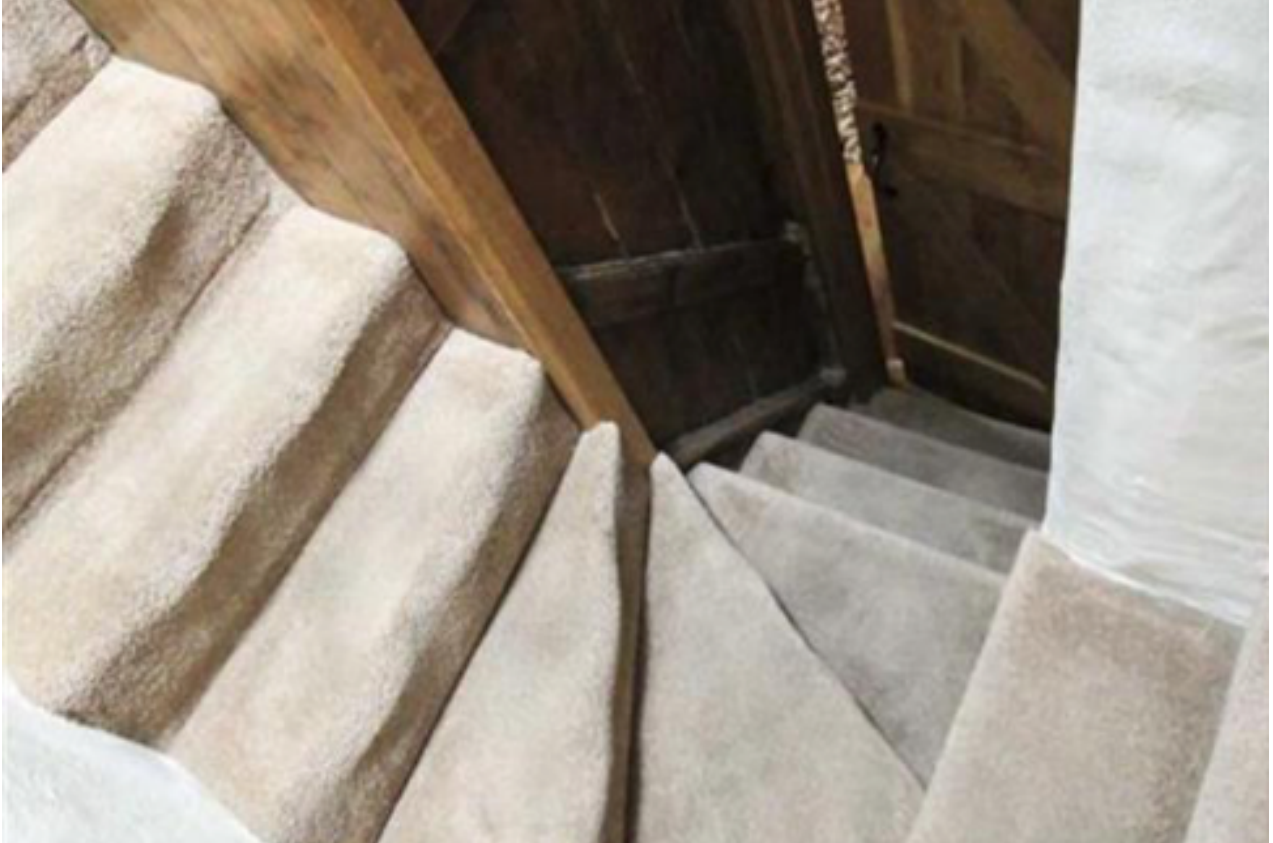
5.2 The reason for replacement was due to the poor condition of the stairs which had loose treads as well as unequal riser heights throughout. In addition, the doorway that provides access from the mid-height level of the stairs was poorly detailed with regard to head height which made its use precarious.

Figure 2: Prior stair from sales particulars, note the bathroom step discharging across two steps on the winder portion of the stair.

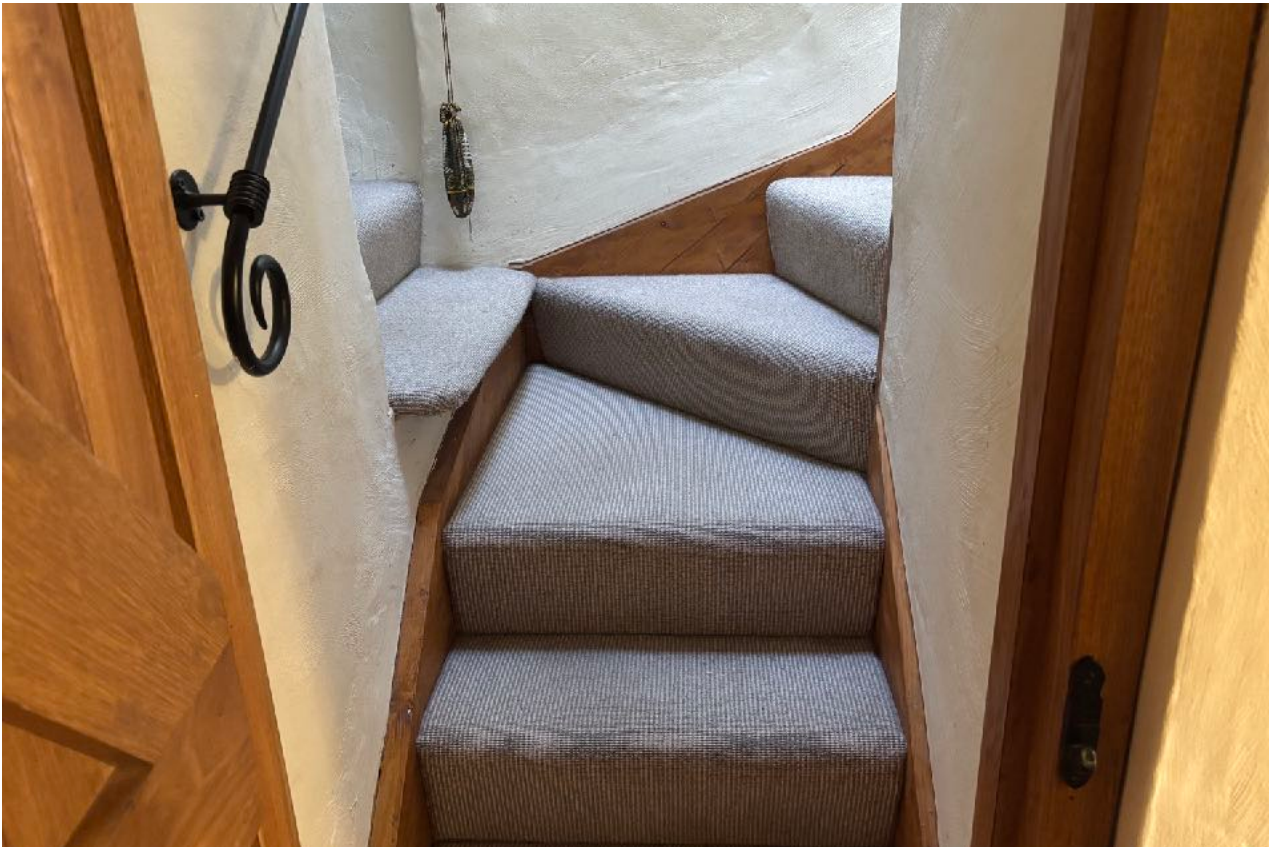
Figure 3: Stairs as seen from the living room. The bathroom stair now discharges on to one large full step.

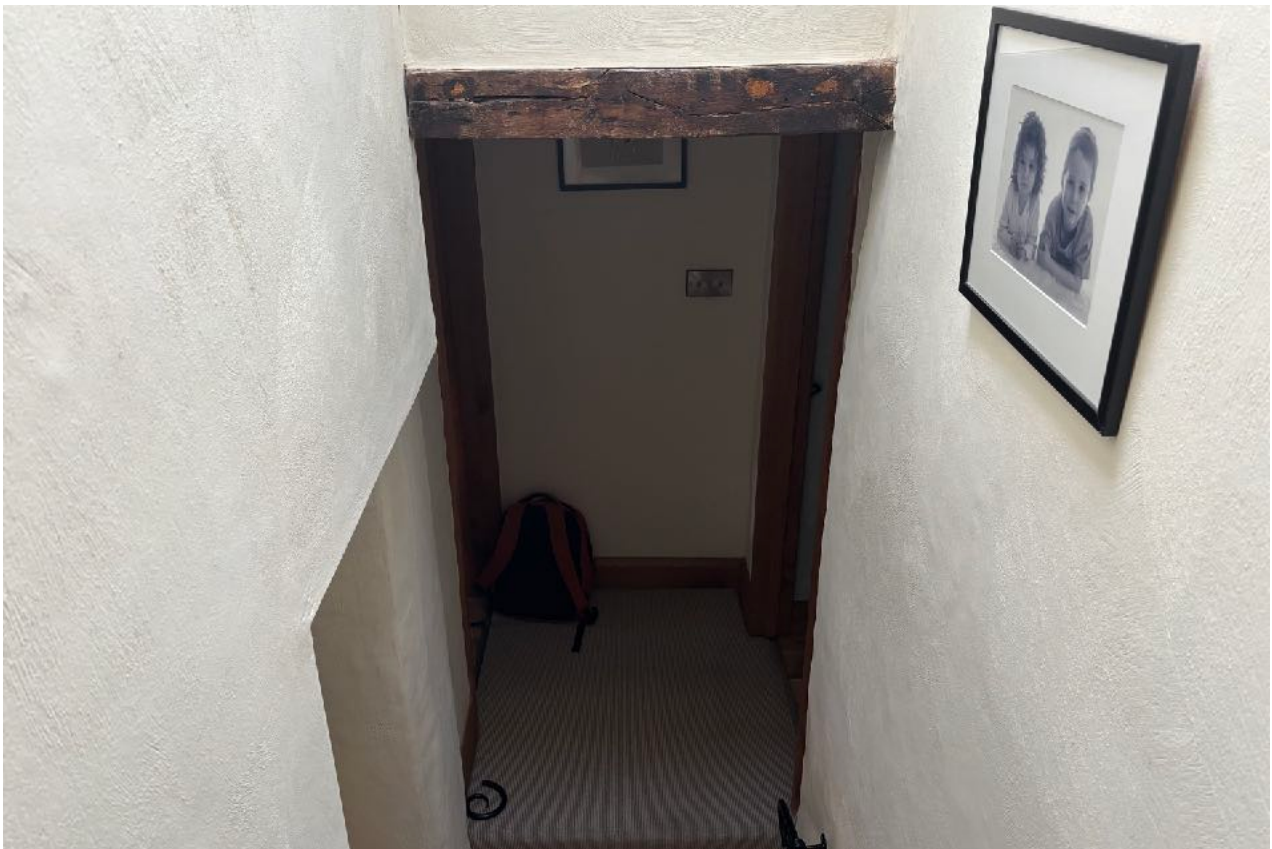
Figure 6: Altered lintel over bathroom/ bedroom entrance.

5.4 Regarding the materials used, the stair is constructed from softwood timber and the raised lintels comprise oak units. There is little recorded evidence of the former stair aside from a single photograph available from old sales particulars, please see figure 2. This photograph shows a timber-planked wall that encloses the stairs which has been replaced with a stud partition wall and plastered. At the time the works were undertaken a building control application was made which also shows the layout of the former stairs<sup>5</sup>.

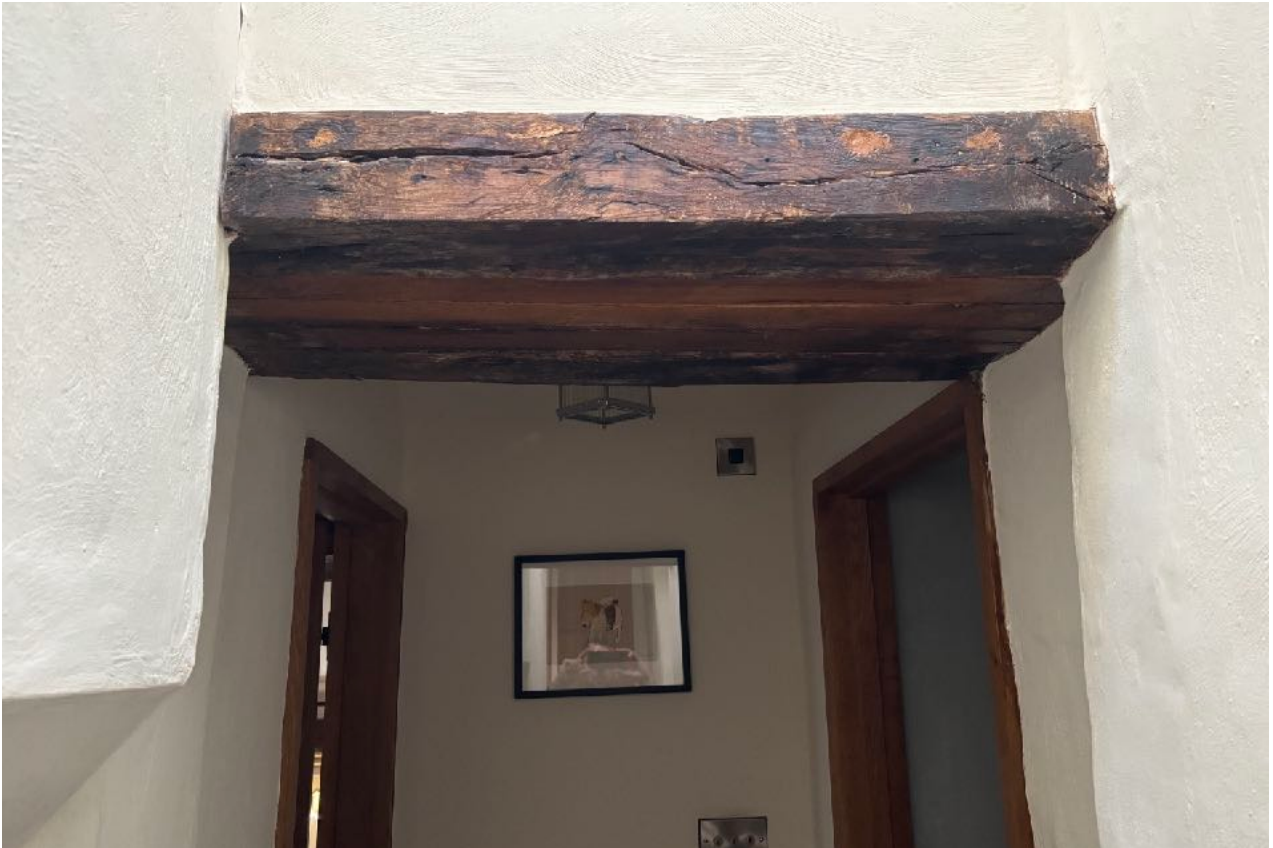
Figure 7: As above, prior timber lintels and reclaimed timbers used.
