# Site Tree Appraisal

## *The Works, Main Street, Gisburn BB7 4HD*

Date: 12<sup>th</sup> November 2024

Ref: RTS/12112024 01

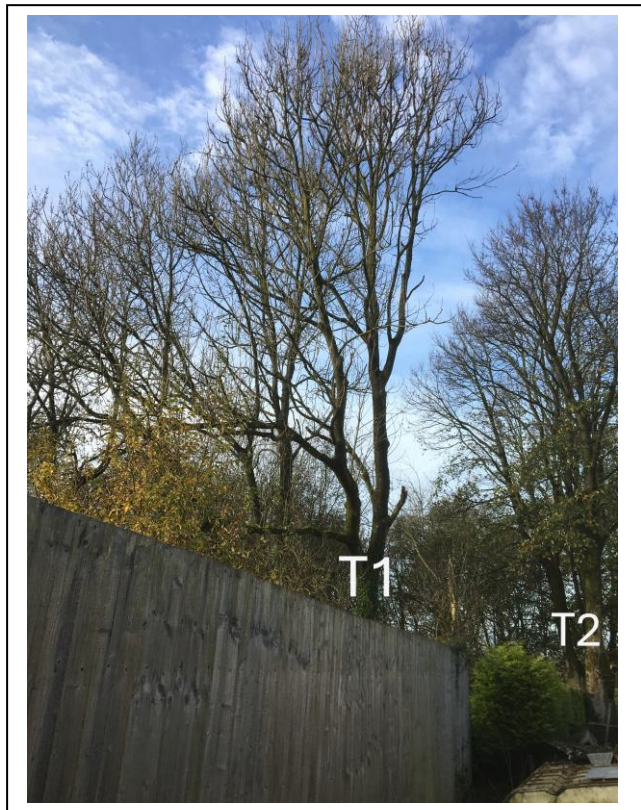
**Photo 01:**

**3.5** Ash tree T1 belongs to the neighbouring property. Its removal will not be required to facilitate the development; however, it was noticed that it has Ash Die-Back disease (ADB) *Hymenoscyphus fraxineus*, (photos 01 & 02). I would, therefore, recommend that T1 be removed on health and safety grounds. Consent, however, will be required by the tree owner and given that it is in the Conservation Area, a statutory 6 weeks’ notice to the Local Authority will be required. I would advise that the tree owner forwards a separate Conservation Area notice to the Local Authority to remove the Ash tree.
