## **Site Tree Appraisal**

### ***Land off Peel Street, Clitheroe BB7 1RA***

**“BS 5837 2012: Trees in Relation to Design, Demolition and Construction – Recommendations”**

Ref: RTS/20022025

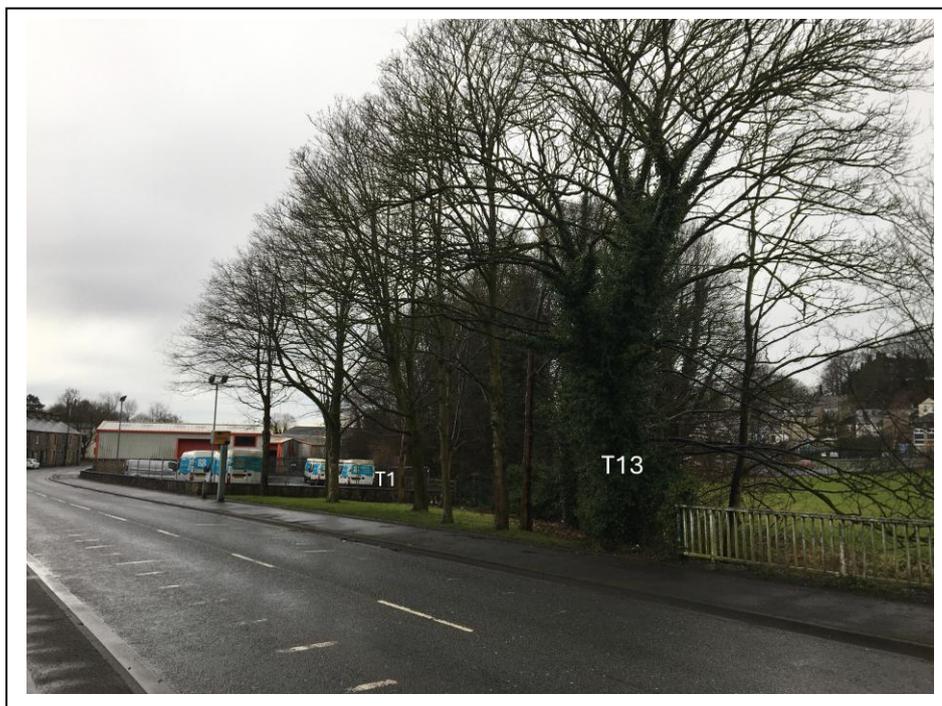
Photo 02:

**3.4** The remaining trees adjacent to the site (T1 to T13, photo 02) are of sufficient distance from the proposed buildings that I do not envisage the need for them to be removed or pruned. Given that trees T1 to T13 are on neighbouring land and beyond the northeast boundary wall, no excavation works will be required within their calculated root protection area (RPA). The linear row of trees (G14, photo 03) are on the opposite bank of Mearley Brook from the development site and their branch structure does not significantly overhang the development site. The trees in G14 are not expected to be affected by the development.

**3.5** Prior to any site development work, given that the northeast boundary wall is only approximately 700mm high, installation of temporary protective tree fencing is recommended along its length. This should deter contractors from accessing the soft ground area within the tree RPA’s, thus avoiding the temptation to store building materials here. The protective tree fencing specifications are noted in the Recommendations, section 5 of the report.
