Project details

Job no.	LTC323
Site	Willow Springs, 58 Pendleton Road, Wiswell, BB7 9BZ
Client	Tim Frear
Agent	Judith Douglas Town Planning Limited
Arboriculturist	Jennie Keighley PhD MSc MArborA
Local authority	Ribble Valley Borough Council
Issue date	6 February 2025

Summary

BS5837 Tree Survey Schedule

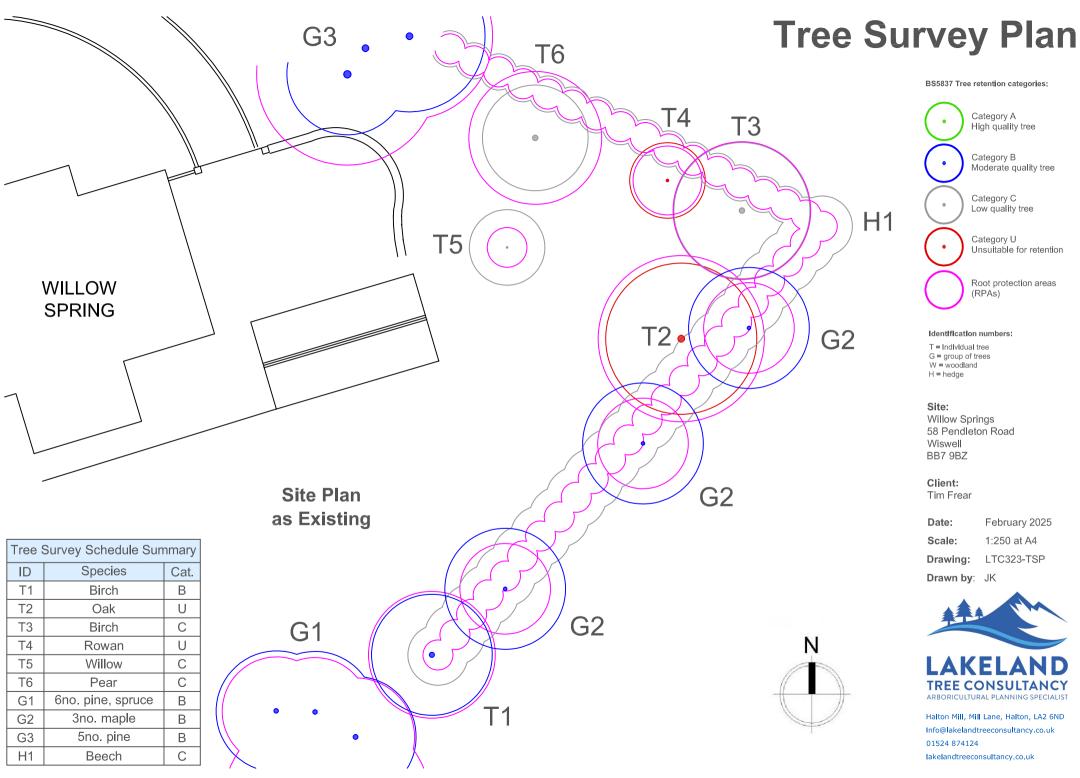
Drawing: LTC323-TSP

- Details and locations of the existing trees in relation to the existing site are included in the tree survey schedule and on the tree survey plan, below. These documents should be used to inform the proposed site design in accordance with BS5837.
