ARBORICULTURAL ASSESSMENT

Hallam Land Management Ltd

**Land South of Longsight Road,
Langho**

February 2025

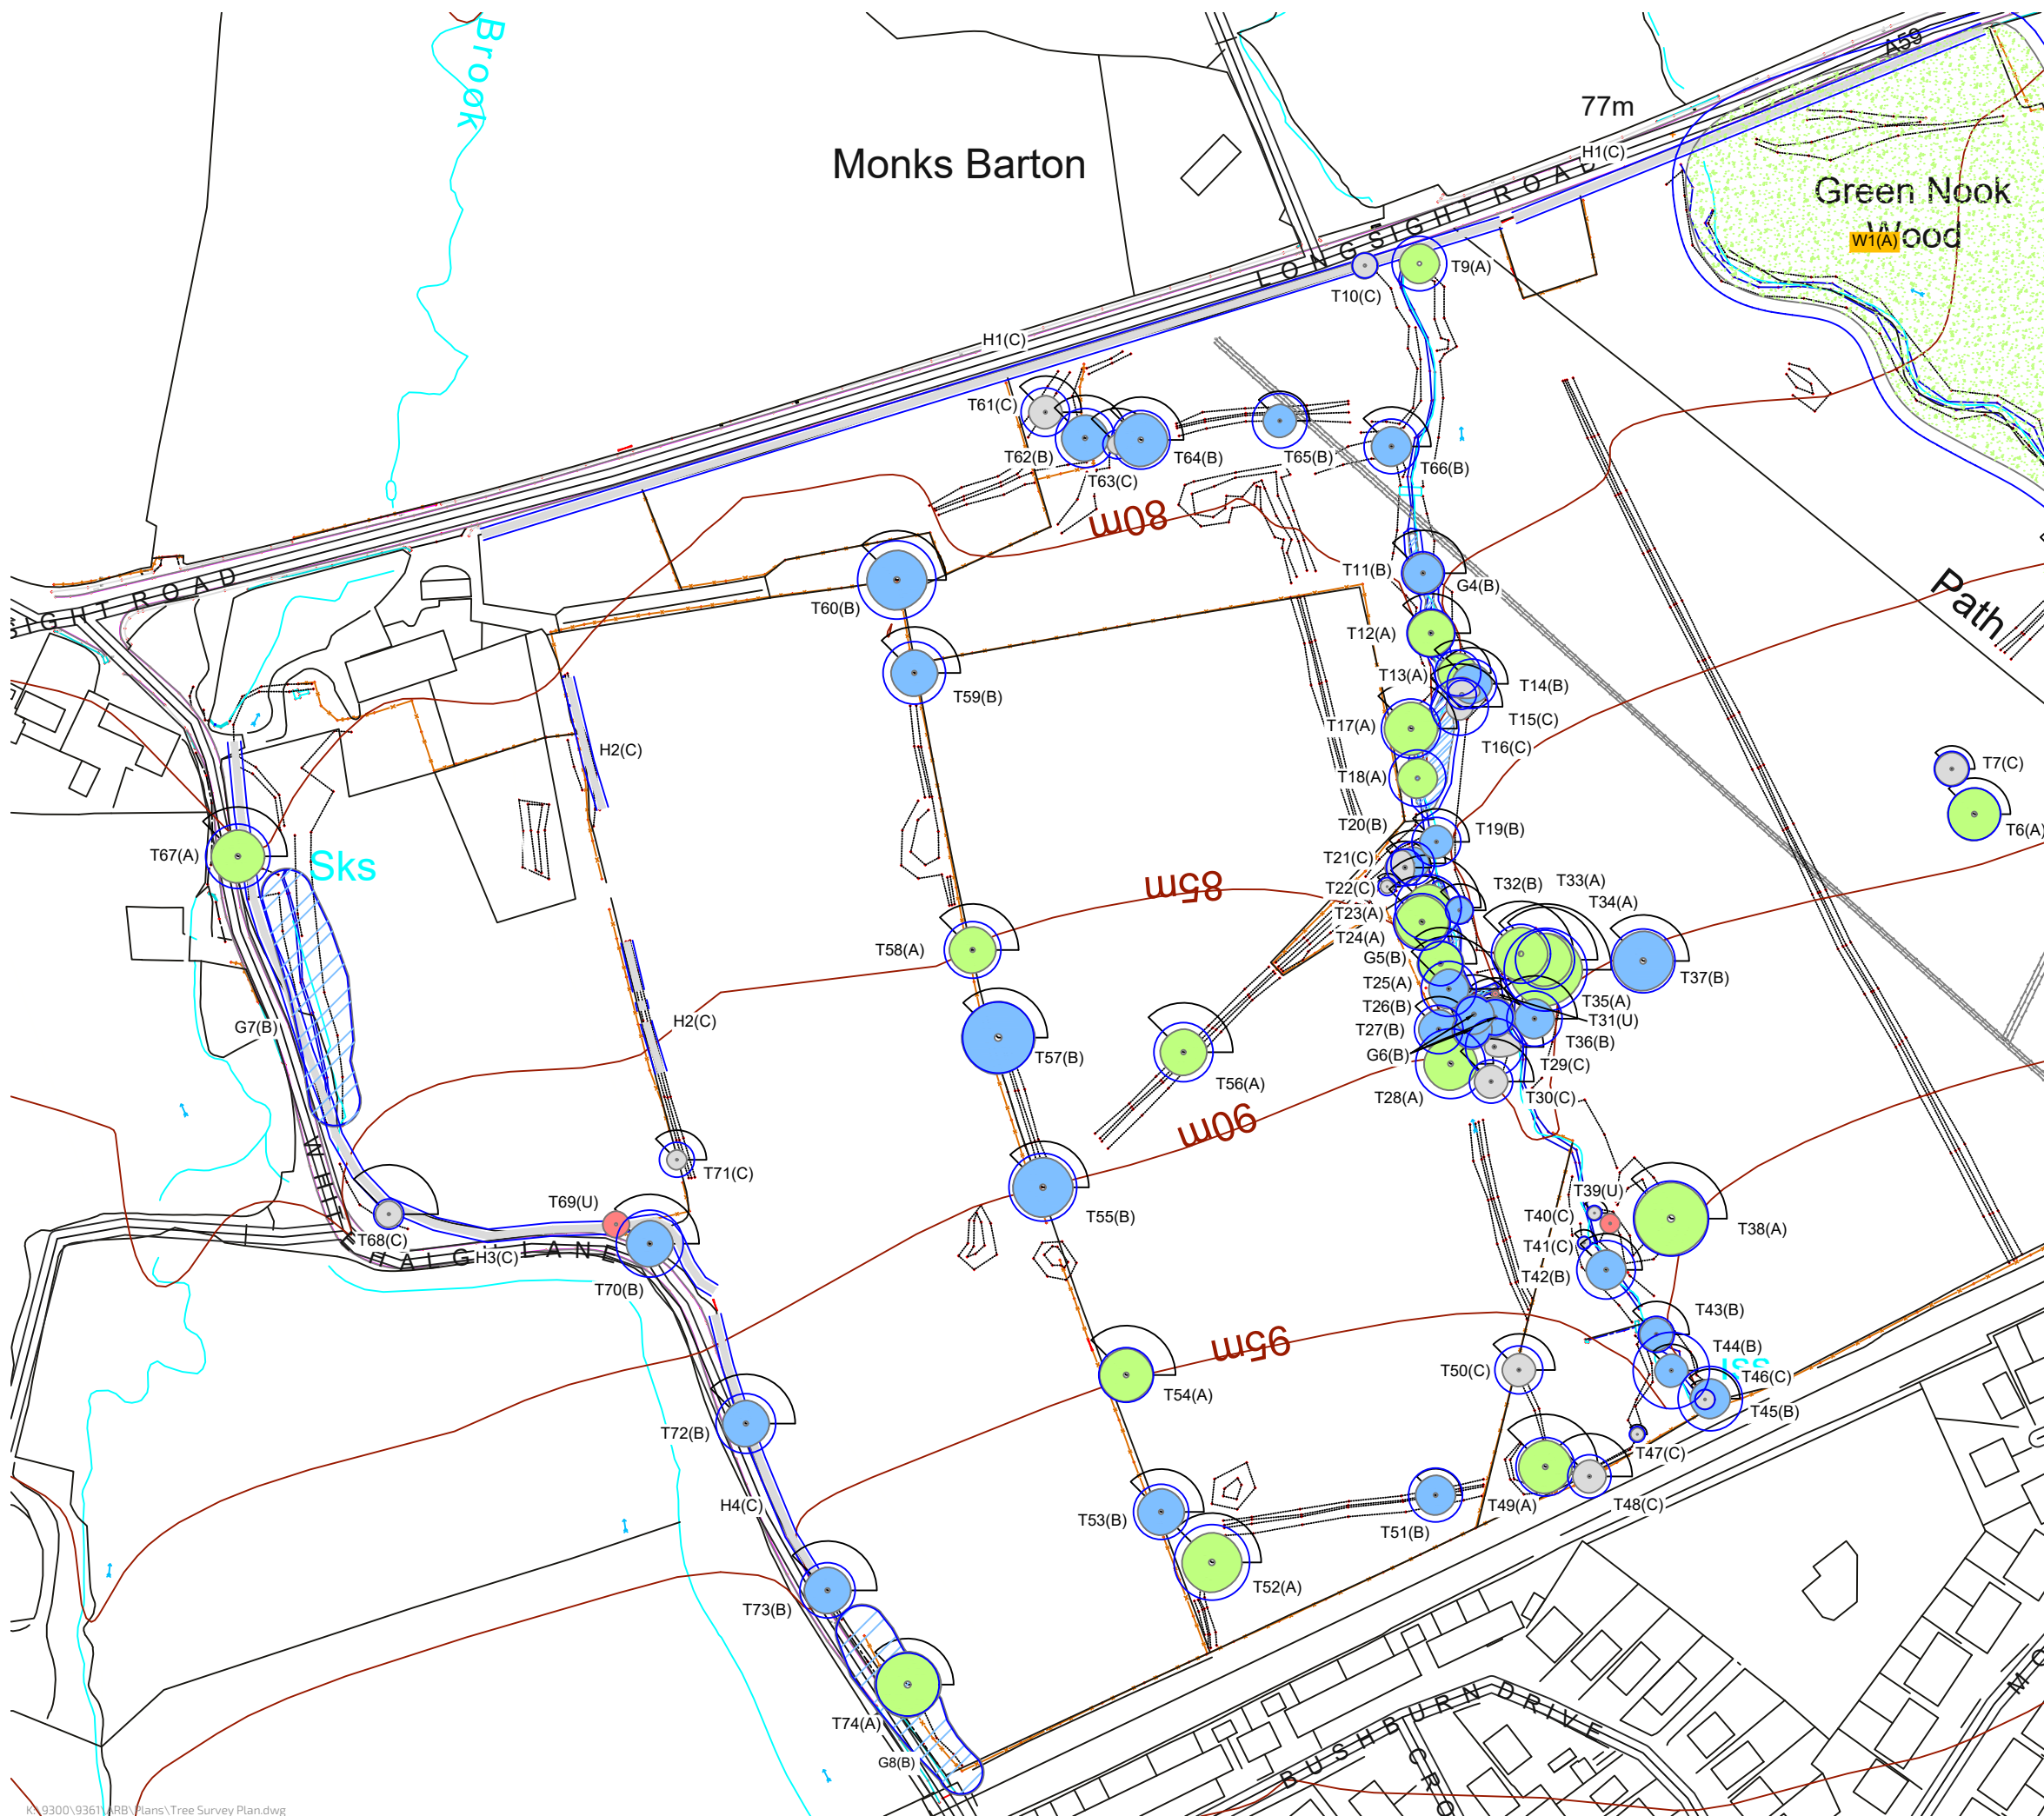
- 4.15 Three individual trees were recorded as unsuitable for retention and Category U. These included T31, a mature alder which had failed at 4m, T39, a dead holly and T69 a mature ash tree in such a poor condition that it cannot realistically be retained as a living tree in the context of the current land use for longer than 10 years. Category U trees are those which would be lost in the short term for reasons connected with their physiology or structural condition and should not be considered in the planning process on arboricultural grounds.
