Preliminary Roost Assessment

2 Chapel Close
Brockhall Village
Blackburn
BB6 8HU

For
Mr & Mrs Turner

Gritstone Ecology

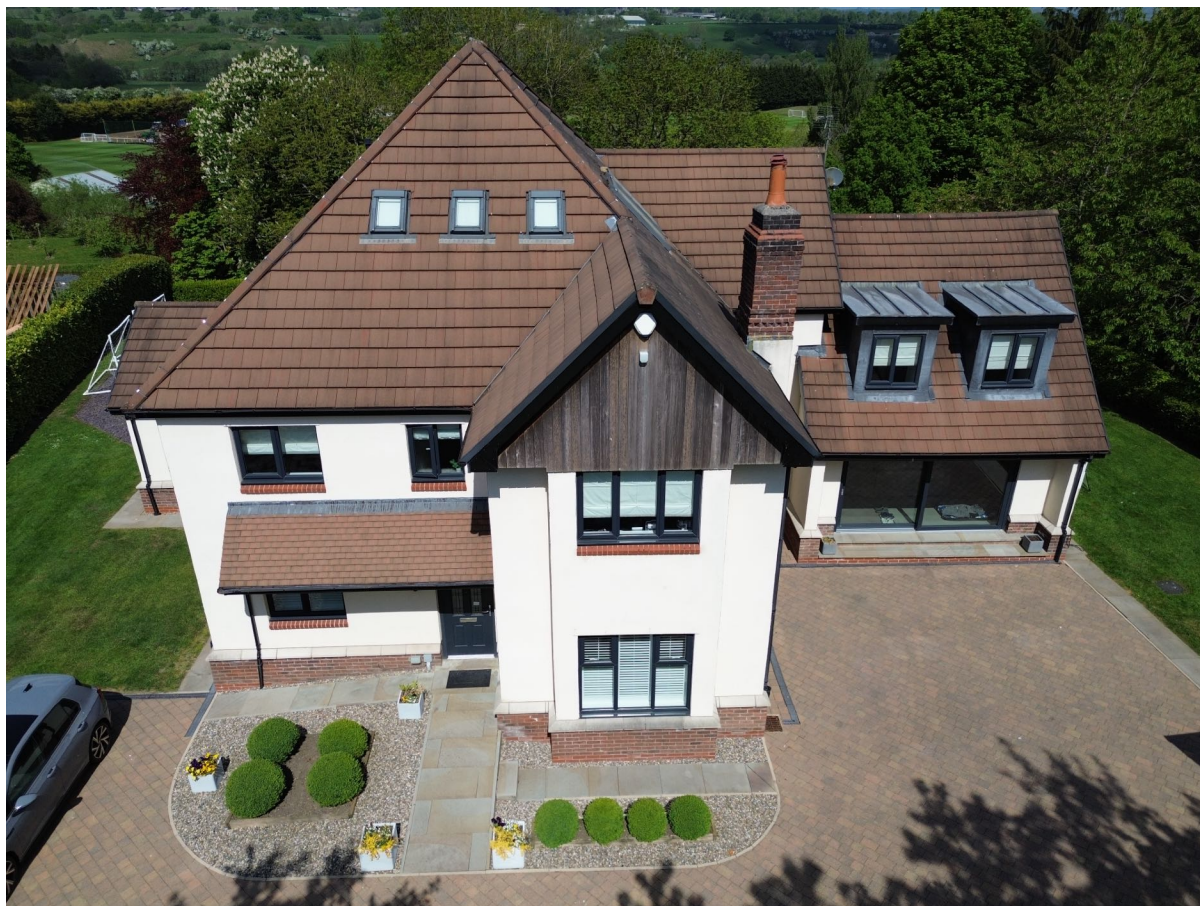
3.1a – The front of the house.

Nº2 Chapel Close, Brockhall Village, is a modern detached house, which is currently occupied. It has a pitched, hipped, roof, covered with concrete roof tiles, and mechanically fixed ridge tiles. Roof pitches face north, south, east, and west; gables face east, west, and south. There are dormer windows on the south facing pitch of the eastern section of the roof, and Velux windows in other areas.

The building is modern, was built to a high standard, is well maintained, and in good condition. Ridge tiles are mechanically fixed, there are no damaged or missing ridge tiles. There are no damaged, slipped, or missing roof tiles. Roof tiles are tightly fitted, with no gaps between tiles. Fascia boards and boxed soffits are fitted tightly against the walls gaps are filled with sealant. Walls and render are in good condition, with no missing mortar or cracks.

The house has no features externally internally which are suitable or likely be used by roosting bats, and no indications of use by bats were present during the inspection.

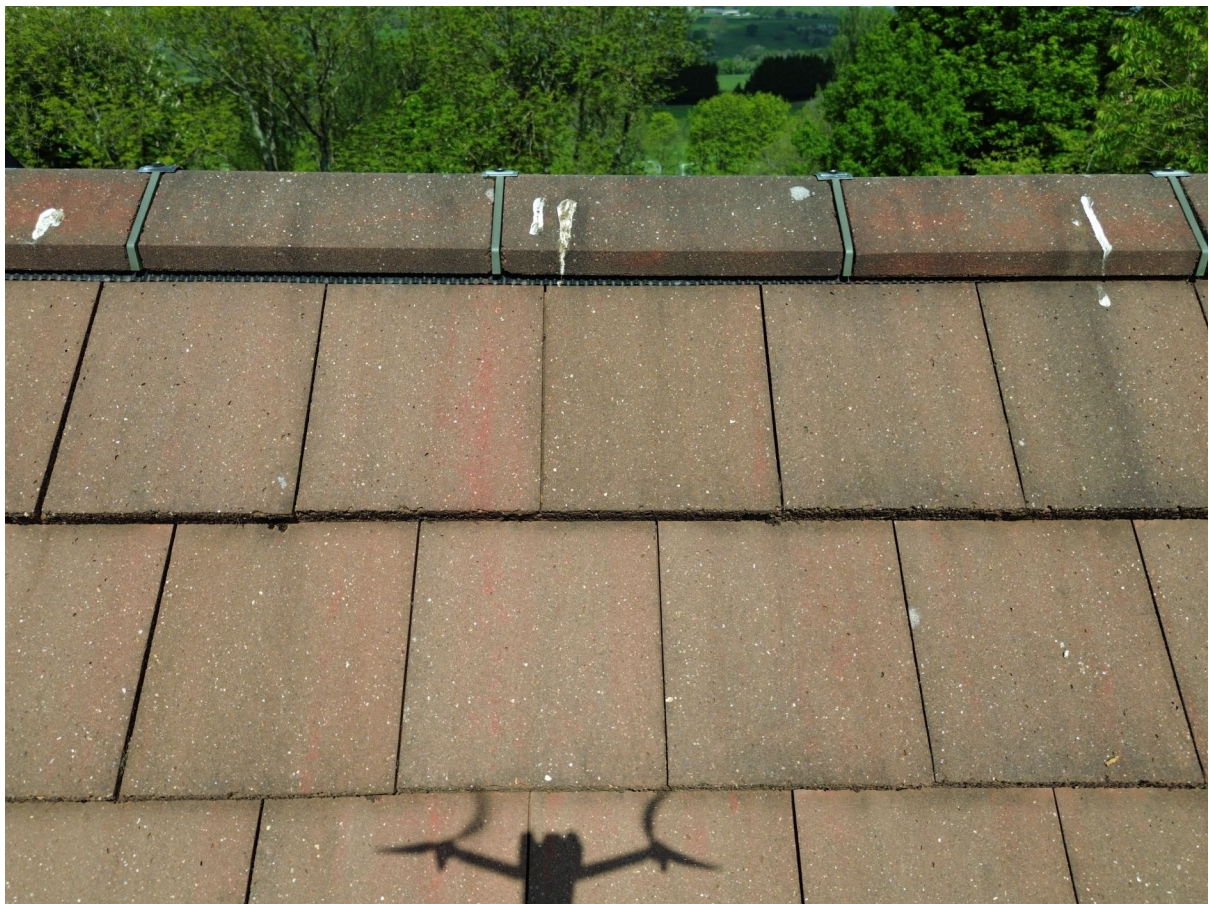
Roof and ridge tiles are in good condition; ridge tiles are mechanically fixed. There are no gaps between roofing materials which could be used by roosting bats.

4 – Ridge tiles are mechanically fixed, roof tiles are in good condition.

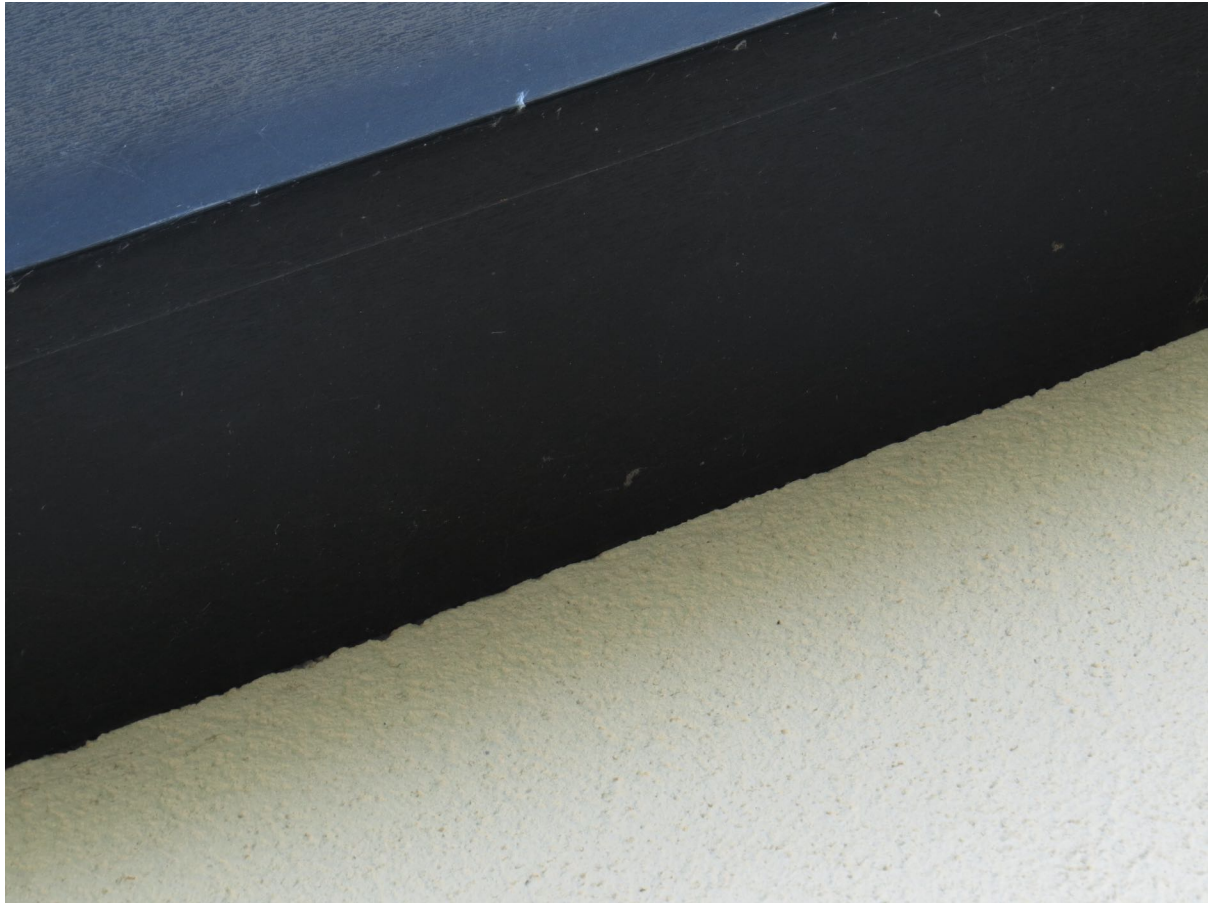
Fascia boards and boxed soffits at the eaves are fixed tightly against brickwork, with no suitable gaps; wall cavities and boxed soffits (in the garage) open into the roof void, and were inspected from above.

5 – Fascia boards and boxed soffits at the eaves are fixed tightly against brickwork.

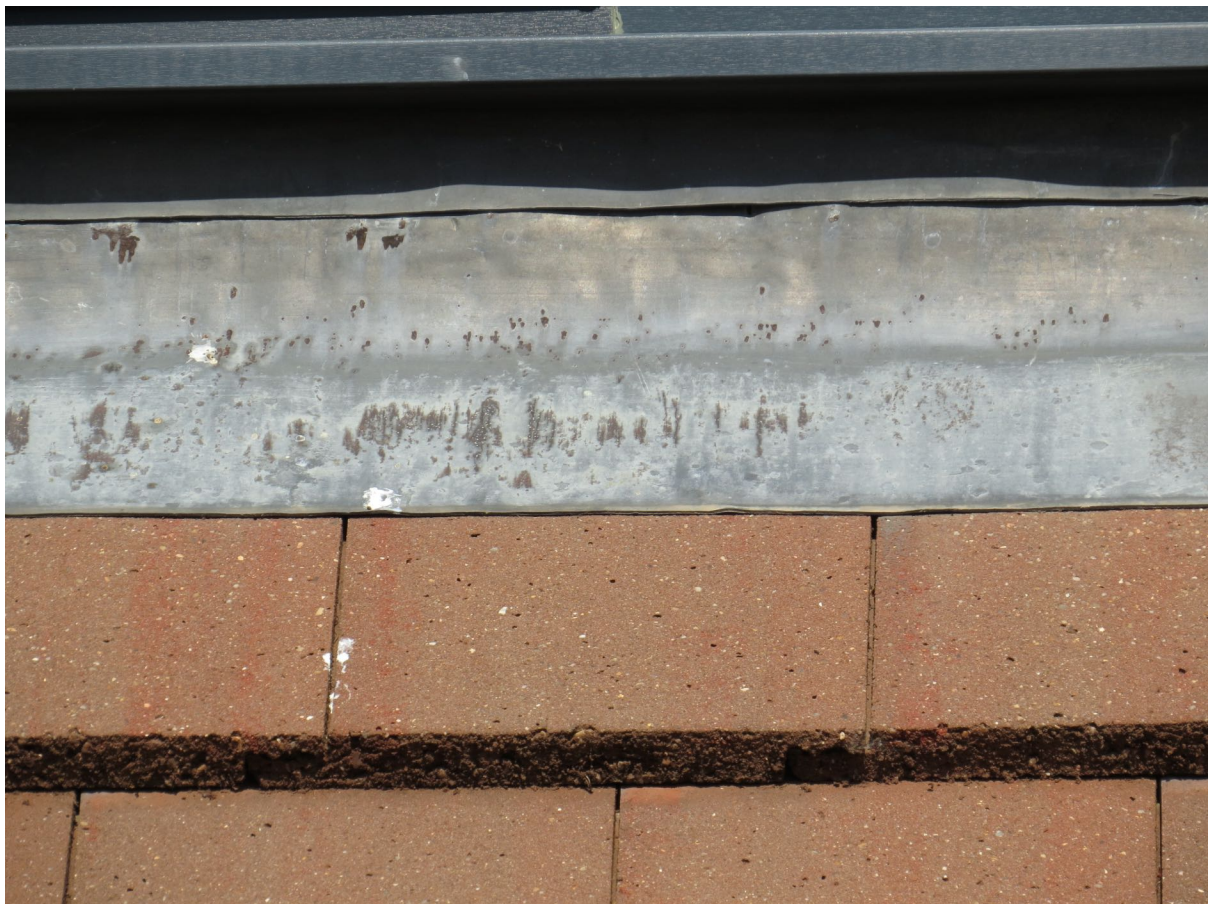
6 – Leadwork is fixed tightly with no viable gaps.

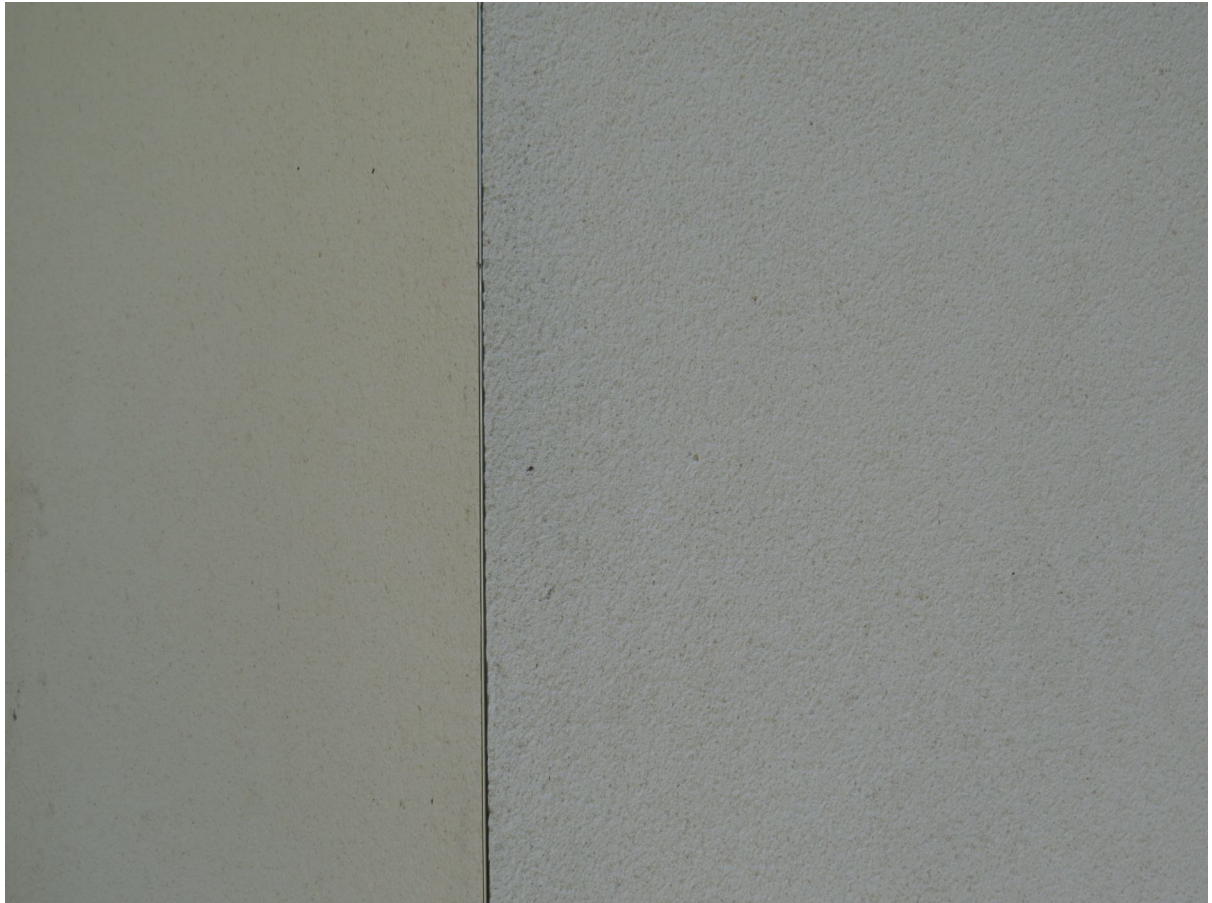
External are brick, and are covered with a modern white render. Walls and render are in good condition, with no cracks, or missing mortar which could be used by crevice dwelling bats.

7 – Walls and render are in good condition.

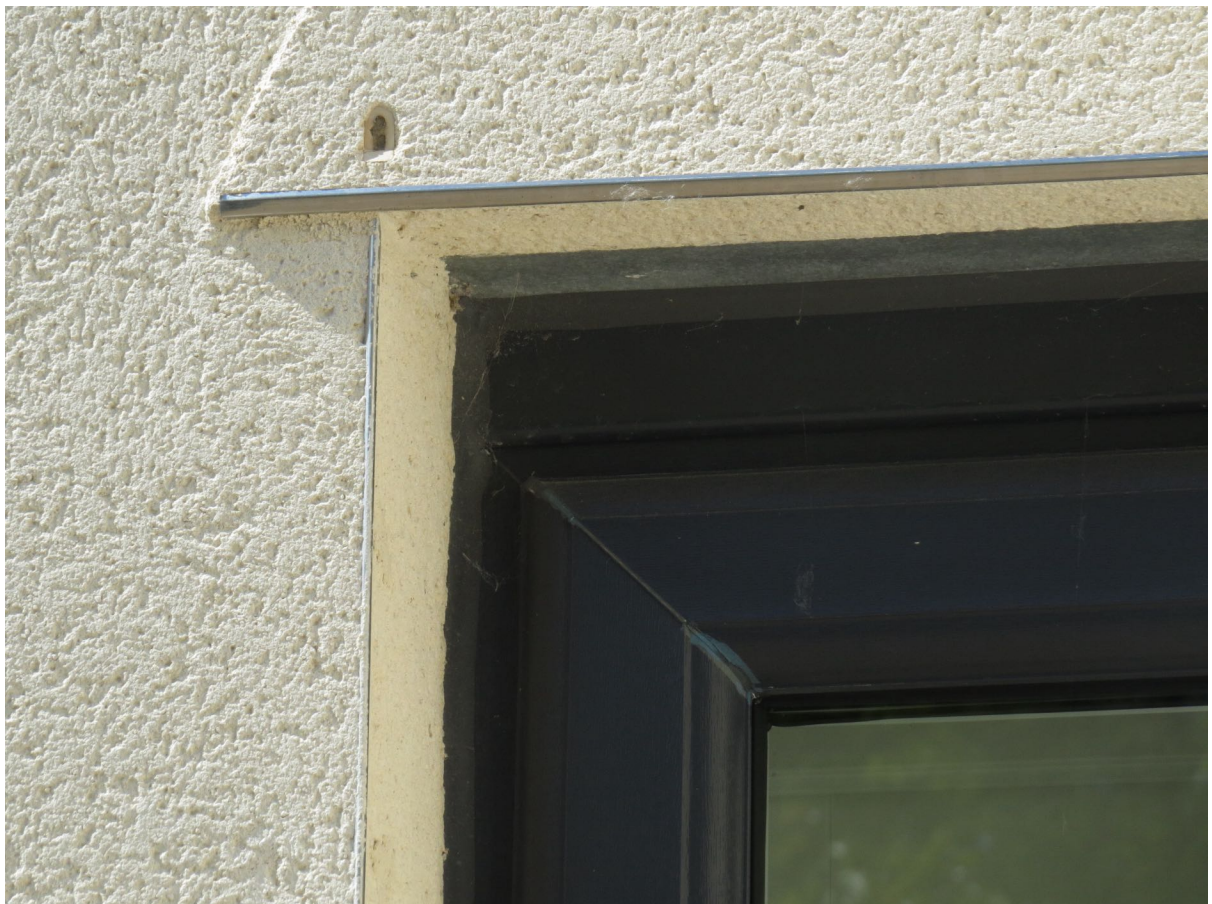
Window and door frames are fixed into the brickwork, gaps are filled with sealant, and offer no suitable roosting opportunities.

8 – Window and door frames are fitted tightly with no suitable gaps.

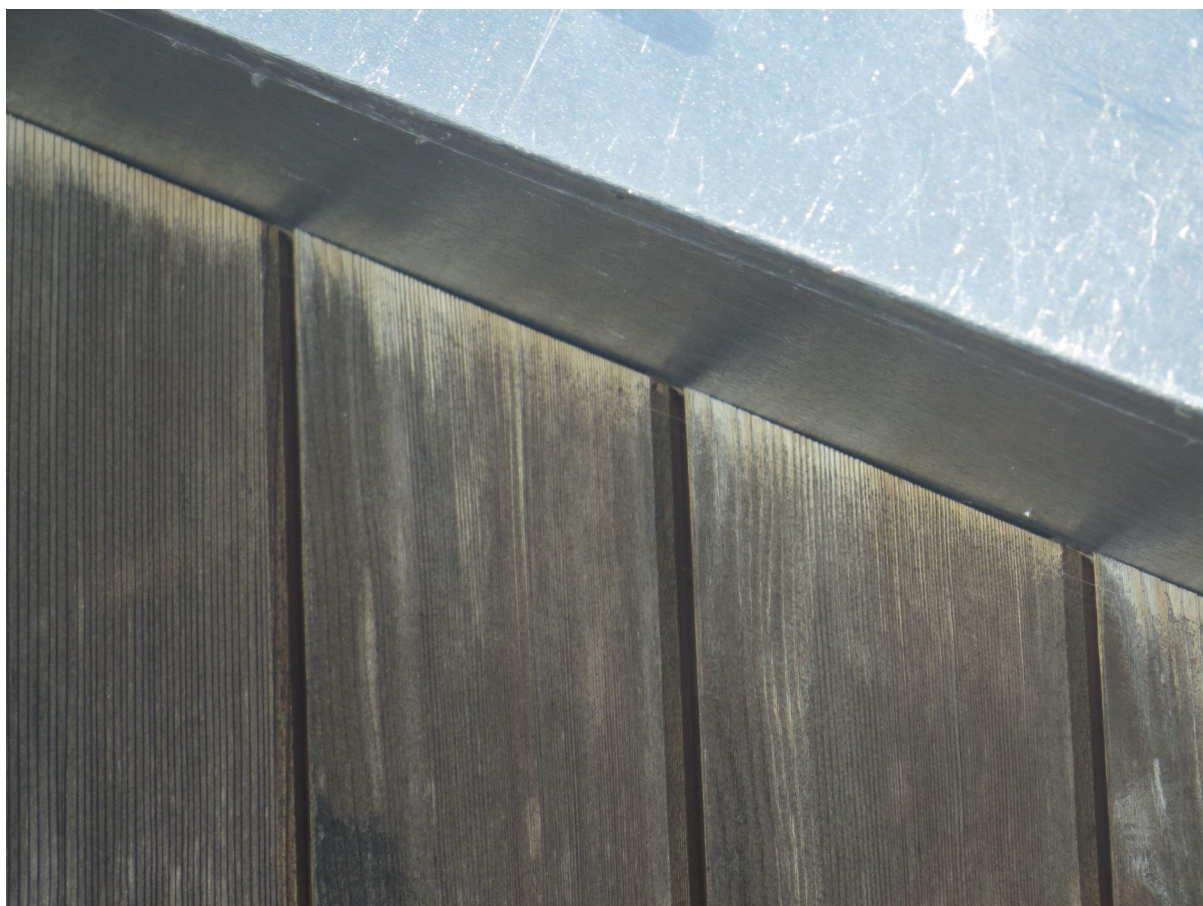
9 – Timber cladding is fitted tightly with no warped boards or gaps between materials.

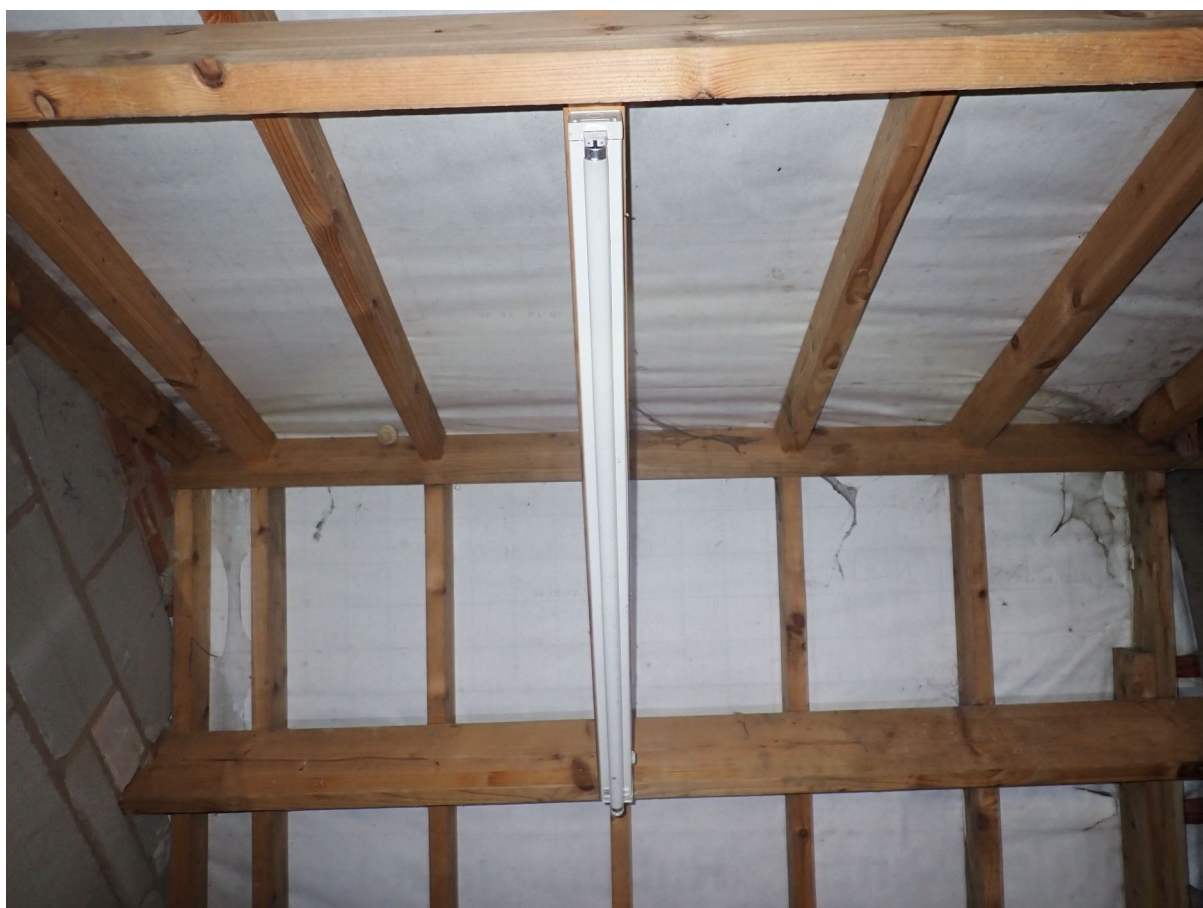
The garage has a single roof void, which is used for storage, and accessed regularly. The roof has a timber rafter and purlin structure, lined with a modern breathable membrane. Roof lining is in good condition with no tears, or gaps.

10 – The garage roof is lined with a modern breathable membrane.
