Proposed Repairs

Houlkers Farm, Whins Lane, Read BB12 7RB

Heritage Statement

May 2025

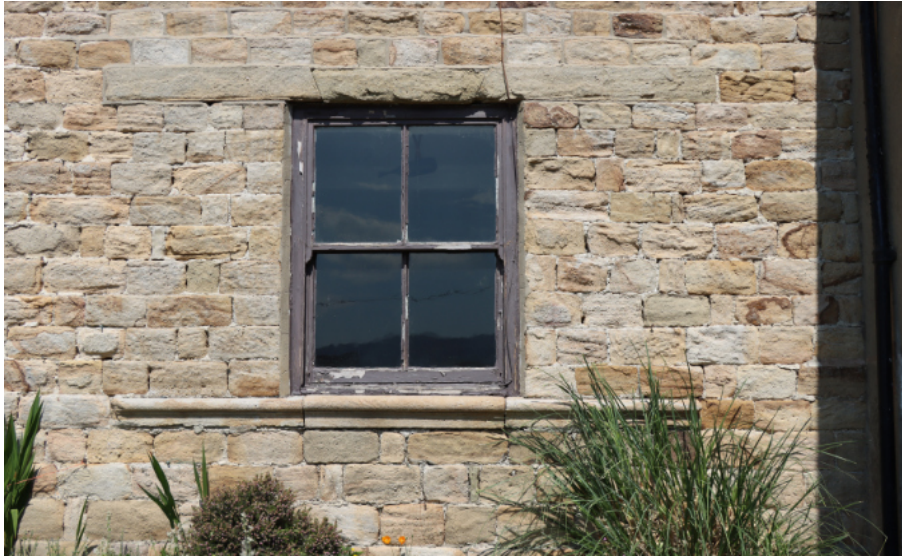
The pitched tooling on the quoins to the chimney stack projecting from the west gable (Photograph 9) is characteristic of the late 18th or early 19th centuries. The lintels and sills to the two ground-floor windows at the front (Photographs 2 & 5) are wider than the present openings, suggesting that the windows were originally tripartite (i.e. with a wide central opening and narrower outer openings separated by flat-faced mullions). This type of window is also characteristic of the late 18th or early 19th century. The hob grates to the two first floor fireplace are a late 18th century type, and so could be original. The surrounds to the first floor fireplaces and the false keystone to the front door architrave are more mid 18th century in style, but this may be because the area lagged behind the latest fashions.

Photograph 5. The right-hand ground-floor window at the front.

Re-pointing the front elevation, and possible hidden strengthening above the ground-floor window lintels.

The lime pointing has eroded. The squared sandstone has narrow joints and is relatively soft. It is proposed to re-point with either a lime putty / sharp sand or a quicklime / sharp sand mix. This will enhance the character of the facade. There are areas of cement pointing above both ground-floor windows. This will be removed and replaced with lime. The stone lintels to both windows may need additional support, and if needed this will be by hidden stainless steel reinforcement or fixings.

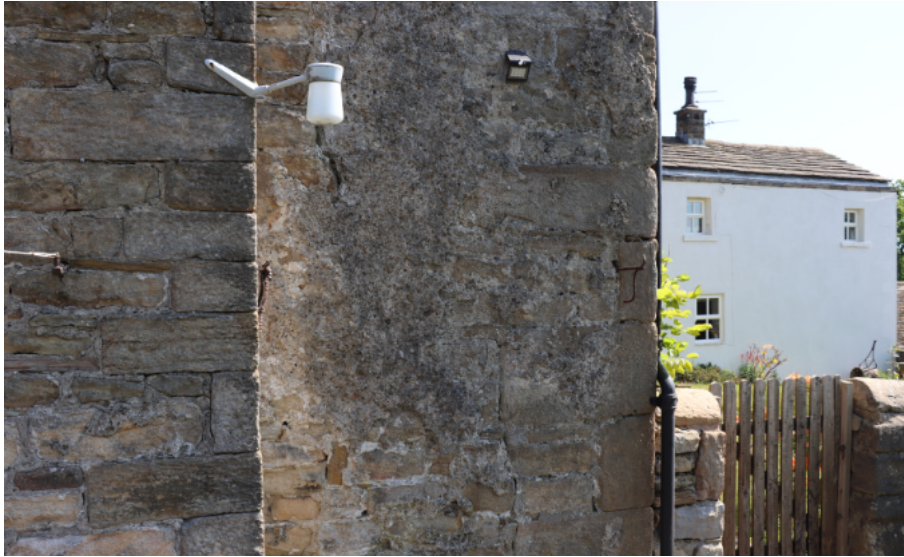
The gable faces the prevailing wind and is suffering from some damp problems internally. Some thin lime roughcast remains to the right and left of the chimney and is evidence that the wall was originally rendered. It is proposed to re-render the whole gable with a roughcast of 'hot lime' or lime putty and coarse sand thrown directly onto the wall and finished with limewash for protection. This will reinstate an original finish and help to eliminate damp problems at this end of the house.

Photograph 9. The remains of lime roughcast on the west gable wall.

Lime roughcasting and lime washing the west elevation.

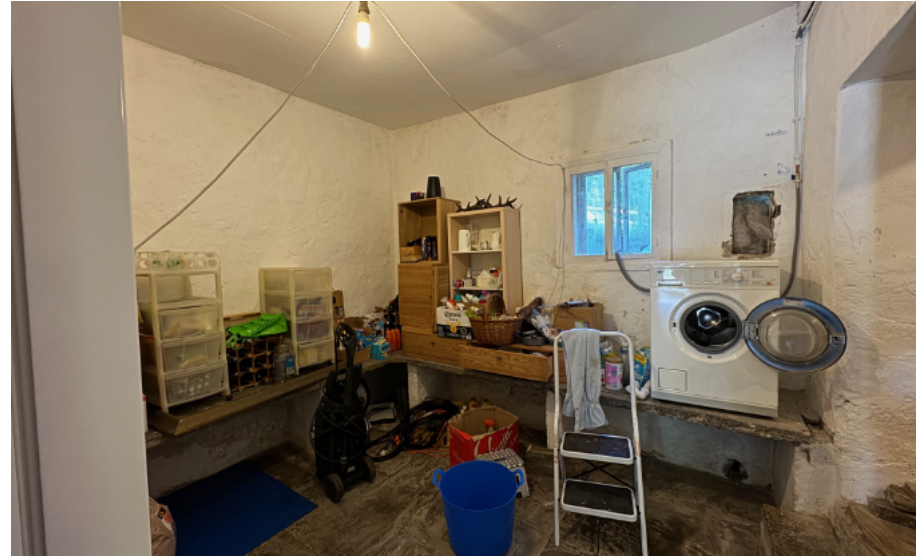
The single-storey lean-to at the rear is clearly a 19th century addition, although it lacks features that could accurately date it. It is on the north side and includes a large pantry with stone slab shelves that suggest that it was used as a dairy (Photograph 14). It also contains the present kitchen, but its lack of a fireplace suggests that cooking may have continued to be done in the main living room after the construction of the lean-to.

Photograph 14. The interior of the dairy /pantry.

Installation of a gas combi boiler with a balanced flue in the pantry.

The boiler will be mounted on a blank part of the wall, and the balanced flue terminal will be in a location where it cannot be seen from public views. Pipework and radiators will be positioned so that no damage is caused to historic fabric.

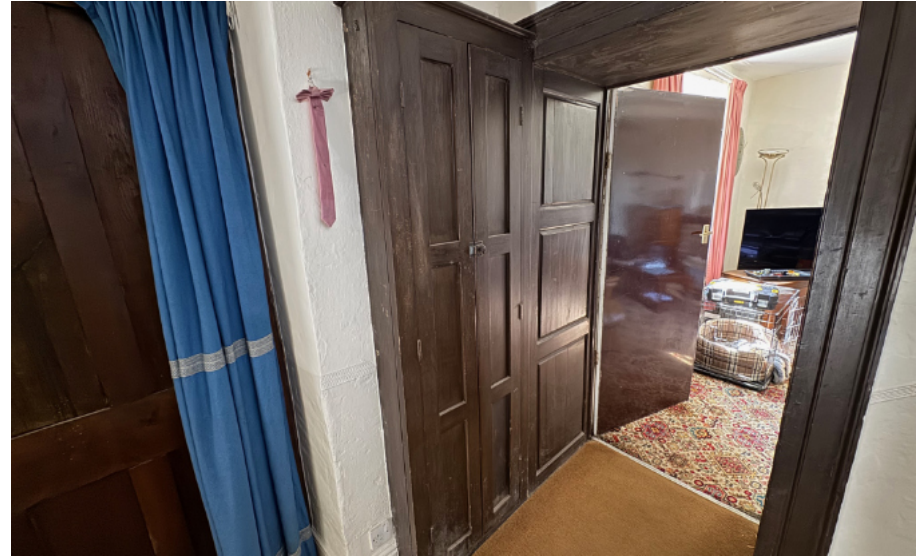
elegant, but the ramped handrail and cur-tail, all with with a flat tops, look like clumsy imitations of more refined work (Photograph 21). The raised-and-fielded panelling on the ground floor (Photograph 18) is oak, which is unusual, as this type of panelling is more commonly painted pine.

Photograph 18. Looking towards the west sitting room from the hallway.

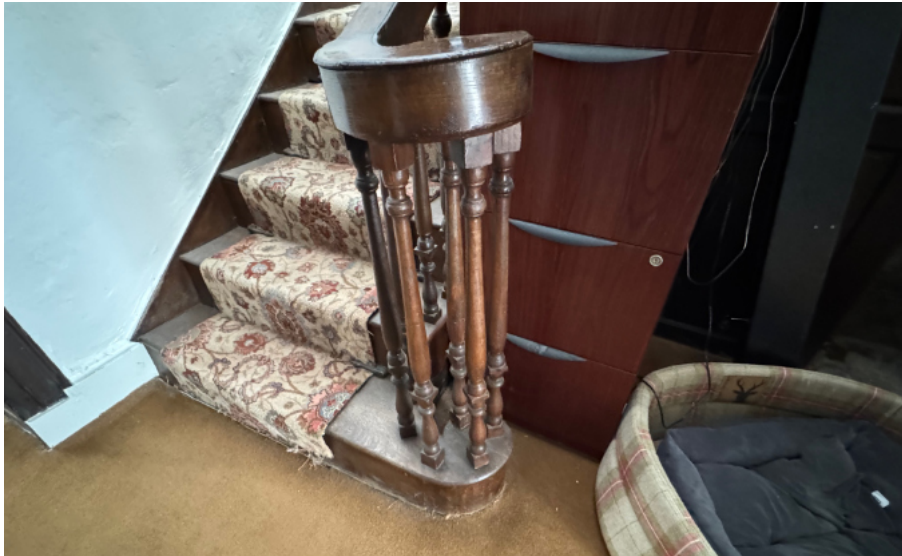
Photograph 21. The bottom of the staircase.

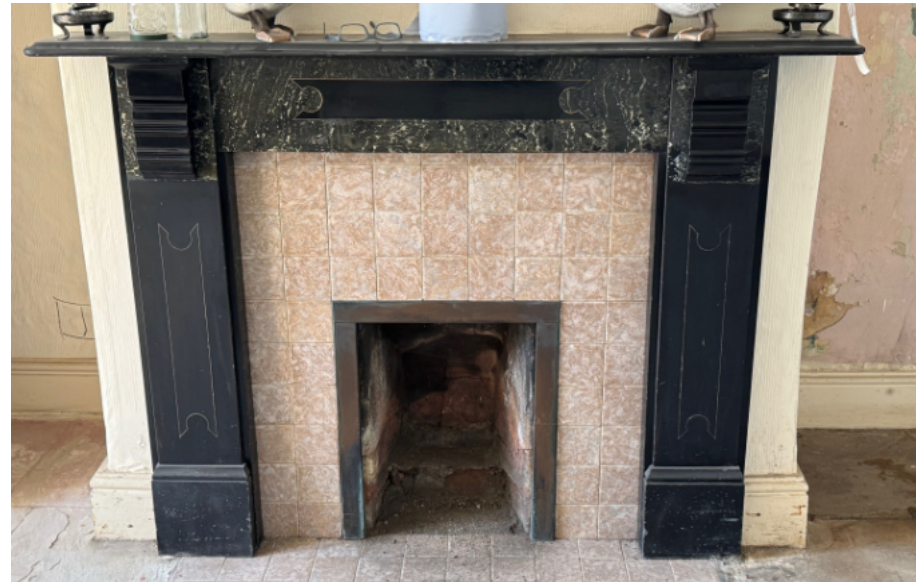
Photograph 24. A slate fireplace surround in the eastern ground floor room.

The fireplace in the western ground-floor room is an incongruous late 20th century stone 'feature' fireplace with a redundant back boiler. The projecting chimney breast externally indicates the probable depth of the original fireplace. It is intended to carefully remove the 20th century fireplace and reinstate the original fireplace opening, including any fireplace surround that still exists. The tiled fireplace in the eastern ground-floor room is also incongruous, and it is proposed to remove it while retaining the late 19th century slate surround.

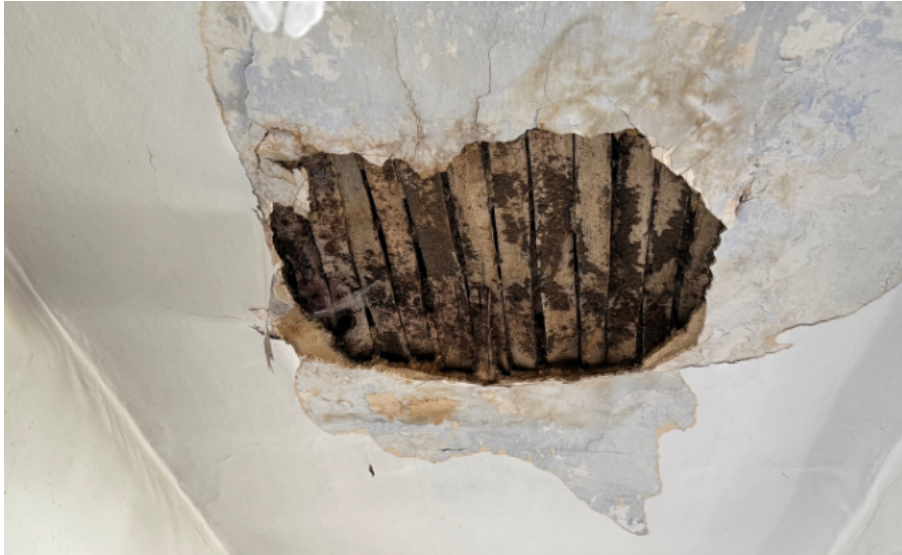
Photograph 25. A partly collapsed ceiling in the eastern ground floor room.

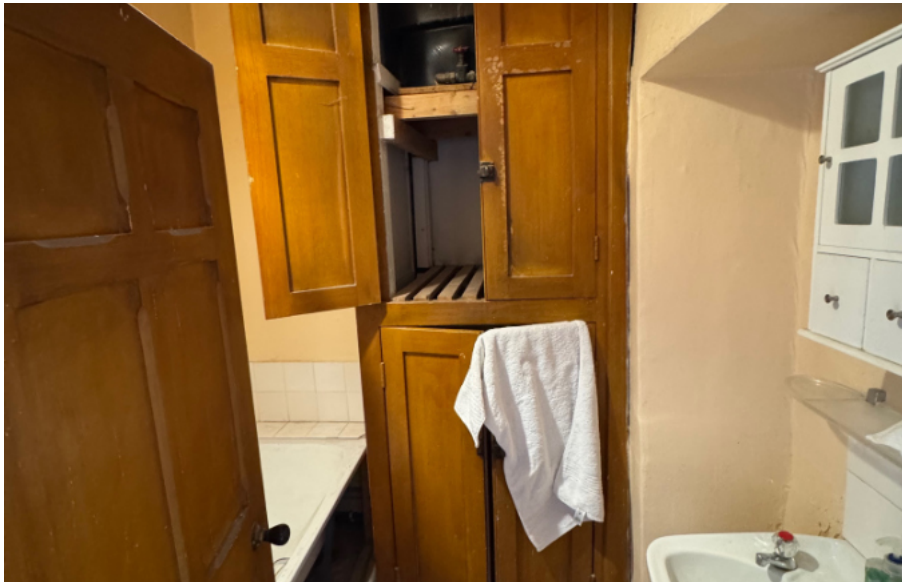
The present bathroom is mid 20th century and the alterations will have no effect on the historic character of the house.

Photograph 35. The first floor bathroom.

Removing the airing cupboard and cylinder from the existing bathroom, re-positioning the bath and installing a WC.

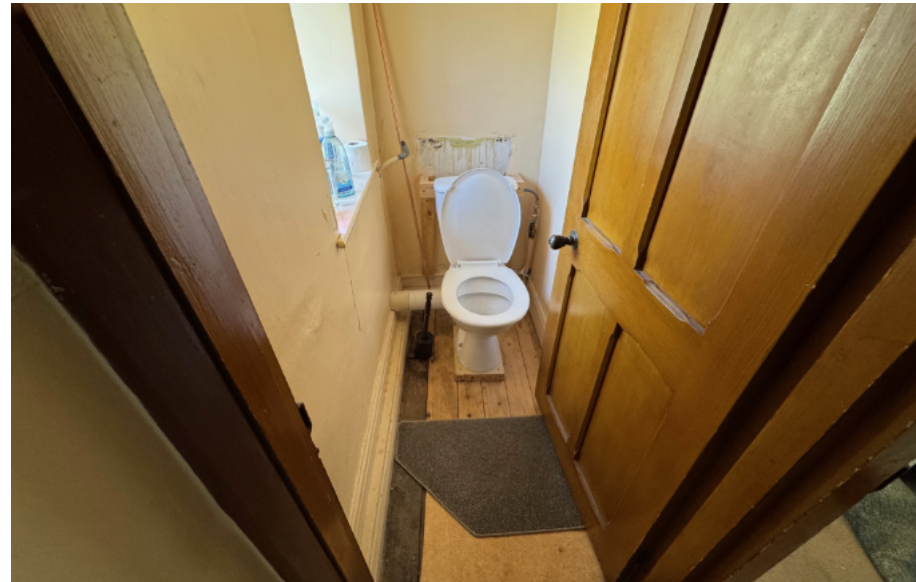
The WC is an early/mid 20th century insertion into a bedroom and its removal will not affect the historic character of the house and will improve its character.

Photograph 36. The first floor WC.

Completely removing the existing WC and its enclosing walls to create a bigger bedroom.
