Written Stone Farmhouse, Longridge

BAT SURVEY REPORT

September 2024

Report Ref: 093_04

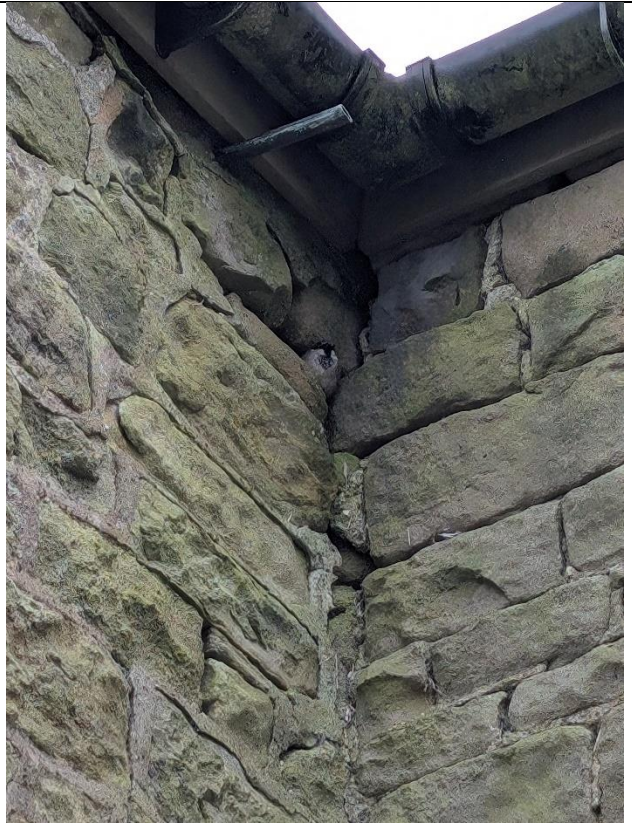
During the preliminary bat roost assessment on 12th April, a male house sparrow was observed exiting a gap in the wall just below the roof eaves on the east elevation (see Photo 3.1 below). This was originally attributed to a nest site. No further evidence of nesting sparrows was observed in later visits. House sparrow is a ‘red-listed’ bird of conservation concern and a priority listed species. The house contains numerous features within the roof to support nesting birds.

Photo 3.1.
House sparrow in cavity on east elevation.

Any works which will potentially impact bird's nests should be undertaken outside of the main nesting bird season of March to August (inclusive). If this is not possible, any works potentially affecting bird's nests must be preceded by a nesting bird check, undertaken by a suitability qualified ecologist. If an active nest is found, it must be left in-situ until no longer in use. This may potentially delay the works programme.

The property owner is recommended to consider installing at least two-house sparrow boxes on the property or adjacent barns. Bird box models, locations and siting advice can be provided as a post-permission matter.

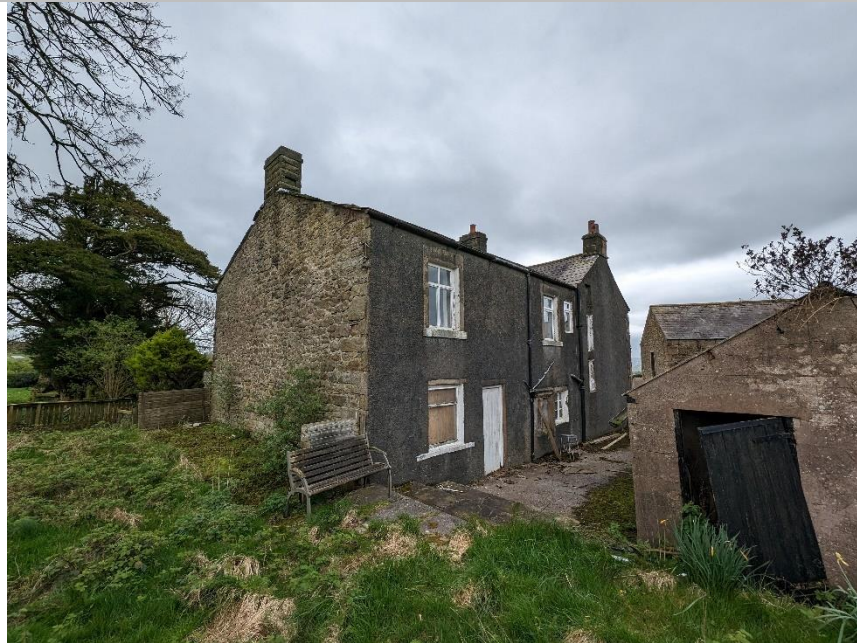
Photo 1.
North-east
elevations

There were also gaps in the stonework on the east elevation. This included a gap in the south-east corner just below the roof and gaps within the centre of the wall. Such gaps appeared to present suitable conditions for roosting bats.

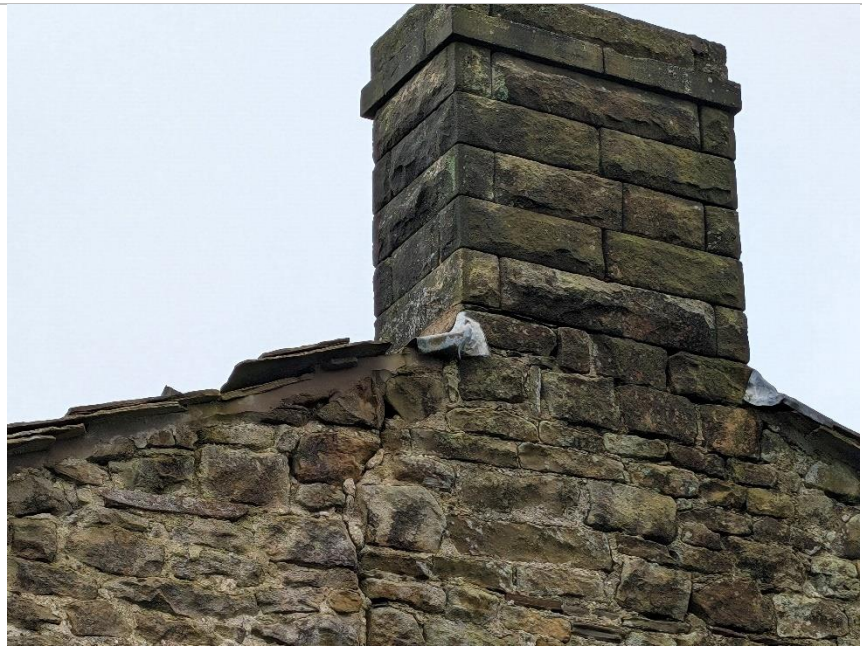
The roof comprises two intersecting gable roofs which form an L-plan. The southern roof had slates and the northern roof had traditional stone tiles. The northern section had missing, misshapen and slipped tiles – all presenting suitable roost egress points for bats. This included lifted and missing tiles on the north roof verge. The southern section appeared to be in better repair. The lead flashing on the chimney on the north gable and the chimney on the east gable were slightly lifted presenting potential roost features for bats.

Photo 3
Gap in stonework, gaps under verge roof tiles and gaps under lead flashing.

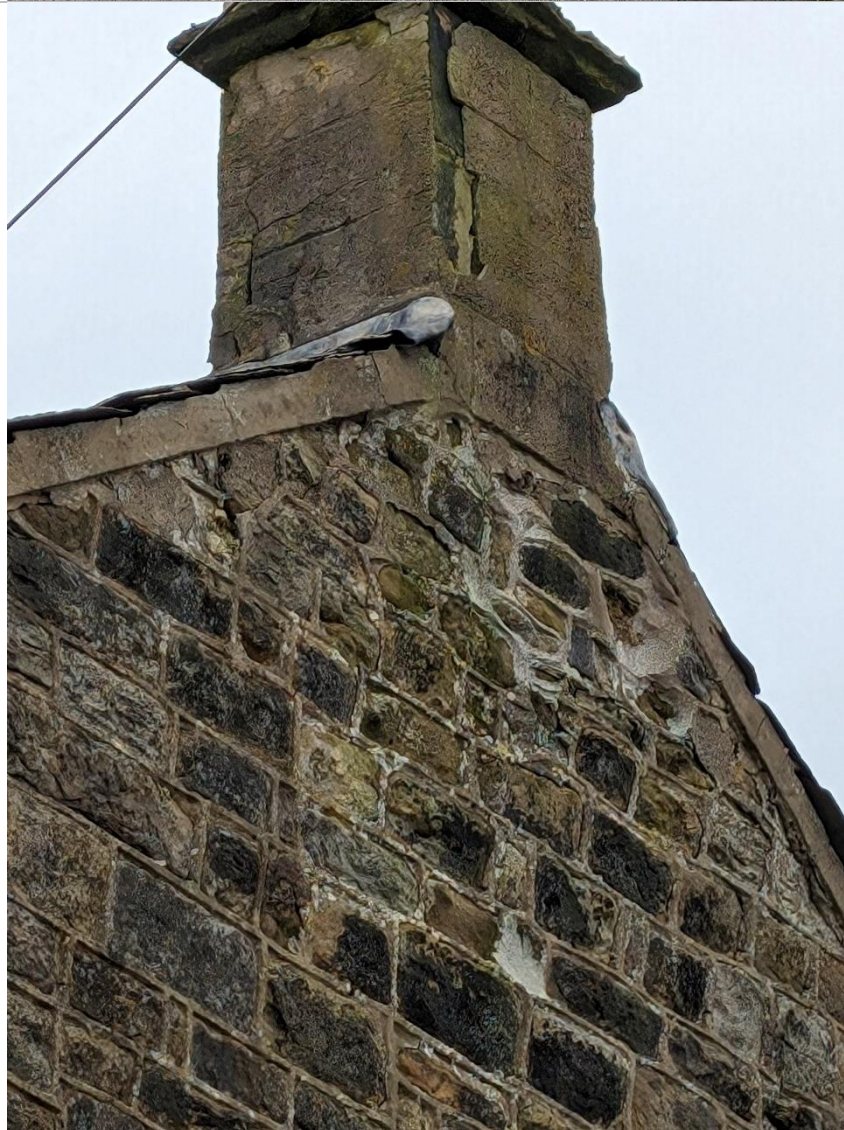
Photo 6.
Gap under lead
flashing on
east gable.
