# BS5837 Tree Survey

Land off Pendle Street East  
Sabden  
BB7 9FX

May 2025

**Drawing:** LTC348-TSP

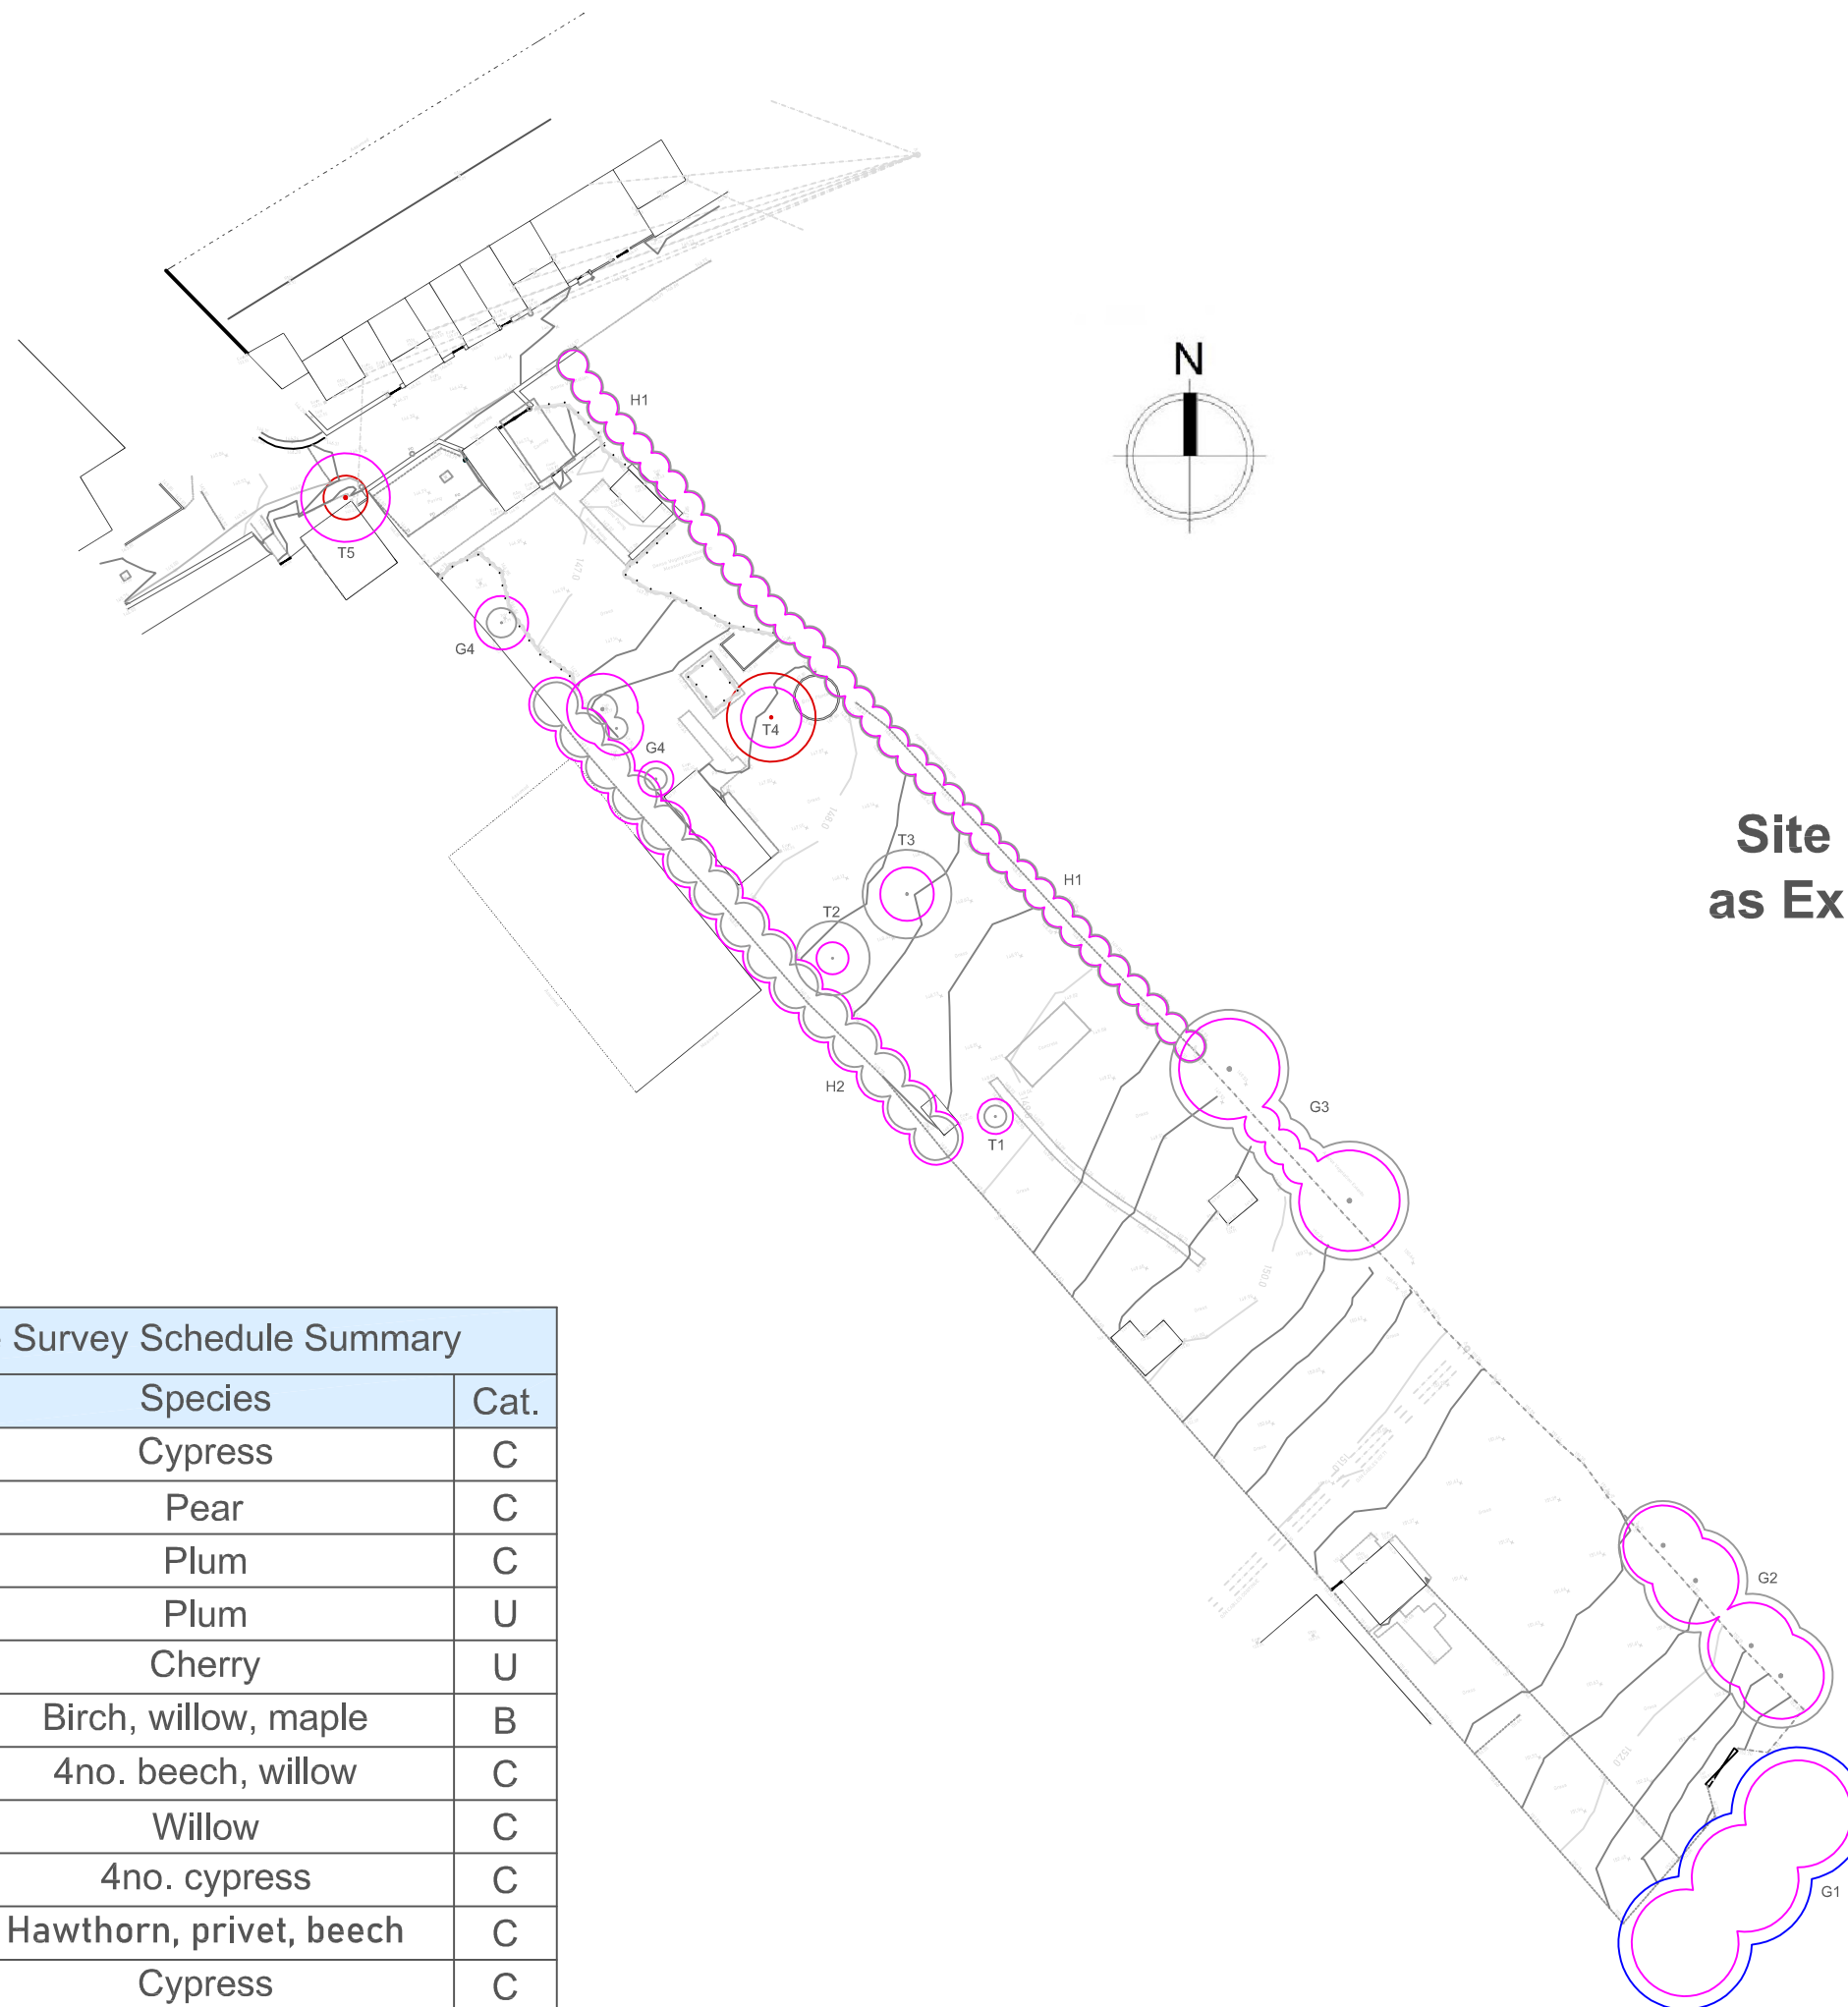
ID	Species	Cat.
T1	Cypress	C
T2	Pear	C
T3	Plum	C
T4	Plum	U
T5	Cherry	U
G1	Birch, willow, maple	B
G2	4no. beech, willow	C
G3	Willow	C
G4	4no. cypress	C
H1	Hawthorn, privet, beech	C
H2	Cypress	C
