**Survey defects notes:**  
Survey was undertaken by Ray Craig FRICS. Chartered Building Surveyor dated 14/11/2023 below is summary of required works.

**Roof survey was undertaken by Alan Johnston Partnership dated 22/03/2024 partnership dated follows are required works not covered within previous report.**

Offices at: Liverpool & Nottingham Halsall Lloyd Partnership Address: 98 Duke Street Post Code: L1 5AG Issuing Office: Liverpool Tel: 0151 708 8944 Website: www.hlpsdesign.com	Drawing Title: INTERNAL WORKS DRAWING WITH IWI Project: Number 1-4, Almhouses, Stydd lane, Ribchester, PR3 3YQ Client: Your Housing Group Scales @ A1 First Issue Date: 05/06/24 Job Number / Dwg. No. / Revision: 3184_D_10_V01 RIBA Stage: Drawing Status: [ 2 ] - PRELIMINARY Drawn: BMc Check: GL	<p><b>Halsall Lloyd Partnership</b> ARCHITECTS &amp; DESIGNERS</p>
---	---	--

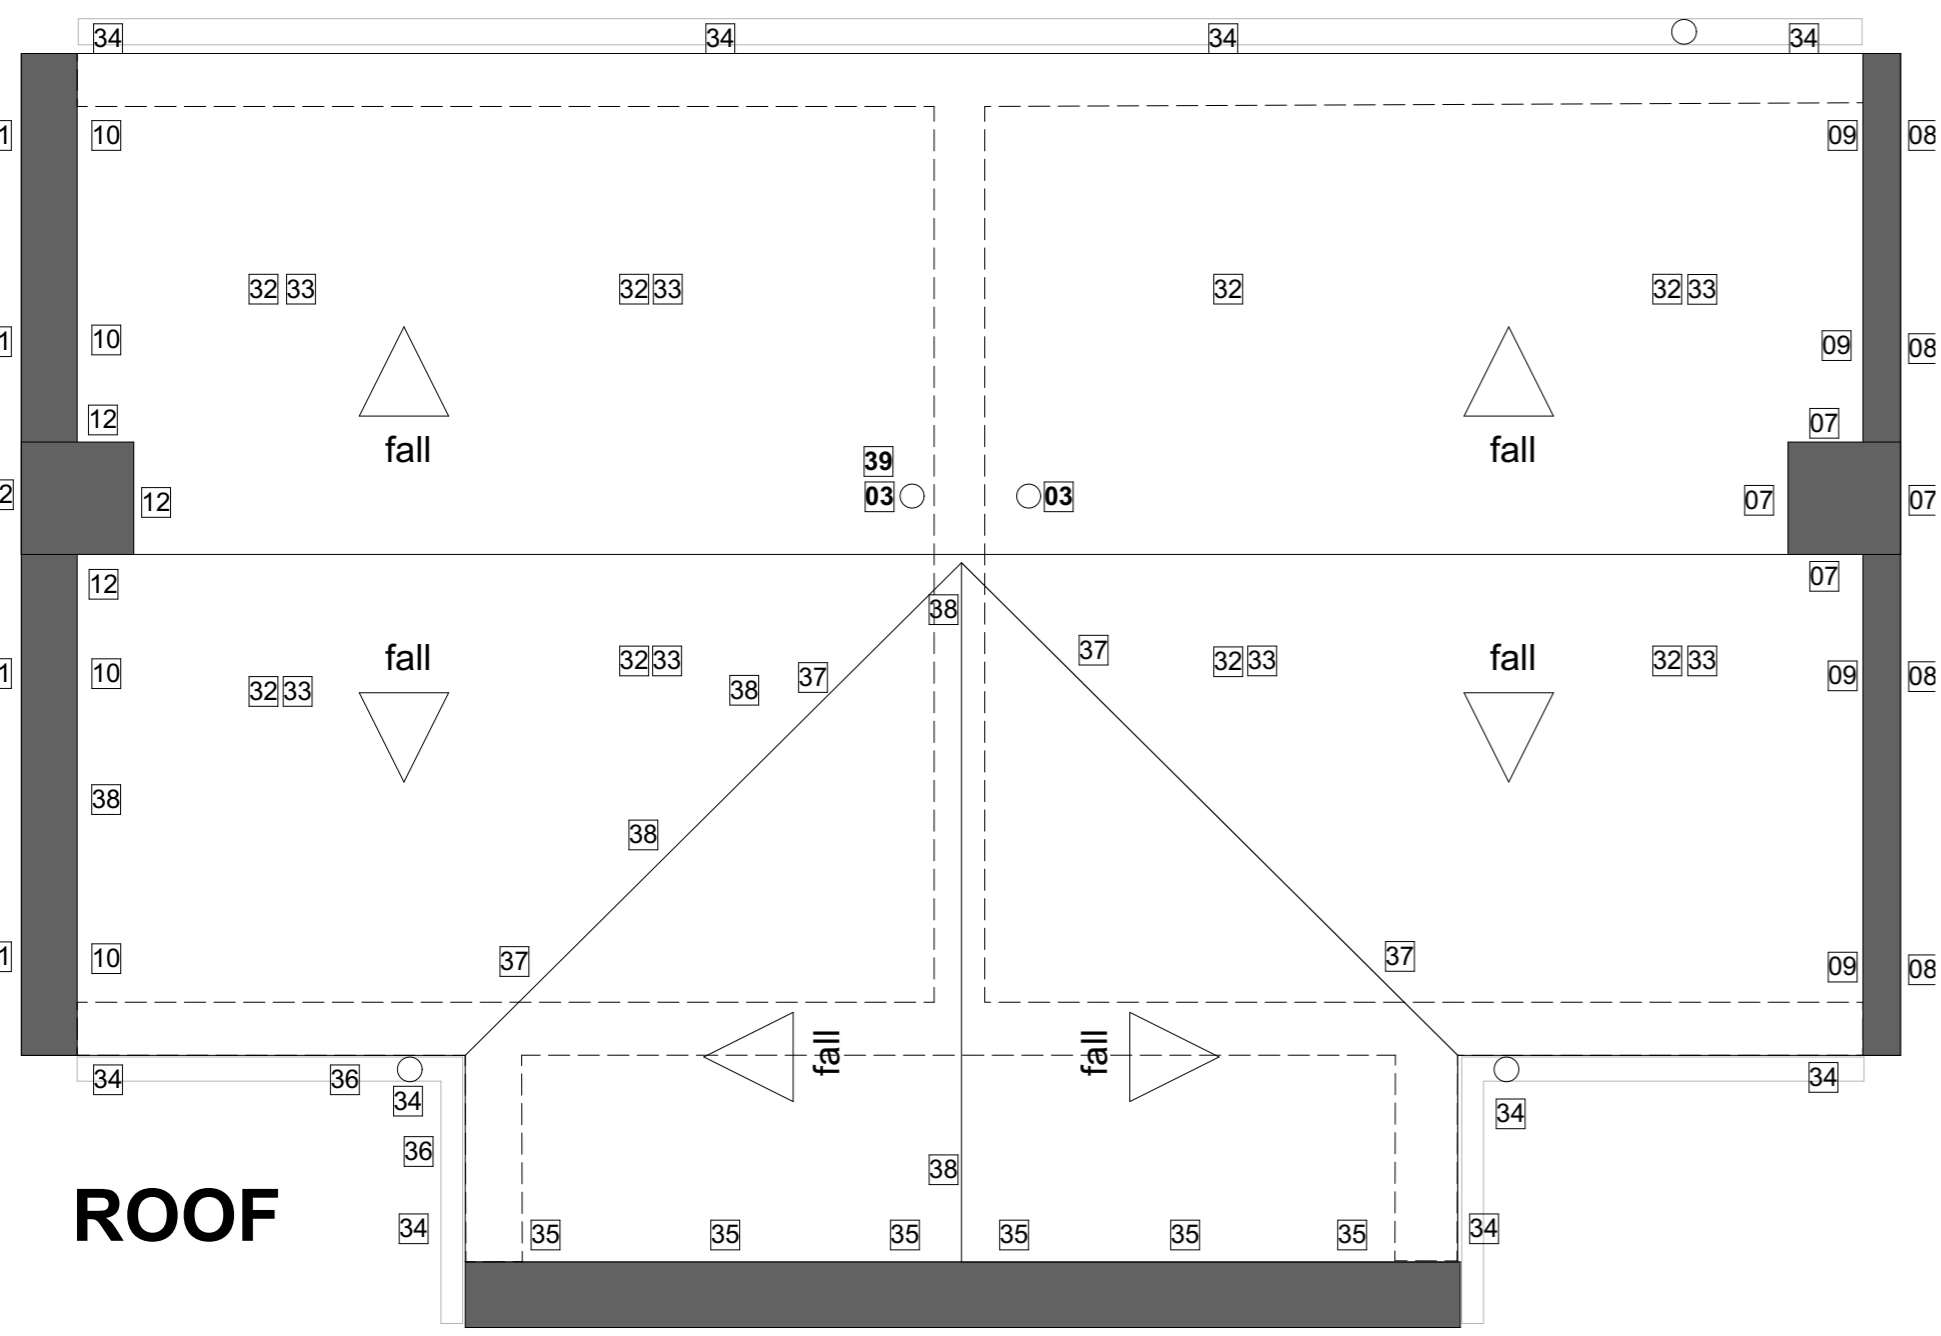
**ROOF**

**33 Vegetation to roof:** Remove vegetation from roof tiles generally taking care not to damage roof tiles or mortar pointing  
**34 Vegetation and debris within gutters:** Allow for cleaning out gutters ensuring left clean and free flowing to down pipes. Undertake gutter water test to test for leaks. Any leaks are to be repaired.

**35 Damaged/ missing lead soaker/ flashing to front gable decorative parapet:** Lead work and mortar pointing is to be checked to front elevation decorative parapet, lead replaced/ repaired using code 4 lead with patination oil to lead sheet association recommendations and poor pointing replaced using lime mortar.

**36 Staining of stonework front elevation:** Staining of stonework in vicinity of gutter due to rain water overspill. Cleaning and testing of gutters described previously. Check gutter supports to identified local area to ensure properly fixed and correct fall to outlet.

**37 Debris to valley gutters:** allow for cleaning debris to valley gutters to ensure water free flowing to gutters.  
**38 Broken tiles:** Allow for inspecting roof generally for broken, slipped, cracked tiles and replace with matching slate ensure fully supported with lead tingles. Identified damaged slate within report shown on roof plan but may be additional unidentified slates.

**39 Slipped boiler flue cover:** Sipped boiler flue to be refitted ensuring watertight  
**Site visit 22/02/2024:**  
**40 Flat 2 damp:** During site visit damp was identified at floor level to gable elevation and front and rear return walls. Ground was noted as being elevated/ level with internal floor. Additional inspections where undertaken, client does not require external levels adjusting as part of this application.

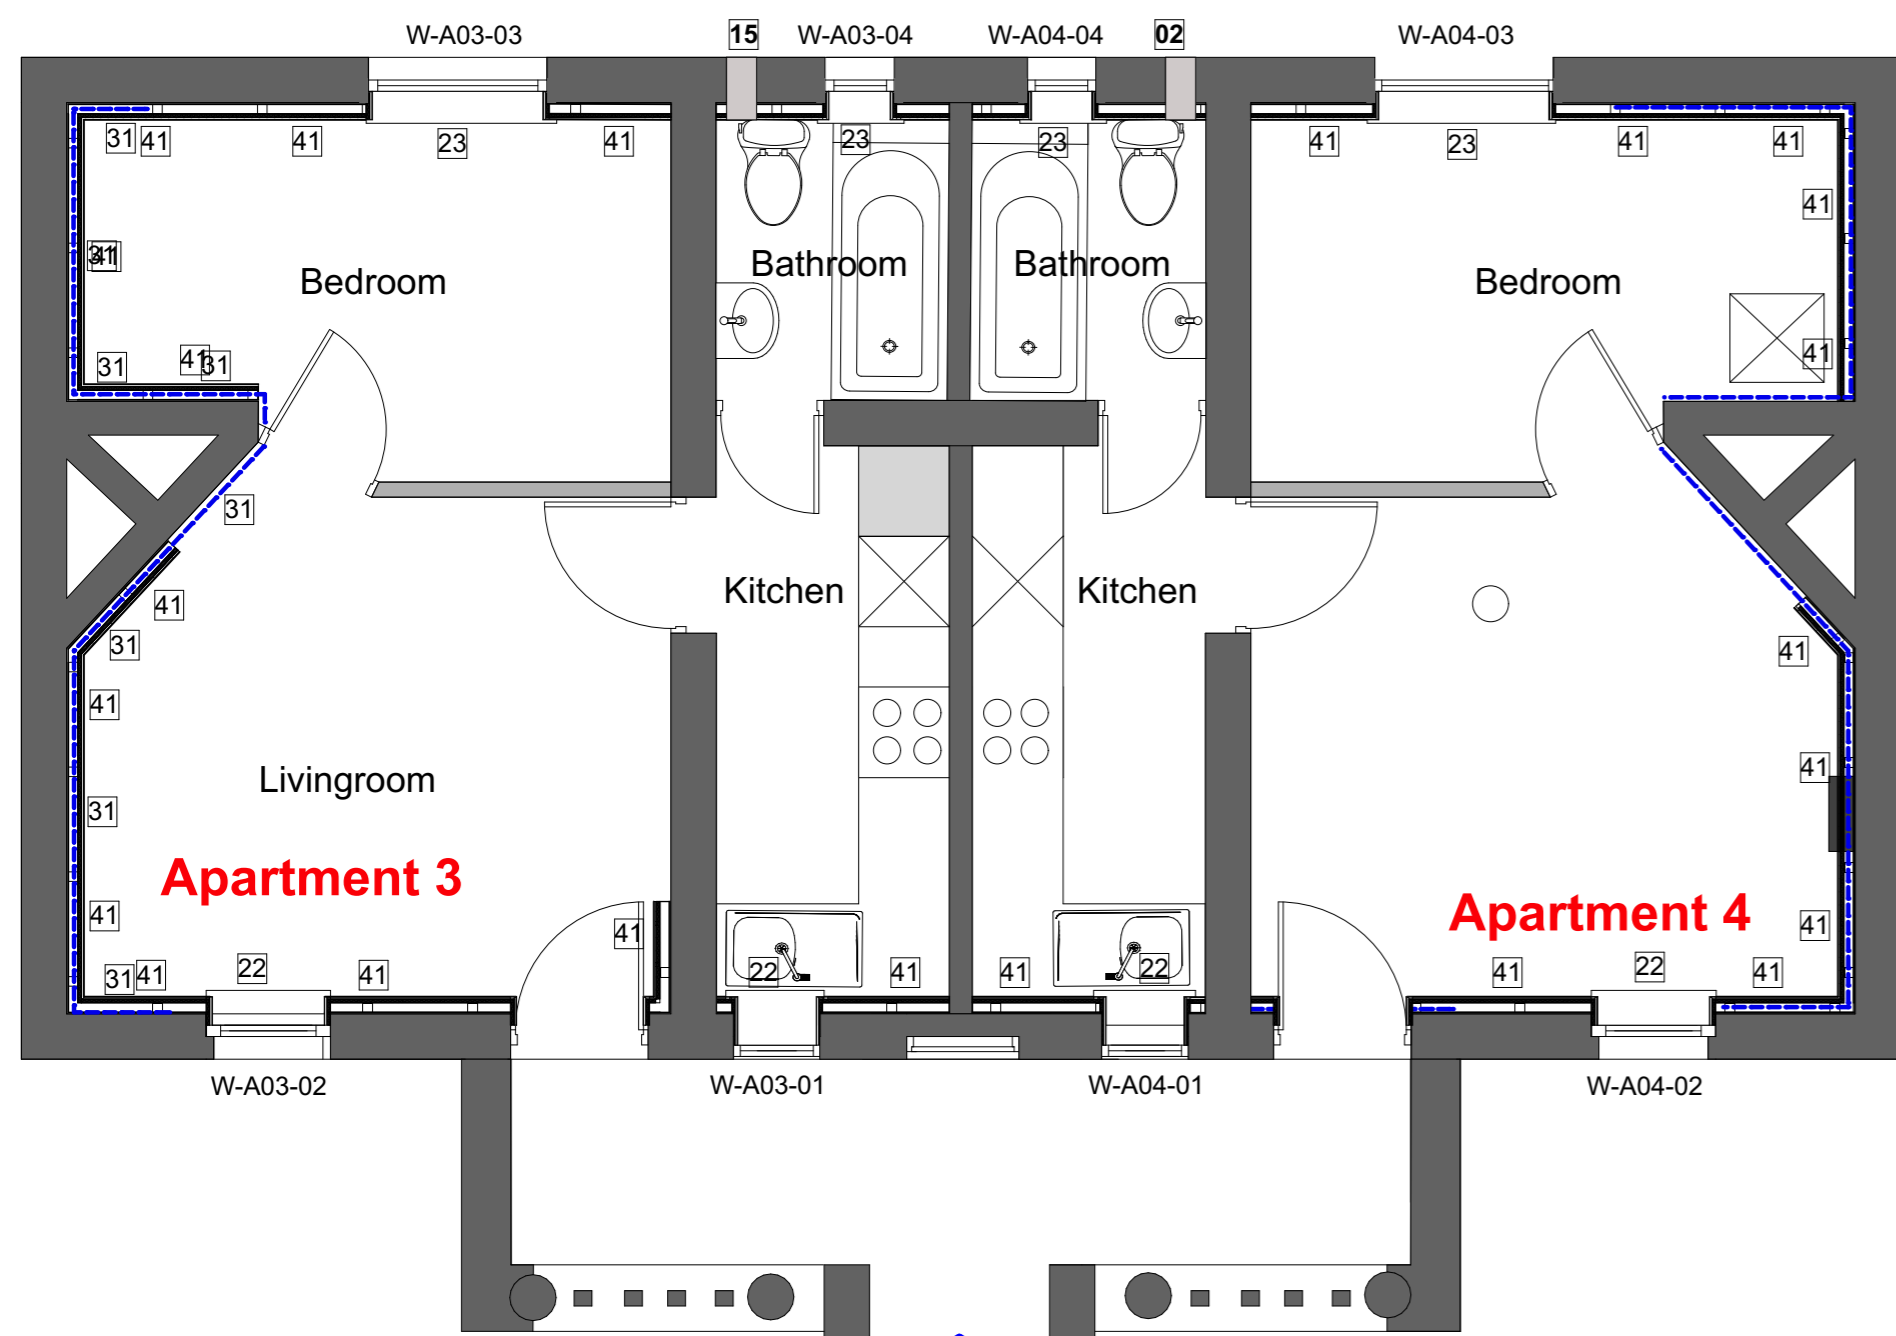
**FIRST FLOOR**

- 22 **Flats 1,2,3 and 4 Windows front elevation:** Windows are in poor condition, single glazed, suffering excessive condensation. Modern sliding sash windows present to front elevation. Proposed to replace all front elevation windows with new traditional timber sliding sash windows incorporating heritage thin double glazed units and draught sealing, polished brass traditional ironmongery.

- 23 **Flat 1,2,3,4 Windows rear elevation:** Windows are in poor condition, single glazed, suffering excessive condensation. Casement present to rear elevation. Proposed to replace all rear elevation windows with traditional flush casement incorporating double glazed units, draught sealing and polished brass ironmongery.

- 30 **Flat 2 front door:** Allow for easing front door to ensure ease of opening and closing.
- 31 **Flat 3 damp:** Damp internally to left hand (gable) wall. Gaps within and damage to gable coping and cracks to sand/cement dashed render ( Analysis for render type provided within listed building consent to apartment number 4). Water getting behind render via defects in coping causing render to crack and damp internally.

**Internally:**  
**High humidity:** Remove high humidity by use of de-humidifier.  
**Wall plaster:** Check existing gypsum based wall plaster for damp, added or otherwise in poor condition plaster, remove all defective areas including any rusting beading (complete to gable wall, returning a minimum 300mm on front and rear elevation walls) and replace plaster and galvanised beading using British Gypsum Drycoat renovating plaster and 3mm thistle skim coat. Ensure plaster kept off floor by 25mm. Decorate all effected areas (full wall, to natural stop or full room as required by the client) . Plaster type verified within flat 4 listed building consent application.

**Skirtings:** Check existing 94x19mm square edge timber skirtings for damp and rot. Where required due to rot or to replace defective plaster, cut out all defective areas and replace on a like for like basis and decorate. Prime all faces of timber prior to fitting. Allow full extent of gable elevation wall and return walls as required)  
**32 Loft insulation to flats 3 and 4:** Check existing loft voids for insulation thickness and to ensure that perimeter edges are well insulated without gaps. To the extent required allow for improving loft insulation to a depth of not less than 200mm using Thermafleece sheep's wool loft insulation  
**External areas:**

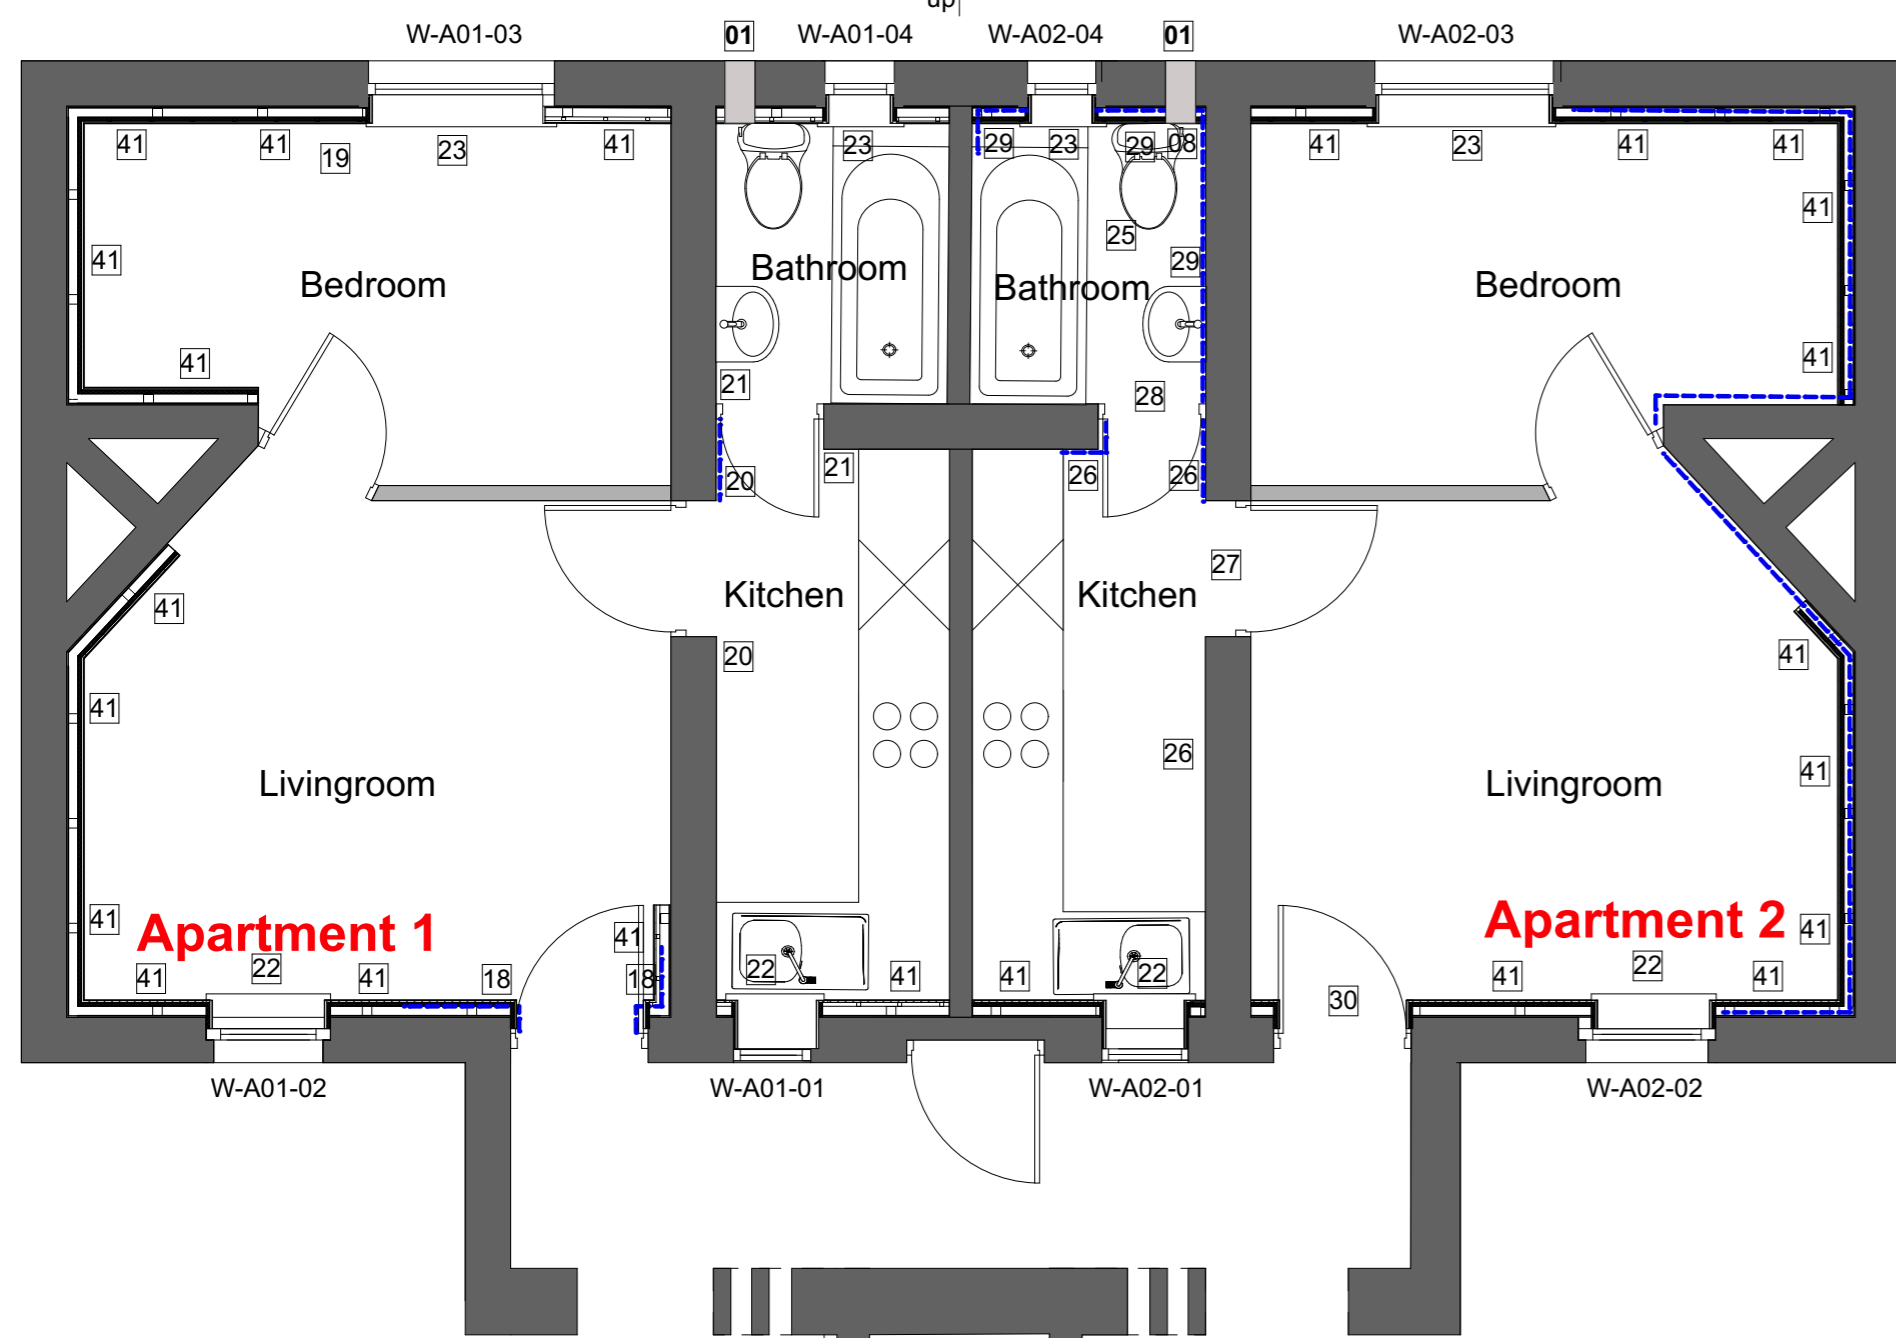
**GROUND FLOOR**

- 18 **Flat 1 Damp near flat 1 front door:**  
**Wall plaster:** Check existing gypsum based wall plaster for damp, added or otherwise in poor condition plaster, remove all defective areas including any rusting beading and replace plaster and beading using British Gypsum Drycoat renovating plaster and 3mm thistle skim coat. Ensure plaster kept off floor by 25mm. Decorate all effected areas (full wall, to natural stop or full room as required by the client) . Plaster type verified within flat 4 listed building consent application.

- 19 **Condensation to flat 1 bedroom:** Allow for use of de-humidifier to reduce air borne water content, humidity level. Improve house ventilation using positive ventilation unit as stated above, treat any effected areas of walls and ceilings with mould remover and apply anti-condensation paint. Decorate as required by client.

- 20 **Flat 1 High moisture readings within kitchen skirting:** High moisture readings identified to skirtings either side of kitchen/ living room internal door. Damp penetration through floor and external walls reviewed with client, no action required. Condition at time of inspection did not warrant replacement timbers. Overall humidity levels to be reduced as stated previously.

- 21 **Flat 1 High moisture readings within Bathroom skirting:** High moisture readings identified to skirtings either side of bathroom/ Kitchen internal door. Damp penetration through floor and external walls reviewed with client, no action required. Condition at time of inspection did not warrant replacement timbers. Overall humidity levels to be reduced as stated previously.

- 26 **Flat 2 Kitchen damp:** Excessive condensation within room and damp to timber work. Penetrating damp through floors and walls reviewed by client, no action required.

- 29 **Flat 2 Bathroom damp:** Excessive condensation within room and damp to timber work. Penetrating damp through floors and walls reviewed by client, no action required.

**Wall plaster:** Check existing gypsum based wall plaster for damp, added or otherwise in poor condition plaster. Remove plaster including any rusting beading to a minimum height of 1.1m and replace plaster and beading using British Gypsum Drycoat renovating plaster and 3mm thistle skim coat. Ensure plaster kept off floor by 25mm. Decorate all effected areas (full wall, to natural stop or full room as required by the client) . Plaster type verified within flat 4 listed building consent application.

- 27 **Flat 2 Kitchen door and door frame:** Remove existing modern pressed panel door and door frame (rotting). Replace door and door frame on a like for like basis including ironmongery and decorate

- 28 **Flat 2 Bathroom door and door frame:** Remove existing modern pressed panel door and door frame (rotting). Replace door and door frame on a like for like basis including ironmongery and decorate.
