Survey defects notes:
Survey was undertaken by Ray Craig FRICS. Chartered Building Surveyor dated 14/11/2023 below is summary of required works.

Offices at: Liverpool & Nottingham Halsall Lloyd Partnership Address: 98 Duke Street Post Code: L1 5AG Issuing Office: Liverpool Tel: 0151 708 8944 Website: www.hlpsdesign.com	Drawing Title: INTERNAL WORKS DRAWING Project: Number 1-4, Almhouses, Stydd lane, Ribchester, PR3 3YQ Client: Your Housing Group Scales @ A1: 1:50 Job Number / Dwg. No. / Revision: 3184_D_05-V01 First Issue Date: 31/05/2024 RIBA Stage: Drawing Status: [2] - PRELIMINARY	Drawn: BMc Check: GL
---	---	-----------------------------

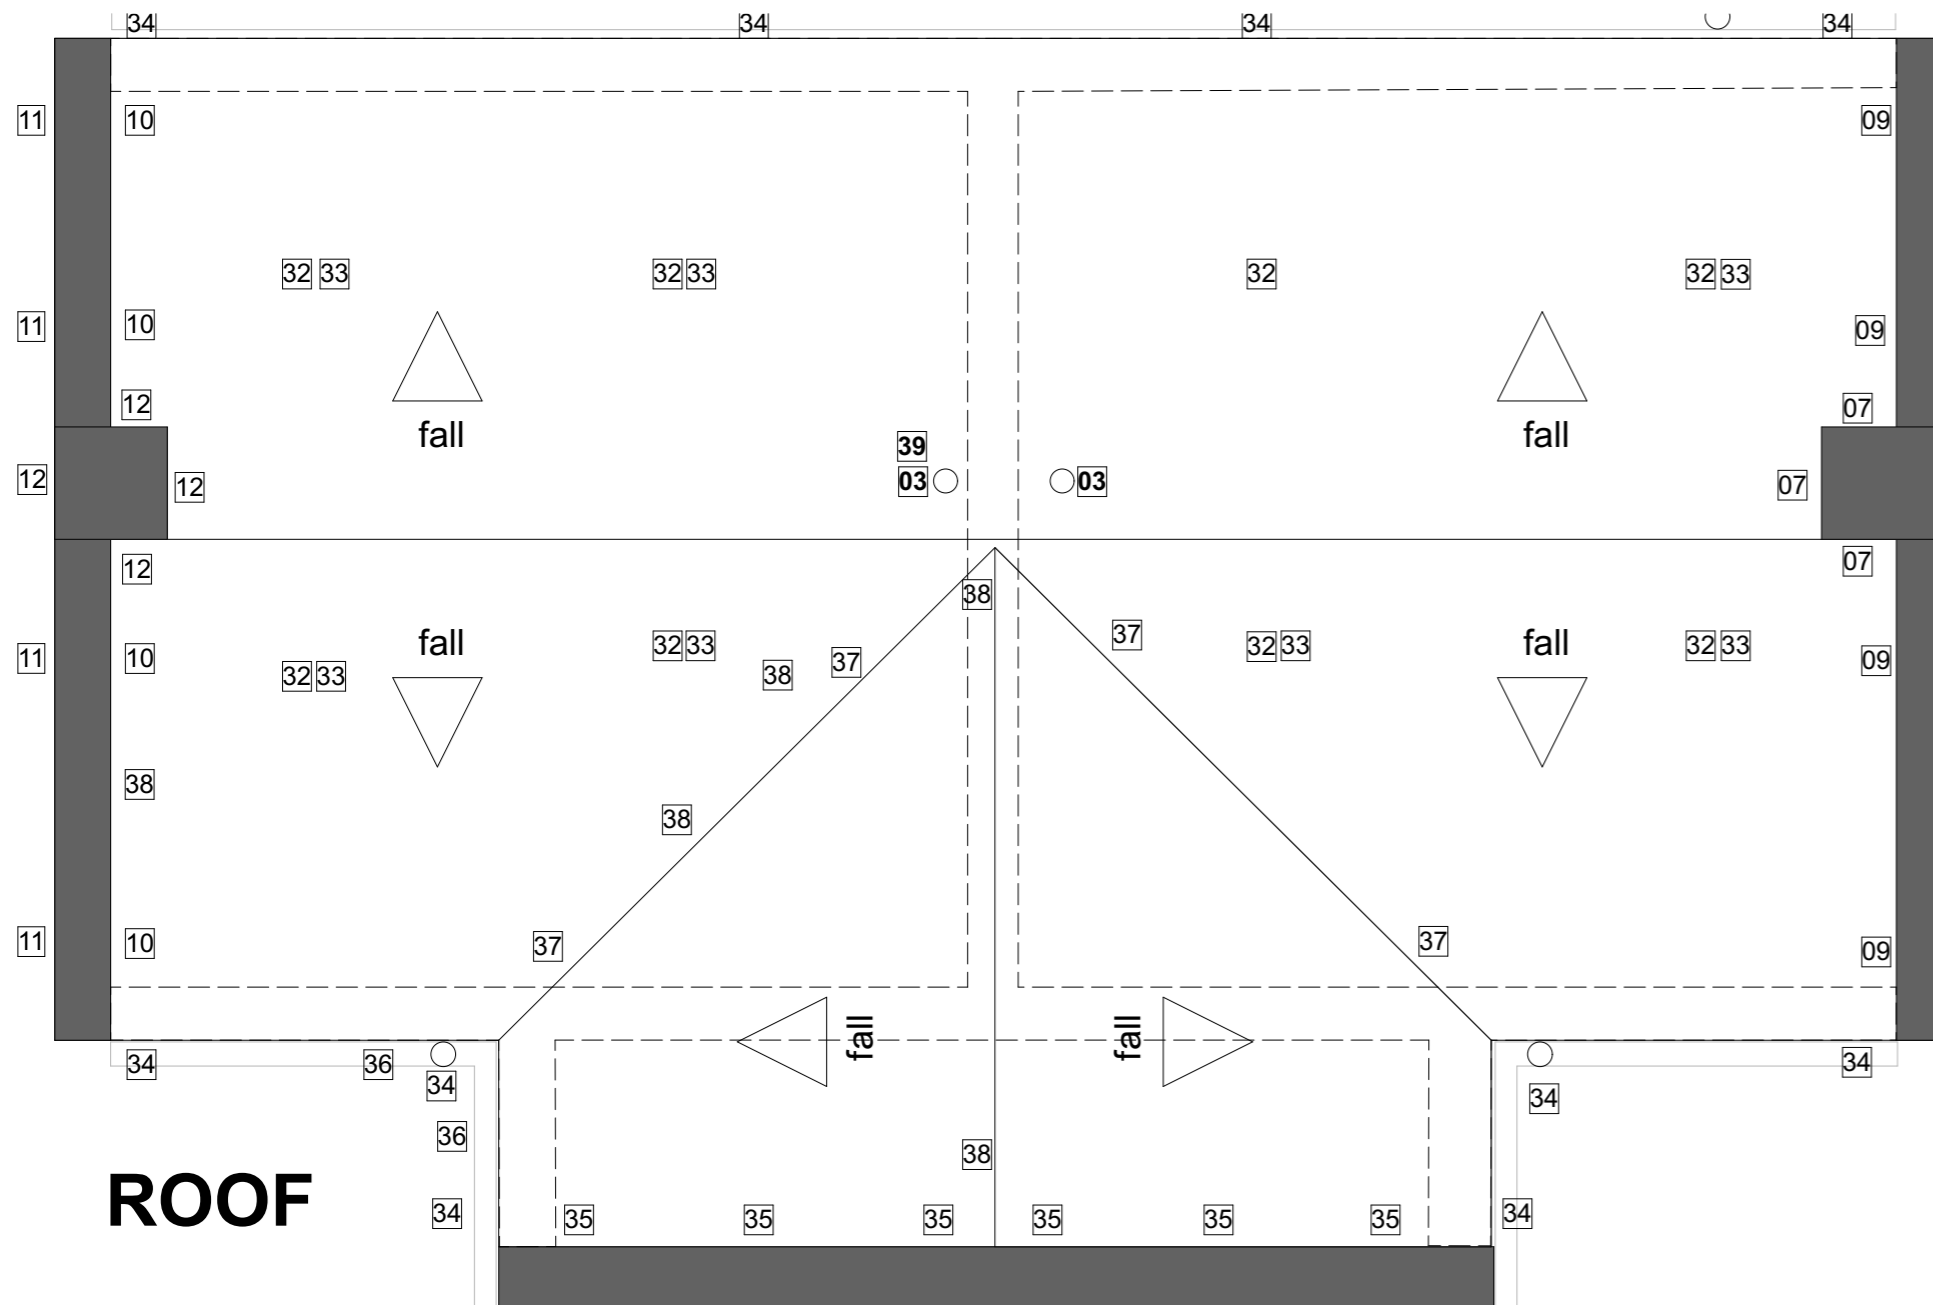
ROOF

- External areas:**
- 33 Vegetation to roof:** Remove vegetation from roof tiles generally taking care not to damage roof tiles or mortar pointing
- 34 Vegetation and debris within gutters:** Allow for cleaning out gutters ensuring left clean and free flowing to down pipes. Undertake gutter water test to test for leaks. Any leaks are to be repaired.

- 35 Damaged/ missing lead soaker/ flashing to front gable decorative parapet:** Lead work and mortar pointing is to be checked to front elevation decorative parapet, lead replaced/ repaired using code 4 lead with patination oil to lead sheet association recommendations and poor pointing replaced using lime mortar.

- 36 Staining of stonework front elevation:** Staining of stonework in vicinity of gutter due to rain water overspill. Cleaning and testing of gutters described previously. Check gutter supports to identified local area to ensure properly fixed and correct fall to outlet.

- 37 Debris to valley gutters:** allow for cleaning debris to valley gutters to ensure water free flowing to gutters.
- 38 Broken tiles:** Allow for inspecting roof generally for broken, slipped, cracked tiles and replace with matching slate ensure fully supported with lead tingles. Identified damaged slate within report shown on roof plan but may be additional unidentified slates.

- 39 Slipped boiler flue cover:** Sipped boiler flue to be refitted ensuring watertight
- Site visit 22/02/2024:**
- 40 Flat 2 damp:** During site visit damp was identified at floor level to gable elevation and front and rear return walls. Ground was noted as being elevated/ level with internal floor. Additional inspections where undertaken, client does not require external levels adjusting as part of this application.
High humidity: Remove high humidity by use of de-humidifier and improve ventilation.

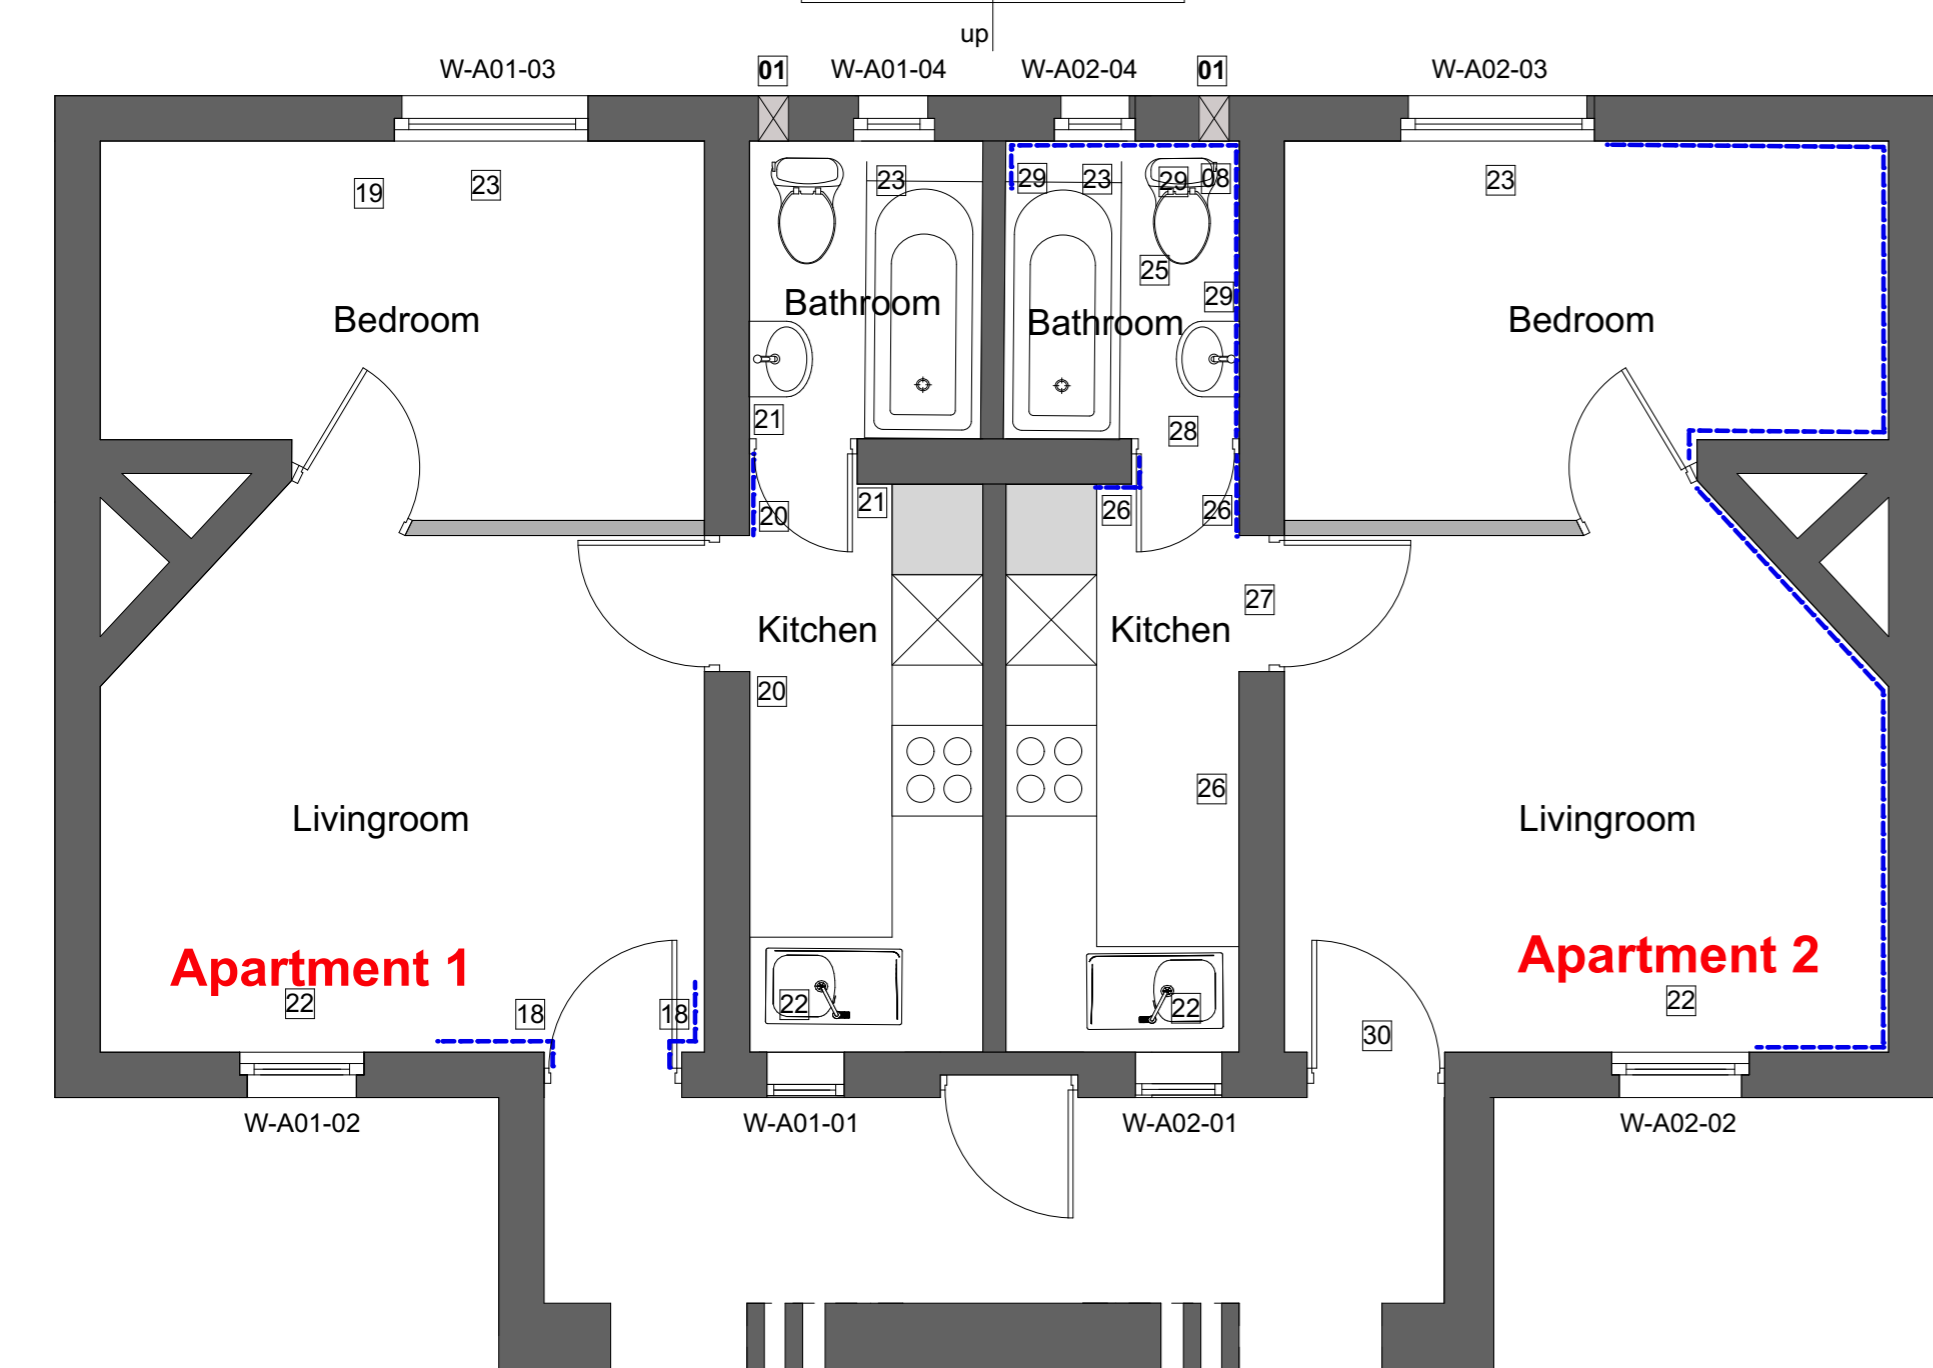
GROUND FLOOR

- 18 Flat 1 Damp near flat 1 front door:**
Wall plaster: Check existing gypsum based wall plaster for damp, added or otherwise in poor condition plaster, remove all defective areas including any rusting beading and replace plaster and beading using British Gypsum Drycoat renovating plaster and 3mm thistle skim coat. Ensure plaster kept off floor by 25mm. Decorate all effected areas (full wall, to natural stop or full room as required by the client) . Plaster type verified within flat 4 listed building consent application.
Skirtings: Check existing 94x19mm square edge timber skirtings for damp and rot. Where required due to rot or to replace defective plaster, cut out all defective areas and replace on a like for like basis and decorate (Prime all faces of timber prior to fitting)

- 19 Condensation to flat 1 bedroom:** Allow for use of de-humidifier to reduce air borne water content, humidity level. Improve house ventilation using positive ventilation unit as stated above, treat any effected areas of walls and ceilings with mould remover and apply anti-condensation paint. Decorate as required by client.

- 20 Flat 1 High moisture readings within kitchen skirting:** High moisture readings identified to skirtings either side of kitchen/ living room internal door. Damp penetration through floor and external walls reviewed with client, no action required. Condition at time of inspection did not warrant replacement timbers. Overall humidity levels to be reduced as stated previously.

- 21 Flat 1 High moisture readings within Bathroom skirting:** High moisture readings identified to skirtings either side of bathroom/ Kitchen internal door. Damp penetration through floor and external walls reviewed with client, no action required. Condition at time of inspection did not warrant replacement timbers. Overall humidity levels to be reduced as stated previously.

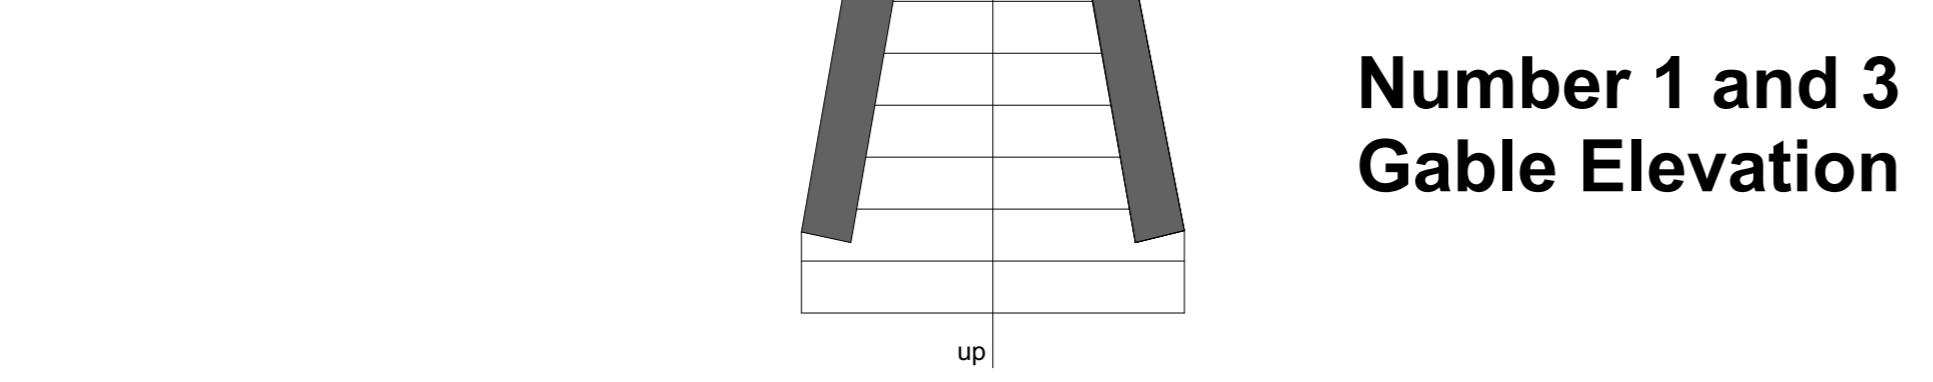
Number 1 and 3 Gable Elevation

- 01** Existing extract fan position
- 02** Extract vented through air brick to apartment number 4 as approved under previous listed building consent.
- 03** Existing boiler flue position

- 04** Existing gas fire flue position
- 05** Existing air vent
- 06** Existing light
- 07** Lead flashings to chimney, apply patination oil (Flats 2/4 gable) as approved under previous listed building consent application.

- 08** Lead flashings laid under coping and dressed down wall to protect upper edge of render, apply patination oil (Flats 2/4 gable) as approved under previous application.

- 09** Stone copings repaired, re-bed, fitted with stainless steel angle supports and pointed in lime mortar (Gable of 2/4) as approved under previous listed building consent application.
Note stone coping repair subject to listed building condition.
Check adequacy of existing lead soakers and where required repair/replace, note particularly around stone kneeler where lead can not be seen to ensure building is fully weathertight.

- 10** Copings carefully taken off, set aside, protected from damage and theft, new lead flashing laid under coping and returned down gable to protect upper edge of render, apply patination oil.

- 11** Coping edges squared off and new section of matching stone coping provided as required, re-bed, repointed in position supported using galvanised steel angles
Check adequacy of existing lead soakers and where required repair/replace and repoint in lime mortar, note particularly around stone kneeler where lead can not be seen to ensure building is fully weathertight.

- 12** New lead flashings to chimney
- 13** Render cracks repaired and gable decorated.
- 14** Exposed brickwork to be carefully raked out and re-pointed using lime mortar.

- 15** Fit new extract fan venting through terracotta air brick to flat 3 as approved to flat 4 under previous listed building consent. Note extract fans are already fitted to flats 1 and 2.
