LAKELAND
TREE CONSULTANCY
ARBORICULTURAL PLANNING SPECIALIST

BS5837 Tree Survey

Laneside House
Sawley
BB7 4LF

October 2025

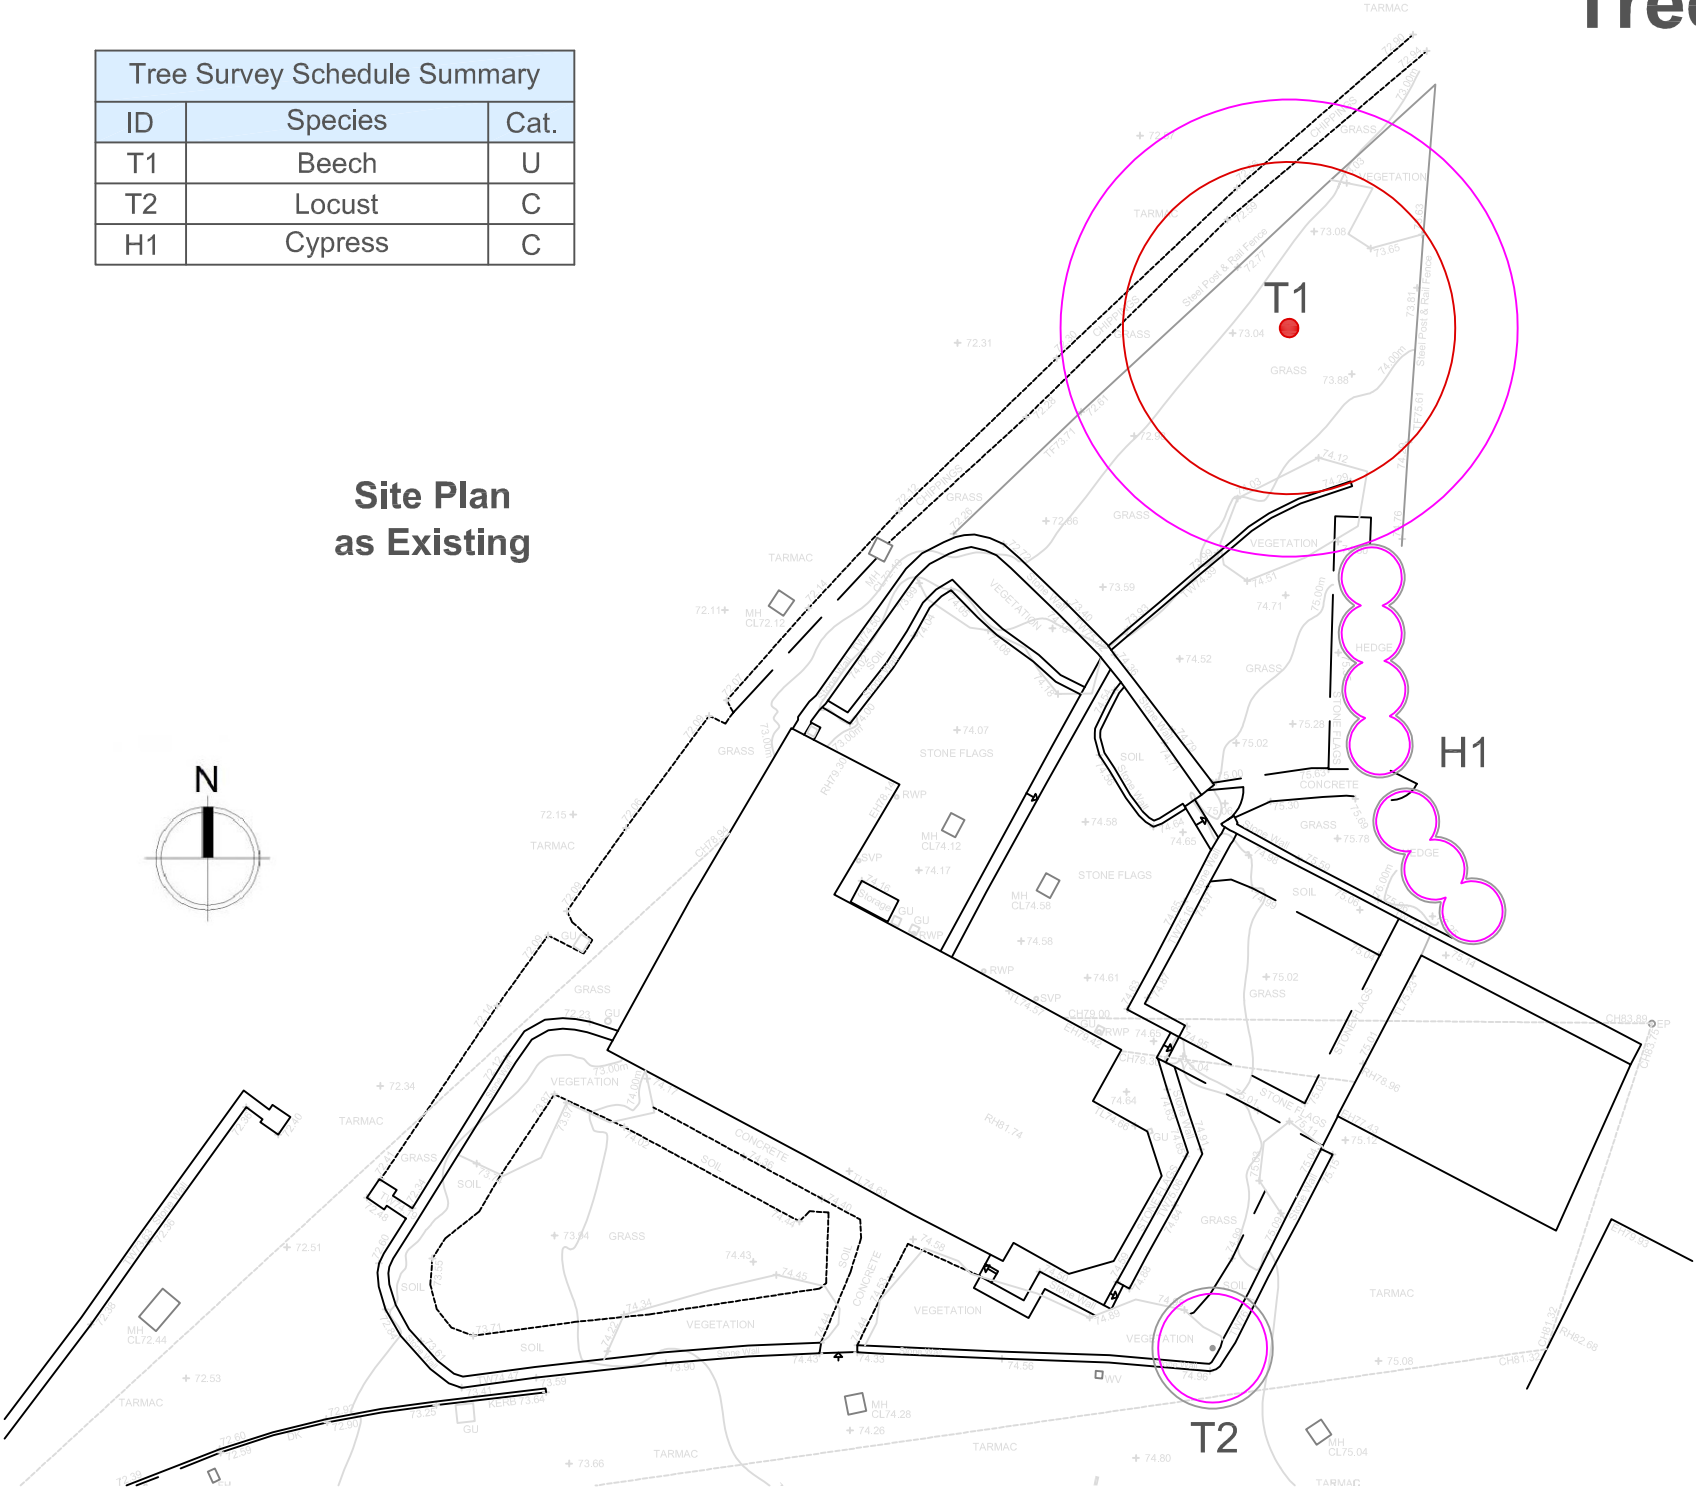
Tree Survey Plan

Tree Survey Schedule Summary		
ID	Species	Cat.
T1	Beech	U
T2	Locust	C
H1	Cypress	C
