An archaeological building record

CRANE WOOD FARM BARN

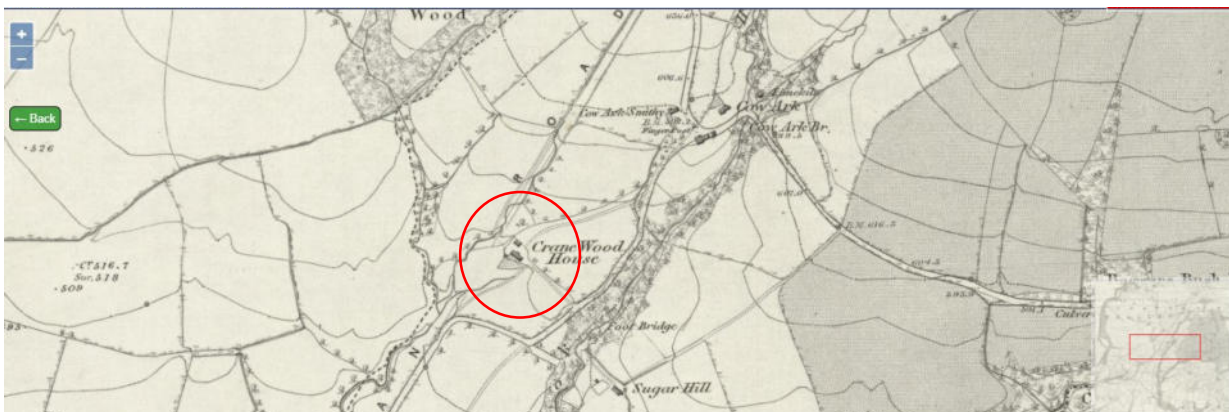
OS six inch map 1850 (surveyed 1848) – Circle around Crane Wood Farm shown as Crane Wood House, with the barn to the north of the house. The map also shows the barn with smaller in relation to the farmhouse, suggesting the north shippon was added after this date.

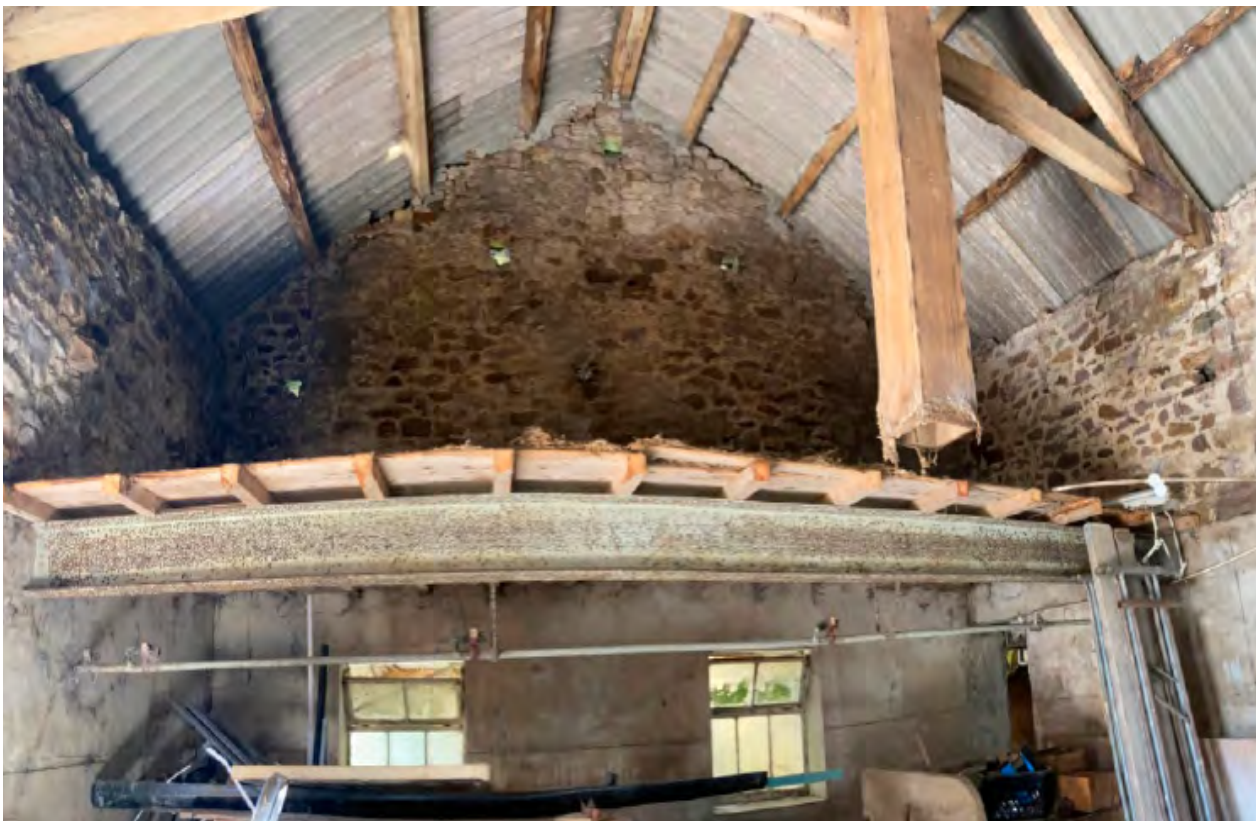
17. View to west side of the main barn from the central threshing floor. C20th hayloft over on steel beam. Note C20th plasterwork to the walls of the byre and exposed rubble work above with cracking towards verge to upper left and right hand sides. Also note water damage and split to right hand / north bearing of the west truss.

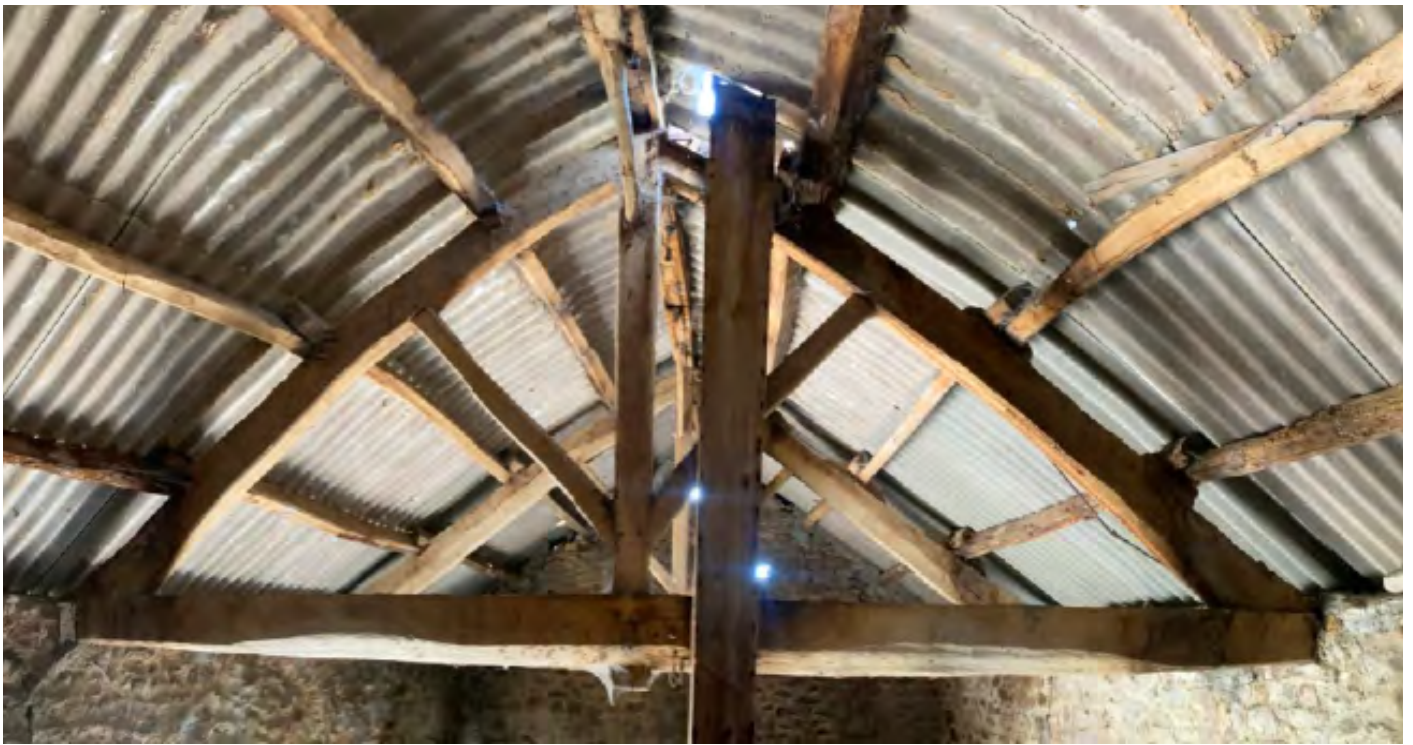
18. East and west king post trusses viewed from the east with remaining purlins and asbestos and fibre cement sheet roofing over.

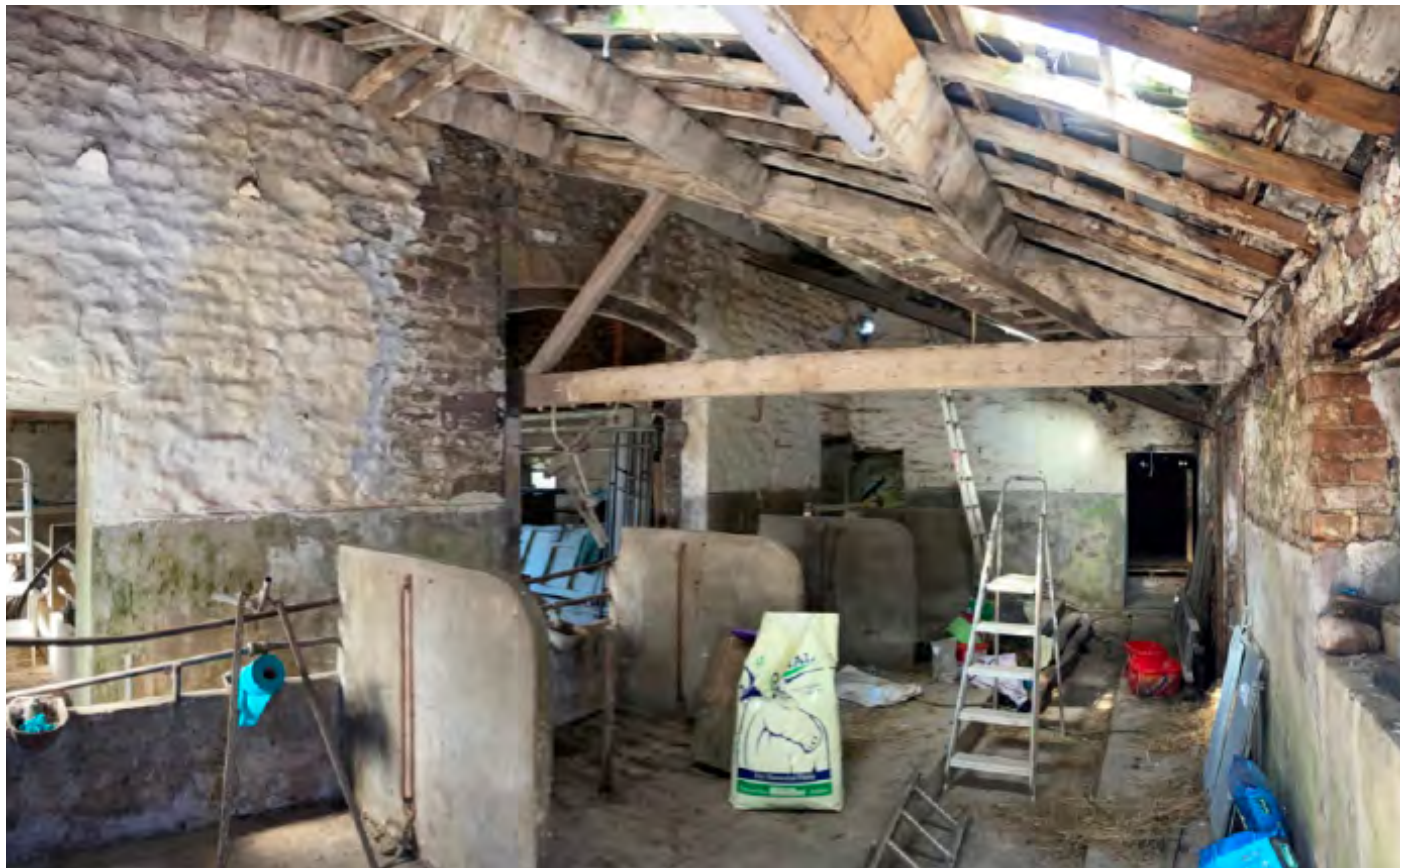
19. View of lean-to shippon from the east door showing threshing door through into the main barn to the left. Note timber half truss to the front and replacement steel beyond.

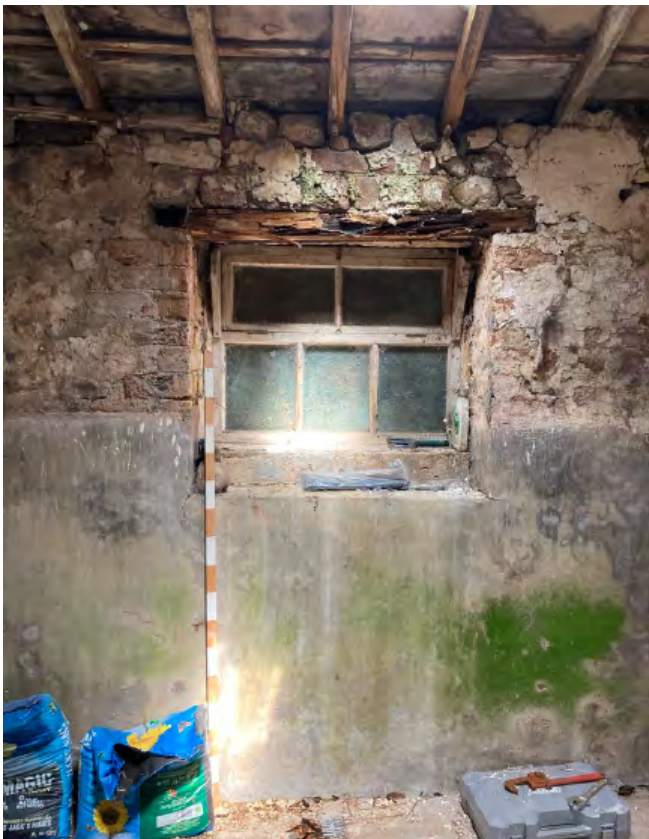
22. Window to north wall of north shippon with lower cementitious plaster and limewash above. Also note decay to the timber lintel.

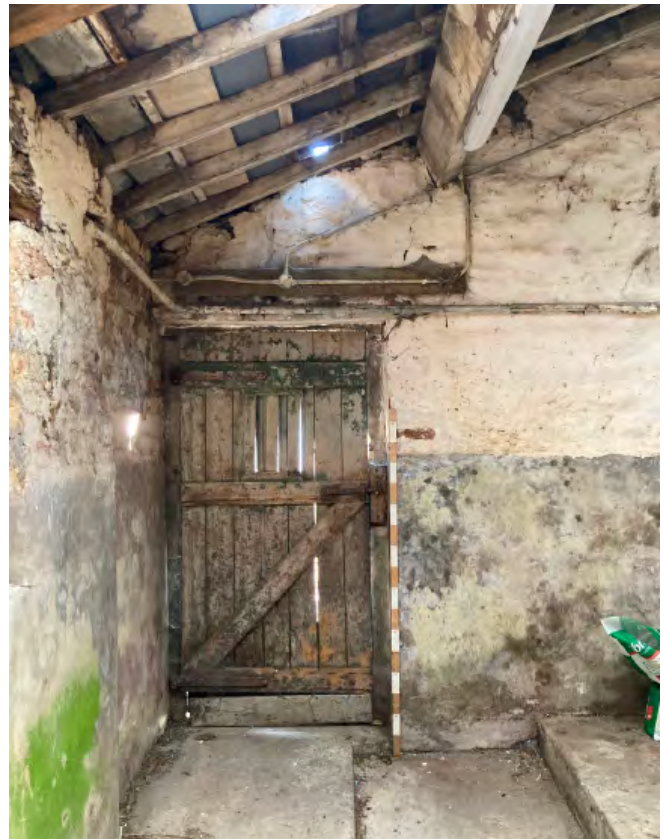
23. Doorway to east side of north shippon. Note board to base of the door covering rotten vertical boards
