# Arboricultural Impact Assessment

Rose Hill Farm  
Whalley Old Road  
Billington  
BB7 9JF

June 2026

| <b>Job no.</b> | LTC336 |

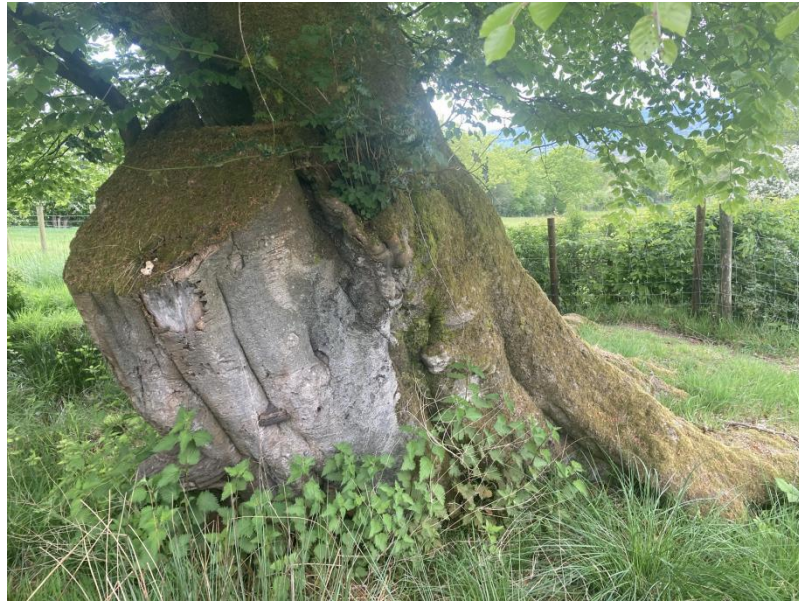
Photograph 1: Veteran beech T3,  
showing codominant stem previously removed

| ID no. | Species<br>Latin name | Stem diameter (mm) | Age | Height (m)# | Crown spread (m) | Crown clearance (m) | Structural condition<br>Physiological condition | Life expectancy (years) | Radial RPA (m) | BS5837 category | General observations |
|---|---|---|---|---|---|---|---|---|---|---|---|
| T3 | European beech<br><br><i>Fagus sylvatica</i> | 1250 | Mature | 14 | N 7<br>E 7<br>S 7<br>W 7 | 1.5 | Moderate<br><br>Moderate/Good | 20+ | 15 | A | <ul style="list-style-type: none"> <li>Veteran tree</li> <li>Codominant stem removed in the past at a height of 1.5m</li> <li>Stem diameter only refers to remaining stem, measured at a height of 1.75m</li> <li>Approximately 12no. young to mature brackets of white rot decay fungus <i>Ganoderma australe</i> growing around full circumference of tree from base to a height of 1.25m (max. bracket width 700mm)</li> <li>Large raised buttress roots on northern side</li> <li>Flaking bark on remnants of removed stem</li> <li>Several visible knotholes of varying sizes</li> <li>Frequent deadwood on southern side of crown to a diameter of 100mm and length of 1m</li> <li>Stem evidently failed at apex</li> </ul> |

| Operation | BS5837 Guidance |
|---|---|
| Relandscaping | <ul style="list-style-type: none"> <li>• The insertion of a new retaining wall as part of garden relandscaping is required close to the RPA of veteran beech tree T3</li> <li>• Veteran trees are of very high value and, as they are often of an advanced age, may be especially vulnerable to the impacts of development, as they are less able to tolerate disturbance or adapt to rapid changes than a more vigorous, younger tree</li> <li>• It is imperative that the RPA is retained as existing, with no ground disturbance, levels changes, soil compaction or excavation, during the demolition, construction and landscaping phases of development, or thereafter</li> <li>• BS5837-specification tree protection fencing must be laid-out exactly as indicated on the appended Tree Protection Plan to form a construction exclusion zone prior to any works on-site</li> <li>• The fencing shall be kept well-maintained and functional for the duration of the works</li> <li>• The construction exclusion zone shall be strictly adhered-to, with no vehicle access, scraping, regrading or installation of services, drainage or any other infrastructure within this area</li> </ul> |

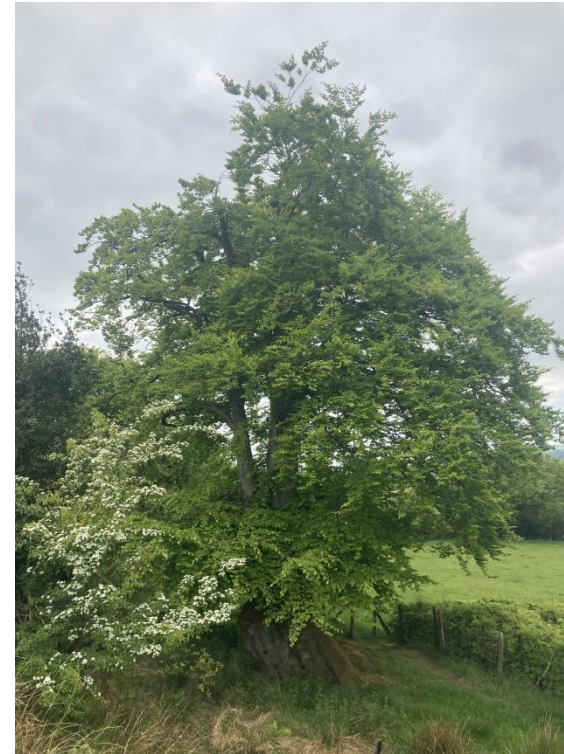
Photograph 2: Veteran beech T3,  
showing general form and evident failure at apex
