# Arboricultural Impact Assessment

Everything Retreat  
Primrose Lane  
Mellor  
BB2 7EQ

March 2026

<b>Job no.</b>	LTC291
<b>Site</b>	Everything Retreat, Primrose Lane, Mellor, BB2 7EQ
<b>Client</b>	Louise Monk
<b>Agent</b>	Zara Moon Architects
<b>Arboriculturist</b>	Jennie Keighley PhD MSc MArborA
<b>Local authority</b>	Ribble Valley Borough Council
<b>Date</b>	6 March 2026
<b>Issue</b>	Final issue for planning

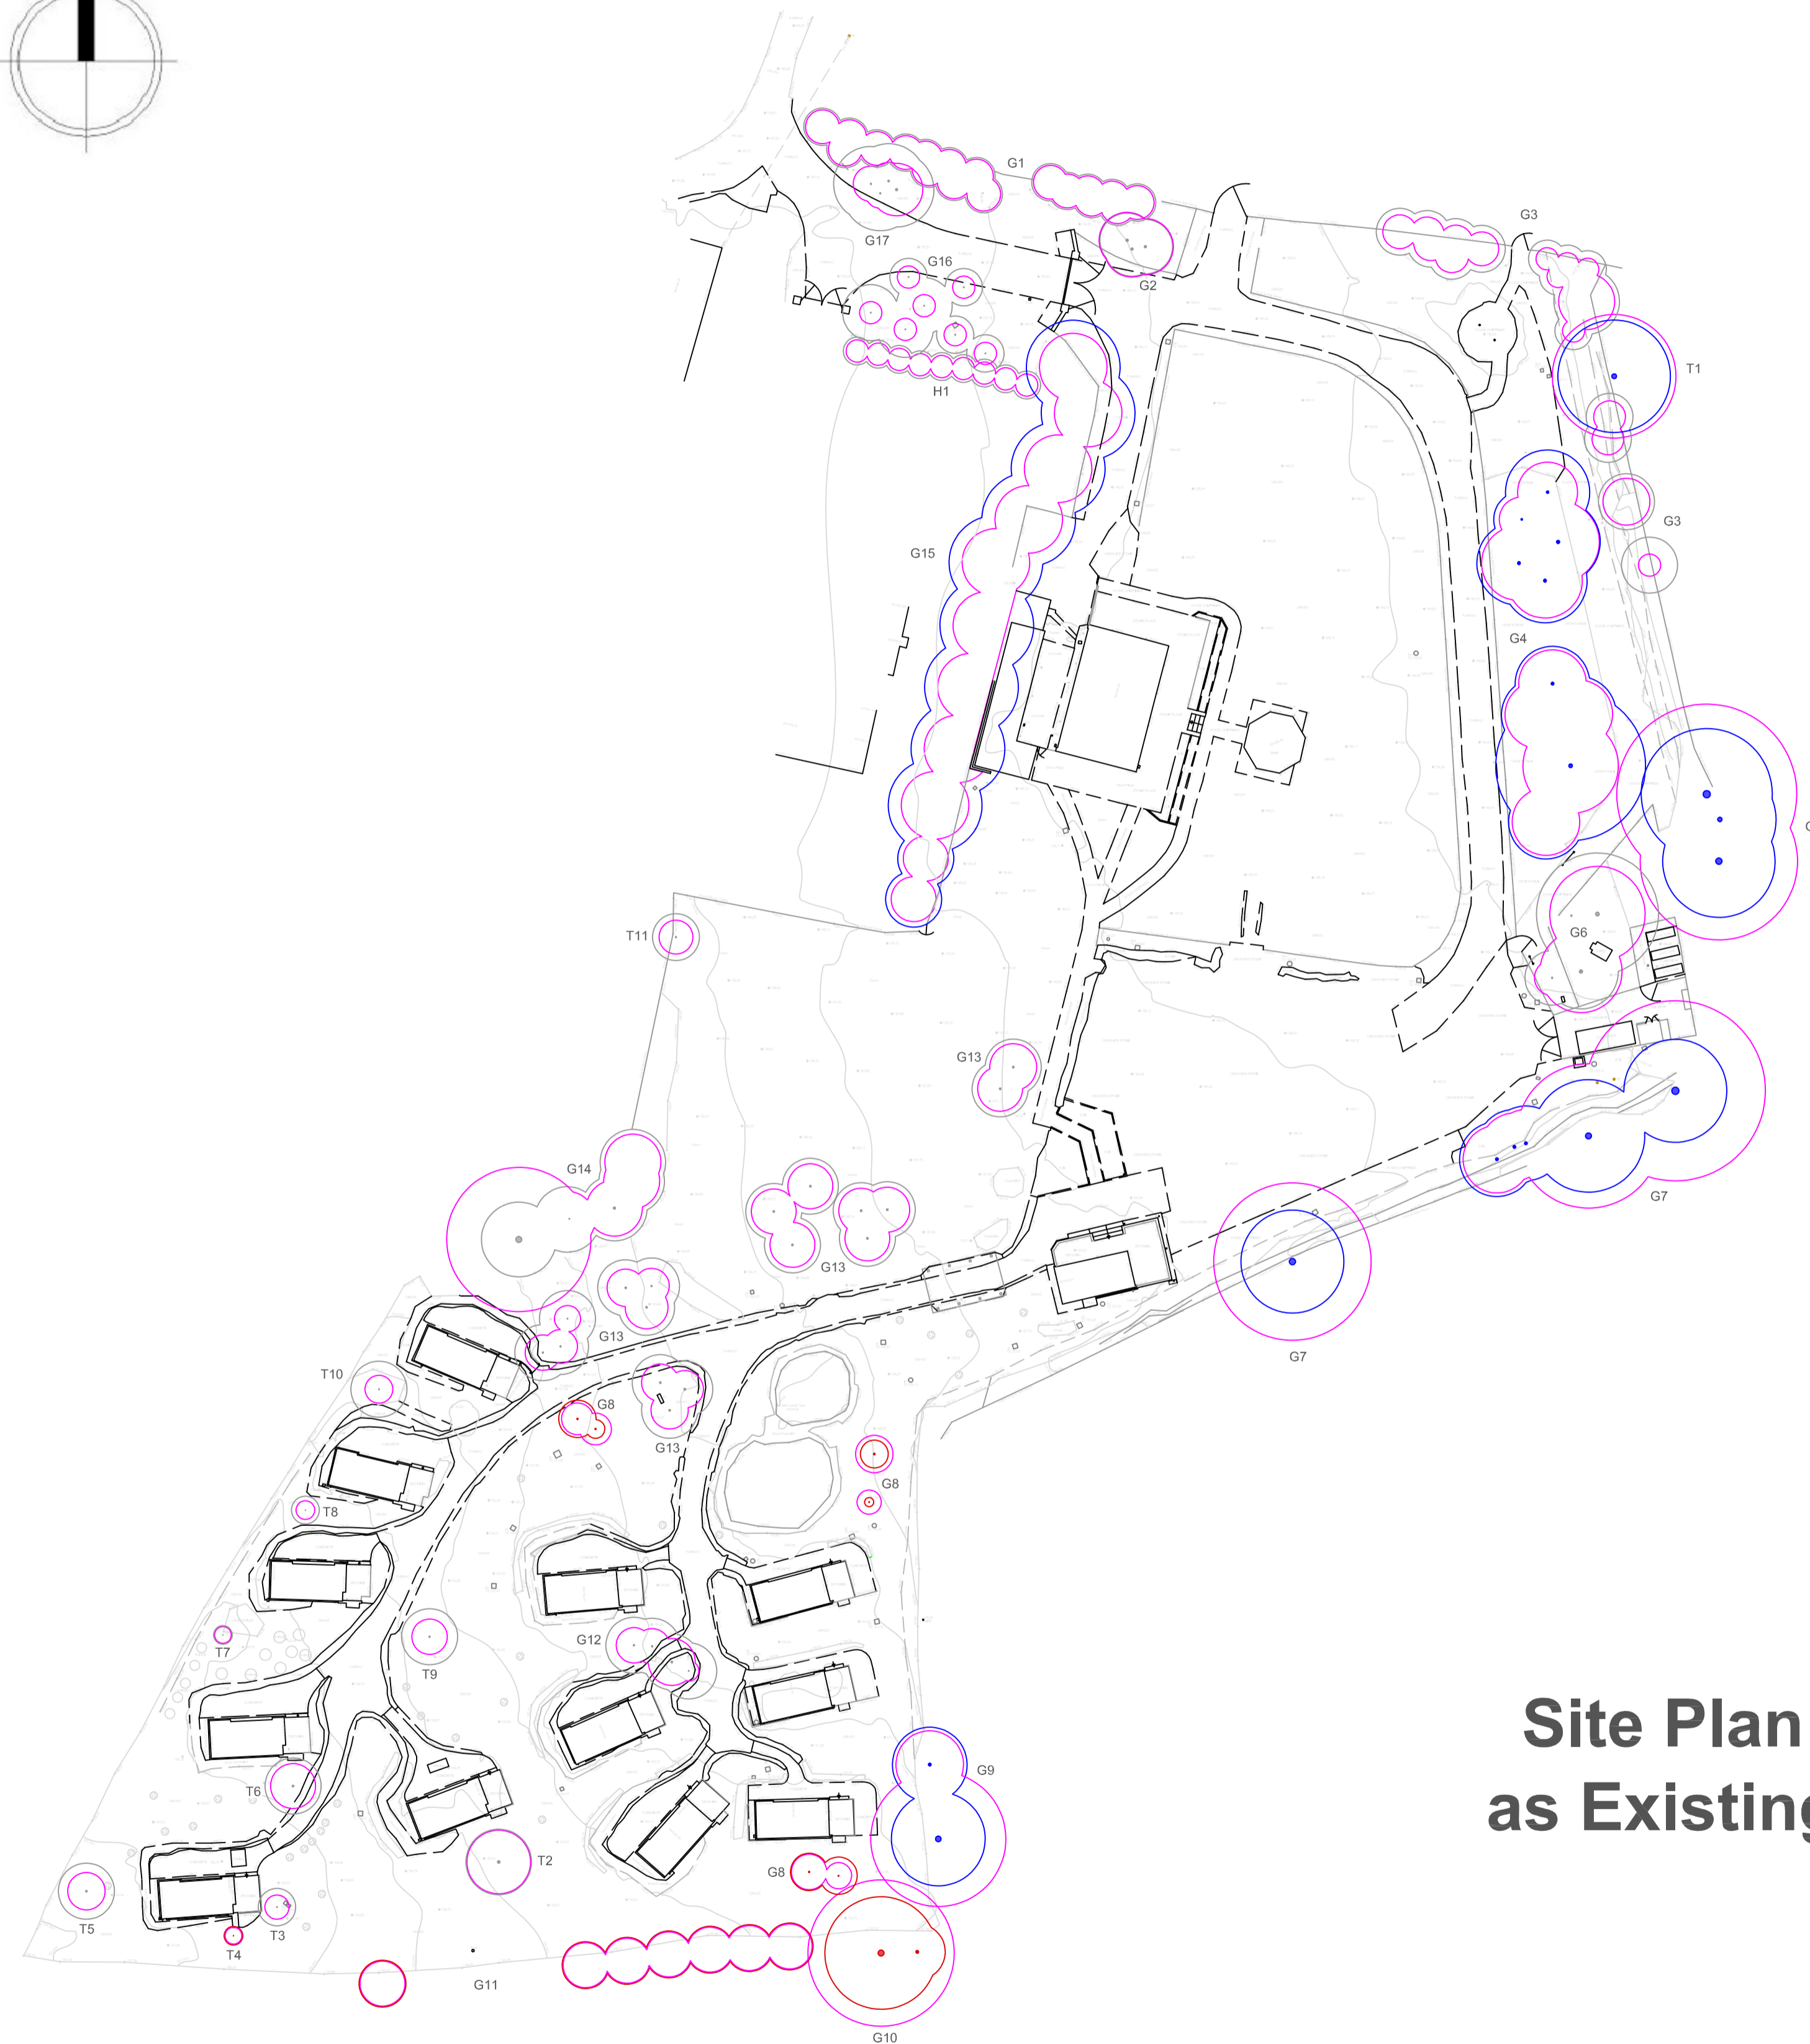
**Site Plan  
as Existing**

Tree Survey Schedule Summary		
ID	Species	Cat.
T1	Oak	B
T2	Alder	C
T3	Pine	C
T4	Ash	U
T5	Alder	C
T6	Alder	C
T7	Cherry	C
T8	Birch	C
T9	Alder	C
T10	Osier	C
T11	Willow	C
G1	Native/ornamental mix	C
G2	3no. osier	C
G3	Native mix	C
G4	Native mix	B
G5	3no. alder	B
G6	2no. osier, 2no. hazel	C
G7	6no. alder	B
G8	6no. ash	U
G9	1no. alder, 1no. rowan	B
G10	2no. ash	U
G11	Elder, hawthorn, ash	U
G12	4no. alder	C
G13	17no. alder	C
G14	3no. willow	C
G15	Native/ornamental mix	B
G16	4no. apple, 3no. pear	C
G17	4no. birch	C
H1	Hornbeam	C

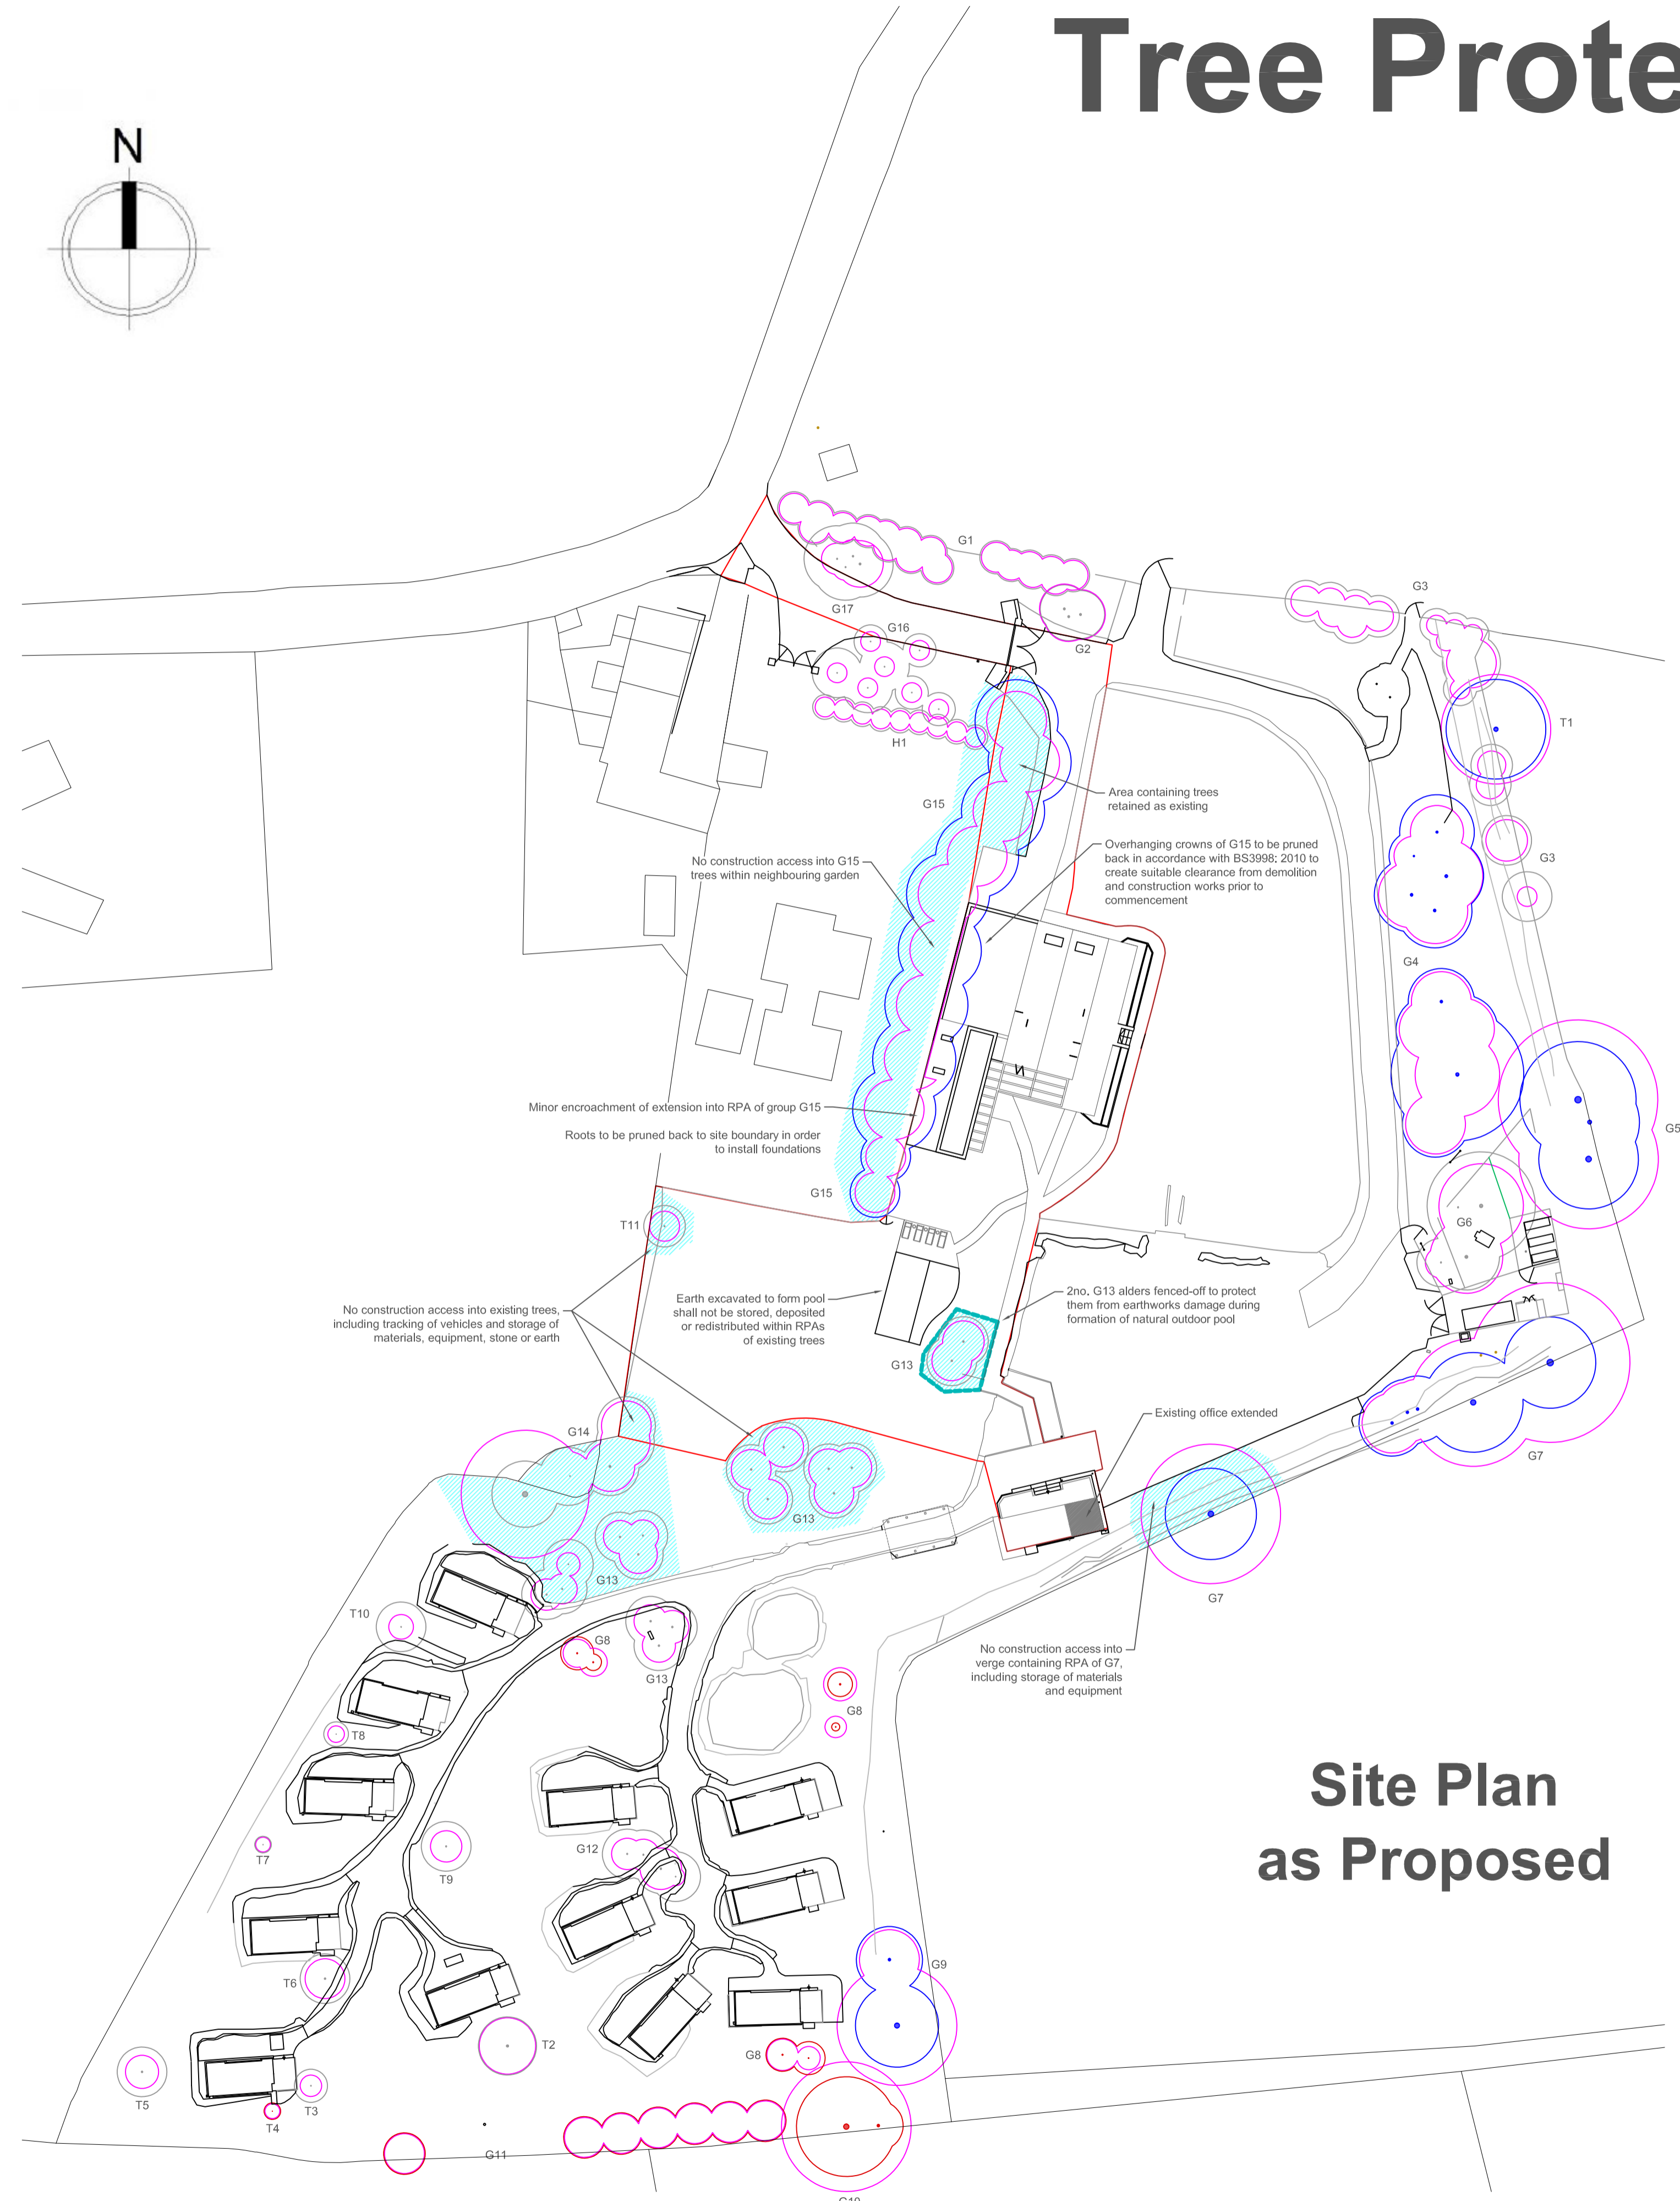
**Site Plan  
as Proposed**

Tree Survey Schedule Summary			
ID	Species	Cat.	Recommendation
T1	Oak	B	Retain
T2	Alder	C	Retain
T3	Pine	C	Retain
T4	Ash	U	Retain
T5	Alder	C	Retain
T6	Alder	C	Retain
T7	Cherry	C	Retain
T8	Birch	C	Retain
T9	Alder	C	Retain
T10	Osier	C	Retain
T11	Willow	C	Retain
G1	Native/ornamental mix	C	Retain
G2	3no. osier	C	Retain
G3	Native mix	C	Retain
G4	Native mix	B	Retain
G5	3no. alder	B	Retain
G6	2no. osier, 2no. hazel	C	Retain
G7	6no. alder	B	Retain
G8	6no. ash	U	Retain
G9	1no. alder, 1no. rowan	B	Retain
G10	2no. ash	U	Retain
G11	Elder, hawthorn, ash	U	Retain
G12	4no. alder	C	Retain
G13	17no. alder	C	Retain
G14	3no. willow	C	Retain
G15	Native/ornamental mix	B	Retain
G16	4no. apple, 3no. pear	C	Retain
G17	4no. birch	C	Retain
H1	Hornbeam	C	Retain
