Arboricultural Impact Assessment

Aisled Barn
Chatburn Road
Downham
BB7 4BN

May 2026

Job no.	LTC231
Site	Aisled Barn, Chatburn Road, Downham, BB7 4BN
Client	Downham Estate
Agent	Sunderland Peacock & Associates
Arboriculturist	Jennie Keighley PhD MSc MArborA
Local authority	Ribble Valley Borough Council
Date	6 May 2026
Issue	Final issue for planning

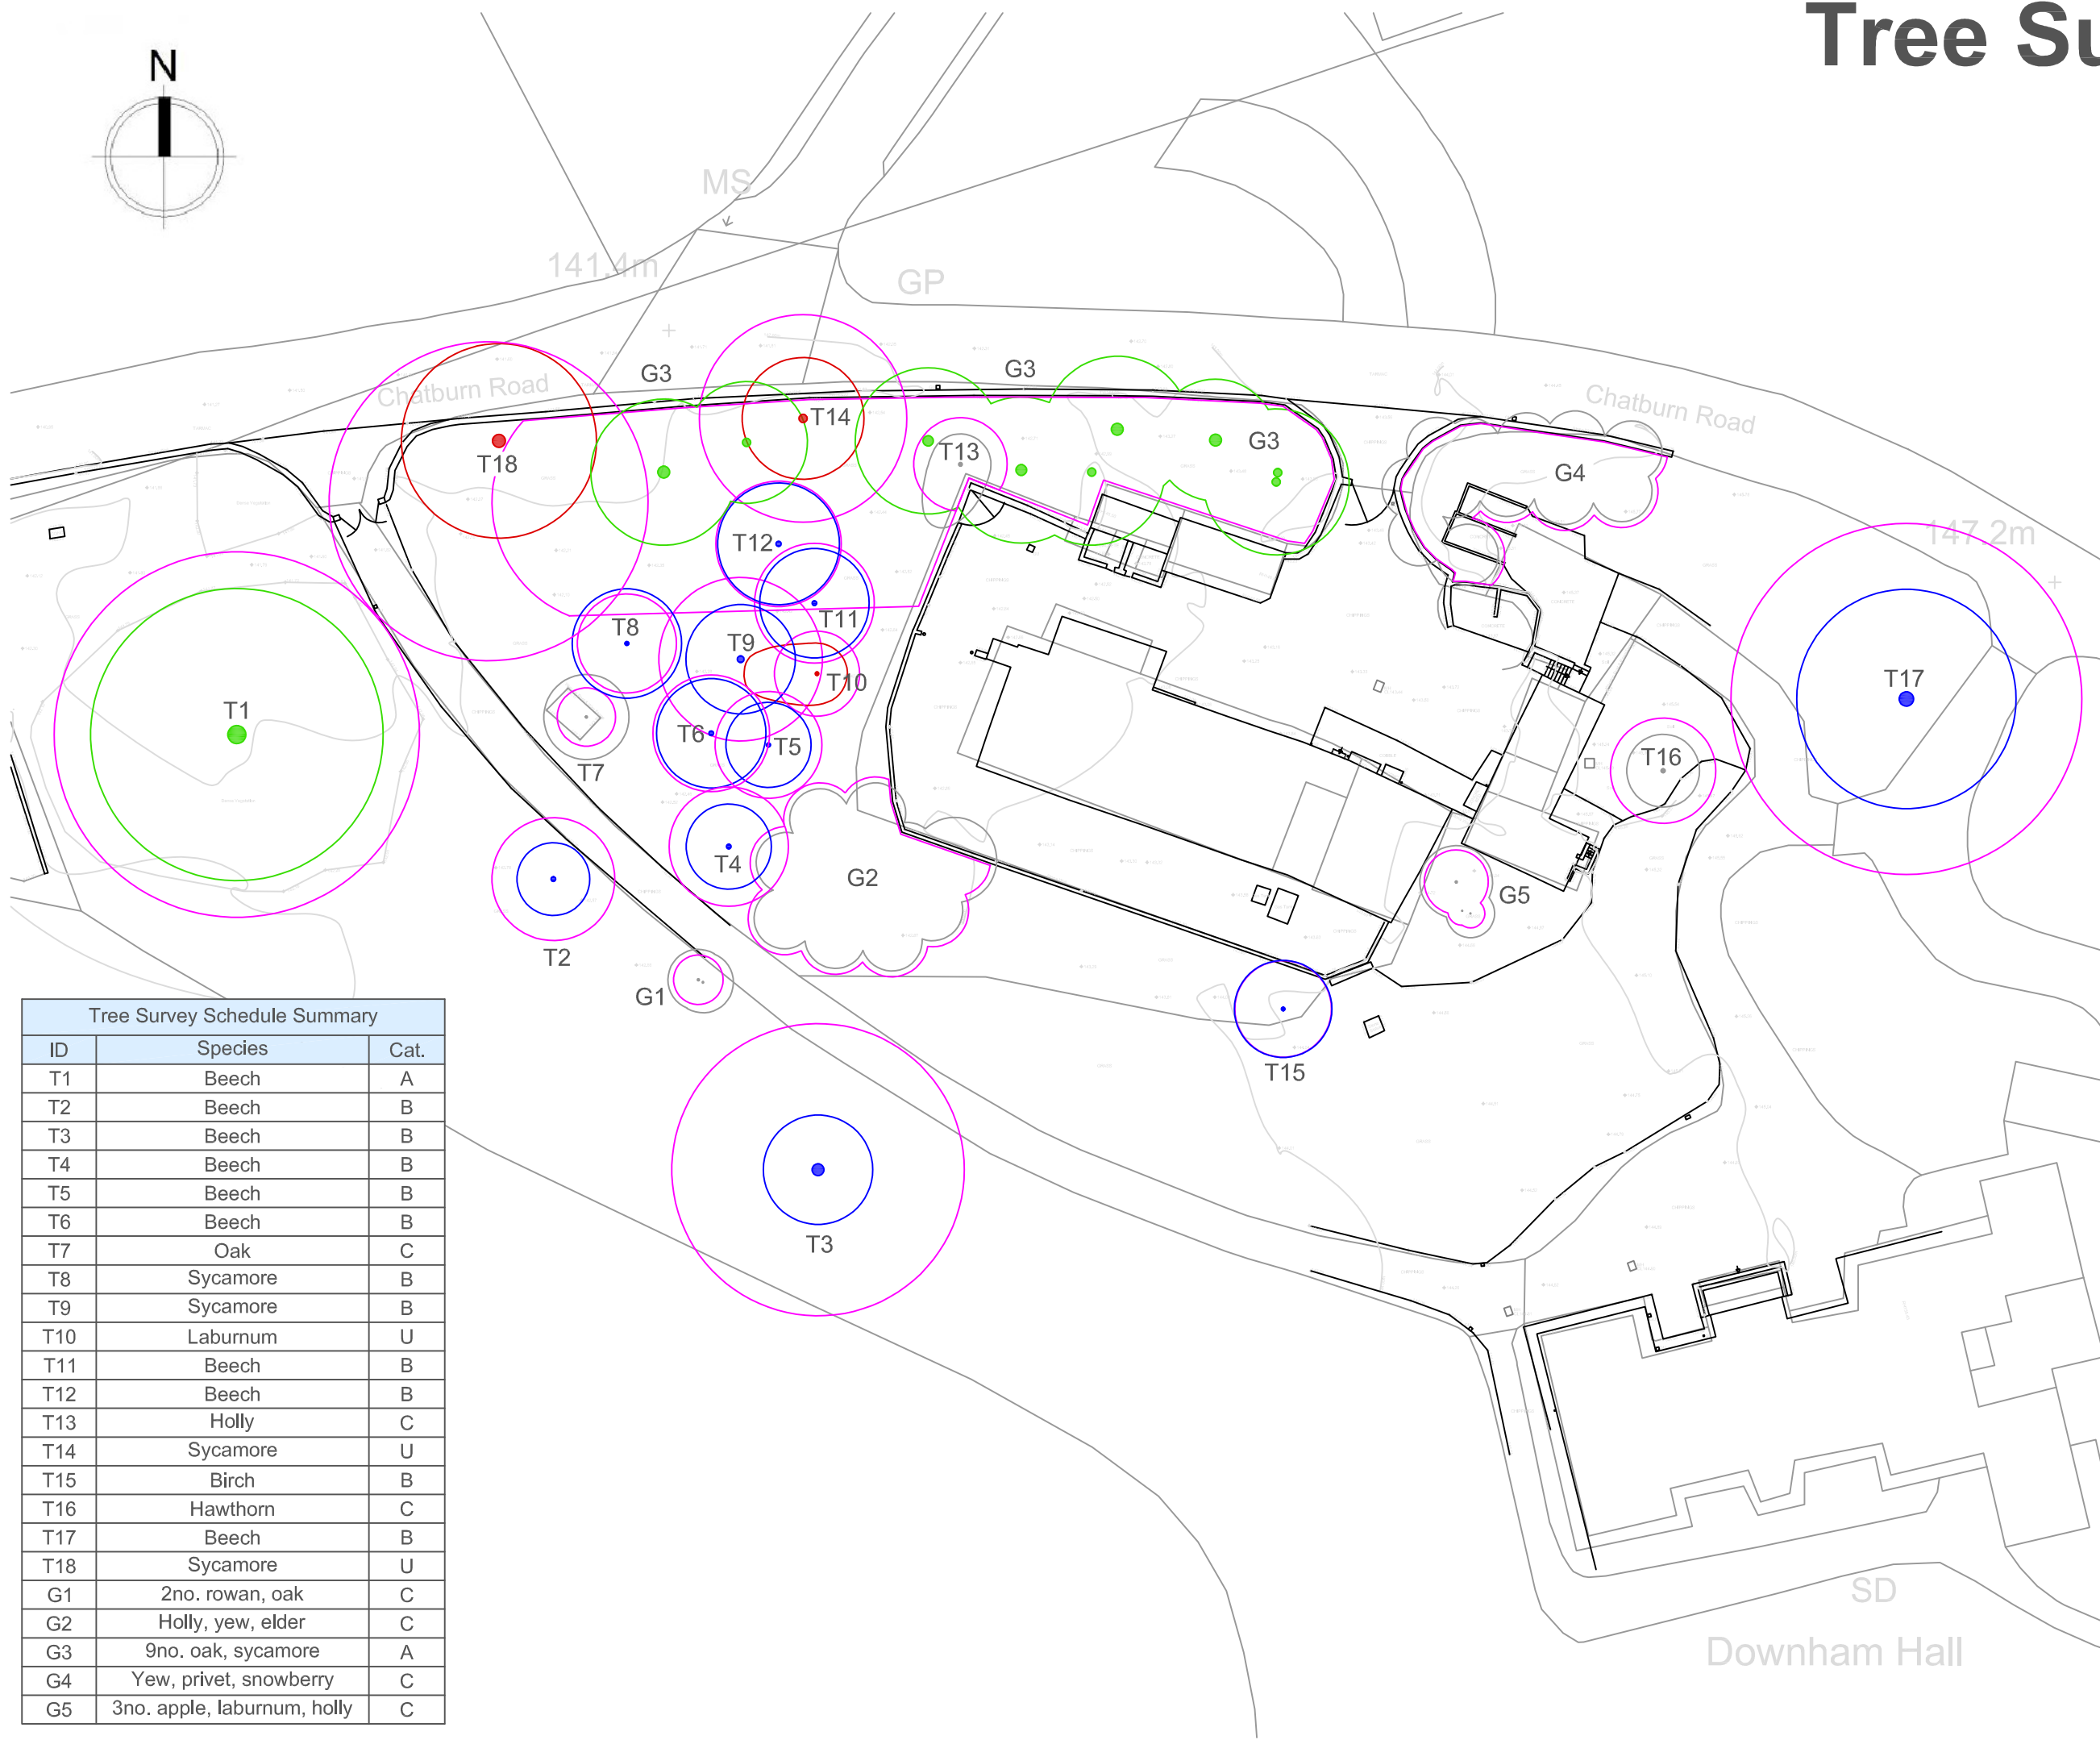
Tree Survey Plan

3.3 The BS5837 tree survey identified 18 individual trees and five groups of trees with potential to be impacted by the proposed development works. These were located both within the site and on areas of immediately adjacent land. The positions of the surveyed trees in relation to the existing site are shown on the appended Tree Survey Plan.

3.4 The retention value of the surveyed trees was categorised using the guidance given in Table 1 of BS5837 (2012), which is explained in the appended Tree Survey Schedule. One individual tree and one group of trees were categorised as high quality (A-category), 11 individual trees were categorised as moderate quality (B-category), three trees and four groups were categorised as low quality (C-category) and three trees were categorised as unsuitable for retention (U-category) due to their limited remaining life expectancies.

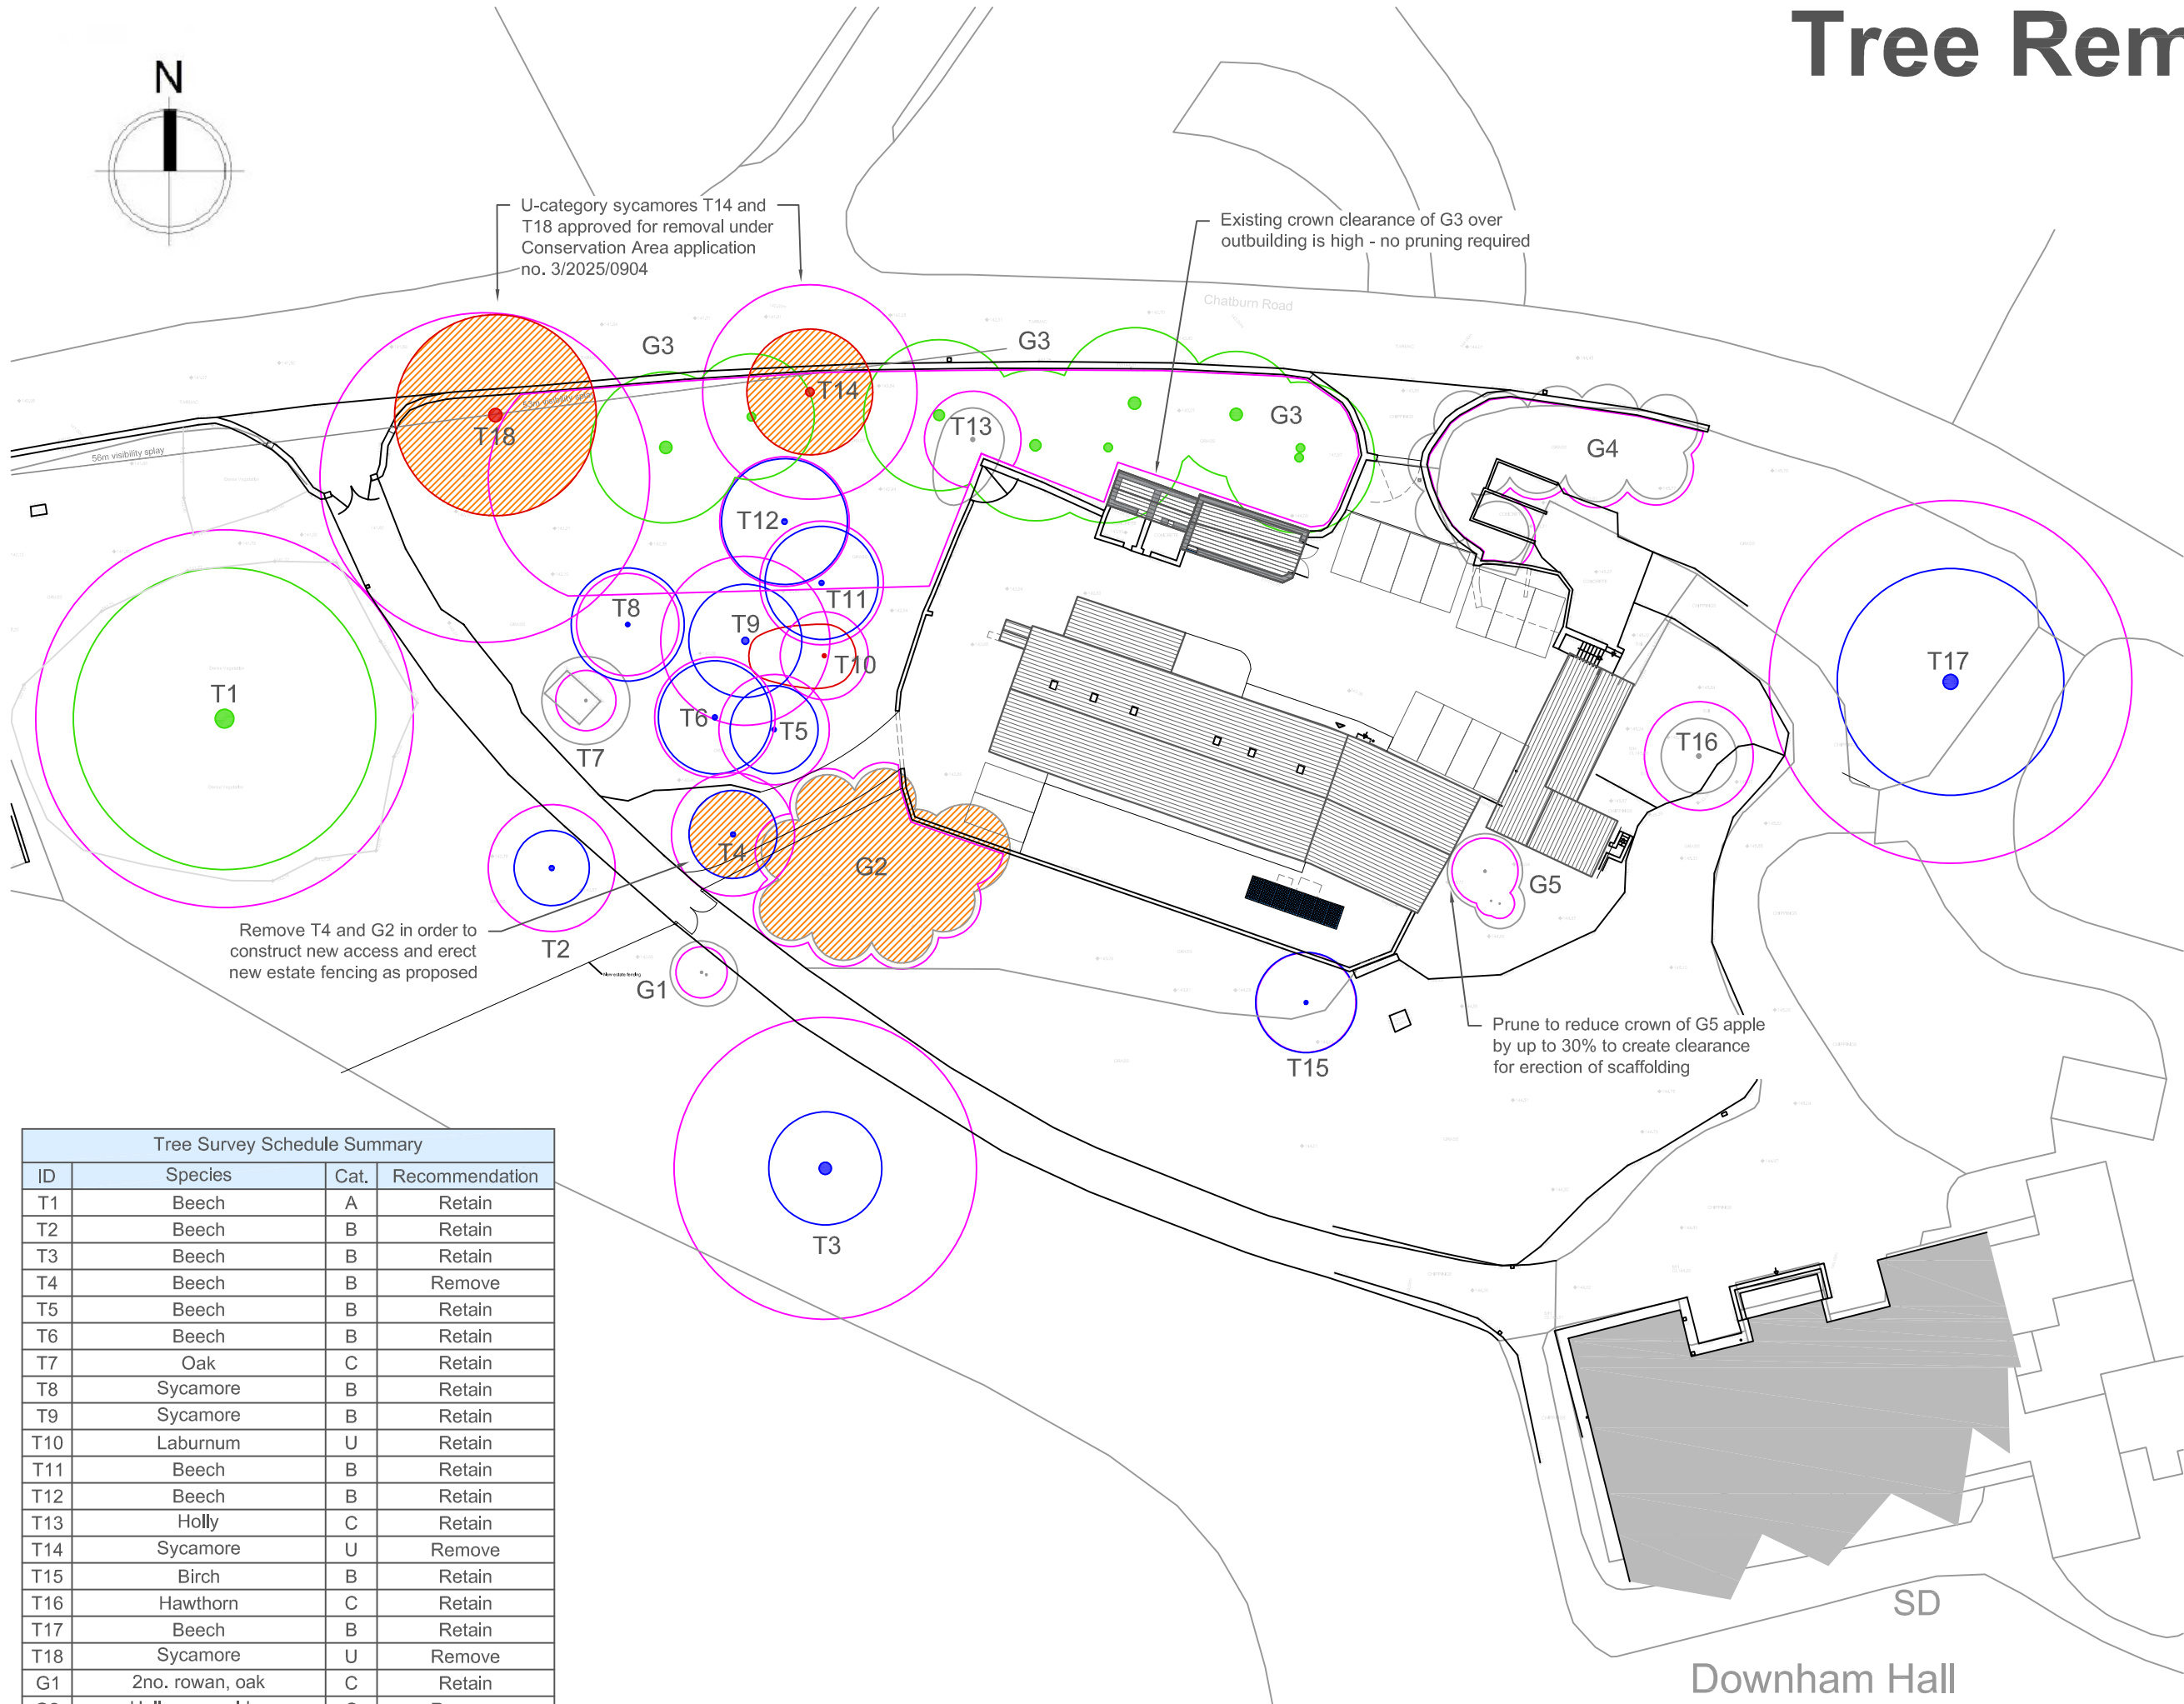
4.3 As shown on the appended Tree Removal Plan and in Table 1, below, construction of the development as proposed will require the removal of one moderate quality (B-category) tree and one low quality (C-category) group in order to construct the new site access and erect the new estate fencing as proposed.

ID no.	Species	BS5837 category	Recommendation
T4	Beech	B	Remove in order to construct access as proposed
G2	Holly, yew, elder	C	Remove group in full in order to construct access and erect estate fencing as proposed
Total tree removals			1no. B-category tree 1no. C-category group

4.5 A landscape area is proposed to the rear of the barn, which can accommodate new tree planting in order to compensate for the development-related tree losses. Further compensatory tree planting can be proposed across the wider Downham Estate, if required. The specification, delivery and aftercare of compensatory tree planting can be secured by means of a suitably worded condition attached to a planning approval and should be implemented in accordance with the British Standard guidance BS8545 (2014) *Trees: from nursery to independence in the landscape - Recommendations*.

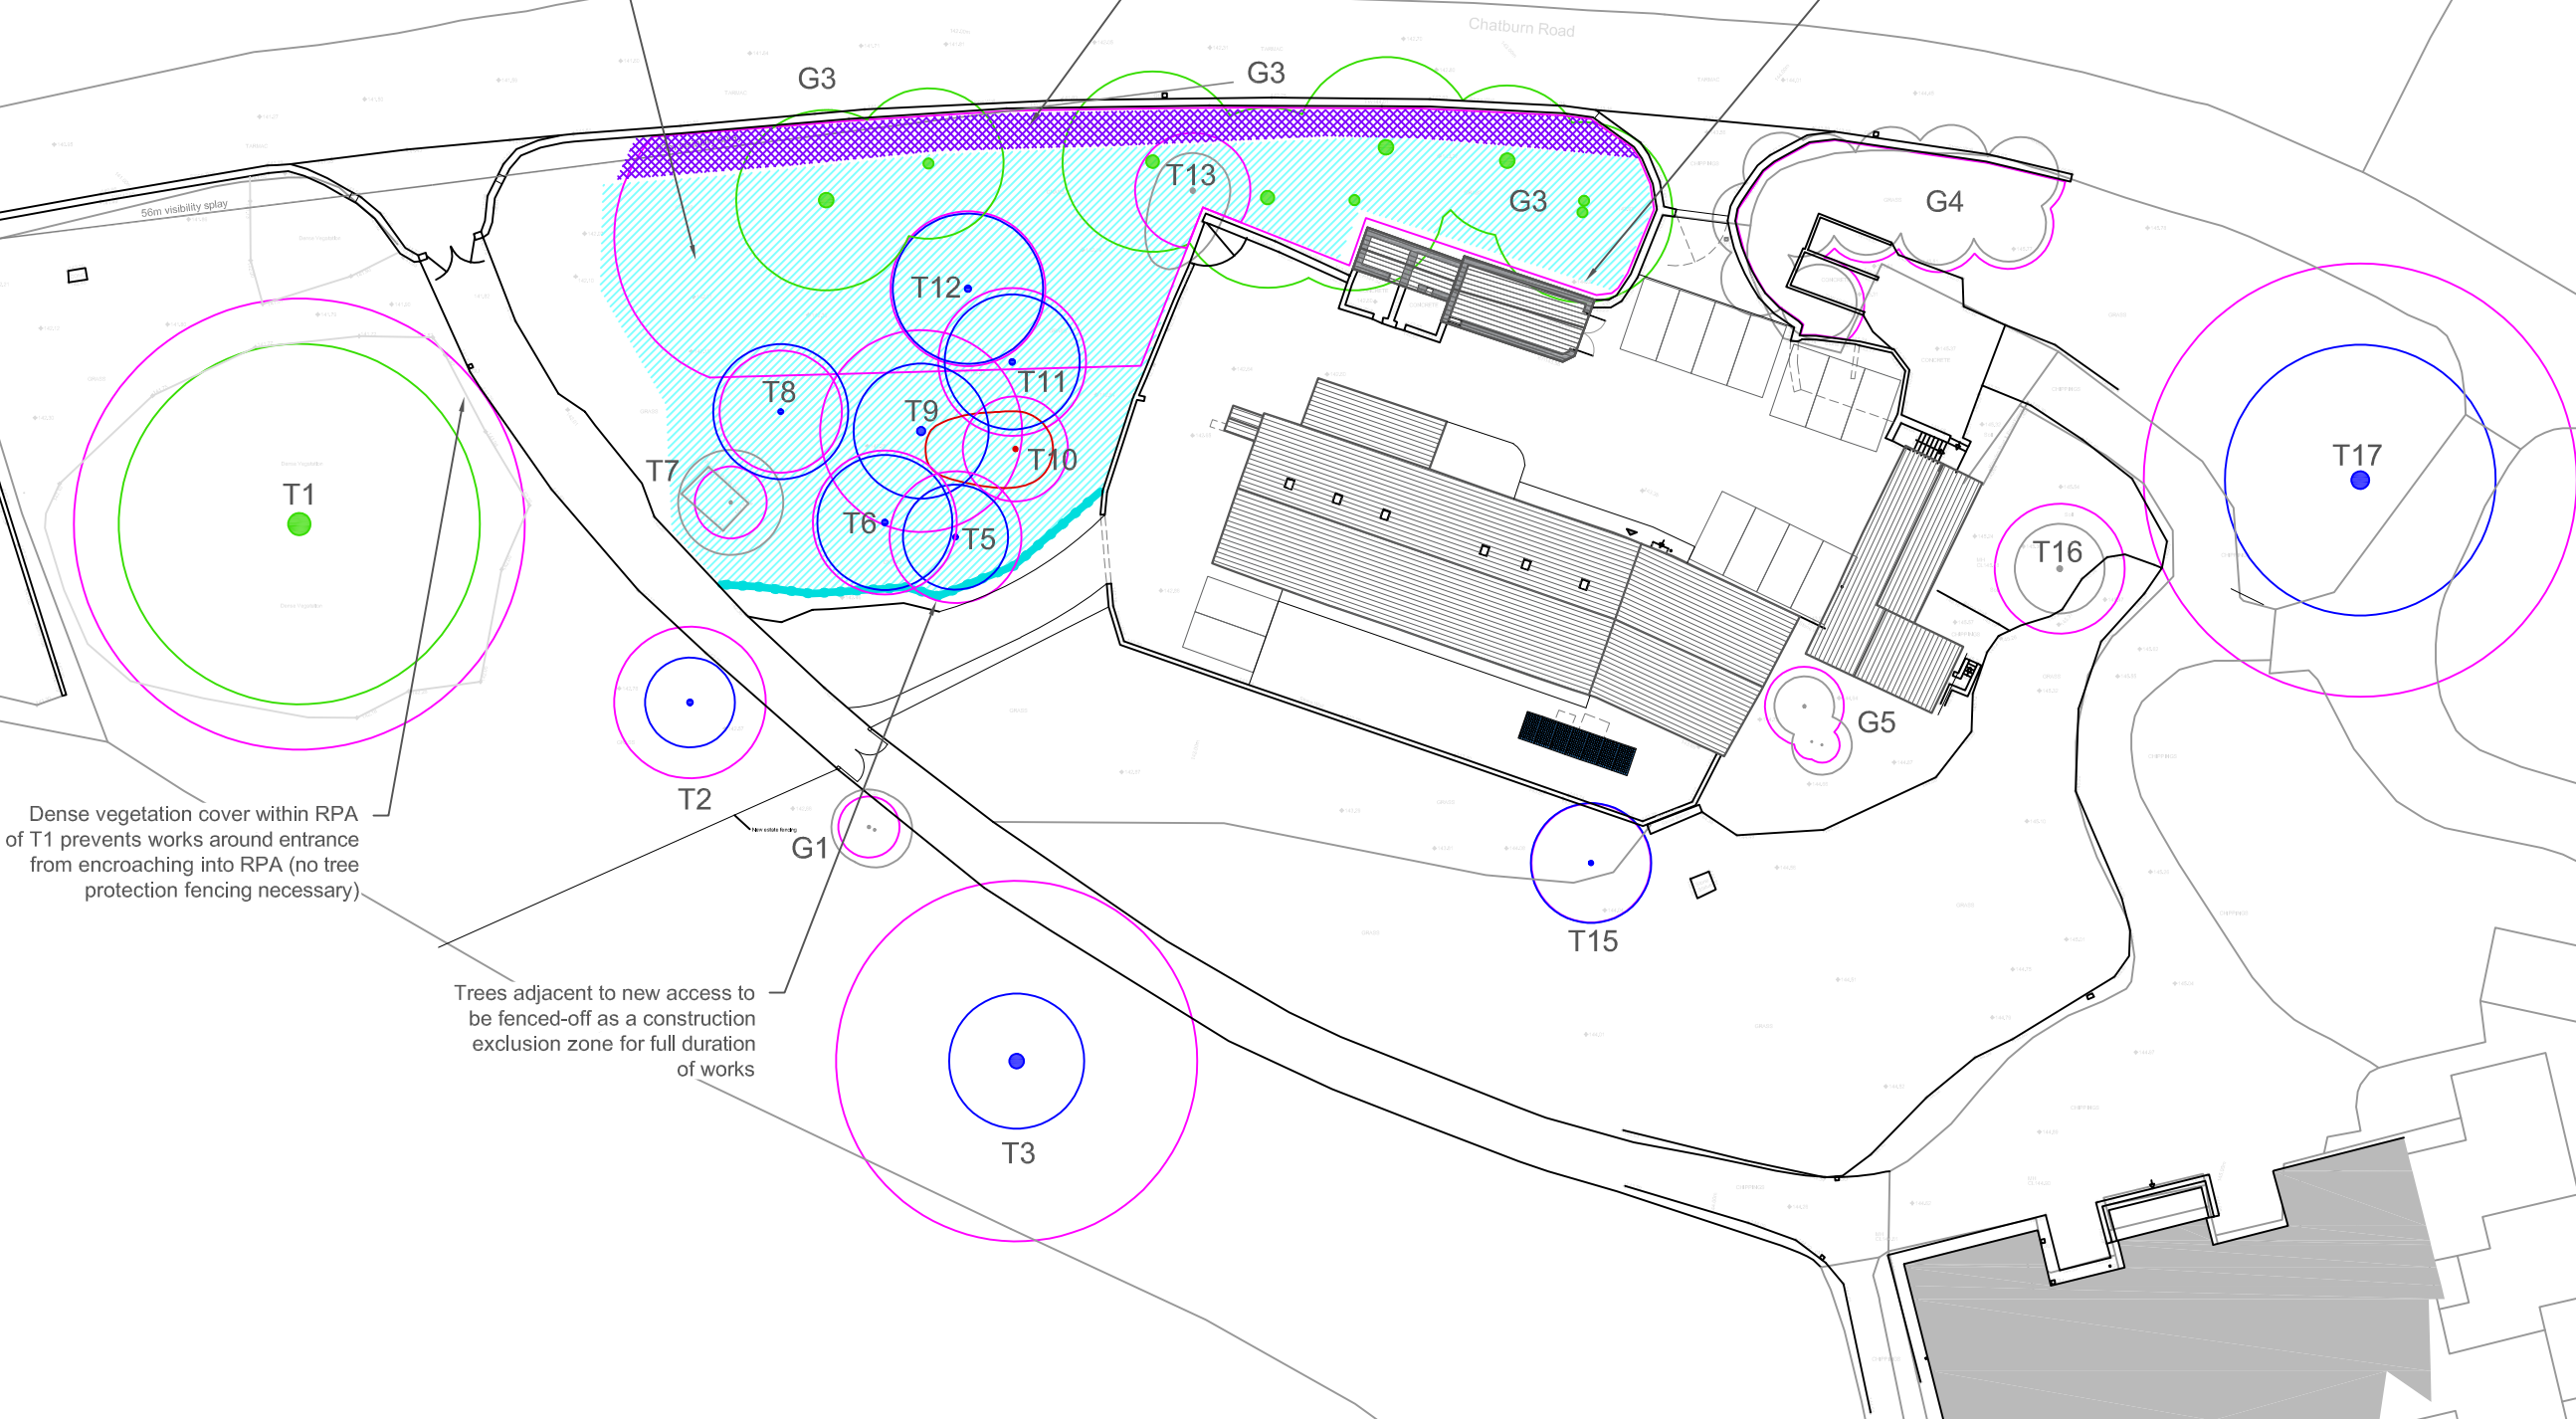
Tree Protection Plan

Dense vegetation cover within RPA of T1 prevents works around entrance from encroaching into RPA (no tree protection fencing necessary)

Trees adjacent to new access to be fenced-off as a construction exclusion zone for full duration of works

There must be no construction access within the construction exclusion zone shown in blue, including tracking of vehicles or machinery, storage of materials, equipment, stone or earth, or repeated foot traffic

Access into group G3 for lowering of the front boundary wall shall be restricted to foot traffic only

There shall be no tracking of vehicles or machinery within group G3

The area shown purple shall be covered with ground protection to prevent soil compaction and associated root damage

Ground protection shall comprise a geomembrane base layer topped with a compressible layer of woodchip or similar, on top of which plywood sheets, scaffold boards or similar shall be laid

There must be no construction access within group G3 during conversion of outbuilding, other than for the erection of scaffolding, if required
