**THORNBERS, SLAIDBURN ROAD,  
WADDINGTON BB7 3JJ**

**FLOOD RISK ASSESSMENT**

**PROPOSED GARAGE**

Project Ref: 26.10  
Client: Mick and Katy Frankish  
Date: July 2026

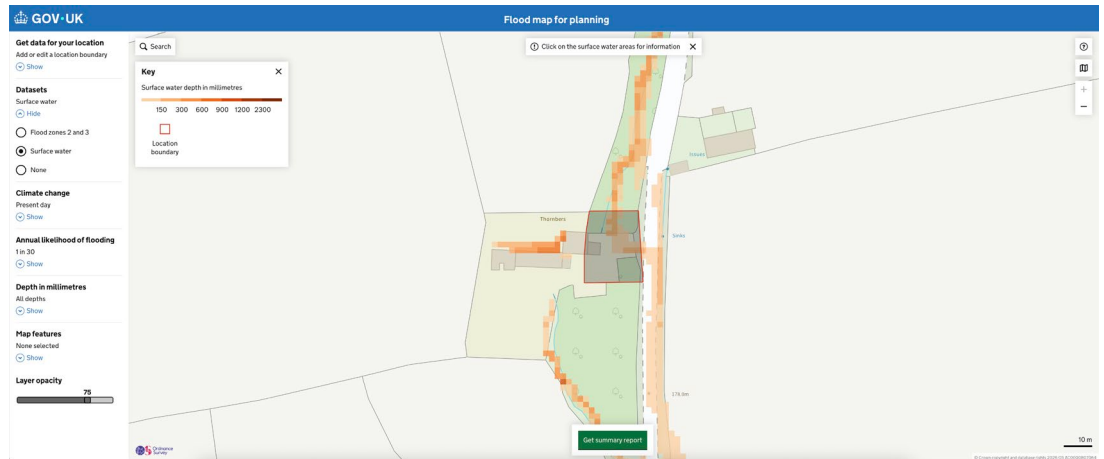
Fig. 2 Surface Water Map

EA Long Term Flood Risk Service (surface water layer) identifies a medium to high surface water flood risk across parts of the application site. This is consistent with anecdotal evidence from the applicant. See map extract below.

Surface water depths in the range 150 - 300mm are indicated within the application boundary in the area of the current site entrance and along the watercourse corridor running diagonally through the eastern part of the site (consistent with the culverted stream shown on Drg.No. 2610/ex.01).

Depths of 300 - 600mm are shown along and immediately adjacent to the watercourse corridor itself - the most constrained section of the drainage path through the site.

A secondary zone of 150 - 300mm depth extends more broadly across the lower part of the curtilage, consistent with overland hillside flow concentrating toward the watercourse.

Slaidburn Road to the east shows significant surface water accumulation, suggesting the road acts as a collection point for flows from this hillside. This is relevant to the design of the garage access and drainage outfall.

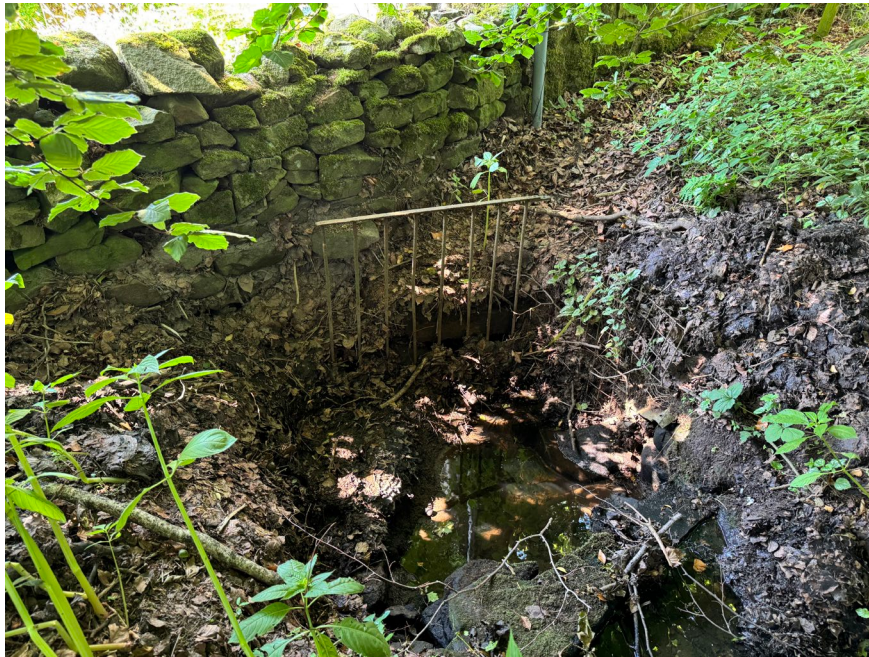
The culvert is stone built probably dating back to when the property was a farmstead. It is approx 600 mm wide and 400 mm tall and accesses the site below the stone wall with a metal guarding to reduce risk of blockages within the culvert.

Fig 3 North end of culvert

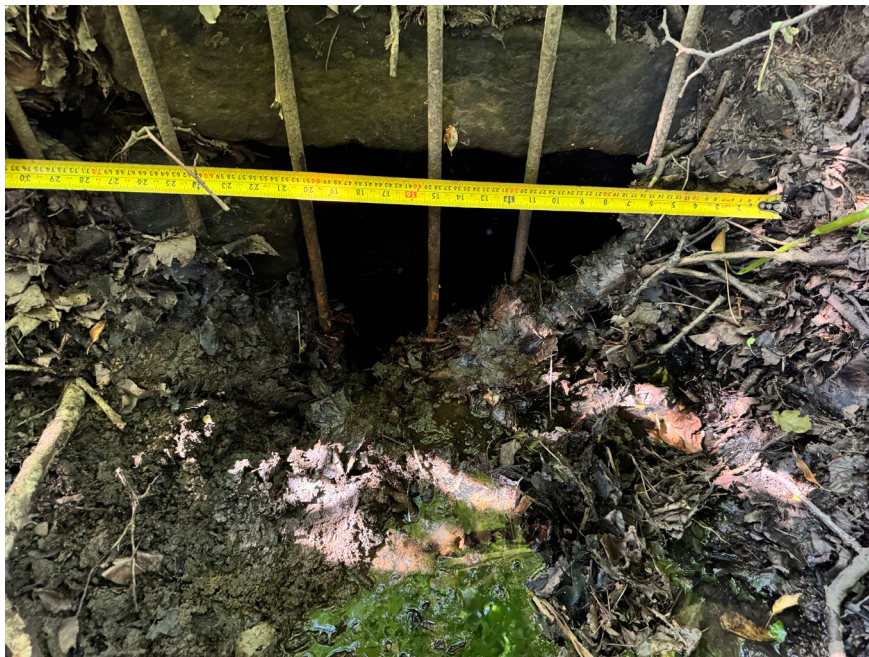
Fig 4 Width of culvert

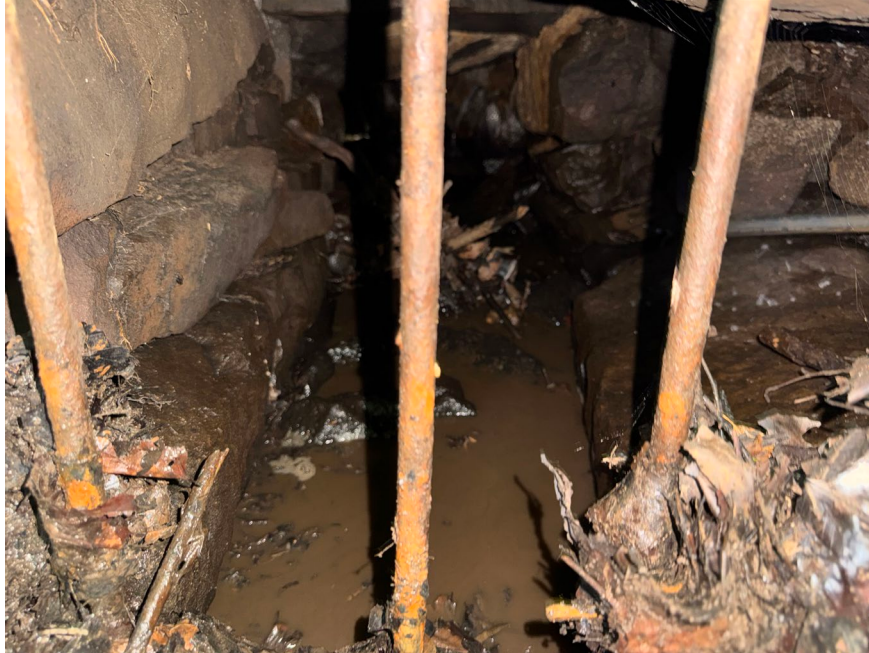
Fig 5 Tree roots and stones form obstructions within the culvert.

From our discussions with the applicant and our investigations on site (we have not tried to investigate beyond what we can see from the entrances to the culvert) we believe the flooding is due to localised blockages at the North entrance due to a build of vegetation/sediment etc rather than a lack of capacity.

The intention is to remove the culvert and bank reprofiling to renaturalise the watercourse for 4m approx, in addition to the reduced culvert length it also allows us to partially remove the stone wall as well as bringing the entrance to the culvert into the garden to a point where it can be seen in passing daily whilst also allowing better access and mechanical clearing of the watercourse if required without impacting on the trees.

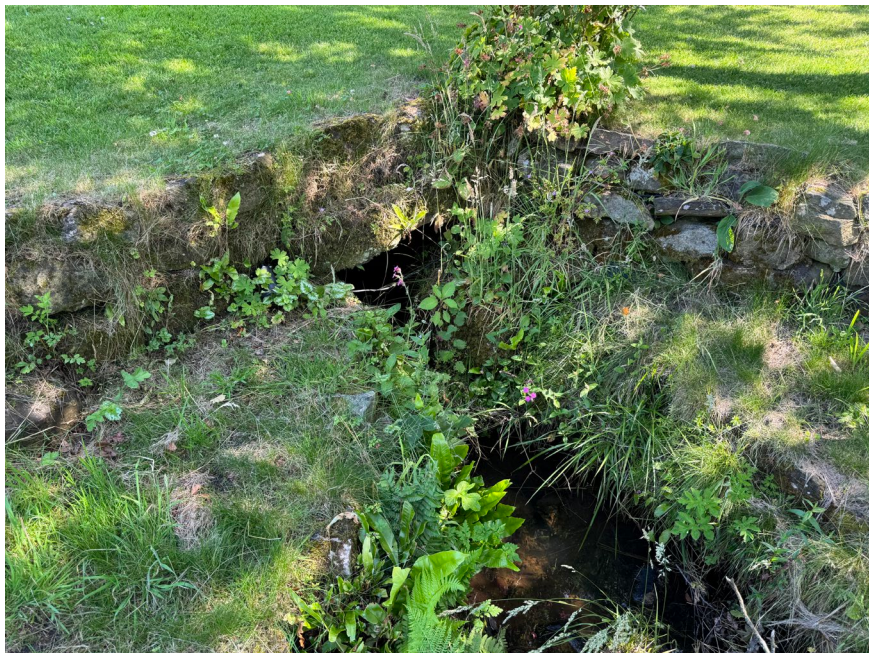
Fig 6 South end of culvert within the garden, opening width has reduced to 400mm
