**ARBORICULTURAL REPORT
AND
ARBORICULTURAL IMPACT ASSESSMENT
to BS 5837:2012
at land off
Kenyon Lane
Blackburn
Lancashire
BB6 8AN**

Client:
Craven Design
Partnership

JCA Ref:
14824/PH

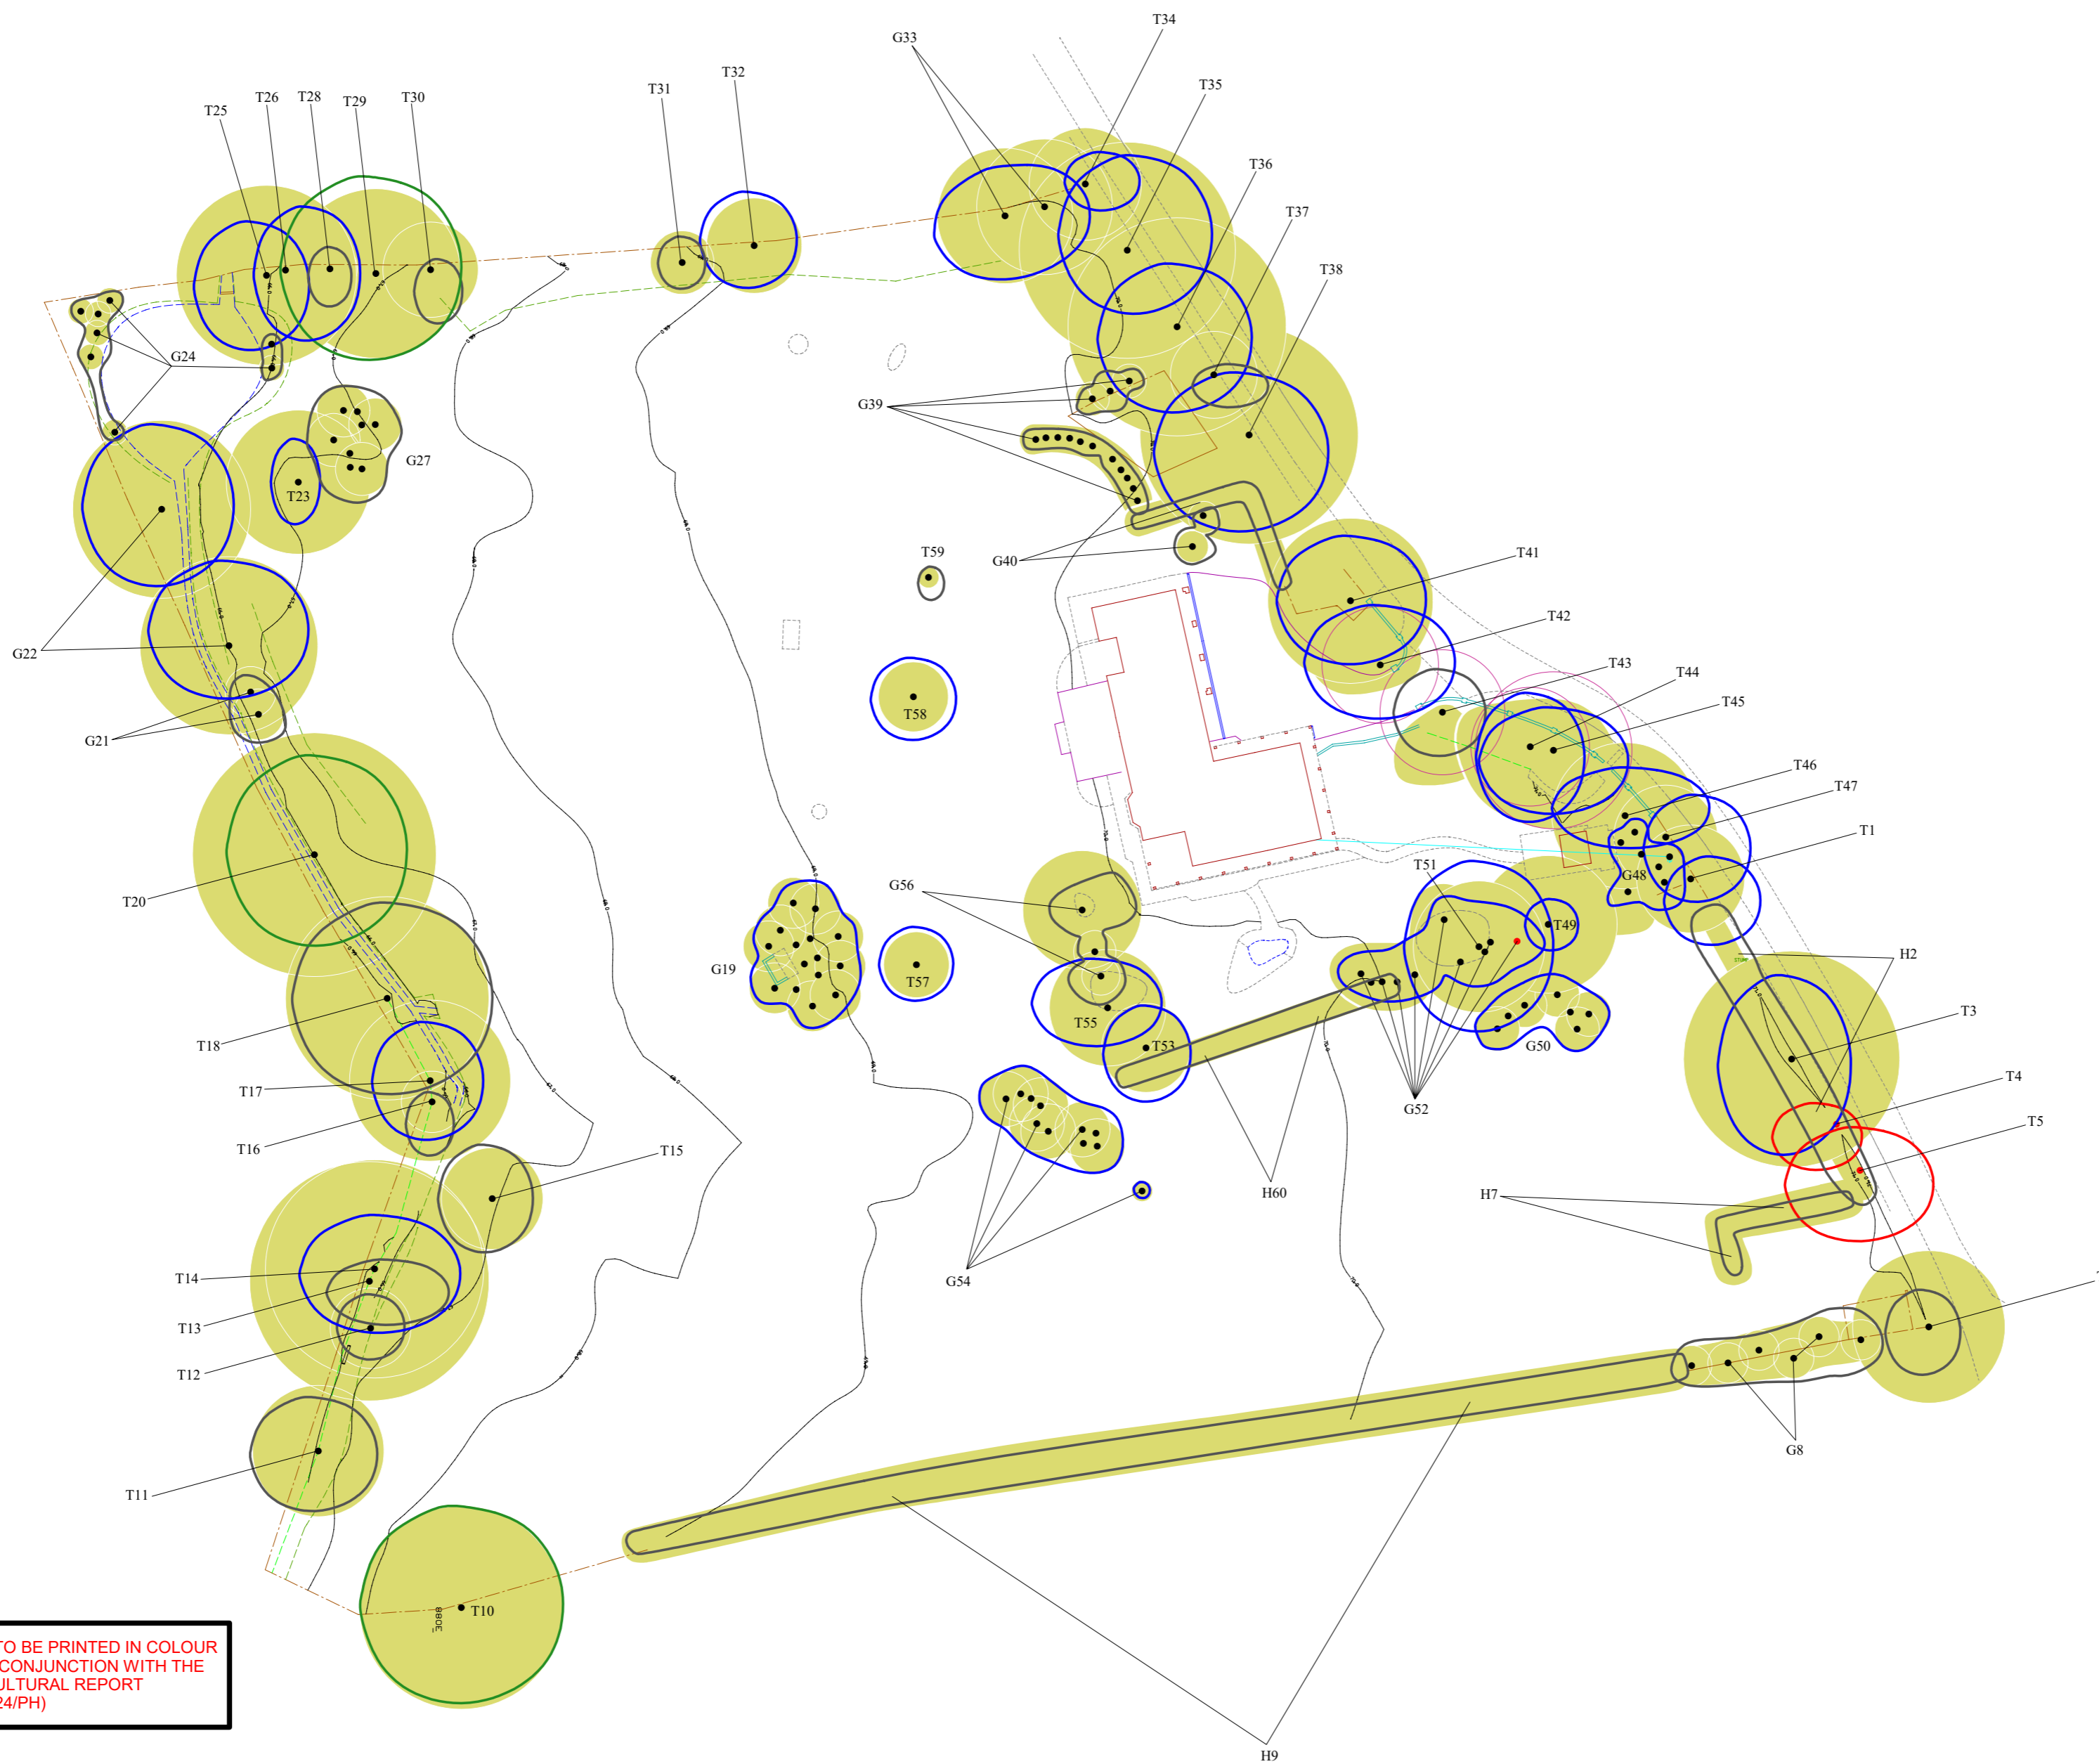
Appendix 6: Tree Constraints Plan

- 4.1 Full details of all individual trees surveyed are recorded in the tables at **Appendix 1**. A full explanation of the tables can be found at **Appendix 2**. Please refer also to the Tree Constraints Plan at **Appendix 6** for tree locations.

- 5.2.1 **Two** trees (**T4** and **T5**) were identified as retention category 'U'. These trees require removal because they pose an imminent health and safety risk.
- **T5** is unsafe and should be removed as soon as it is reasonably practicable; its removal is of **highest priority**.
 - **T4** has been recommended for removal to prevent it from becoming dangerous; its removal is of **moderate priority**.

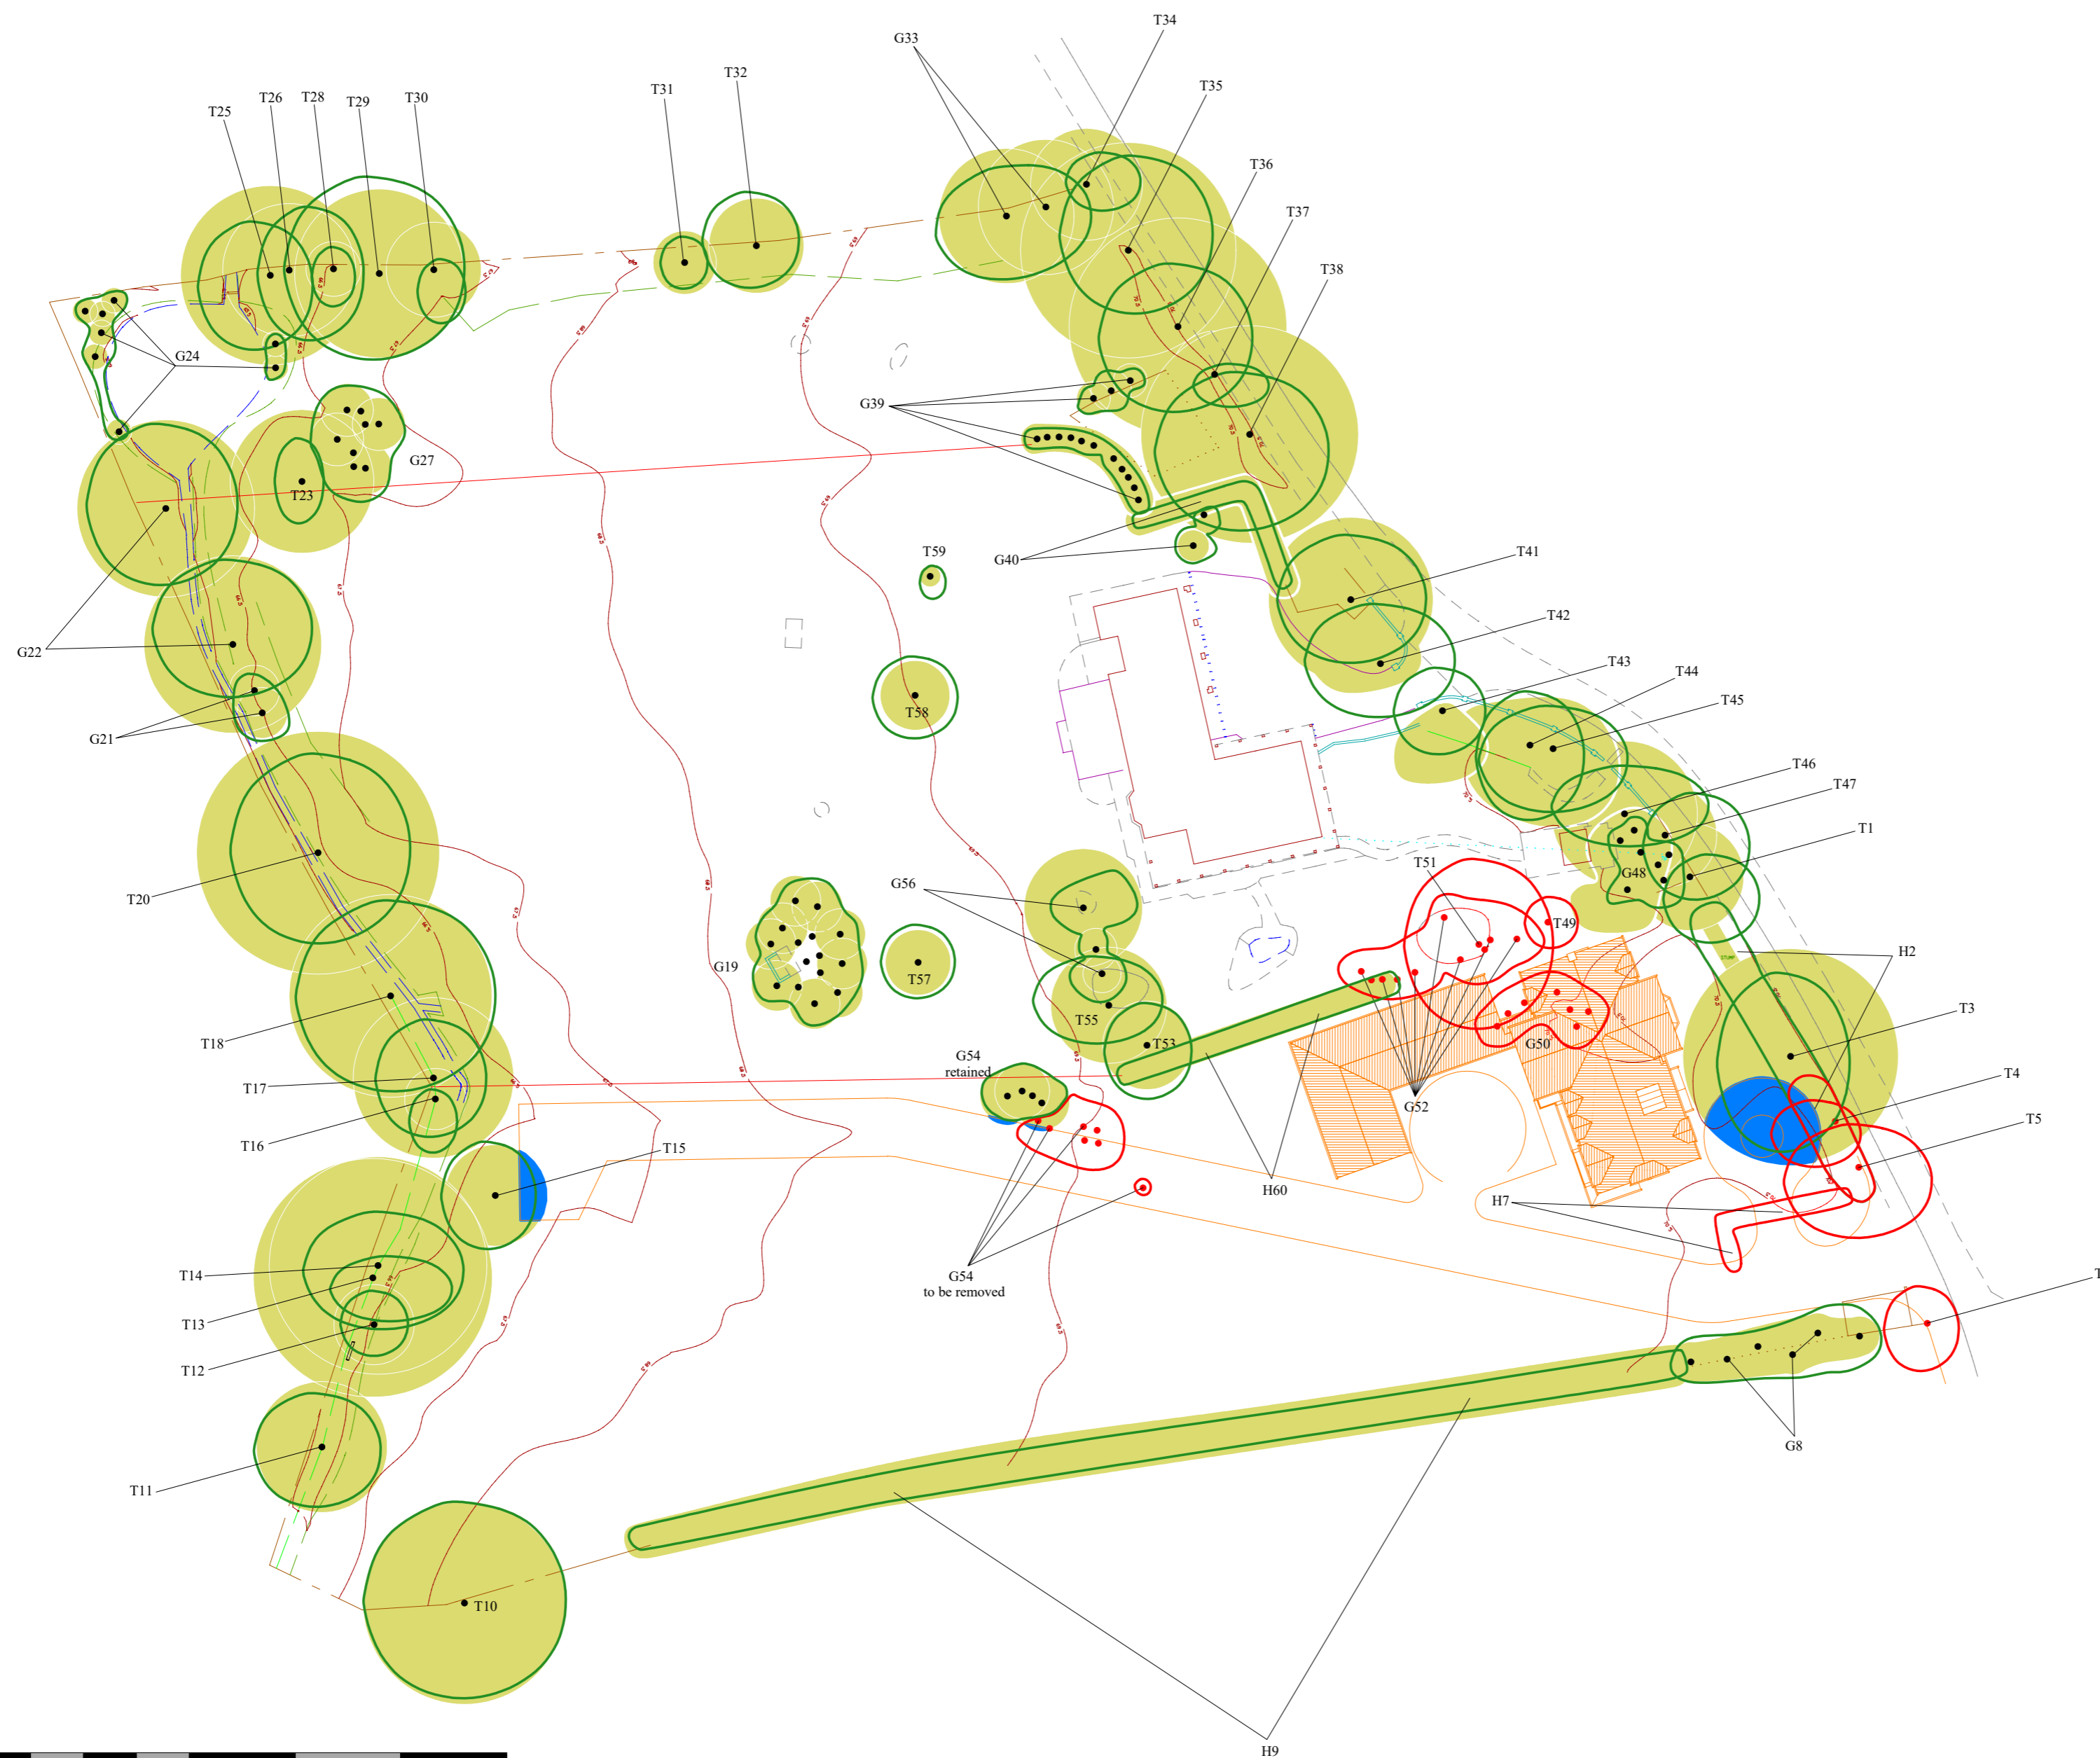
Appendix 7: Arboricultural Implications Plan

- 6.4.2.2 In order to prevent foreseeable damage to tree roots, a 'no-dig' method of construction will be utilised for the turning circle. This is relevant to **T3**.

- 6.4.2.4 Proposed hard surfacing is located within the RPA of **T15** and **G54**. Due to the minimal nature of the incursion, it is not considered necessary to install specialised surfaces. Instead, root pruning will be undertaken under the supervision of an appointed arboriculturalist to minimise potential damage to tree roots and prevent 'ripping' damage, which is commonly associated with mechanical excavation.

- 6.4.4.2 The footprint of the proposed residence borders the predicted RPA of a mature tree (T3) which is to be retained. Due to this, a specialist foundation design may be required. This must reduce excavations and reduce any detrimental impact this can have on tree roots (minimum diameter piles or pad and beam).
