BAT SURVEY

AT
The Moorcock inn
Waddington
Clitheroe
Map ref. SD 720467

DATE AND TIME OF VISIT
14th June 2014 9.15pm -1 hour after dusk

REFERENCE NO. 4512

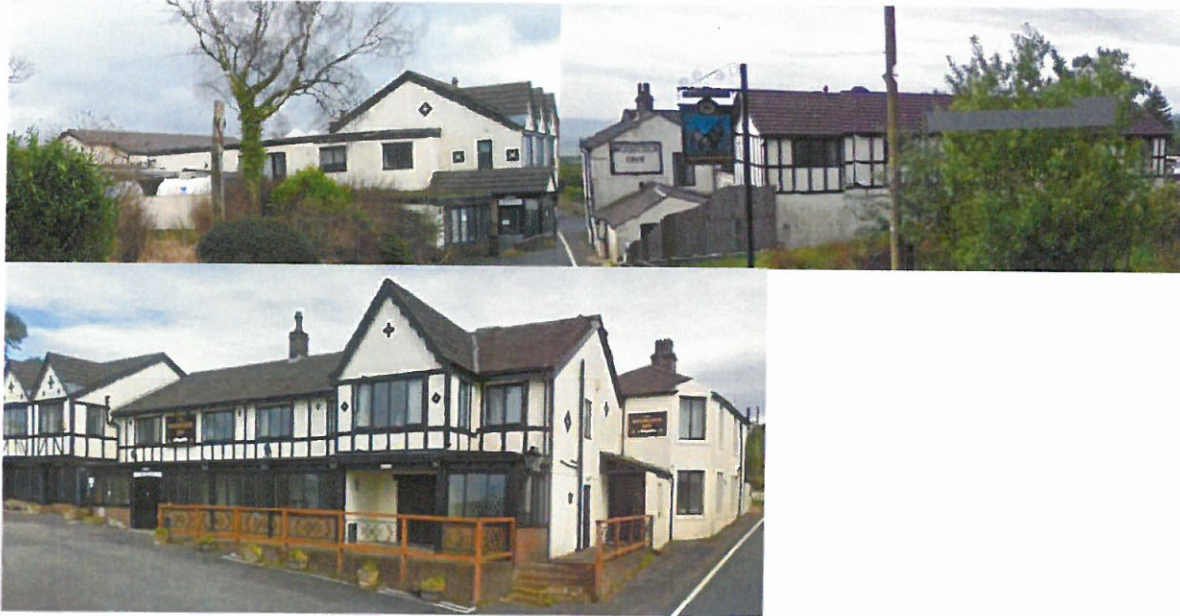
COMMENTS: The original Public house building has been extended over the years to include a function room. The building has been closed a number of years and has deteriorated significantly.

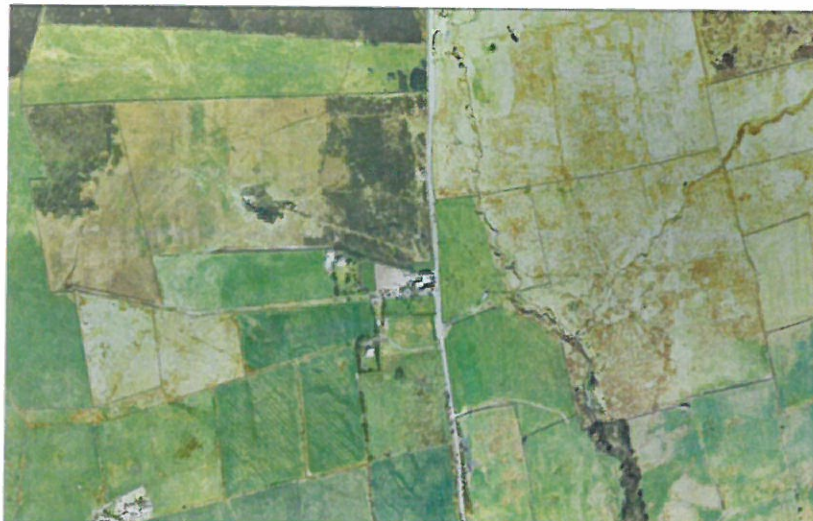
COMMENTS: The public house is remote from the village of Waddington located next to Fell road at 250m above sea level. A detached house is located approx 100m to the North west of the Moorcock.

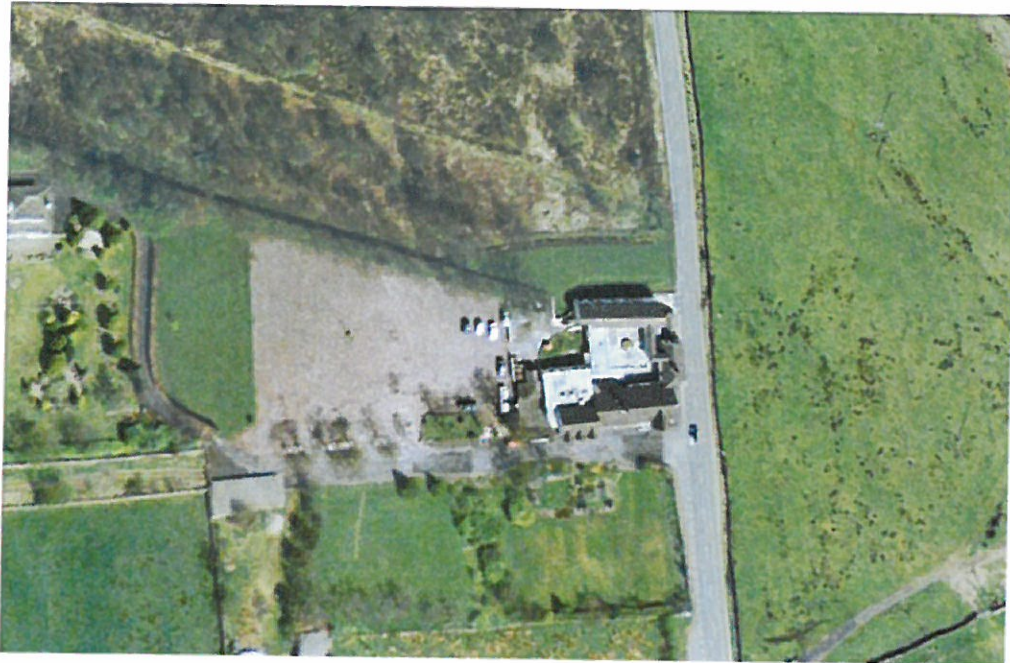
COMMENTS: The land to the east of the road is moorland and pasture land to the west. A plantation of trees extends from the rear (north) of the pub forming the rear boundary of the site in a westerly direction towards the detached house. Mature trees line the lawned areas to the front (south). Scattered garden shrubbery forms the garden boundary of the nearby house. See below. The nearby roosting and foraging potential moderate to the west, low to the East.

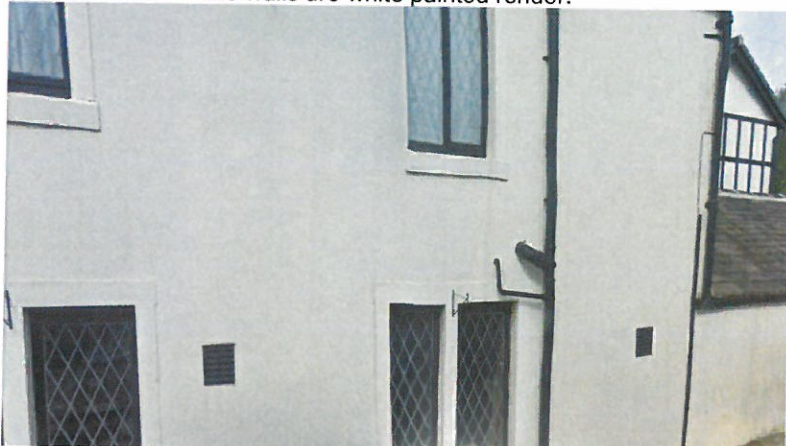
Wall adjacent to Fell road

COMMENTS: The walls are white painted render.

COMMENTS: There are no access points in the walls, however a number of windows have been broken on the west elevations allowing free access to the interior.

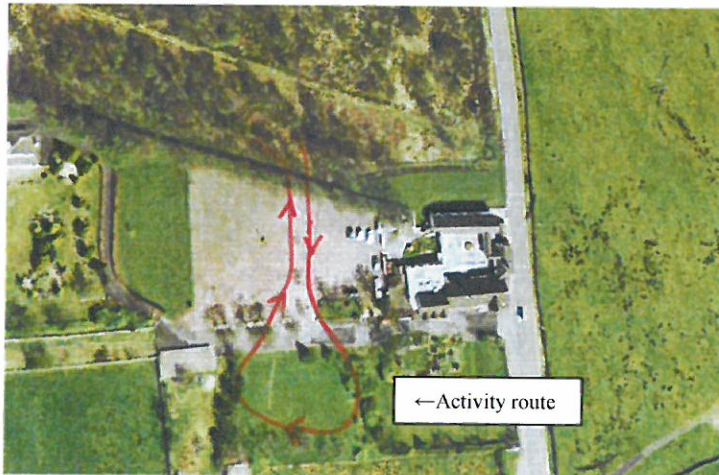
COMMENTS: Low level Pipistrelle activity was recorded starting at 9.45 pm they emerged from the plantation of trees to the north and travelled south over the car park to forage in the trees in the front garden areas. No emergence from the building was recorded. See below
