# Arboricultural Impact Assessment

in Respect of Proposed Development of 7 Residential Properties at

Moorcock Inn, Slaidburn Road,  
Waddington, Lancashire, BB7 3AA

ARBORICULTURAL IMPACT ASSESSMENT	
Site:	Moorcock Inn, Slaidburn Road, Waddington, Lancashire, BB7 3AA
Proposal:	Residential development of 7 units
Survey Date:	19 September 2013
Report Date:	26 June 2014
Prepared By:	Phill Harris – Chartered Arboriculturist
Report Ref:	BTC544
Agent for Client:	Sunderland Peacock & Associates Ltd

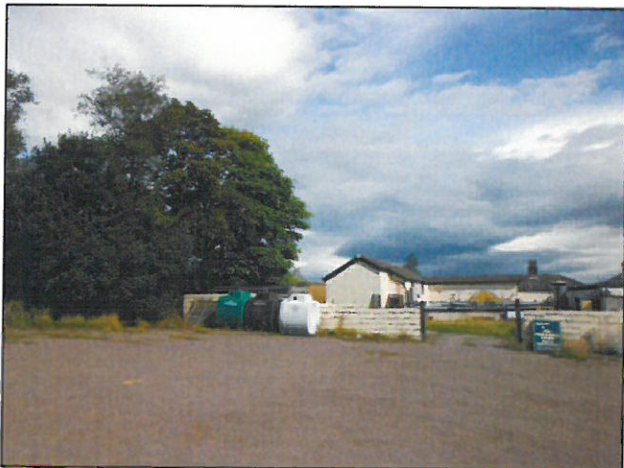
Fig 1: Eastern section of the site, looking east

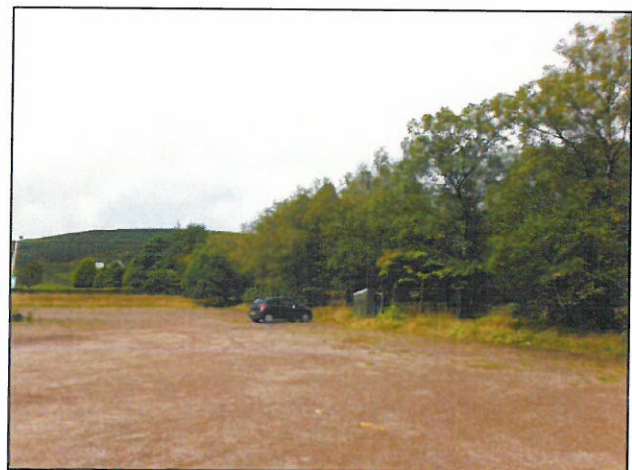
Fig 2: The western section of the site, looking west
