BAT, BARN OWL & NESTING BIRD SURVEY AT

Old Garage Site, Dunsop Bridge

Author	Flora Whitehead	Date	22/2/22
Checked by	Andrew Gardner	Date	23/2/22
Report Version	1		
Field data entered	<input type="checkbox"/>		
Report Reference	7794

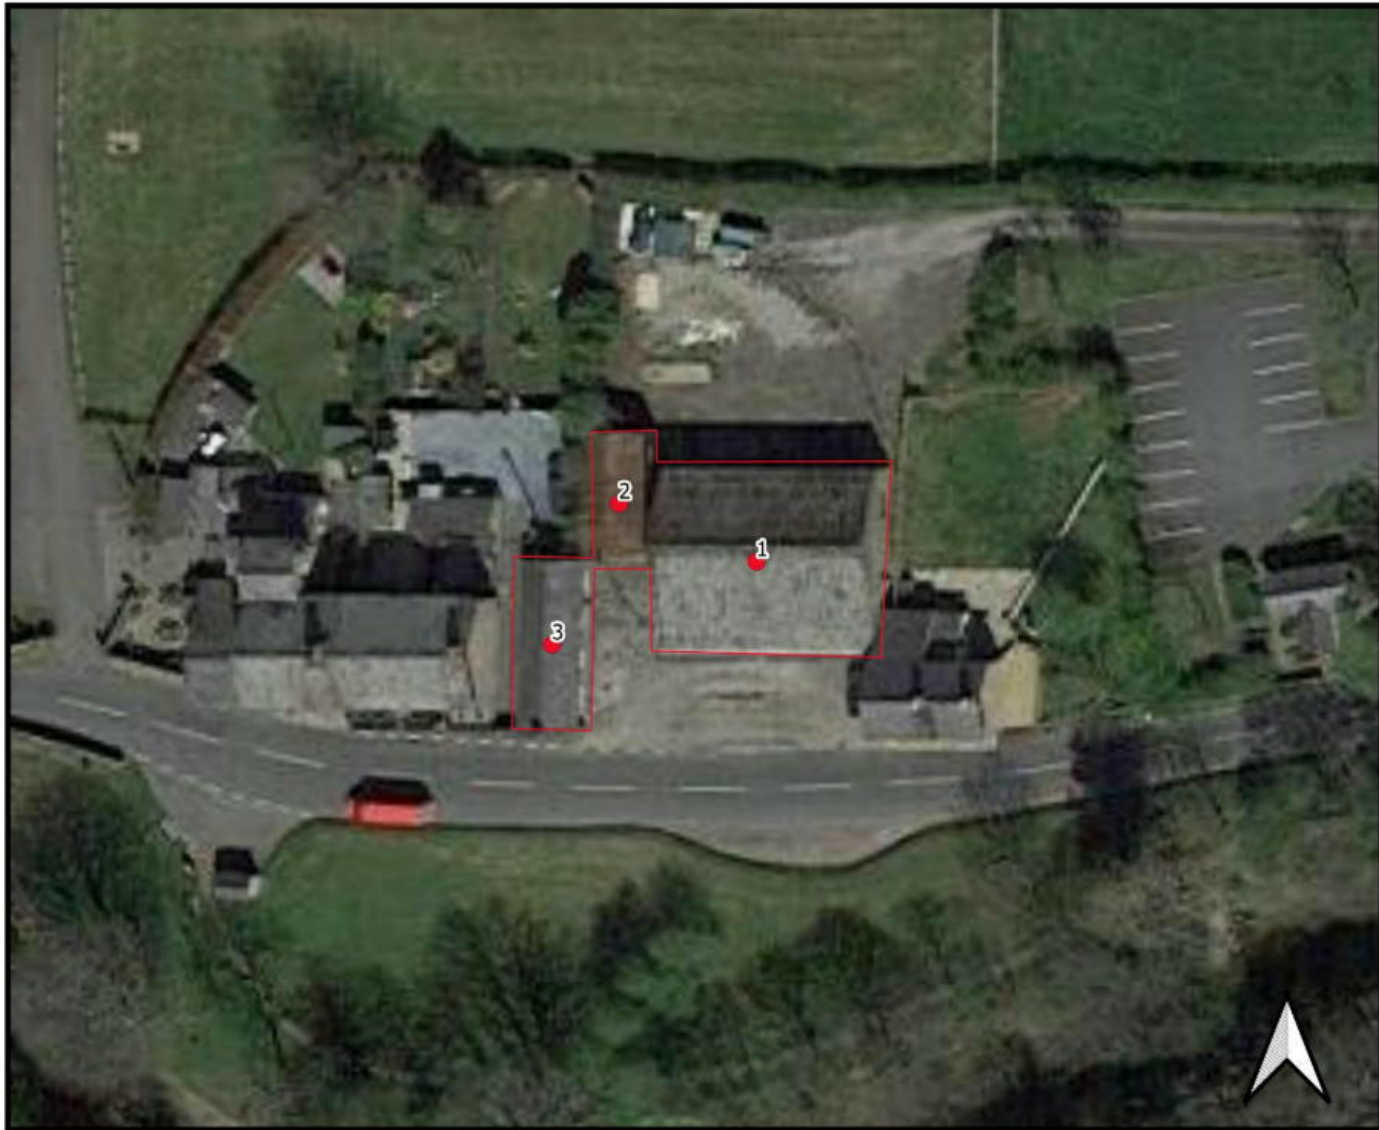
Figure 2
Site Boundary

- Site Boundary
- Building Number

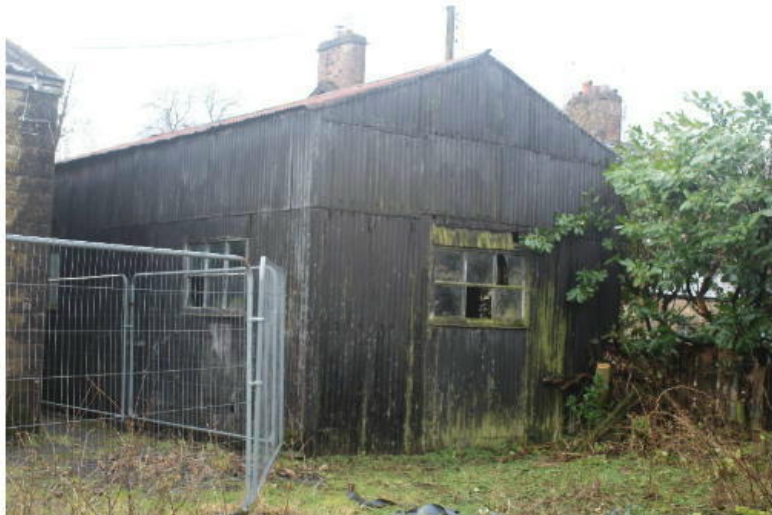
Building 2

The walls of the building are made from a single layer of corrugated metal. There are occasional gaps between the sheets, and large gaps where glass panes are missing from windows. These offer possible access but no roosting potential. Shrubs conceal the west elevation. No signs of bats were found.

Metal walls with open gaps in windows

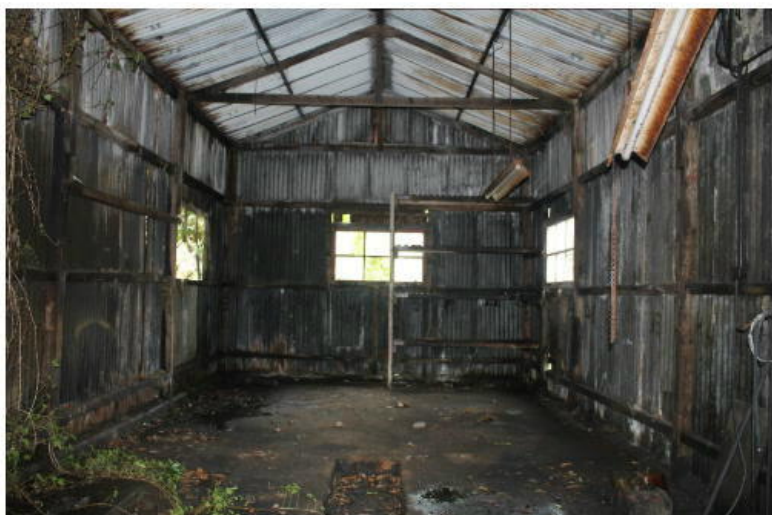
There was no roof void. The timbers beams in the roof were found to be in moderate condition with no rot, splits or gaps suitable for roosting or hibernating bats, though the internal space was draughty and relatively damp. The underside of the roof sheets offered no roosting potential. No indications of use by bats could be found.

Internal space damp and draughty, unfavourable to bats

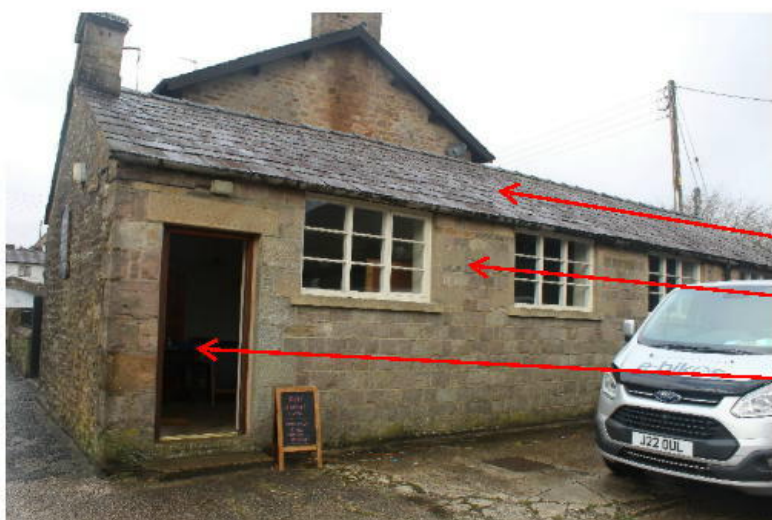
Building 3

The walls of the single-storey church are made from natural stone and are in excellent condition with structural gaps or cracks, and with pointing fully intact. The door is often open during the day. There are no eaves boards or soffits, but the eaves lines are well sealed. No signs of bats were found.

The roof of the building is also made from slate and is in very good condition. All slates are in place and well fitted, with no significant lifting. The roof verge is sealed. The full extent of the roof could be seen from the ground with close focus binoculars and a 1,000,000 candle power torch. No indications of use by bats could be found.

Roof in very good condition

Walls and eaves well sealed

Door often open during day

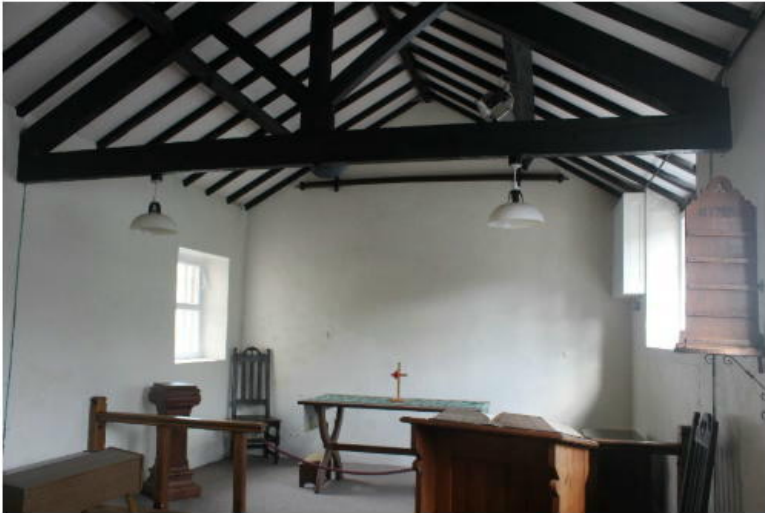
The internal walls of the building are fully plastered and painted with no opportunities for bats. No signs of bats were found.

Internal space well sealed and in good condition

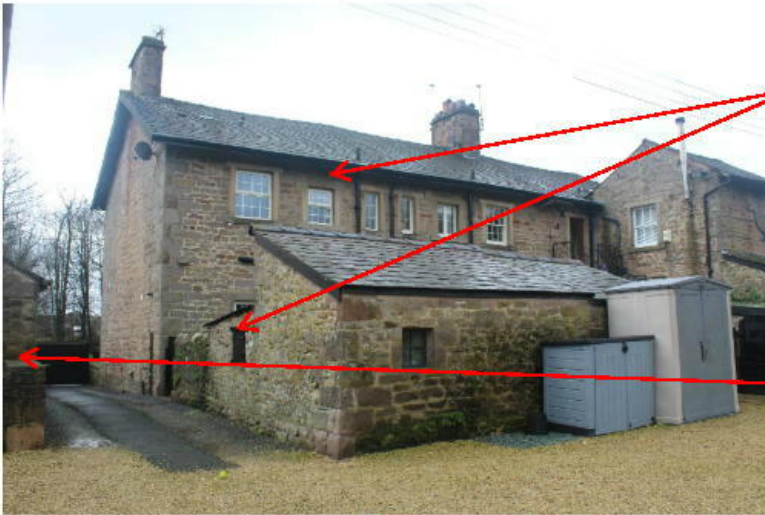
Church (Building 3)

Bats know to roost in buildings and walls adjacent to west
