**94 Ribchester Road,  
Salesbury,  
Blackburn,  
Lancashire  
BB1 9HQ**

**Preliminary Survey & Assessment  
in Respect of Bat Species and Nesting Birds.**

**Echo Calls Bat Surveys**

**22<sup>nd</sup> June 2022**

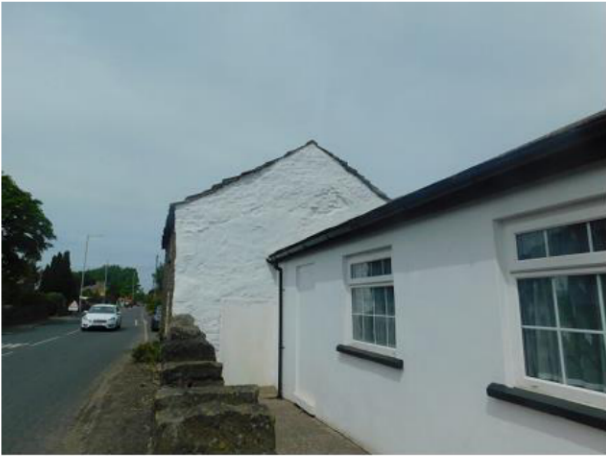
**PHOTO 1**  
**Eastern Elevation**

The building was two storied, and constructed from un-lined stone, and its eastern elevation had been whitewashed, however, it lay in a south-east to north-west orientation, and had a pitched slate covered roof, with neither insulation nor roof void.

Although the house was structurally sound, all parts were in a deteriorating condition, and it was currently unoccupied, unheated and uninsulated, and would be draughty and cold throughout most of the year, and therefore the structure was deemed unsuitable for either feeding bats, daytime roosting bats, or breeding bats. It was also concluded that the building would be damp and cold

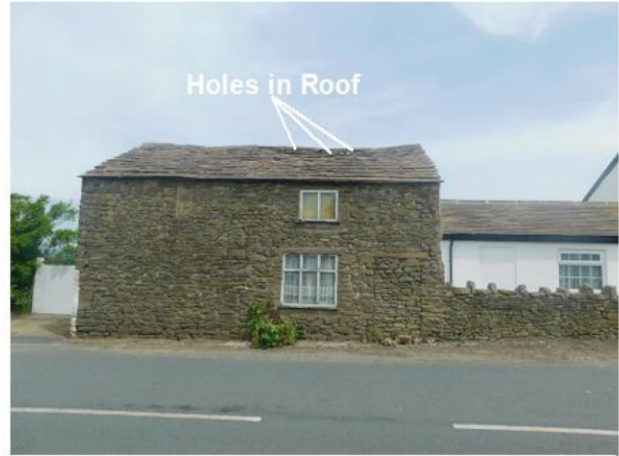
**PHOTO 2**  
**Southern Elevation**

- Over the years, a number of the roofing slates had moved due to inclement weather and frost, leaving numerous holes and gaps that could be used by roosting bats, however where possible, these gaps and the roof both around and beneath them, were searched both by sight, and by close focus binoculars, and the interior floors beneath the holes and gaps was also carefully searched. However, some of the holes were found to be cobwebbed, and elsewhere, neither bat droppings, insect prey remains, nor urine or fur staining was found anywhere, and therefore all of these gaps were judged to be of low bat roost suitability, (refer to **figs 3, 4, and 5** and **photos 2, 6, 9 and 10**).

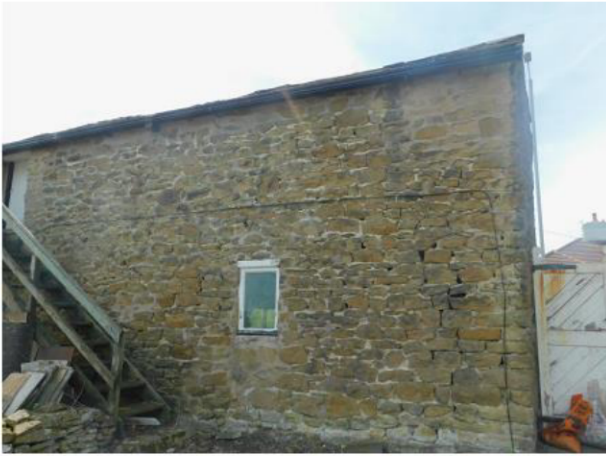
**PHOTO 7**  
**Northern Elevation**

- There were numerous holes between the stones at the north-western corner of the external northern elevation, and these were searched by sight and where possible by using the endoscope. The holes were found to be either of insufficient size or depth to offer any bat roosting potential. Others were found to be heavily cobwebbed or filled with debris, and therefore all were thought to offer negligible bat roosting potential, (refer to **figs 3, 4, and 5** and **photos 5 to 7**).

There was an external staircase attached to the north-eastern corner of the building, and a close inspection of this found it to be constructed entirely from timber, and deemed to offer negligible bat roosting potential, (refer to **figs 3, 4 and 5**, and **photos 7 and 8**).

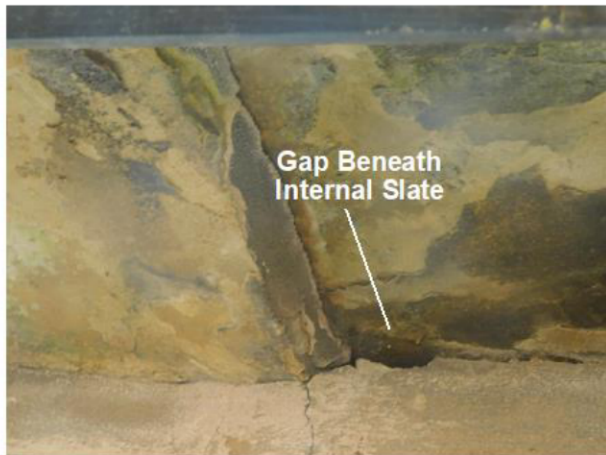
**PHOTO 11**  
**Internal View of Western Wall**

- There was a hole beneath a roofing slate at the internal junction between the western first floor wall, and the edge of the roof, and another hole in the internal first floor southern wall, but neither bat droppings were found in them, nor on the wall and floor beneath them, nor were any other signs of bat usage found, (refer to **figs 3, 4, and 5** and **photos 11 and 12**).
