Outbuilding at 29 Church Street  
Ribchester, Lancashire:  
Historic Building Assessment

December 2010

# Outbuilding at 29 Church Street Ribchester, Lancashire: Historic Building Assessment

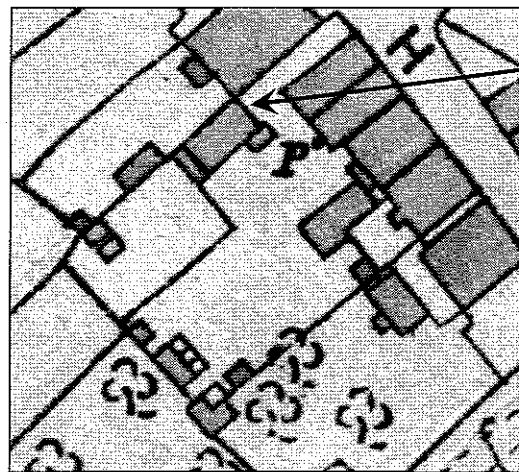
**Figure 5:** OS 1:2500 map, surveyed 1892 (Lancashire, sheet 54.14, published 1893)  
The outbuilding again shown larger than at present

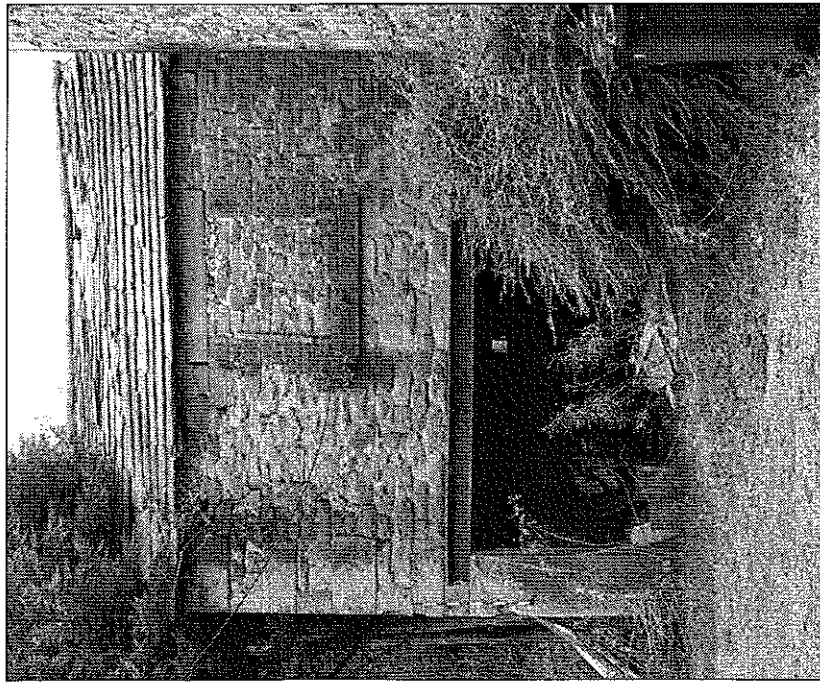
Photo 1: North-east elevation

- 5.1 The outbuilding is of two storeys, and is built from sandstone rubble with punch-dressed quoins and stone slate roof, materials typical for the district and period. The stonework is slightly better to the north-east front, but this side has had a large doorway inserted beneath a steel lintel, do doubt to enable its use as a garage, in the mid 20th century (photos 1 & 2). All that remains to indicate an earlier arrangement is the jamb of a doorway (with marked diagonal tooling) at the left-hand end of this elevation, but there is also a blocked window or forking hole to the first floor. An unblocked, two-part forking hole survives in the south-east gable (hidden by the conifers), which was probably put in when the earlier opening was blocked. The only openings in the south-west side are one or two breathers, and the cement line of an adjoining lean-to roof is visible here (which fits with the map evidence for there having been a building there, well into the 20th century). It is interesting to note that the boundary wall running to the south-west contains a date-stone of 1834 (carrying the initials J W – presumably those of John Waterworth), but its almost random inclusion suggests that the wall may have been rebuilt. However, as no quoins are visible in the south-west face of the building where the wall adjoins, it does imply that the wall pre-dates the outbuilding.

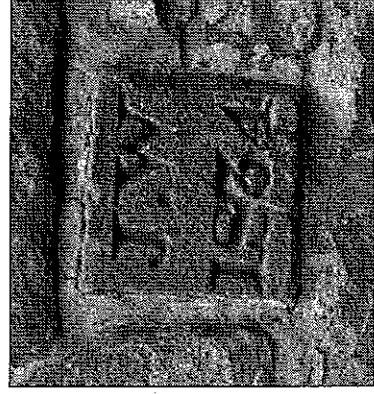
Photo 3: Date-stone in boundary wall, to south-west of outbuilding

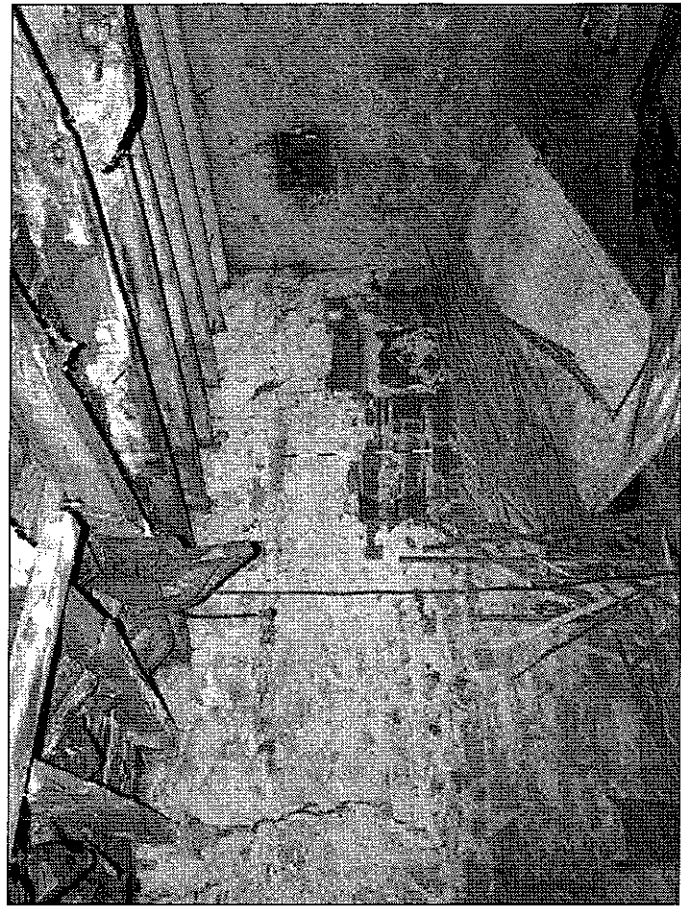
Photo 6: Interior, from the north

- 5.2 The interior has almost no features and no internal divisions, with only a few recesses and blocked breathers in the south-east and north-west walls, which suggest livestock were kept in here, most likely ponies or horses, or a house cow or two. The walls are whitewashed, as might be expected for such a function. The ground floor appears to be a mixture of stone flags and concrete and it is not possible to see any stalling arrangements, but overhead the first floor is simply constructed from joists and boards, which are in very poor condition. A hole which has been cut through the floor would have allowed access up onto the loft from below, but there is no fixed ladder or other surviving means of ascending. This upper storage space is open to the roof and evidently served as a feed loft.
