| TREE IMPACT AND PROTECTION REPORT | |
| Site: | Oak Bank Farm, Stoneygate Lane, Ribchester, Lancashire, PR3 3YN |

# PROTECTED SPECIES (BATS) SURVEY

Detached house at Oak Bank Farm, Stonygate Lane, Ribchester, PR3 3YN ( NGR: SD 651,364).

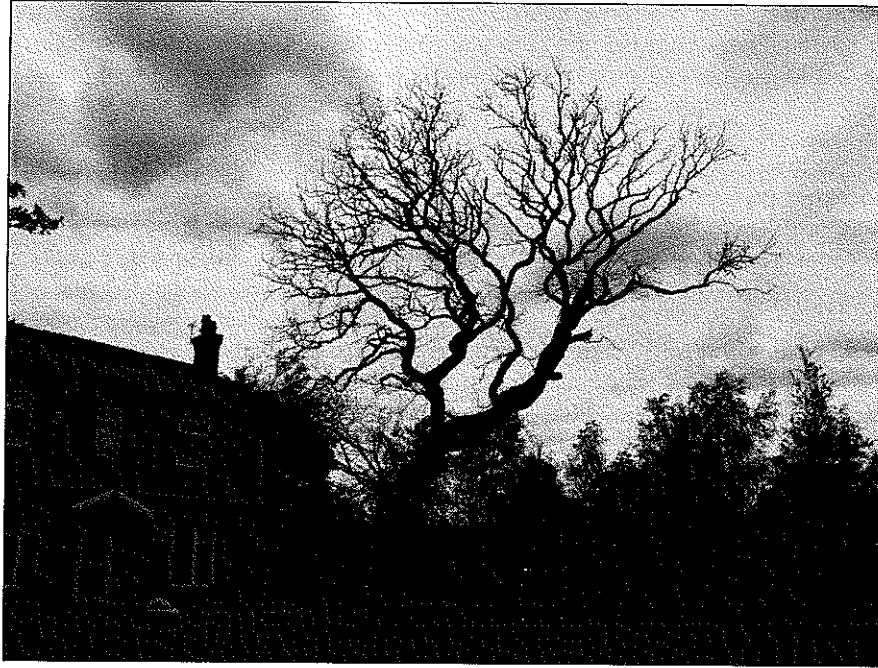
Fig. 1: Dead Oak tree T2

The trees were allocated remove, moderate and high BS5837:2005 retention values in accordance with Table 1, attached. Oak tree T2 was noted to be dead (see Fig. 1, overleaf), whilst the remainder were seen to be expressing good overall vitality. Detailed tree dimensions and other pertinent information such as structural defects and/or physiological deficiencies, along with any recommendations for works are included in the TSS attached.

| No. | Species | Height | Stem Diam. | Branch Spread | Height of C.C. | Age | PC | Comments on Condition, etc. | Management Recommendations | ERC | Cat. Grade | RPA (m²) | RPA Radius (m) |
|---|---|---|---|---|---|---|---|---|---|---|---|---|---|
| T2 | Common Oak | 12.5 | 600 | N 5<br>E 4<br>S 7<br>W 4 | 3 | M | D | <ul style="list-style-type: none"> <li>Dead.</li> </ul> | <ul style="list-style-type: none"> <li>Remove tree and grub out stump.</li> </ul> | <10 | R | 162.88 | 7.2 |

One of the oak trees is high quality, the two groups are moderate quality and the remaining oak is dead. The amended proposals will require the removal of the dead oak, but the remaining trees can be retained and protected accordingly throughout development.

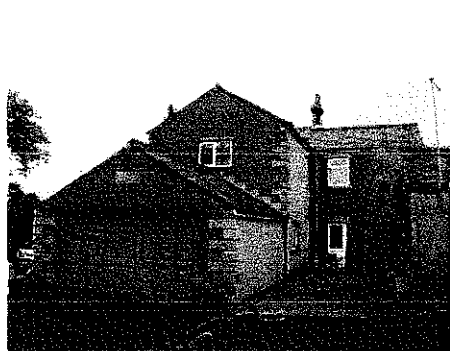
Fig 1.

You have requested an inspection of the above named property on behalf of your client Mr J Wade to undertake a bat and barn owl inspection as a condition of a planning application to Ribble Valley Borough Council for a proposed replacement dwelling requiring demolition of the existing detached house as shown in figures 1 to 9 of the following report.

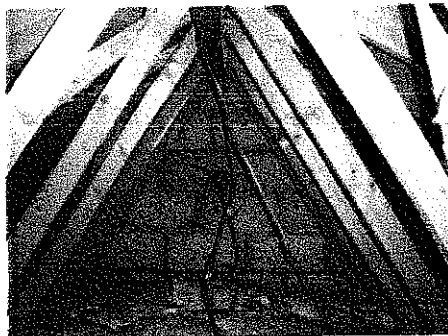
Fig 8.

**Roof void C:** A recent two storey extension with pitched slate roof under lined with a breathable roofing membrane and insulated with a glass fibre material laid over ceiling joists. This area is also clean, dry and well-sealed (figure 8) There is no evidence of bat droppings in the void although some cluster flies are present.
