Application for Planning Permission and conservation  
area consent for demolition in a conservation area.  
Town and Country Planning Act 1990

## **Archaeological Desk-Based Assessment**

**English Martyrs R.C. Church**  
**Boundary walls**  
**WHALLEY**  
**LANCASHIRE**

**Heritage Statement**

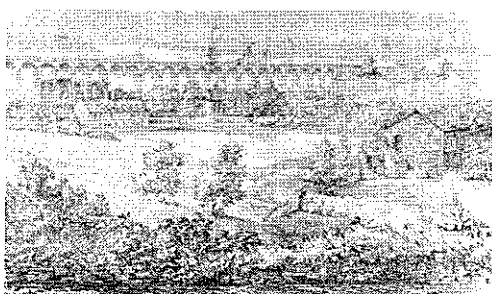
(Left) **Fig 10:** illustration of the West Range, Sands Orchard, Abbeycroft, North West Gateway, and Anglican vicarage, c. 1860s [Clitheroe Lib.]; (Centre) **Fig 11:** details from 1893 1<sup>st</sup> edition OS 1:2500 map, and (Right) **Fig 12:** 1938 edition, showing North West Gateway, Lower Fold (still called this on 1912 edition, later Abbeycroft), West Range, Abbey Farm (R. C. Presbytery by 1938), and the English Martyrs R. C. Church, of 1926. Of the two outbuildings at the SE corner of Sands Orchard, only the (extant) eastern one was shown on the 1912 edition.

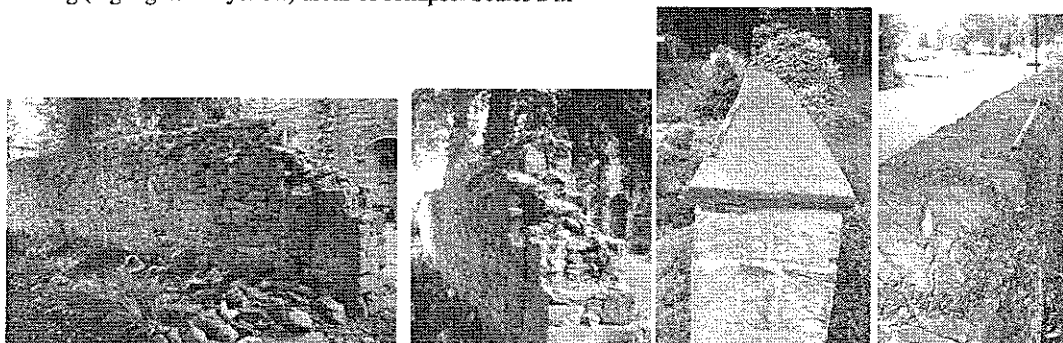
(Left) Fig 17a and b: collapsed S end of east wall; (Centre) Fig 18: recent concrete slab capping of northern part of east wall; (Right) Fig 19 older 'slobbered' concrete wall-head of north wall, parallel to The Sands. Scales 2m

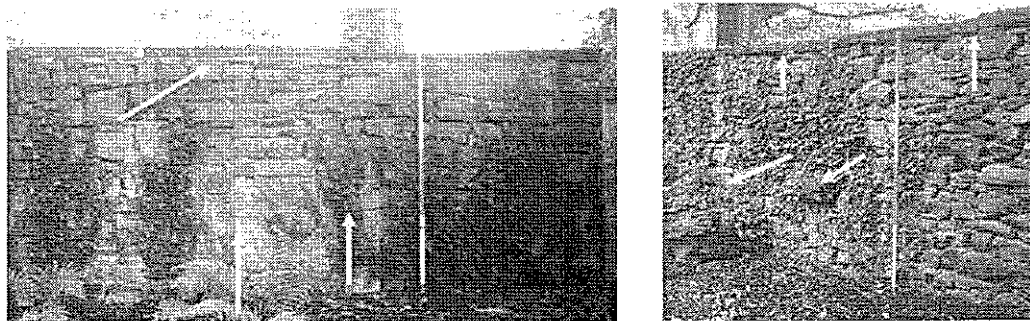
(Left) Fig 23: repaired stretch at east end of south wall, showing pale cement, and blocked doorway; (Right) Fig 24: very large original capping stone, and through/projecting stones, in south wall (Scales 2m, 500 mm divisions)

- 3.2.2 However, even in these areas of better-preserved walling, previous and urgently-needed repairs are apparent. The south-eastern c. 13 m of the south wall has been heightened and re-capped with smaller (250-350 mm long) flags of similar width and thickness, but using pale brown sandy cement, rather than lime mortar (Fig 23). This work seems to have been occasioned by

removal of an outshot building shown on the OS (1938) map, adjacent to a blocked doorway in the wall. An area at the SW corner has collapsed completely (**Fig 25**); the exposed core-work and rubble show that the wall had previously been repaired using a mixture of stone and recent machine-made Accrington brick, again using cement rather than lime mortar. The northern half of the west wall, and the whole length of the north wall, parallel to The Sands, has been reduced in height, without replacing the coping, and with a roughly 'slobbered' cement cap. In places the south and west walls have 'slobbered' pointing (**Fig 27**) – a typical feature of late seventeenth and early eighteenth century garden walling, though probably not original here - but no actual render is apparent.

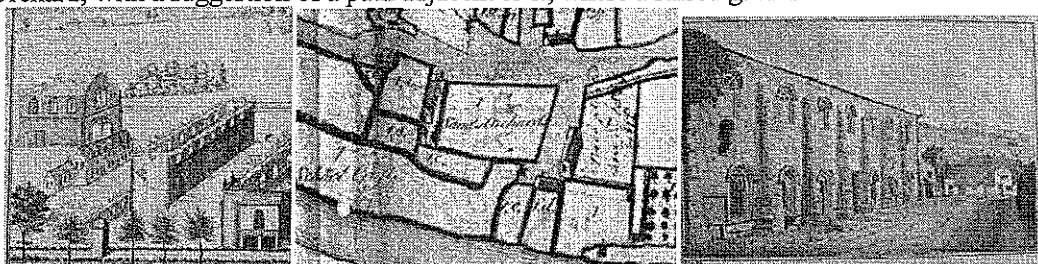
(Left) Fig 1: Detail from Buck brothers' prospect, 1727; (Centre) Fig 2: Porter's map, 1762, showing Sands Orchard, in which the English Martyrs Church now stands (LRO DDWI Map 1); (Right) Fig 3: Weld's illustration of the West Range, and house near the river, 19<sup>th</sup> Sept 1837 (LRO DP 386/1, f5).

- 2.3.1 The Buck brothers' 1727 prospect is the earliest surviving illustration of the abbey site, and has been archaeologically proven to be correct in many details. The North West Gatehouse and The West Range are shown roofless. The distance between the West Range and Abbeycroft has been fore-shortened, but no enclosing wall is shown (Fig 1). Porter's estate map, dated 1762, is the earliest surviving map of Whalley (Fig 2). It shows the West Range re-roofed and a large house at the south end of it; the West Range became a shippon (cow house) and hayloft. A roughly rectangular enclosure – clearly the English Martyrs plot – described as 'Sands Orchard', is shown. At this date there was no building where the Presbytery now stands. There is an illustration by John Weld (1813-88), dated 19<sup>th</sup> Sept 1837 (Fig 3) of the West Range, with the white-painted house in the distance. On the right, in shadow, is the boundary wall of Sands Orchard, with a suggestion of a path adjacent to it, where a raised garden bed and trees are now.

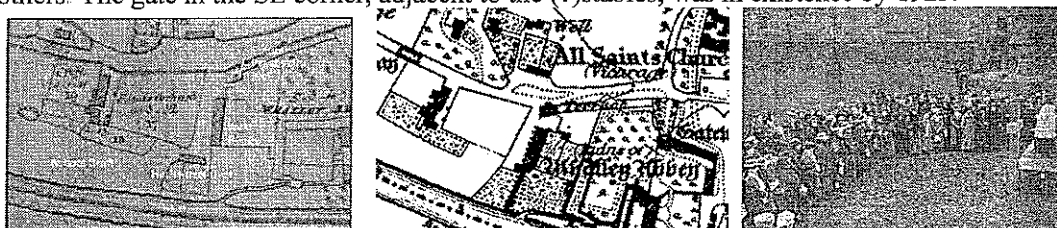
(Left) Fig 4: detail from Earl Howe's conveyance plan, Sept 1834, showing Sands Orchard and house near river (LRO DDX 638/5/4); (Centre) Fig 5: detail from OS (1848), showing Sands Orchard, farmhouse which is now the Presbytery, but house near river demolished. (Right) Fig 6: Fr. McDonnell addressing pilgrims in March 1923, on the future site of English Martyrs Church, with the boundary wall and West Range, in the background (Anon 1923).

- 2.3.2 On the map accompanying Earl Howe's conveyance of 27<sup>th</sup> Sept 1834, Sands Orchard (Fig 4) and the house near the river are extant, but now a small building is present on the site of part of the present Presbytery plot. By 1848 (OS, surveyed 1844; Fig 5), the house near the river had been demolished, and the farmhouse which was to become the Presbytery had today's footprint. A blocked doorway was found in the south wall during the field visit and there may have been others. The gate in the SE corner, adjacent to the (?)stables, was in existence by 1923.

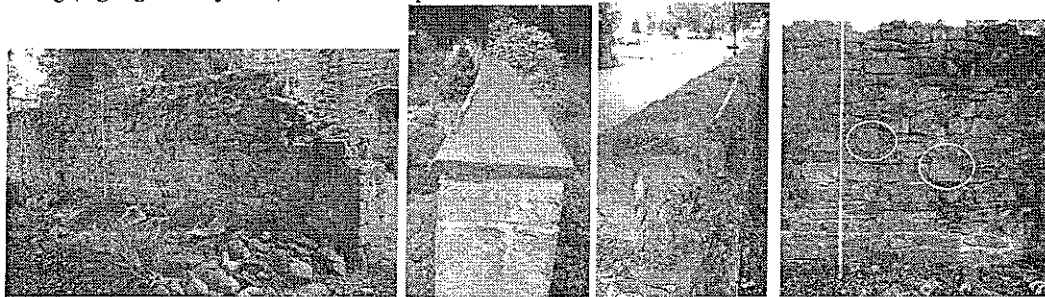
(Left) Fig 9: collapsed S end of east wall; (Centre left) Fig 10: recent concrete capping of northern part of east wall; (Centre right) Fig 11 older 'slobbered' concrete wall-head of north wall; (Right) Fig 12: possible medieval architectural fragments incorporated in the east face of the east boundary wall. Scale 2m, with 500 mm divisions.
