Application for Planning Permission.  
Town and Country Planning Act 1990

Conversion of barn into holiday accommodation, as part of a Change of use application

**Structural Appraisal:** Barn at Burnhouse Farm, Back Lane, Newton In Bowland, Clitheroe

Dilworth Barn, Burn House Farm, Newton-in-Bowland

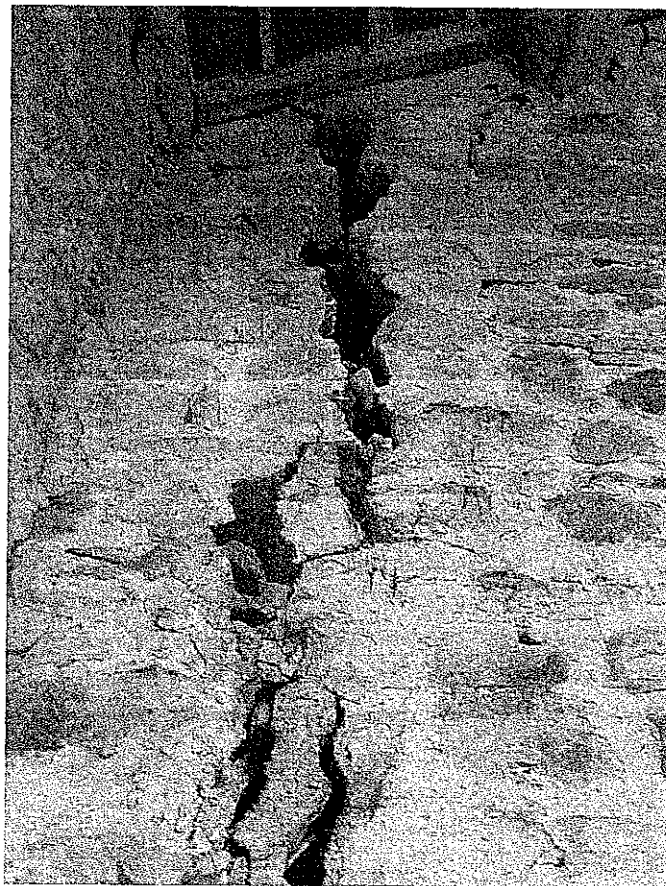
Photo 2:

There is a crack in the dividing wall between the two barns which replicates that noted on the opposing elevation, being some 100-150mm in width (see photo 2).

- 4.5 Despite the obvious outward lean in the front elevation, in itself remains to be in surprisingly good condition, however some rebuilding of the gables and the internal dividing wall is inevitable. The extent of the rebuilding that would be required at this time has been illustrated on a sketch on pages 8-9, however given the condition of the walls and the likelihood that without remedial works, they will deteriorate further, this should be addressed again prior to the commencement of its conversion. There is little evidence of the tension movement in the outer leaf of the north eastern gable externally, therefore at this time, we have recommended the rebuilding of the internal aspect only. It is appreciated that this may not be practical and therefore provision should be made to rebuild this corner fully. The works to these walls should be done following further consultation with ourselves regarding the provision of temporary works to adequately support the remaining structure and safeguard the operatives during this phase.

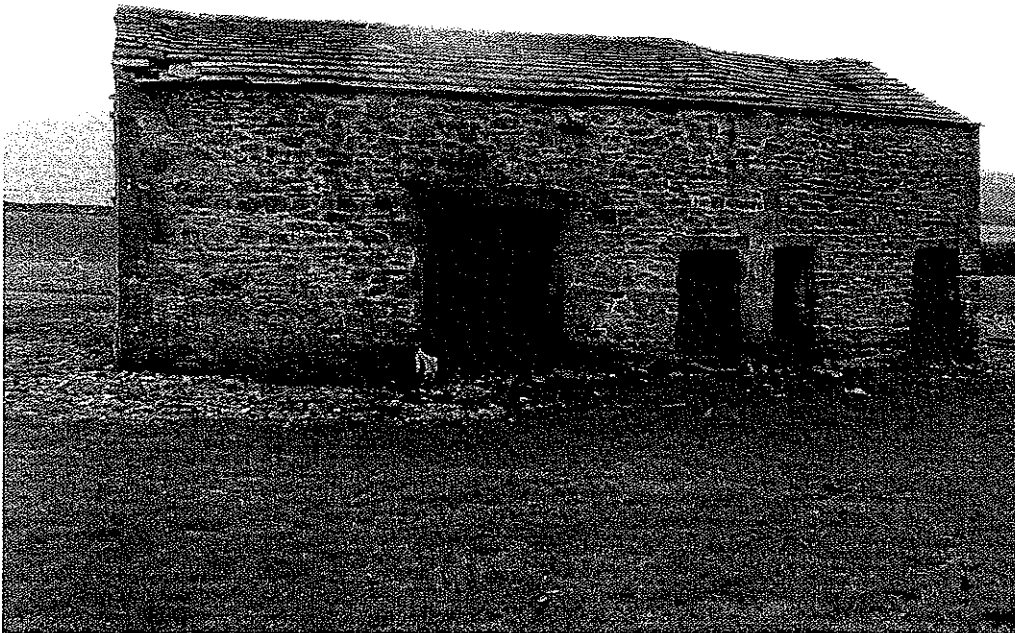
South-East elevation

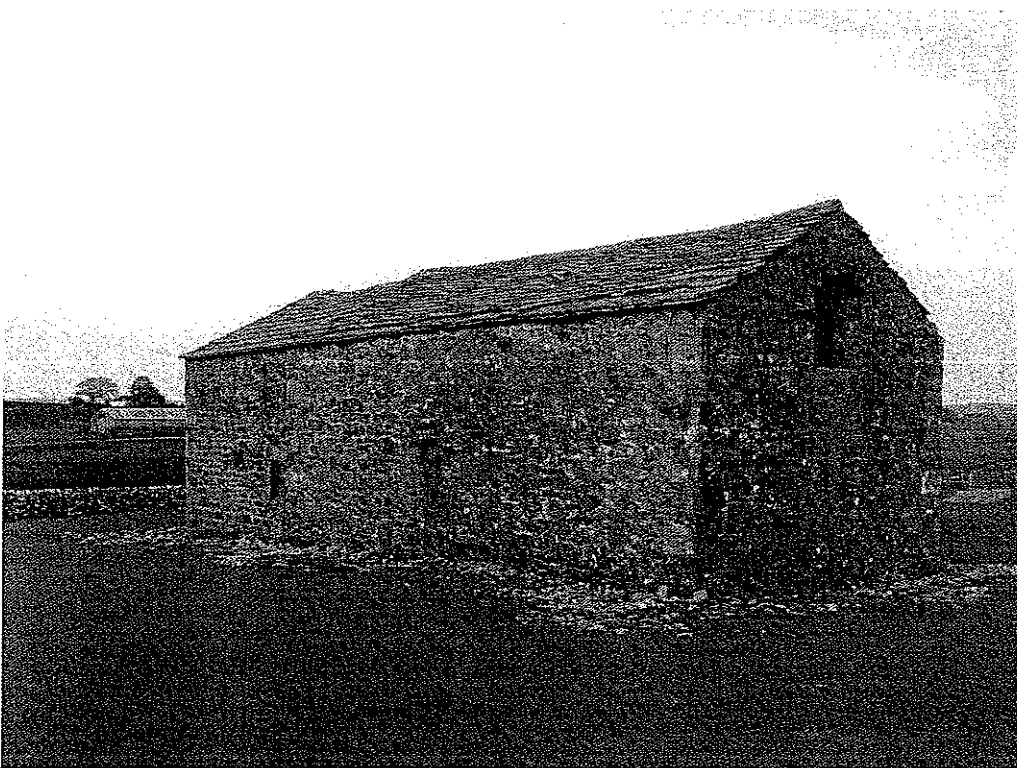
The walls of the building are constructed from natural stone; there are gaps and cracks in the walls; most of these are large and open but some may be suitable for use by bats for roosting.

North-West elevation and South-West gable
