# earthworks environmental design

22 July 2011

Ref: B996

Protected Species Survey: Barn at Hubbersty Fold Farm, Commons Lane, Balderstone, BB2 7LL

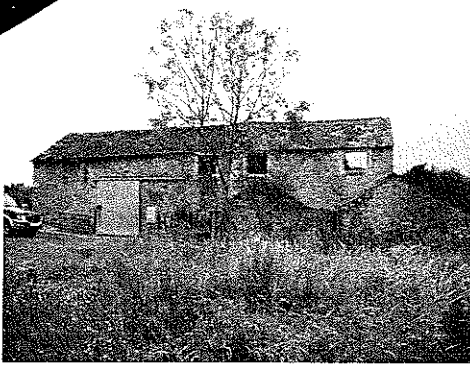
Figure 1: east elevation

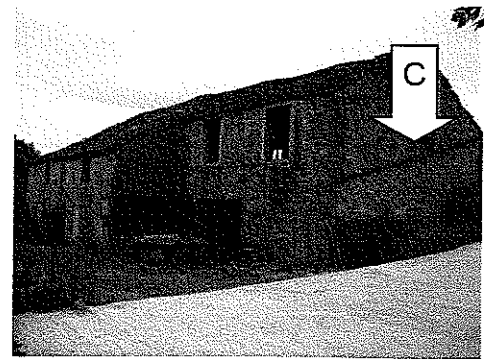
Figure 3:

Additionally there is a small single storey building (shown as area 'C' figure 3); this area is open fronted and only one half of the pitched roof remains intact; the remainder of the building has been removed or collapsed.

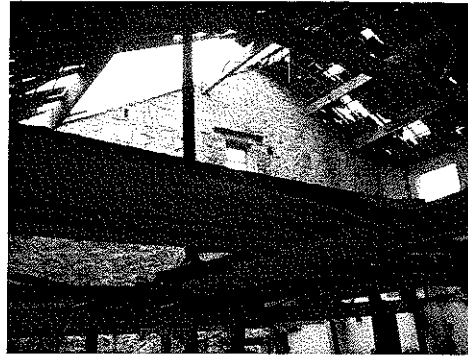
Figure 5: interior of building B'

The former milking parlour and hayloft (shown as 'B' in figure 2) has two floors: (i) the ground floor cubicle area and (ii) the timber hayloft above. The building has an unlined slate and batten roof; approximately 30% of the roof area has already collapsed and the structure is very unsafe (figure 5). Inspection of this part of the building was restricted to observation from the doorways at the front and rear due to safety concerns.
