## HERITAGE STATEMENT

IN RESPECT OF A PLANNING APPLICATION FOR THE  
PROPOSED CONVERSION OF A BARN TO A SINGLE DWELLING  
AND ATTACHED DOMESTIC GARAGE

HUBBERSTY FOLD FARM  
COMMONS LANE,  
BALDESTONE

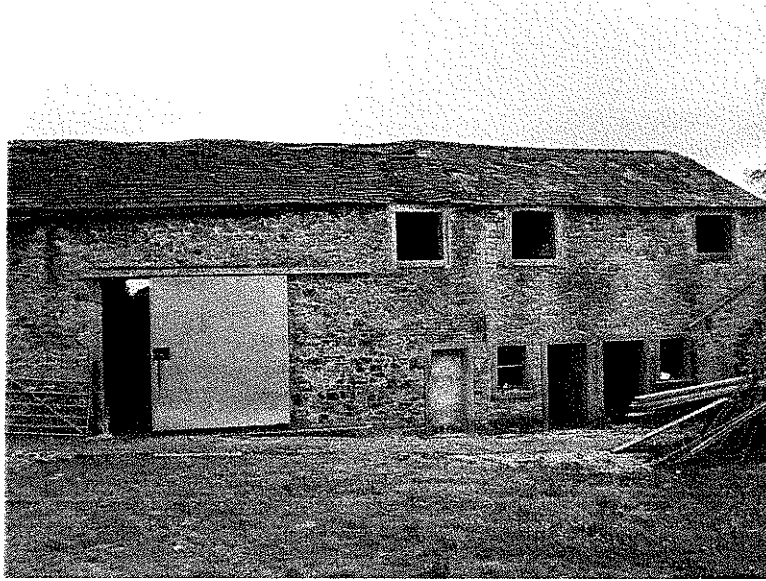
**Image 01.** The image below shows part of the east facing elevation and the large existing cart door. It is proposed to retain this opening and to provide some fenestration.

- 2.5 Building No 1 - the hay barn is a traditional barn believed to have been built during the late 18<sup>th</sup> C. There is evidence that the lower section of the barn (southern end) has in the past housed cattle (cow house) and this section has a dilapidated first floor probably used for storing hay or

perhaps straw. The existence of former stalls and a feeding passage below the absent first floor area is evident. The barn has a large Cart door opening to the eastern side and other miscellaneous openings which are probably former fork holes. The southern end of the barn was used for storing hay. There is no evidence of any previous intermediate floor construction in this area so hay would have piled up to the underside of the roof. Generally this barn is in better condition than the more dilapidated former milking parlour (building No 2). This is probably a reflection of its more recent use as domestic storage space. However, it is not in good condition and structurally the fabric needs some repair work to be carried out. Please refer to the Structural condition report that accompanies this planning application for information, regarding the condition of the barn. There are openings in the separating wall between building No 1 and building No 2. Two former openings were evident at ground floor level and a single opening is evident at first floor level.

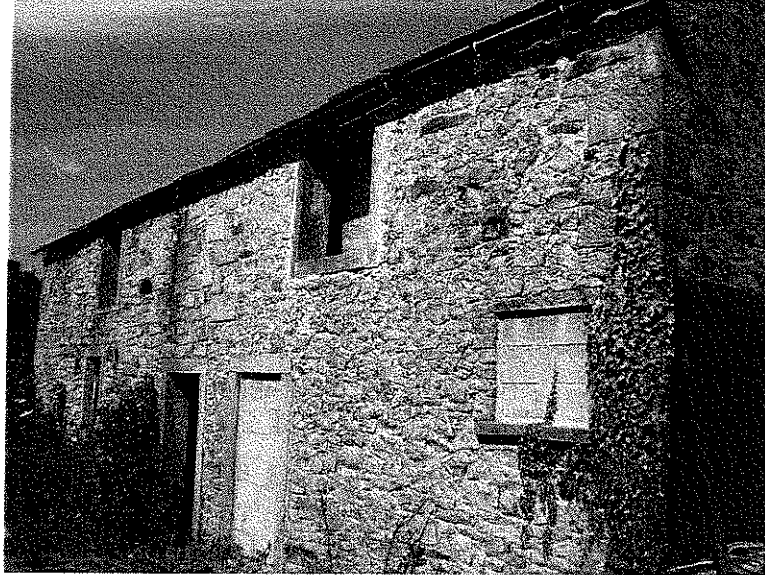
**Image 03.** The image below shows the lower section of the West Elevation (building No 2) The windows that are blocked up are scheduled to be re-opened under the proposals for conversion.

- 2.6 Building No 2 is a later addition to the hay barn. It once had an intermediate first floor construction which was probably used for storing feed and hay / straw. This floor has collapsed over a large area of the building and any remaining timbers are in very poor condition. The ground floor has three distinct spaces within the external walls. The smallest room to the south east of the building is probably a former preparation room for a dairy it has an external door opening to the east and a door opening connecting it to the largest internal space. The next smallest space (located in the north east corner of the building) was used as a stable for two horses and the main larger space (to the western side of the building) served as a milking parlour. There is evidence of former stalls with feeding facilities in this area and although the first floor construction is no longer present it was from the first floor location that cattle food was distributed to the feeding system for the cows below. All fixtures and fittings are in a derelict condition and the asset has not been used for many years. The roof of building No 2 is in poor condition. Its finish is slate, although some large sections on the west side are completely missing having collapsed a number of years ago. The applicant has known the property since being a young boy in the 1950's since it has been in the family as his grandparents home many years ago. Anecdotal evidence from the applicant confirms the former use of the spaces within the main assets identified previously as being correct.
