**HERITAGE STATEMENT**

**A PROPOSED REPLACEMENT DWELLING**

**ASHES FARM COTTAGE, SALESBURY,**

**Historic Building Record**

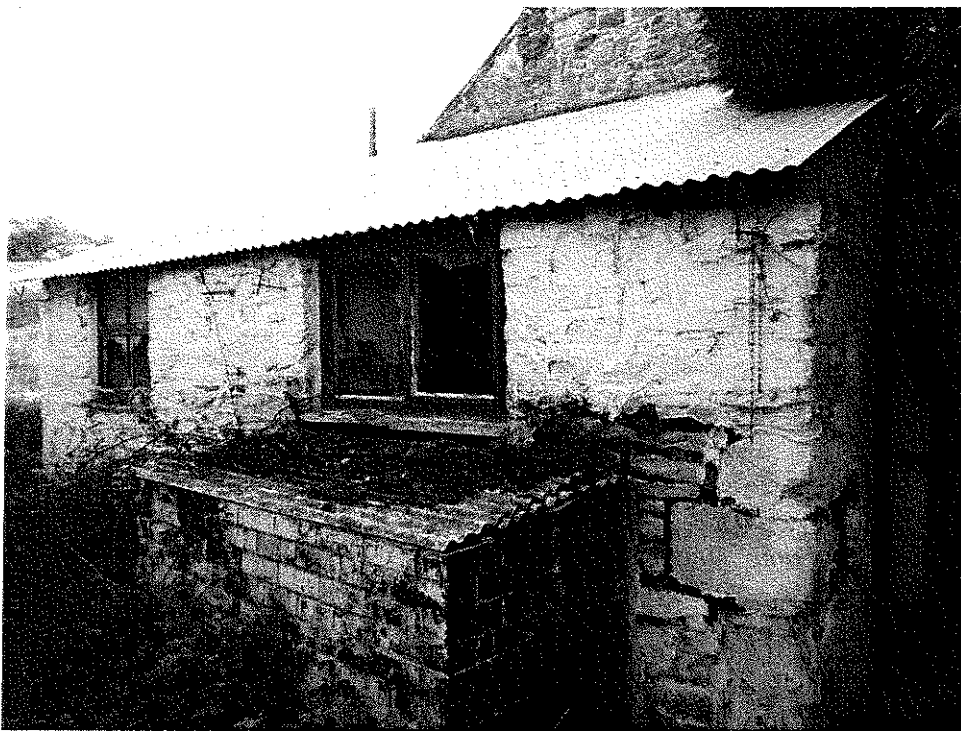
*3. Eastern lean-to addition of rubble construction with a sheet covered rafter roof. An entry door to the north wall of this addition can be seen to right beneath the heavy vegetation that surrounds the north side of the building*

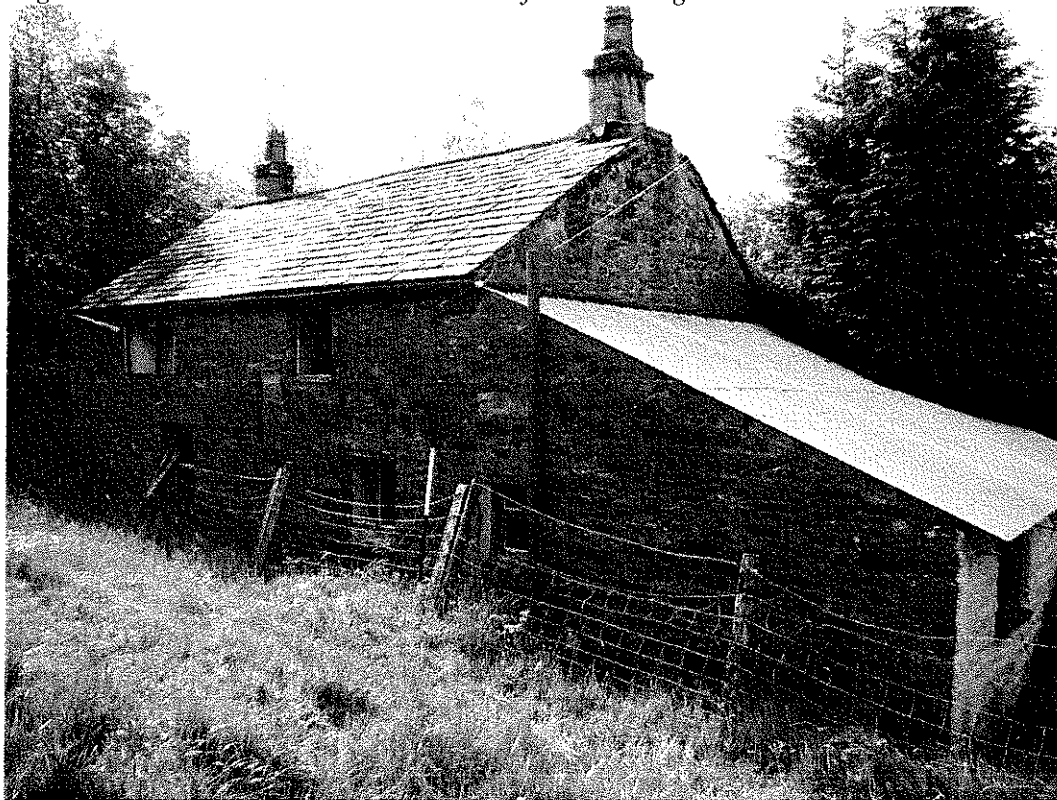
*4. Southern elevation facing pasture the sloping nature of the ground can be seen. The eastern lean-to is at the right of the shot with the main two-storey section of the building central*

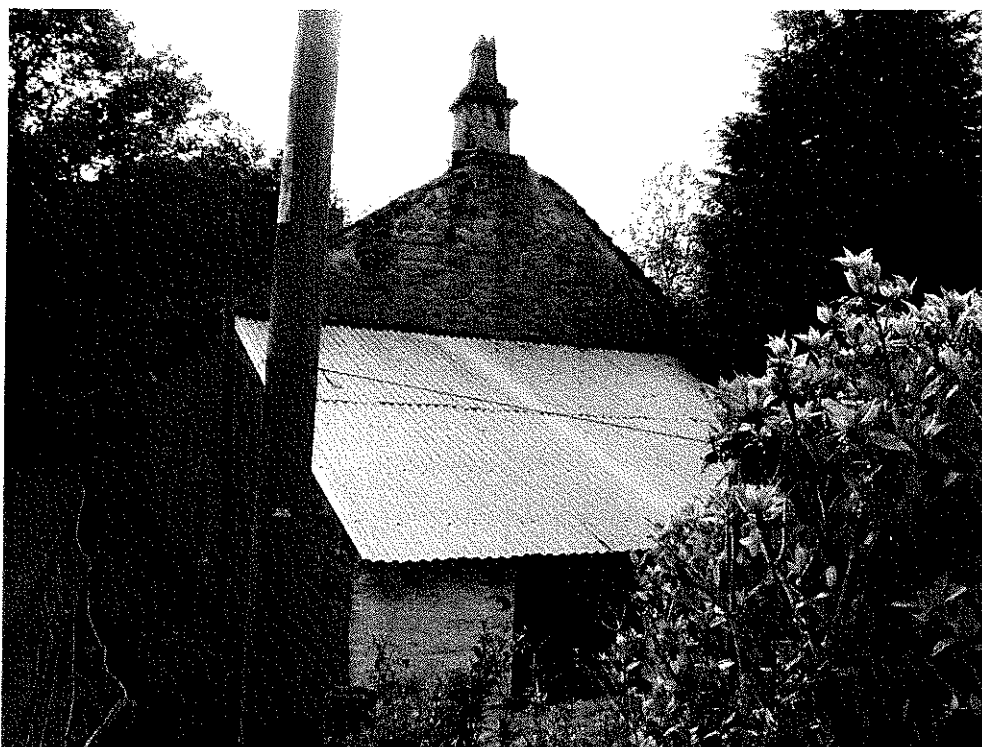
*4a Eastern gable over the lean-to The irregular nature of the stonework at high level indicates past alteration work, possibly building up when the roof covering may have been altered from thatch to slate (discussed later)*

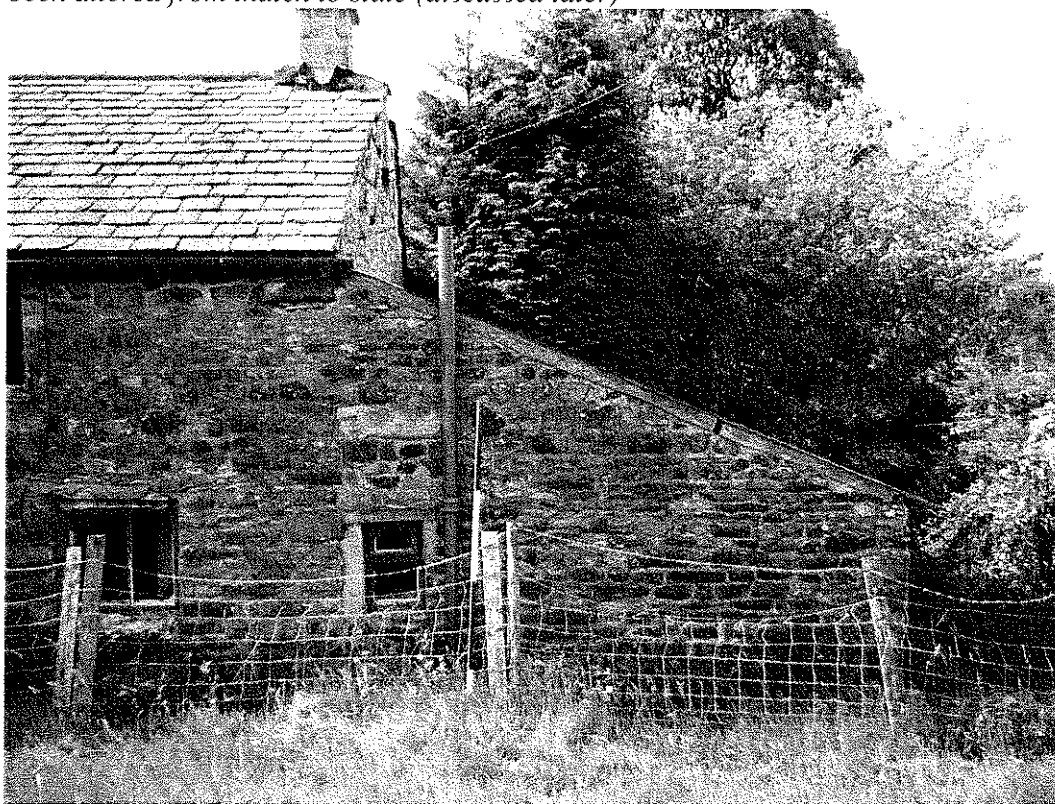
*5 Southern elevation with eastern lean-to junction to main two storey part. Here original quoins of the two storey part have been swung around to provide a starting 'key' for the lean-to addition.*

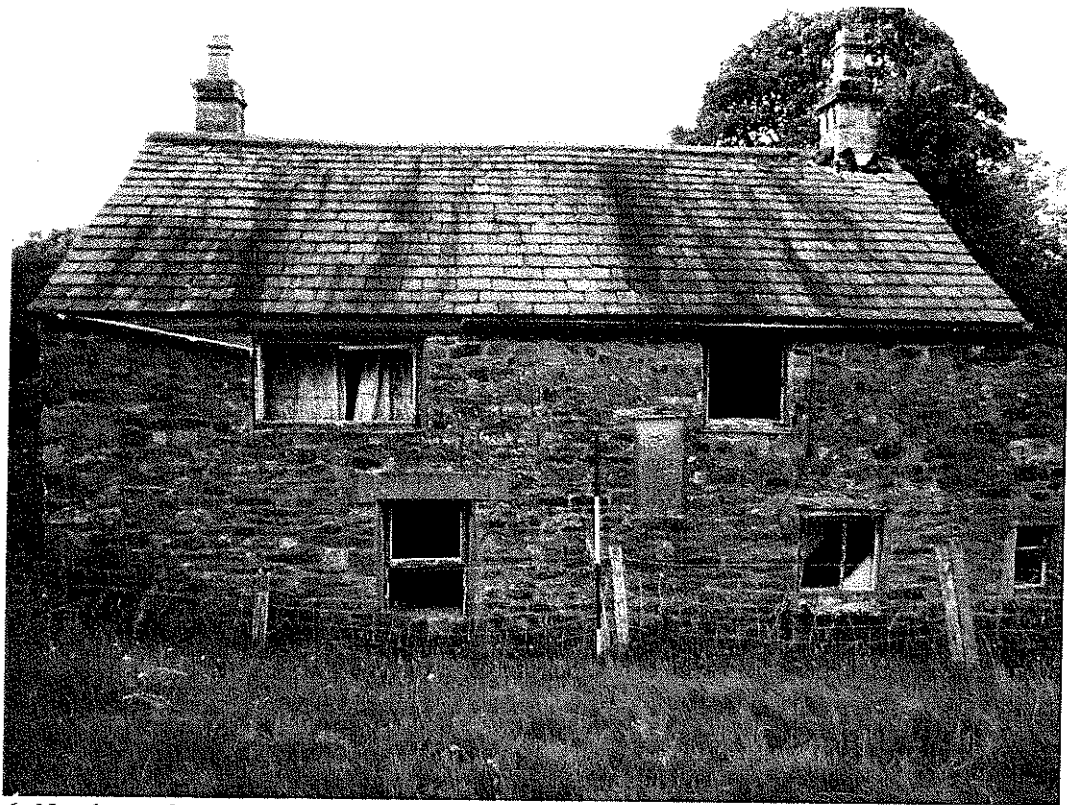
*6. Northern elevation, main two storey part. The upper left window appears to have been widened, whereas the lower inner right window is inserted*

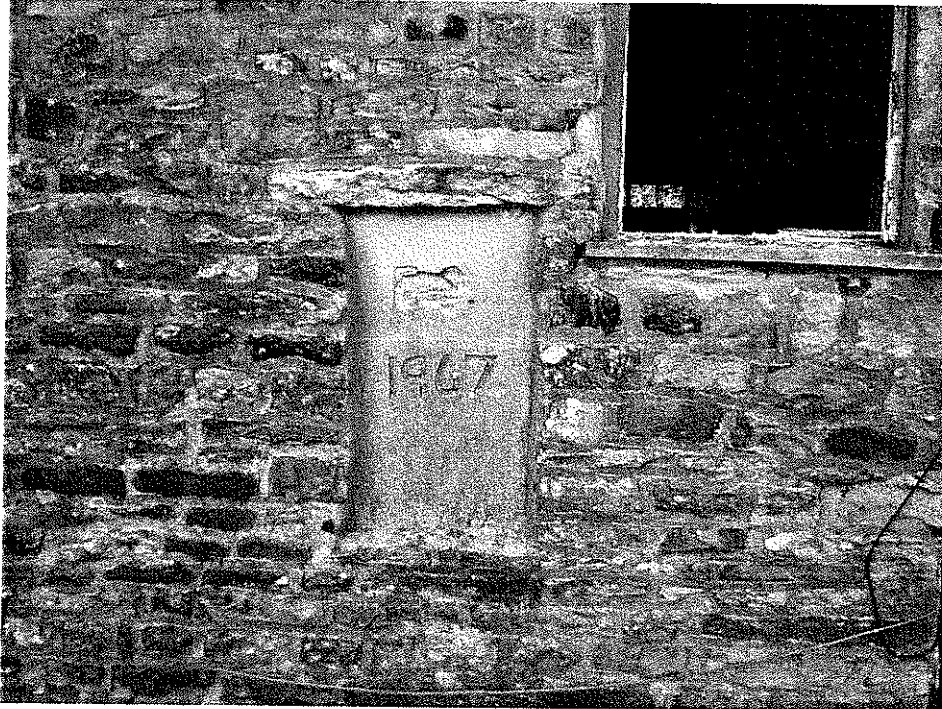
*6a. Cemented datestone to southern elevation inserted in possible previous window opening. Quite what the 1967 commemorates is unclear, but it is possible that the cottage may have been renovated at this time*

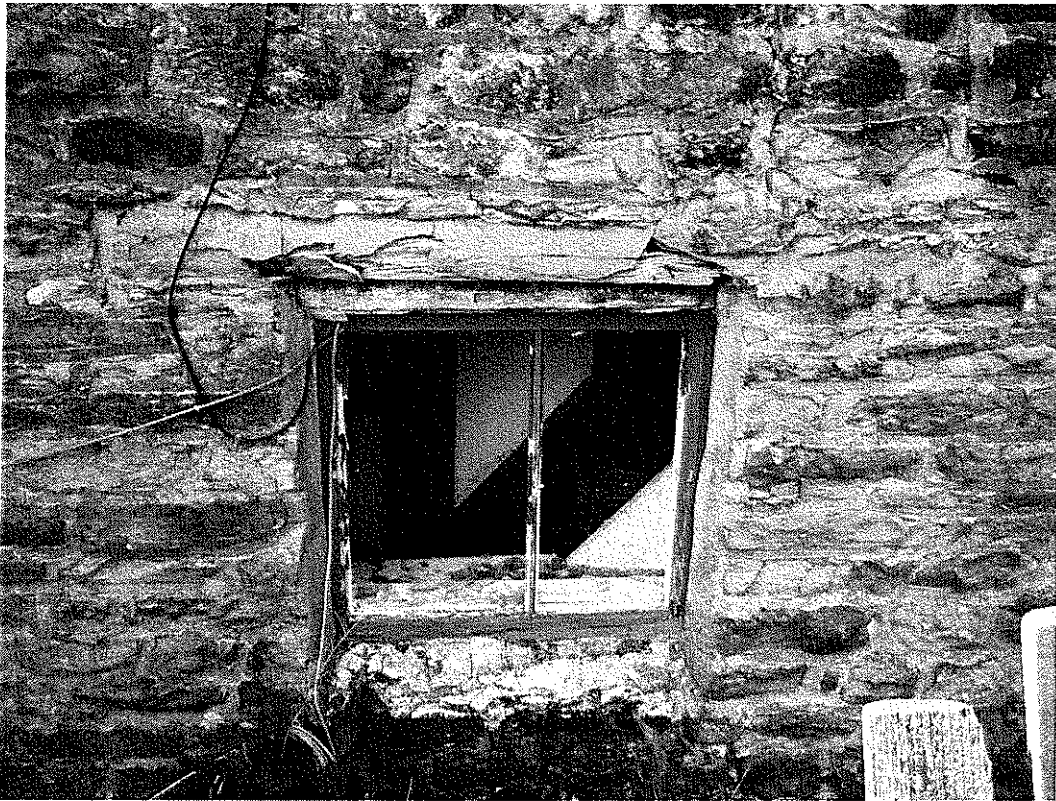
*6b. Inserted window to southern elevation, ground floor to right side of two storey part, with cement covered timber lintel.*

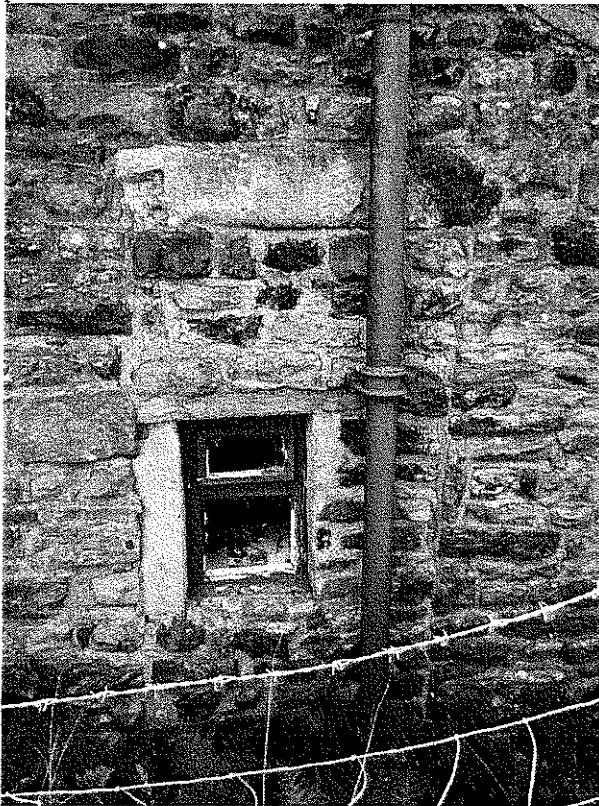
*6c Southern elevation, window in former door opening to eastern lean-to*

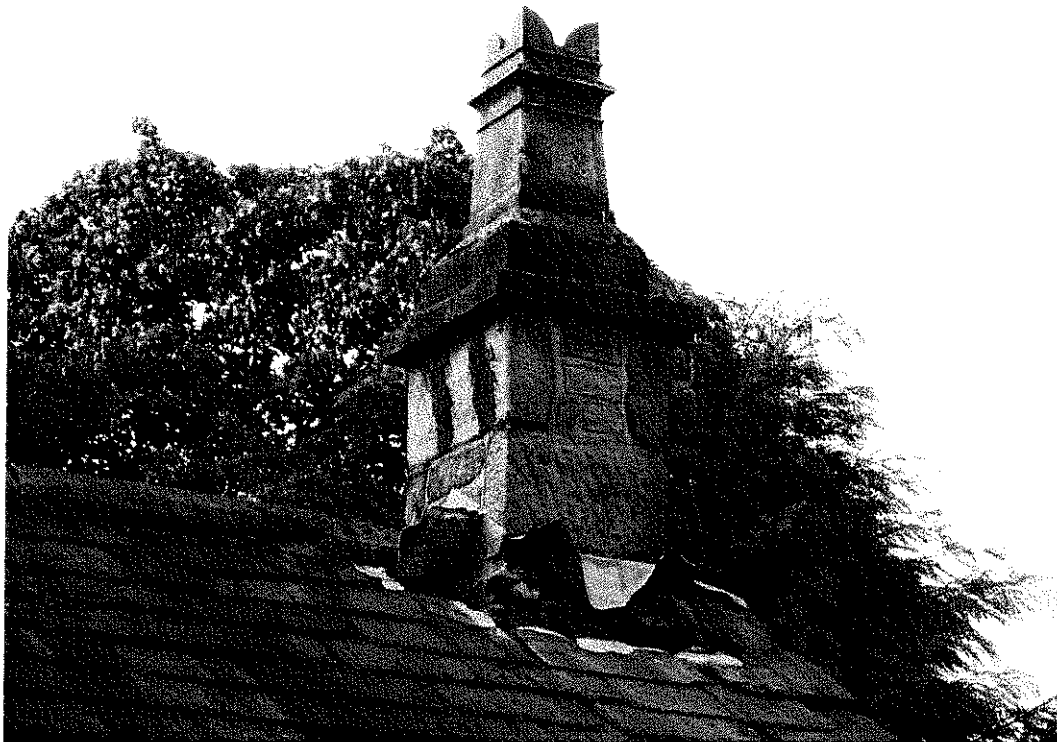
*7. Eastern chimney (single flue)*

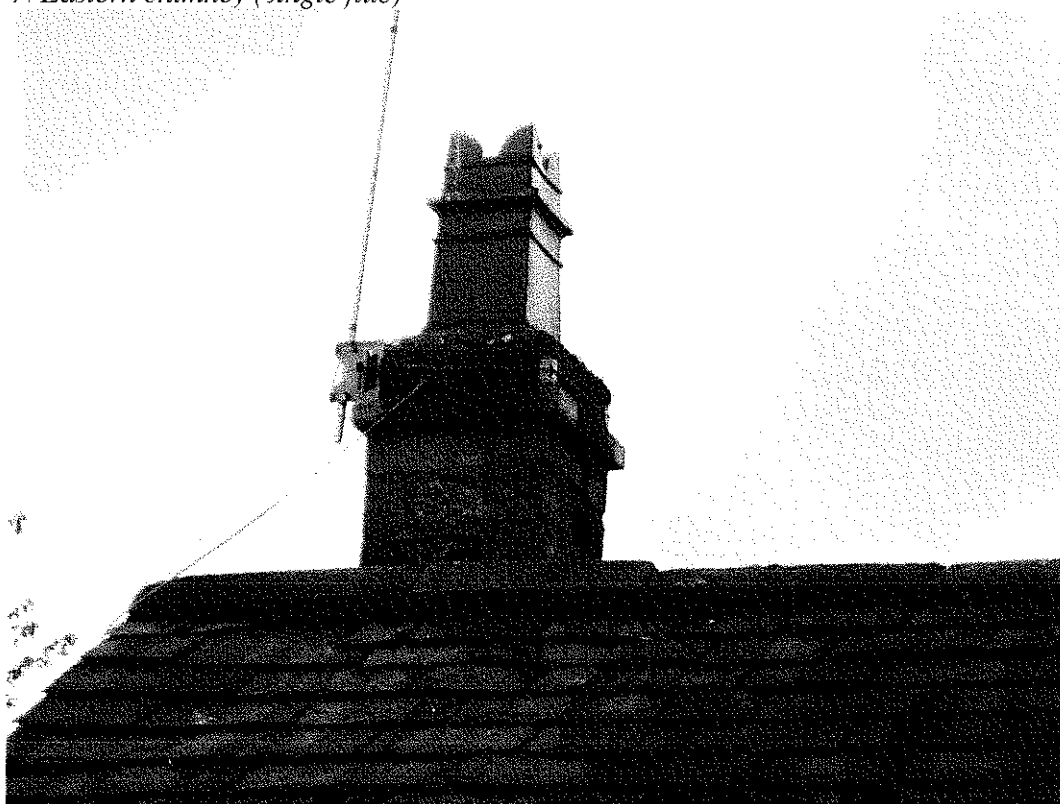
*8. Western chimney (single flue).*

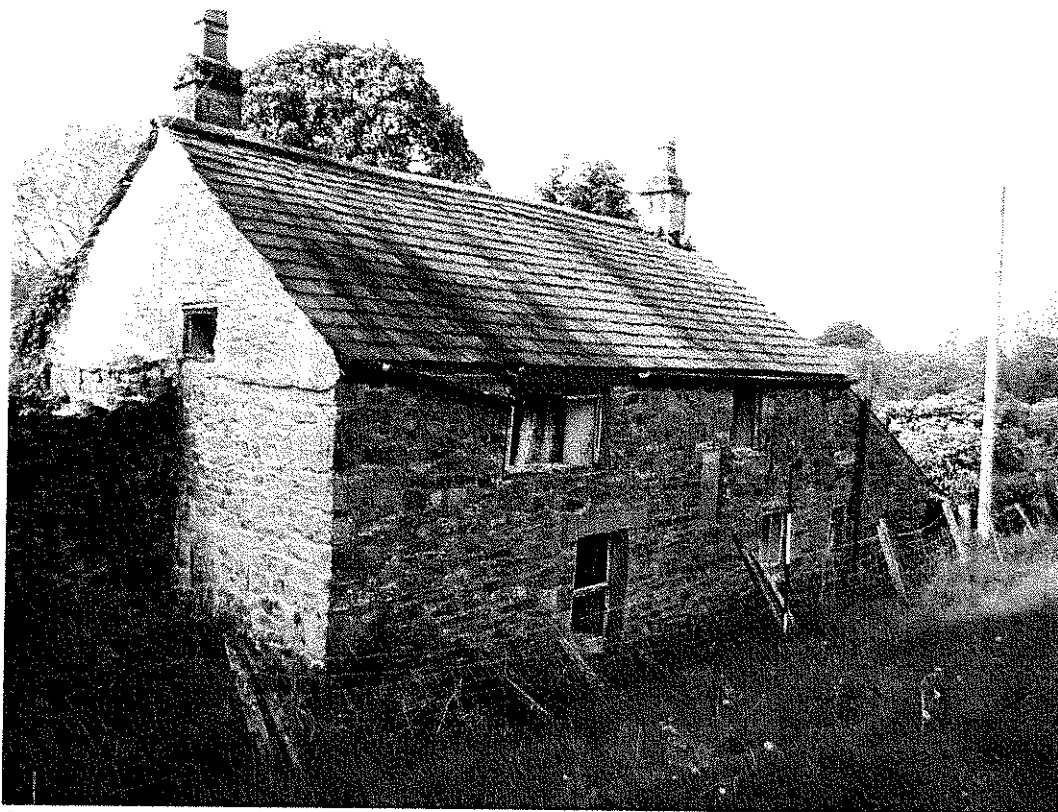
*9. View from the south west showing small gable window inserted over the line of what appears to have been a full gable width lean-to structure.*

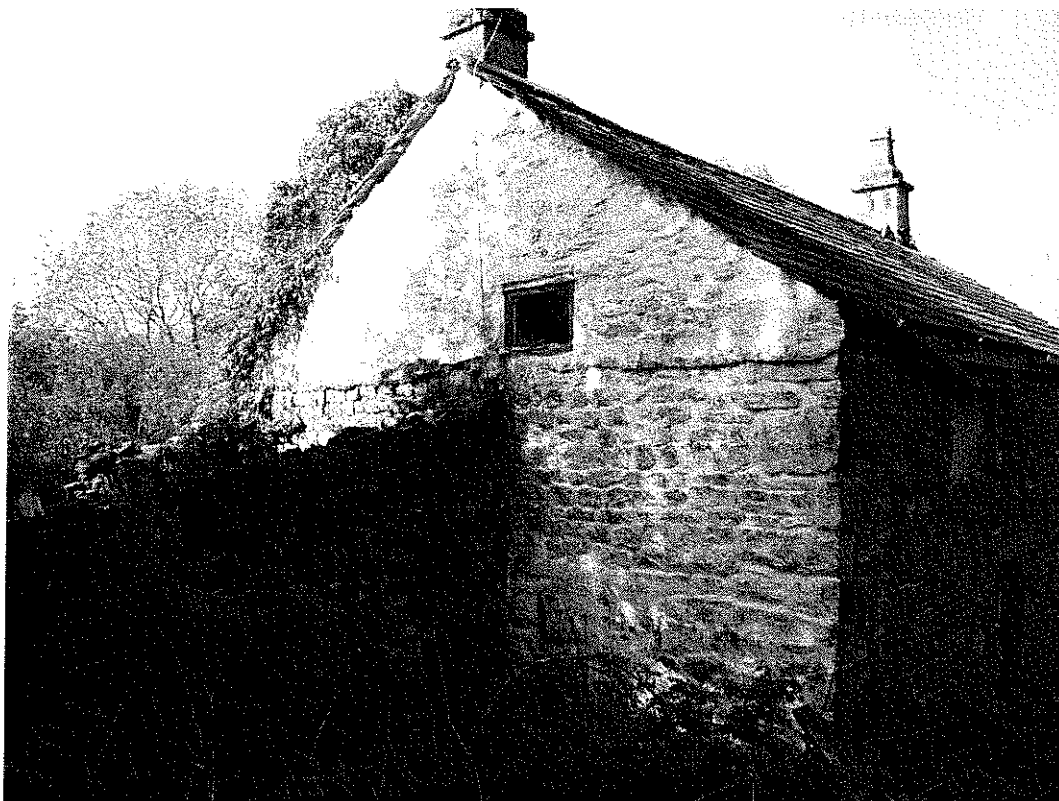
*10. Western gable*

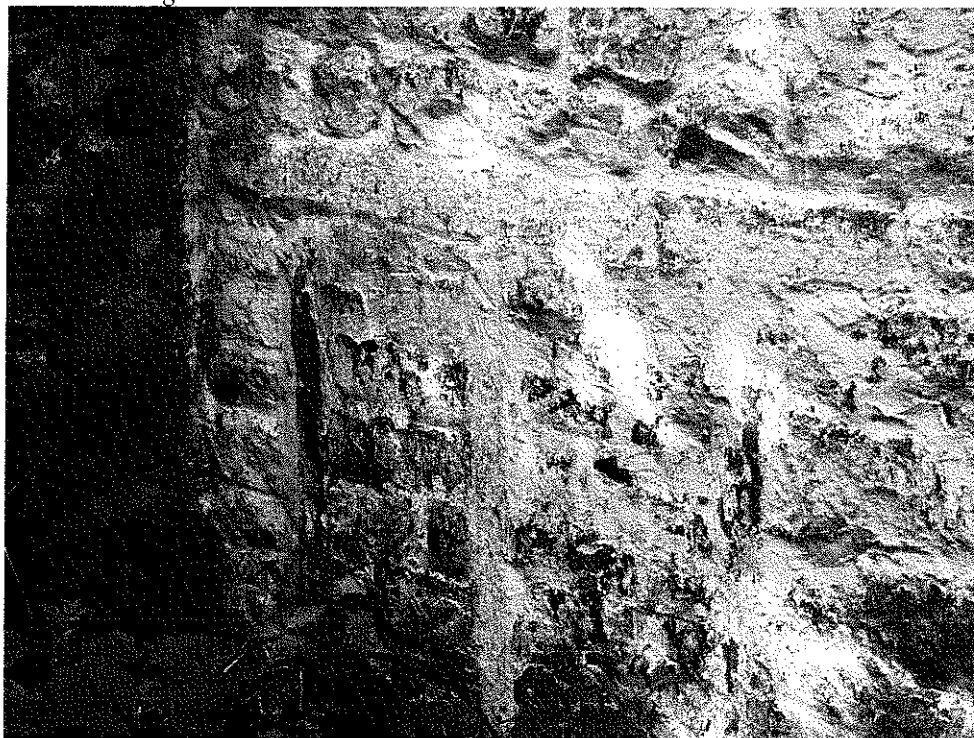
*11. Blocked twin light mullion window to the western gable at ground floor level. This former window was probably blocked when the lean-to to the west (only part remaining) was constructed. The square mullion profile (to the face) is indicative of C18th construction.*

On inspection of the physical characteristics of the cottage, as described more fully in the photographic record, there is good evidence that a building dating back at least to the C18th exists. Features indicating this are the blocked mullion window (western gable), the roof structure (probably formerly thatched) and the simple single pile nature of the plan form. There is further evidence that the upper floor level was a later insertion which in turn indicates that the cottage may have originated as a simple two unit single storey building of stone wall construction with a thatched roof of timber construction. The thickness of the stone walling to the single storey eastern bay and presence of this bay on the aforementioned maps shows this part to be of notable date, but there are clear signs to the southern elevation that the eastern part is an addition.

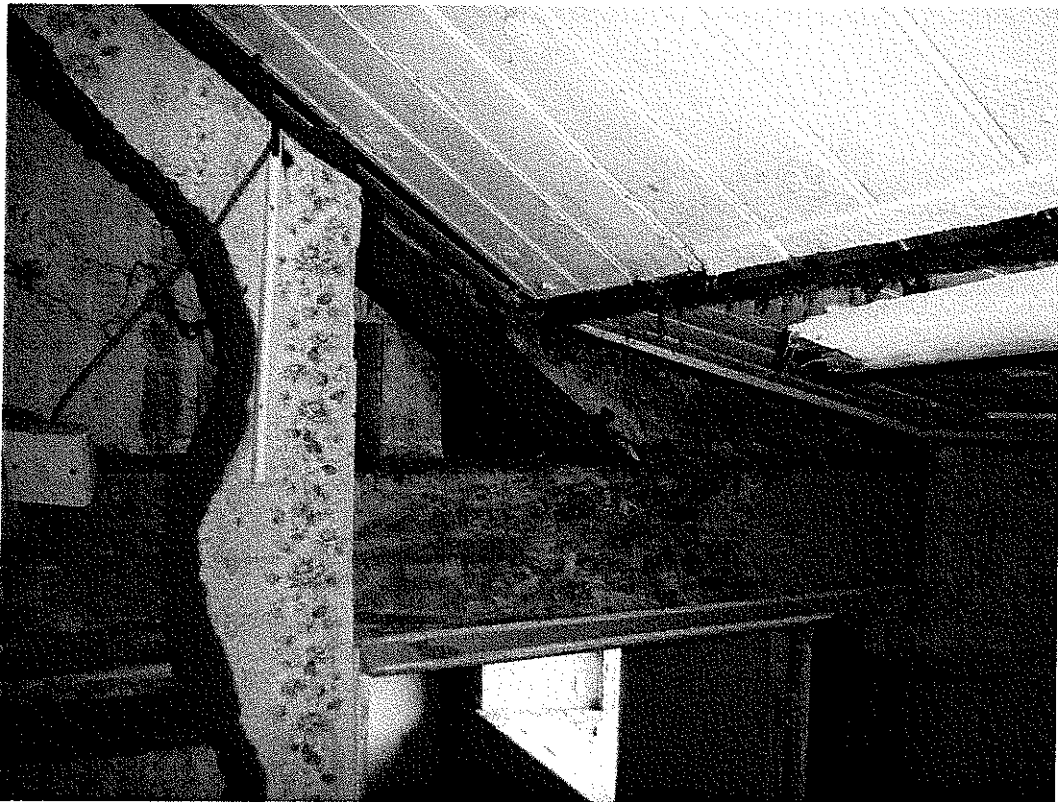
*13. As 12, doorway with low head (1.2m) through to adjacent room formed by cutting out lower edge of truss tie. Here the cranked profile of the principal can also be seen where the principal meets the tie. The alteration of the tie beam and low head of the doorway here suggests that connection between the two upper rooms was an insertion rather than an original feature. This in turn indicates that the cottage was either a) at some stage two separate adjoined dwellings or b) a single storey (open to the roof) dwelling into which the first floor was added (see also later).*

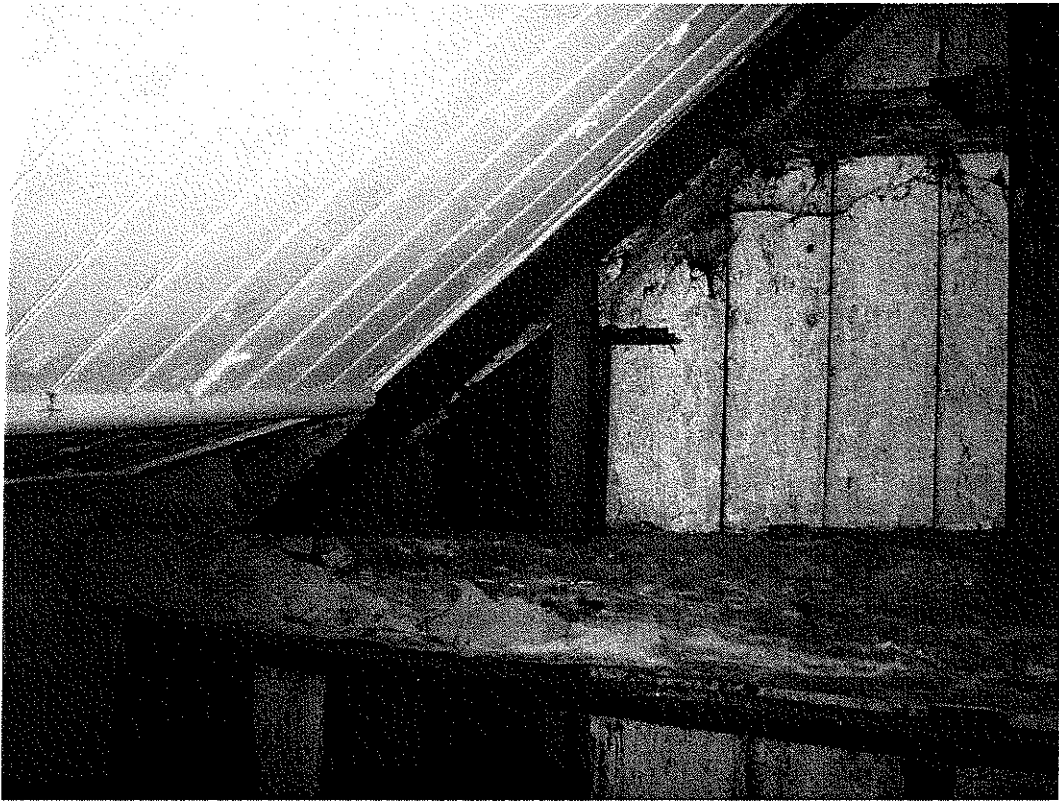
*14. As 12 & 13, opposite end of truss bearing to the northern wall again showing the cranked profile of the principal and also the plank boarding*

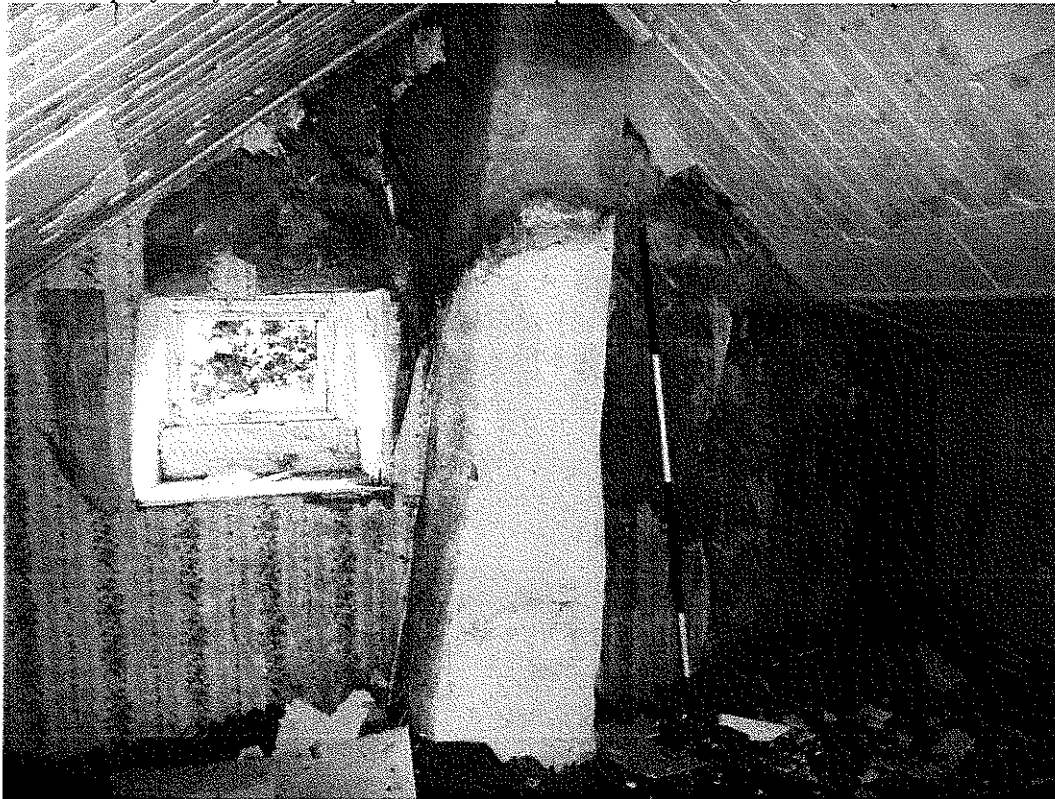
*15. First floor western room chimney flue to western gable serving fireplace to ground floor below*

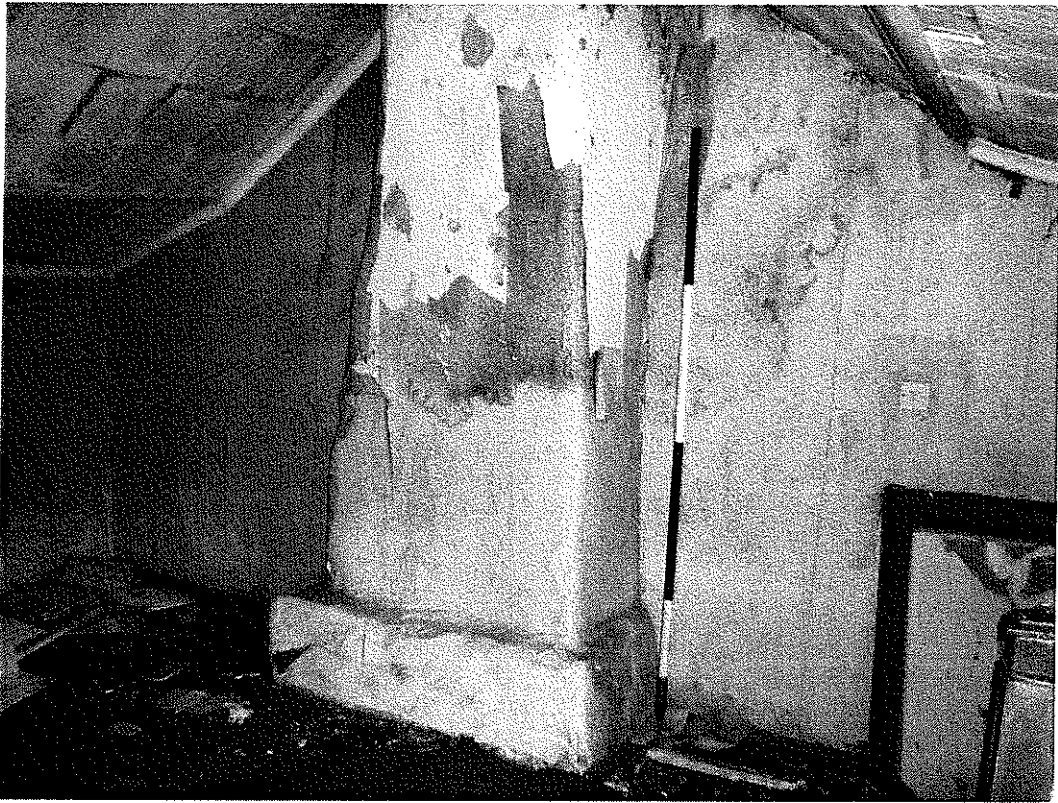
*16. Eastern first floor room, single flue to eastern gable The cranked profile of the ceiling can also be seen indicating the unusual nature of the roof structure above*

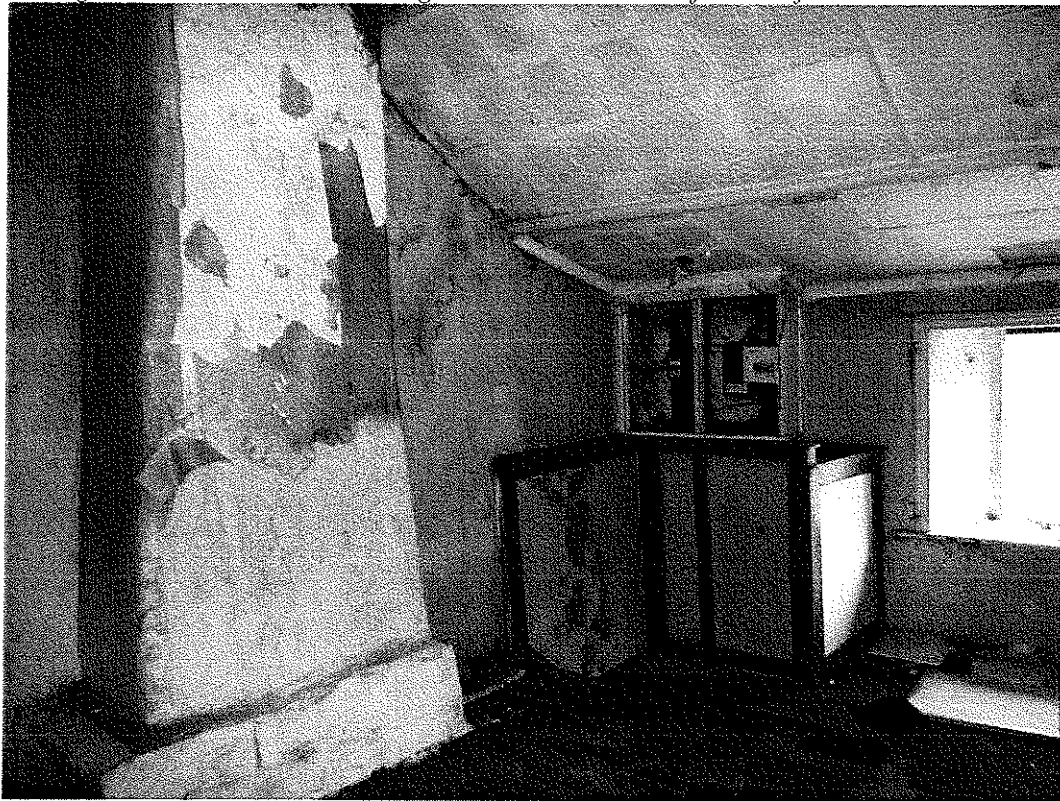
*17. Eastern first floor room, looking to stair in south east corner*

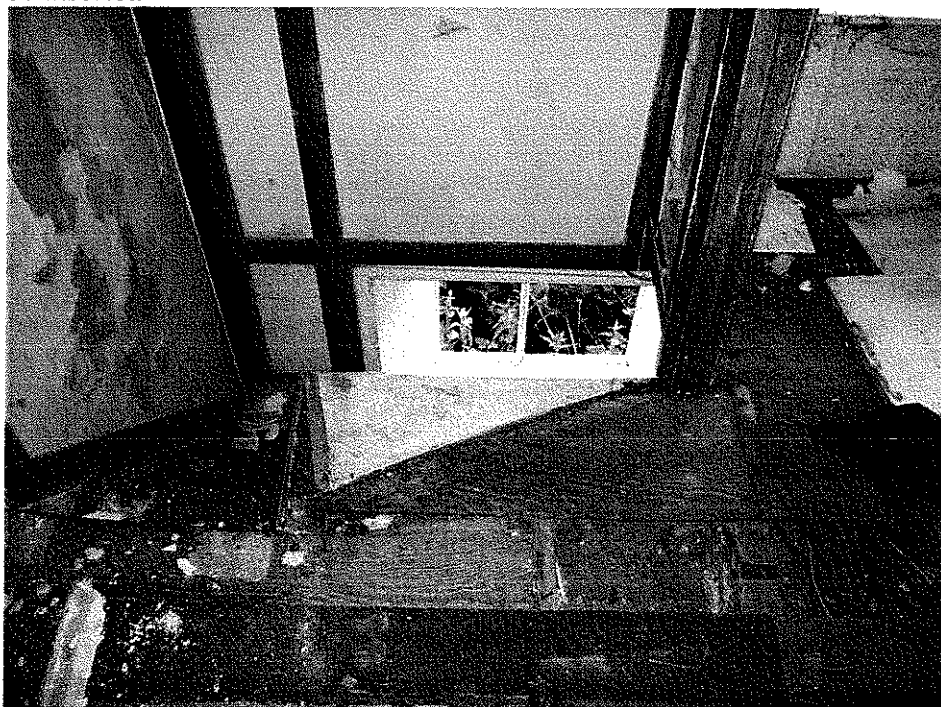
*19. Staircase down to ground floor. This is almost certainly inserted which again suggests the upper storey was formed in what formerly had been an open single height dwelling*

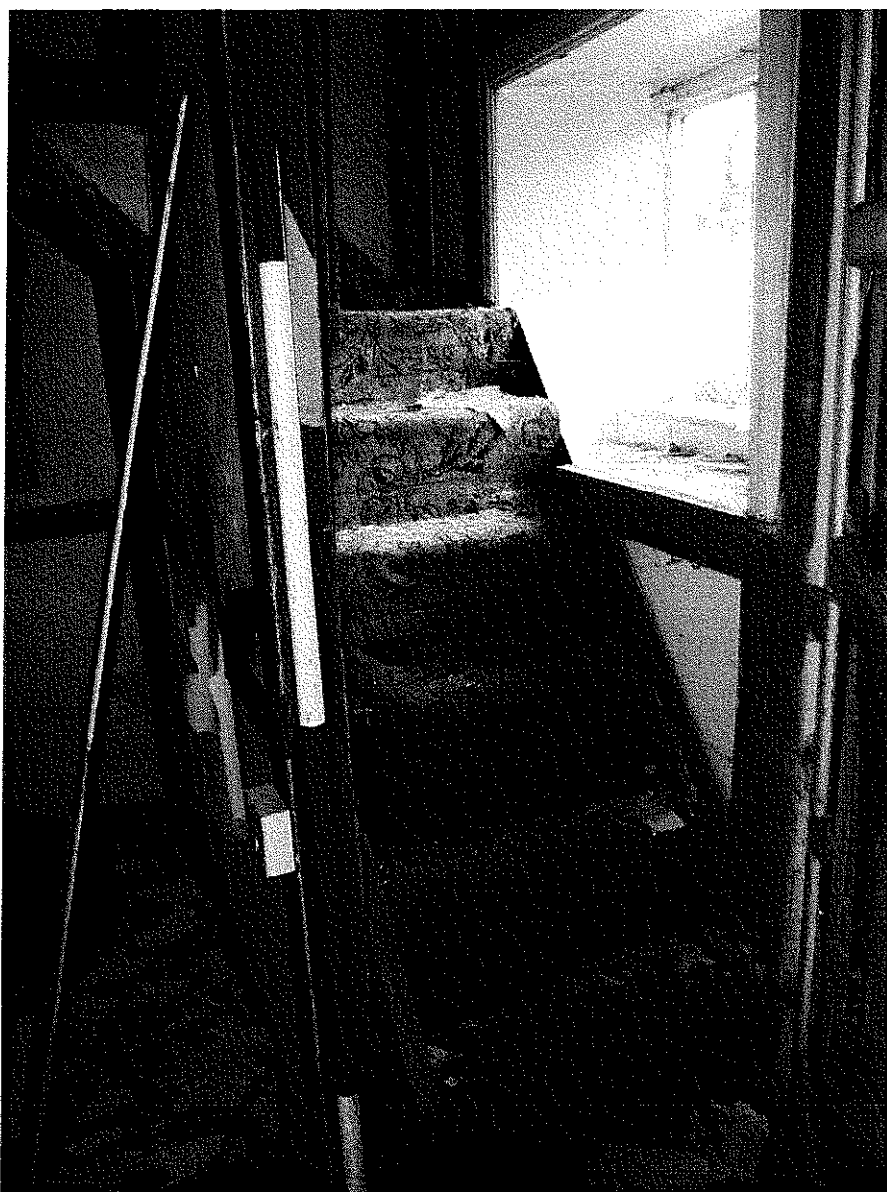
20. *The staircase from the eastern ground floor room (of two storey part).  
That this cuts partly across the window is another indicator that it was inserted*

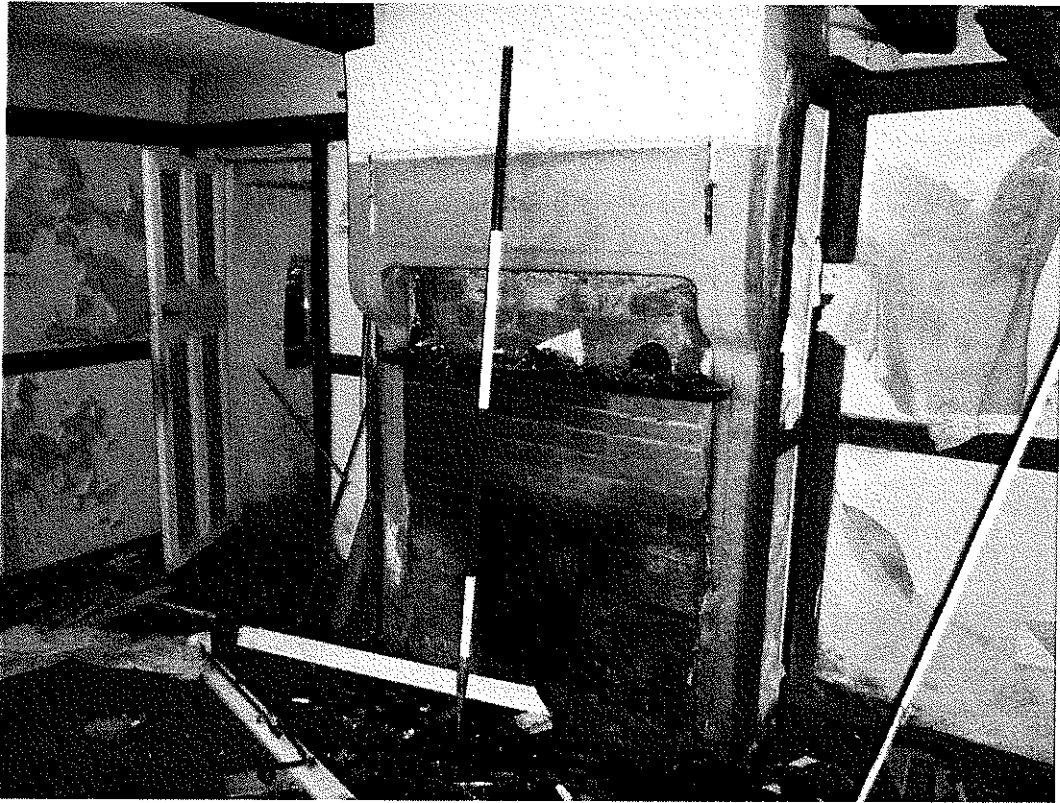
21. Eastern ground floor room of two storey part. Fireplace to eastern wall with stone chimney piece and corbelled mantelshelf. This is likely to be C18th. Two first floor beams can be seen to the left and right sides of the chimney

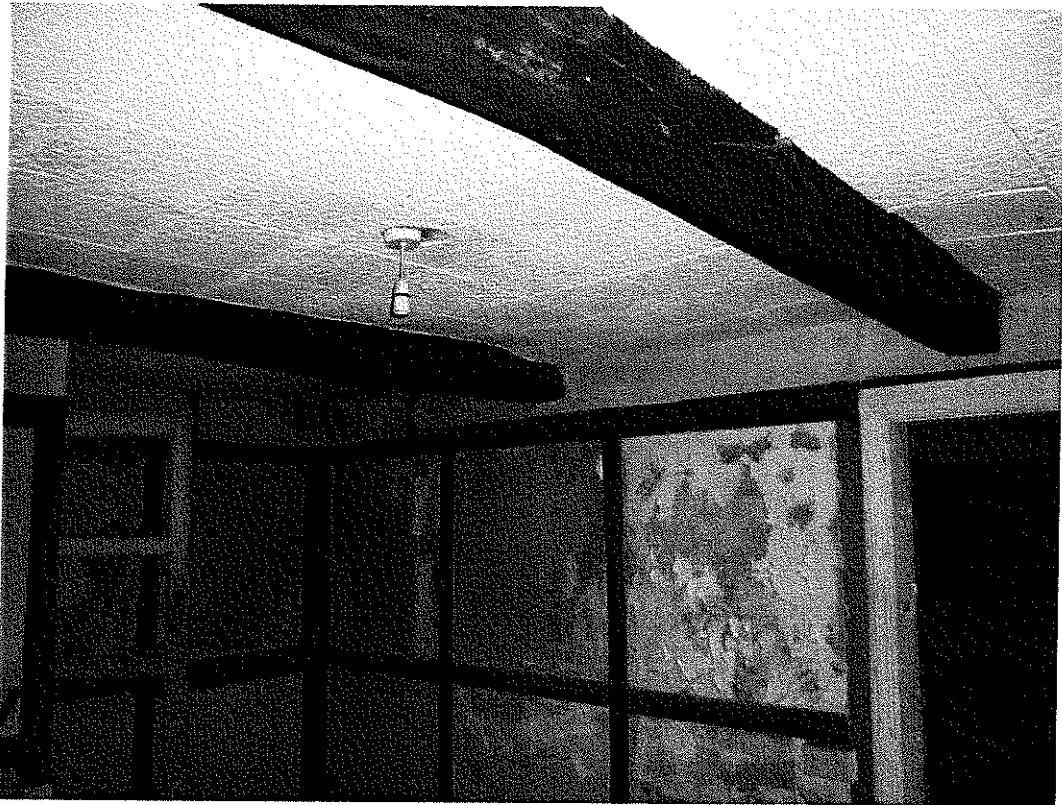
23 First floor beams over eastern ground floor room. The wooden wall framing is applied rather than structural

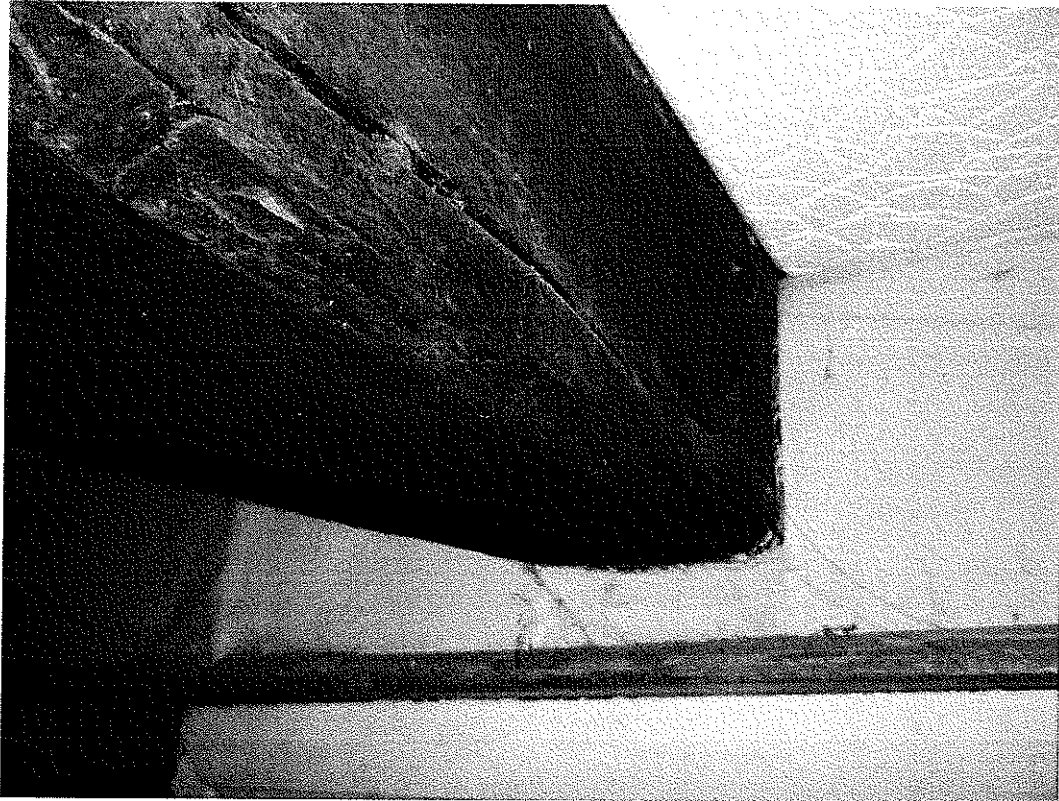
24. As 23, showing chamfer to beams (without stops)

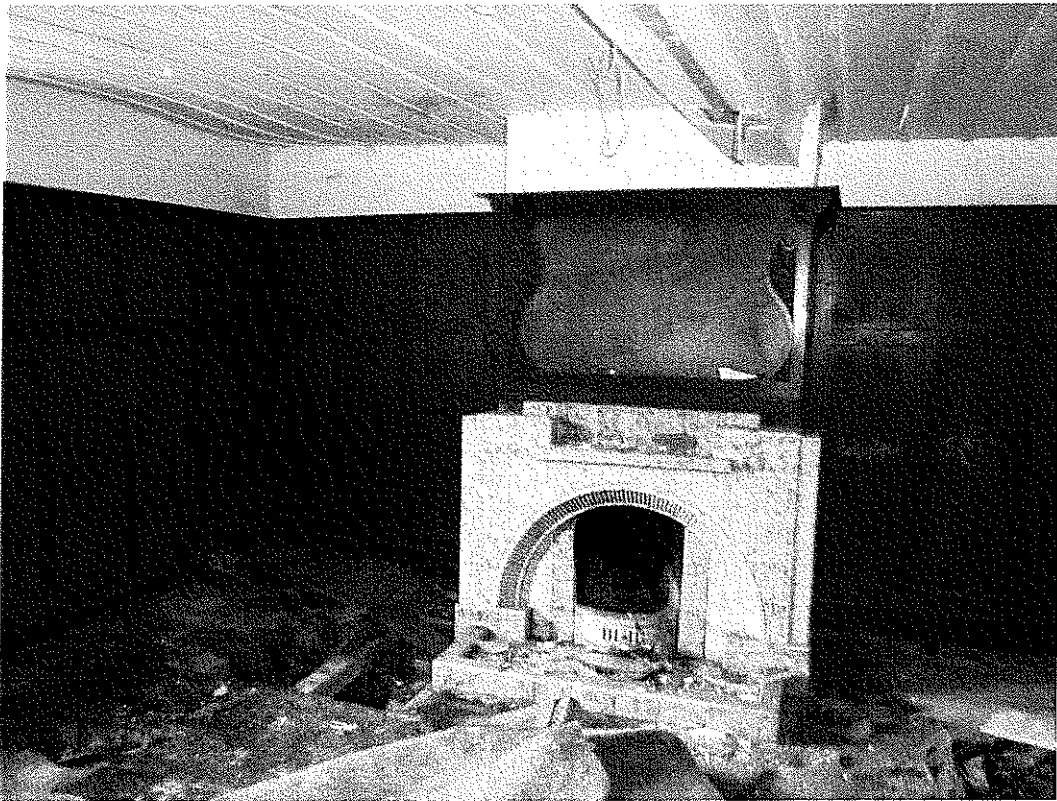
25 Western ground floor room with chimney to west gable The fireplace is probably C20th as is the wall panelling. Only a single central beam is evident. This differs from the adjacent room where two beams are present.

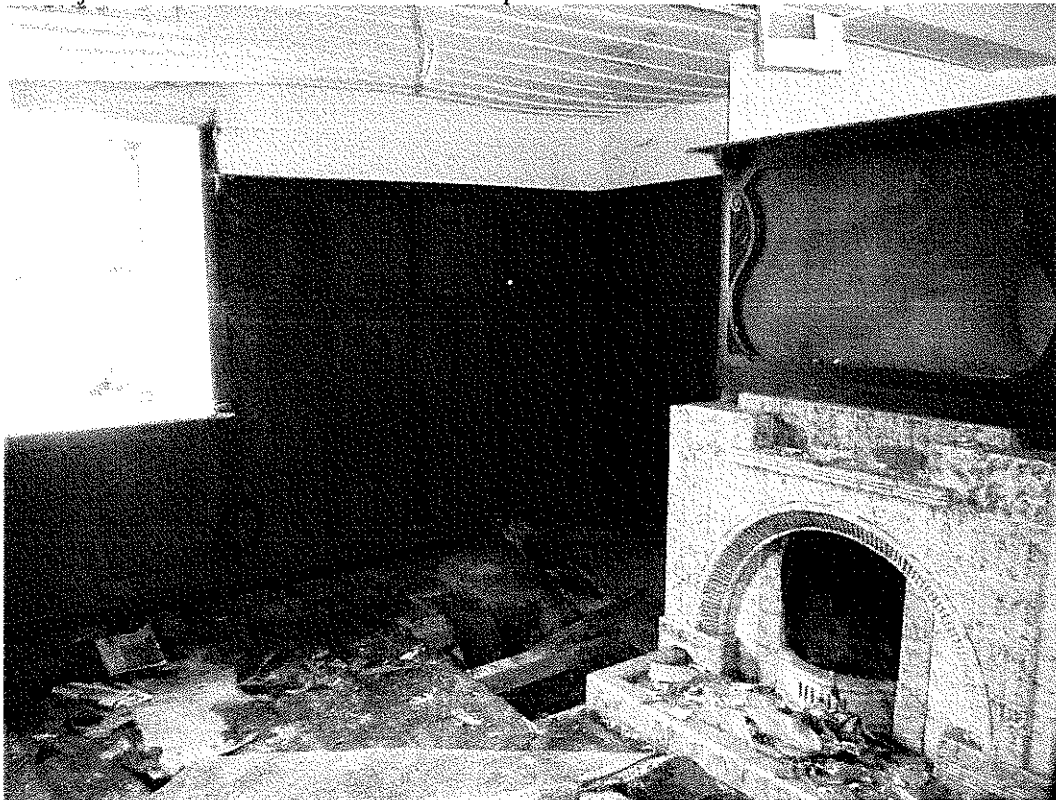
26. As 25, looking to south

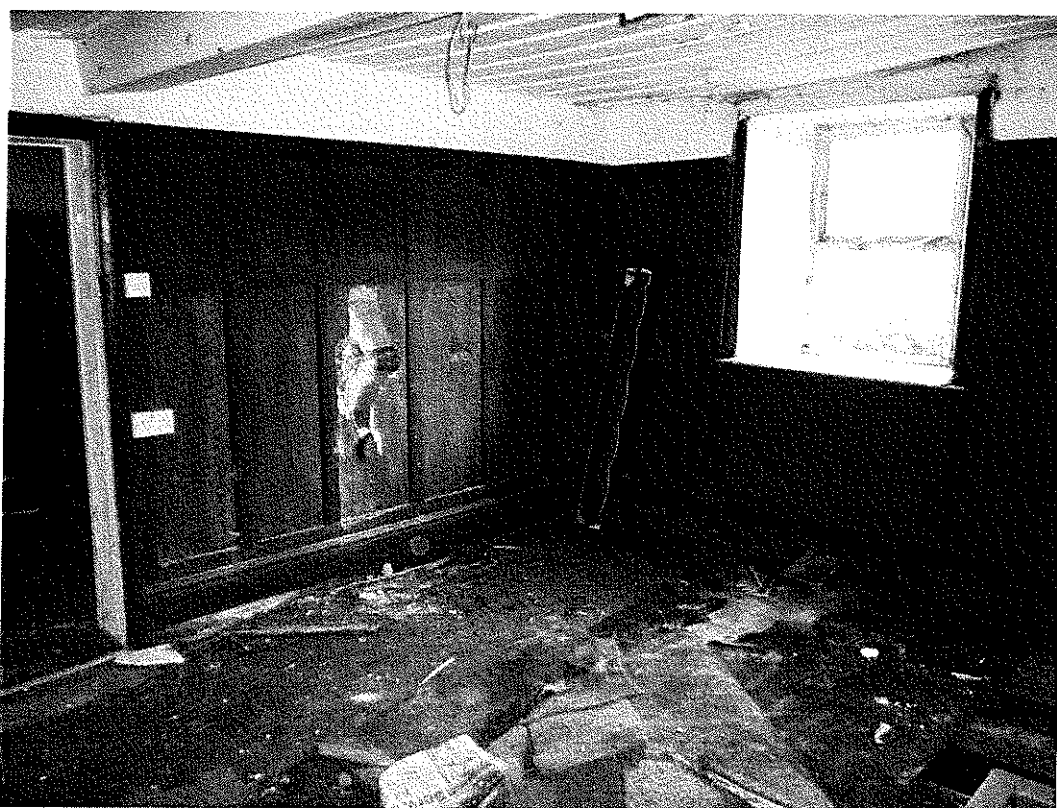
27. As 25, looking to south east corner

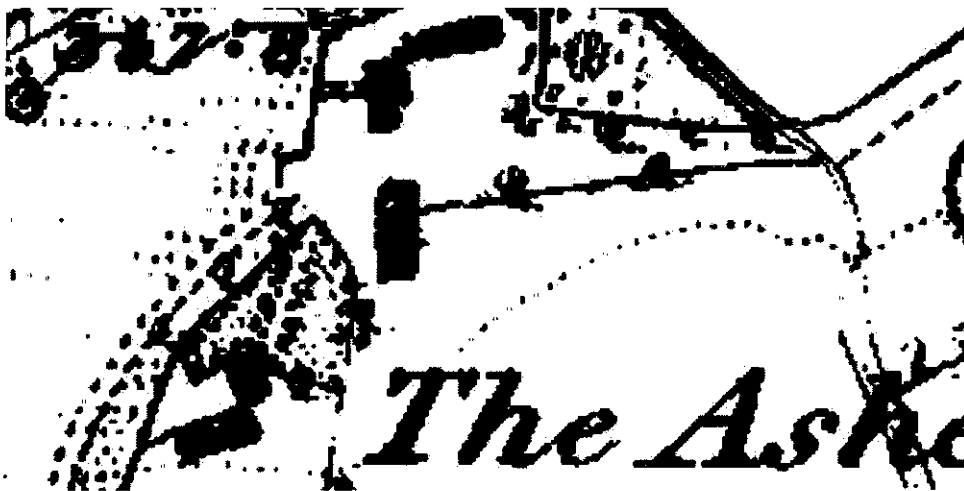
Figure 31. Extract of first edition OS map of c 1843 showing Ashes farm Cottage to the bottom left and Ashes Farm above to the north. Here the map labels the site merely as 'The Ashes'

Historic map research reveals that the cottage existed in the mid-nineteenth as shown in figure 31. At this time, however, the footprint of the cottage appears not to include the western most bay (now derelict) and there appears to be separate structure to the north east which is no longer present. The buildings slightly north of the cottage are in the position of what is now known as Ashes farm and appear to be structures that were replaced/enlarged in the later C19th. Little can be determined from this earlier map given its small scale
