| TREE IMPACT AND PROTECTION REPORT | |
| Site: | Ashes Farm, Salesbury, Blackburn, Lancashire, BB1 9EQ |

# BAT AND BARN OWL SURVEY

Cottage at Ashes Farm, Salesbury, Blackburn. BB1 9EQ ( NGR: SD 680,333).

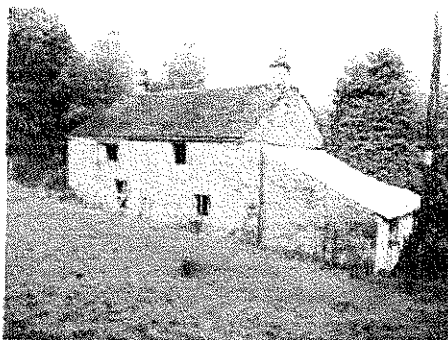
Fig 1.

To the side of the house is a single storey kitchen extension with mono-pitch roof of corrugated metal (figures 1 and 4). The extension has a suspended ceiling enclosing a roof void insulated with a glass fibre material. The void is dark, cool and relatively dry and there is no evidence of bat roosting activity although jackdaws appear to have nested within the void. A stone out-building is located at the south gable end; this building is now totally dilapidated and there is no roof, windows or door (figures 2 and 3).

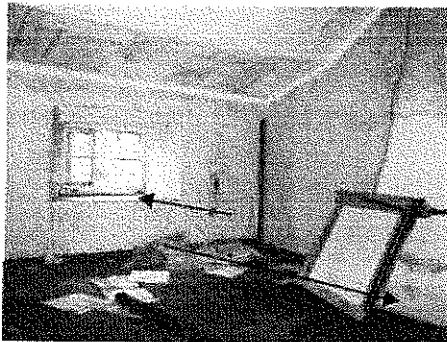
Fig 6.

- (1) A small number of relatively fresh bat droppings were found on the window sill of a first floor room as shown in figure 6, indicating recent flight within the building.
- (2) Four discarded moth wings (yellow under wing moth) were found in a first floor room (as shown fig 6).
