Application for Planning Permission and listed building consent for alterations,  
extension or demolition of a listed building.

Conversion of barn into 2No. dwellings

CHADWICKS FARM

## BAT, BARN OWL & NESTING BIRD SURVEY AT

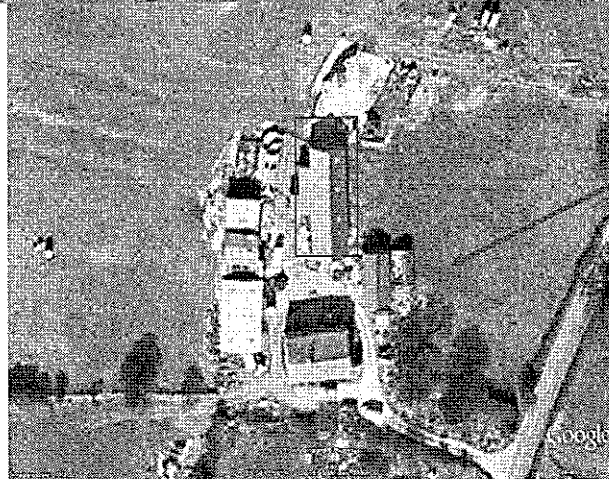
Figure 2

The trees to immediately adjacent to the site to the Southeast and the area of long grass to the east are judged to be the primary foraging areas for bats around the site.

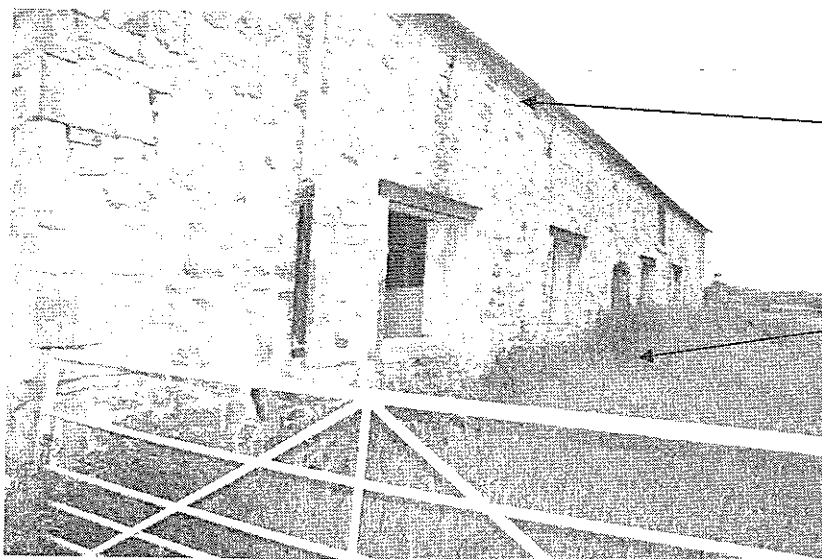
East elevation

Facia boards along the eaves offer some roosting potential, easy to inspect.

Area of long grass offering foraging potential.

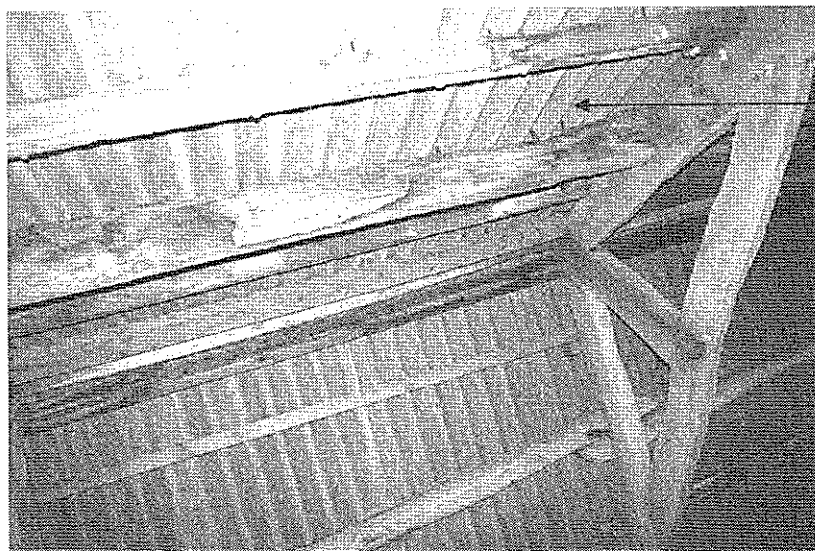
Asbestos roof offering negligible roosting potential.
