Application for Planning Permission.  
Town and Country Planning Act 1990

**DESIGN AND ACCESS STATEMENT****SITE: RAKEFOOT FARM, CHAIGLEY, CLITHEROE. BB7 3LY****PROPOSAL: CONVERSION OF BARN TO DWELLING, ERECTION OF GARAGE, CREATION OF DRIVEWAY AND GARDEN****SITE DESCRIPTION**

## CONVERSION ASSESSMENT

Site/Location Address: Barn at Rakefoot Farm, Chaigley, BB7 3LY. (Grid Reference: 441600:366200)

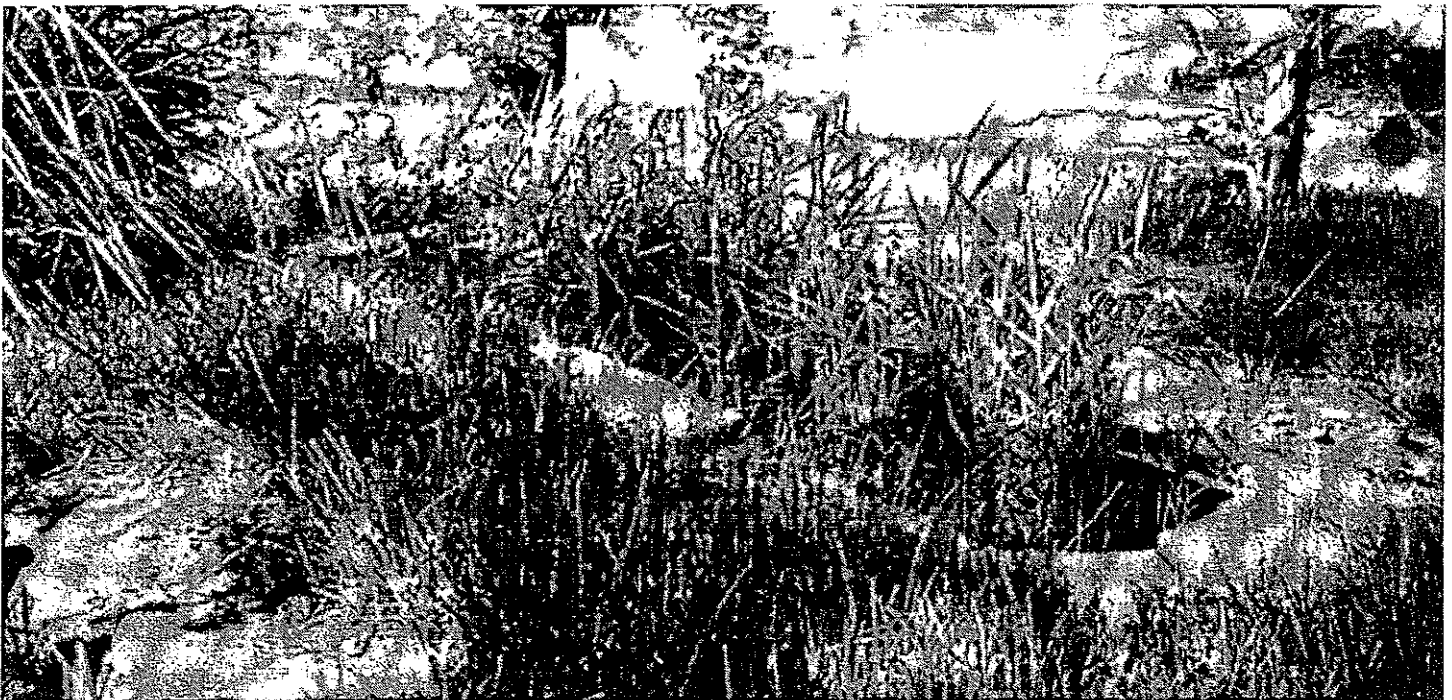
- Advanced Patented design delivers superior performance
- Pre-fabricated to ensure correct sizing
- Modules designed with a hydraulic gradient across the length of the units
- Performance tested in Germany to EN12566-3 in combination with a Part 3 plant
- Adjustable outlet weir allows water level control
- Modular system comprising of:
  - 2 individual reed beds = Single house application**
  - 4 individual reed beds = Two house application**
- One piece GRP moulding installed flush to the ground
- Reeds and GRP beds supplied. Washed pea gravel, 'growing' media by others (not included)
- Effluent discharge is typically improved by at least 50%, providing reduced BOD and suspended solids
- Provides rooting zone depth of 600mm (required by Phragmites Austrails)

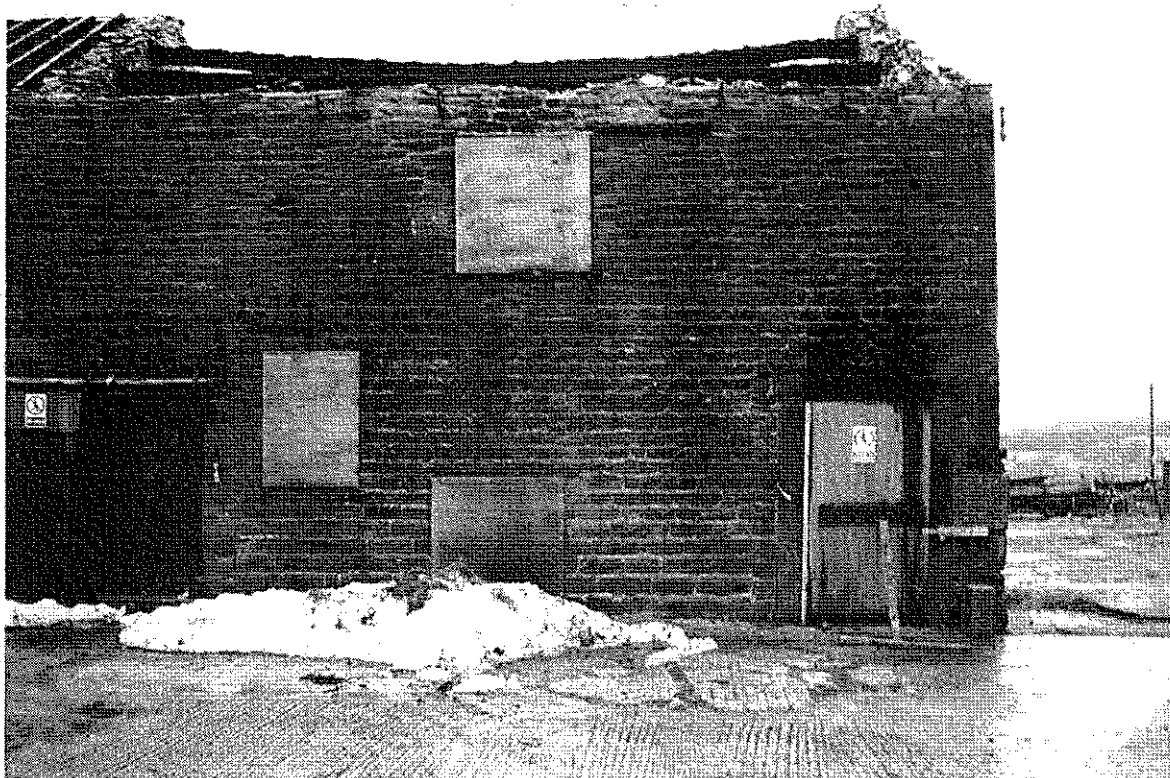
Photograph No. 1

The external walls shown on the plans as position 1-3 are reasonably plumb and in generally good condition showing no real signs of excessive movement or large cracking, except in the vicinity of the fire damaged part of the barn. All the pointing however is in poor condition.

All areas require the existing pointing to be removed and replaced. Any loose stonework must also be replaced as necessary once the pointing has been removed with stone work to match; this should be carried out both externally and internally

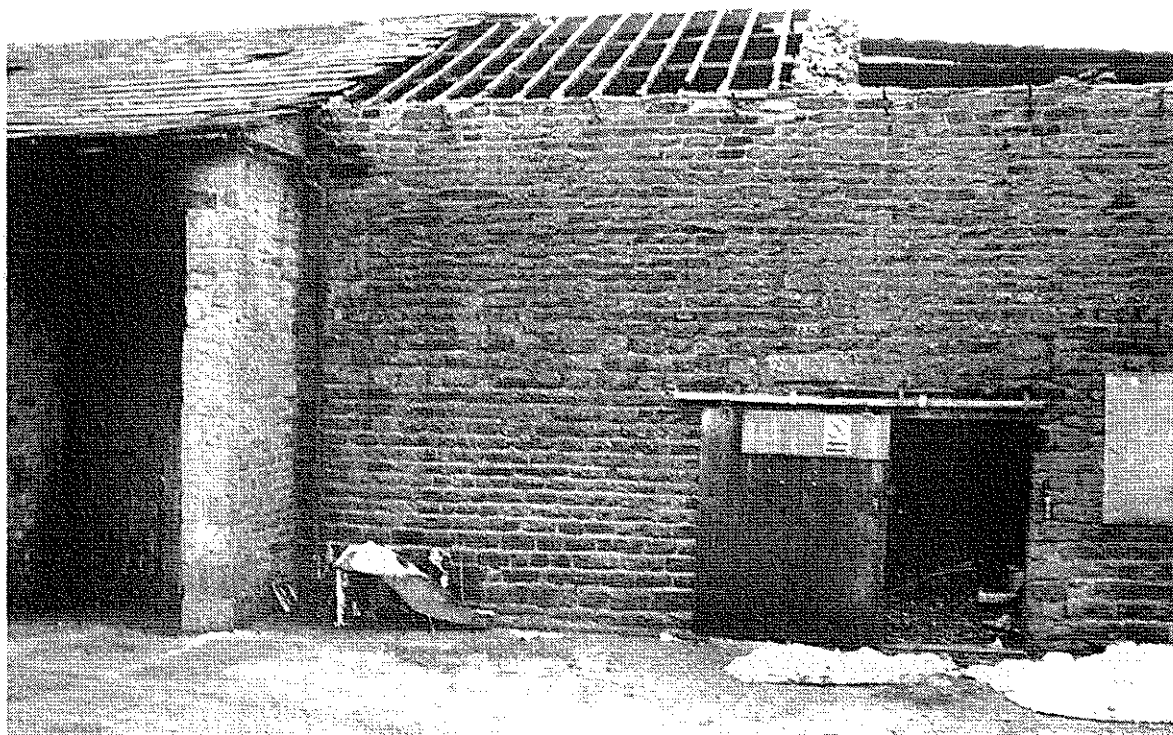
Photograph No. 2

The additional large opening as shown in photograph number 2 has a defective stone lintel along with the door in the vicinity of the fire as shown in photograph number 4.

All lintels to openings to be replaced with new stone lintels to external face and Catnic lintels to internal masonry as per manufacturers' details and specifications.

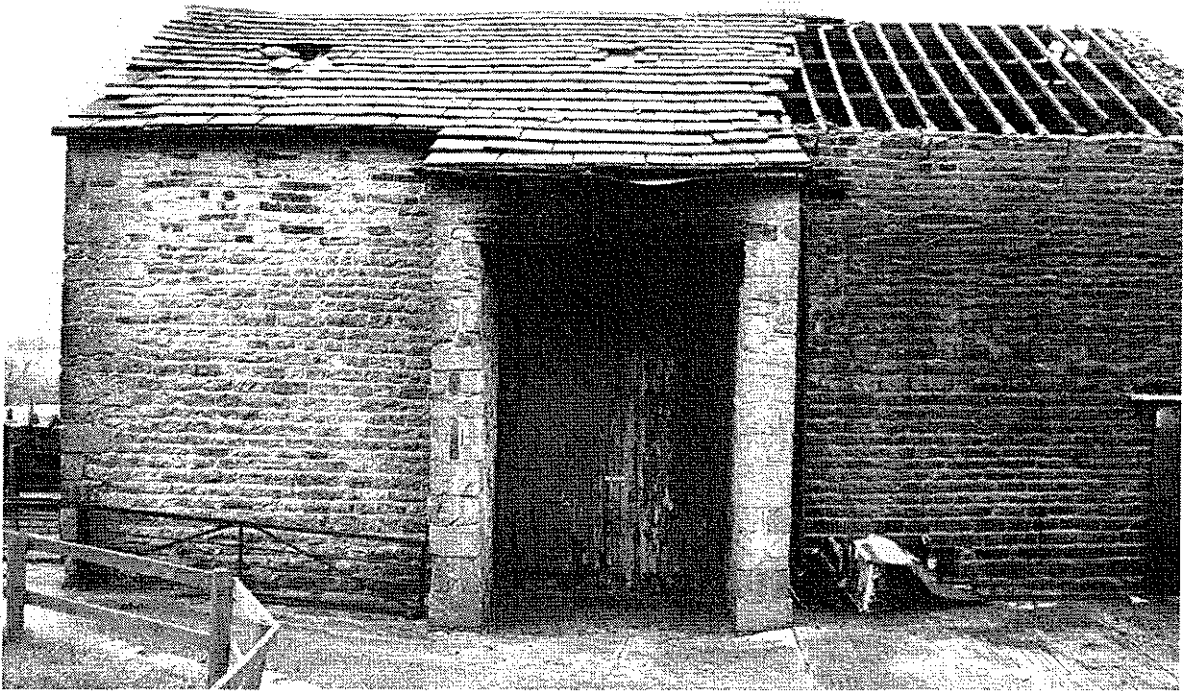
Photograph No. 3

The main barn wall which is shown as position number 3 of the photographs showed the existing timber lintel over the main doorway to be defective. Another timber lintel positioned slightly inboard of this which gives support to the existing first floor construction is also defective.

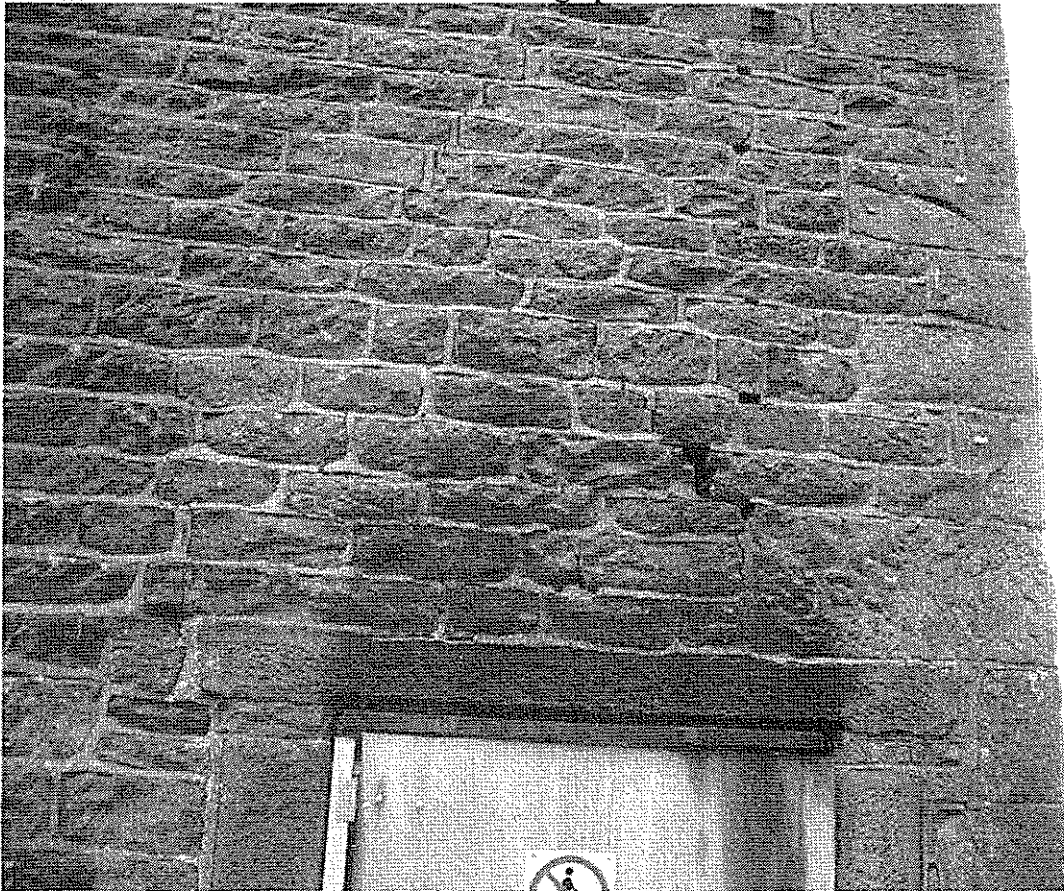
Photograph No. 4

Cracking to the wall externally and internally could also be seen in numerous areas. Large cracking was also evident above the door as shown in photograph number 4.

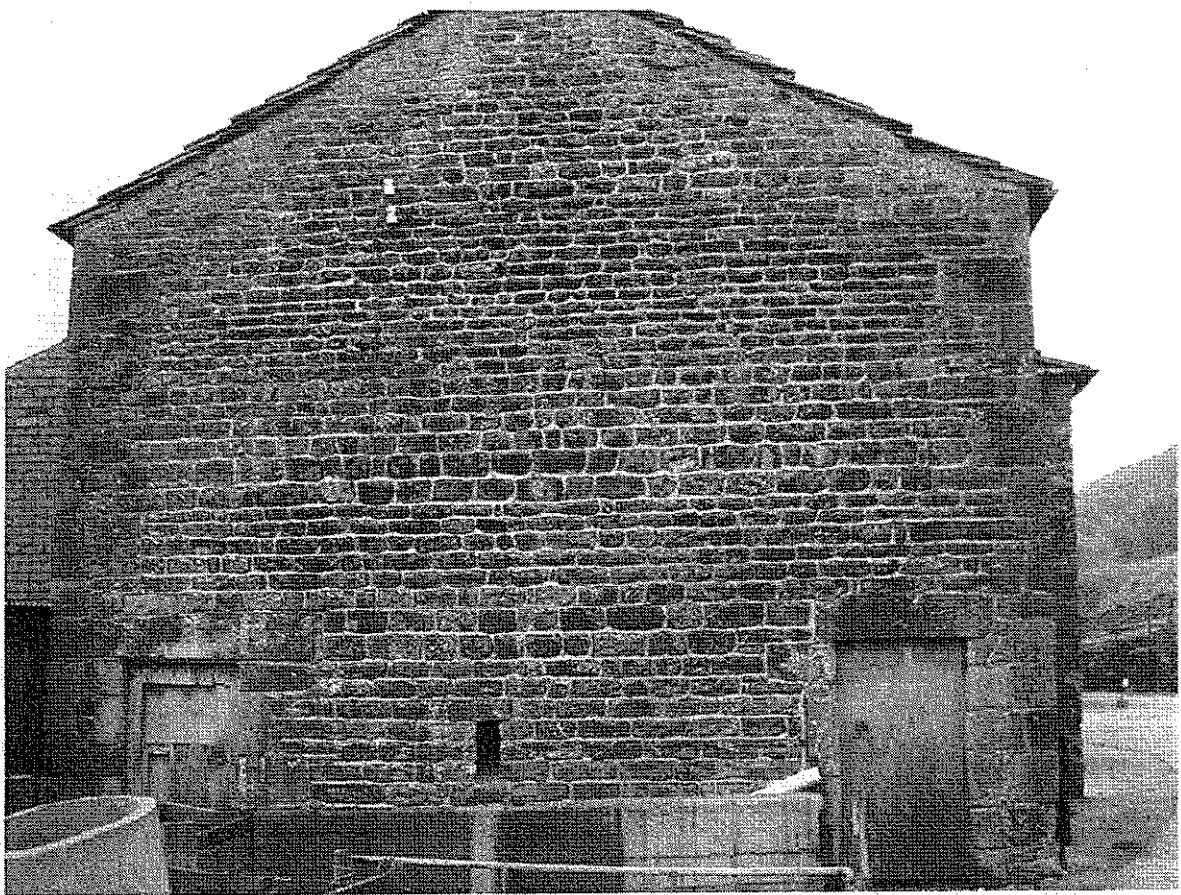
Photograph No. 5

The original barn wall as seen in photograph number 5 is reasonably plumb and in good condition externally showing no real signs of excessive movement or large cracking. The internal finish of the existing barn wall as seen in photograph number 11 can be seen to have large areas of render missing.

All lintels to openings to be replaced with new stone lintels to external face and Catnic lintels to internal masonry as per manufacturer's details and specifications.

All areas require the existing pointing to be removed and replaced. Any loose stonework must also be replaced as necessary once the pointing has been removed with stone work to match; this should be carried out both externally and internally

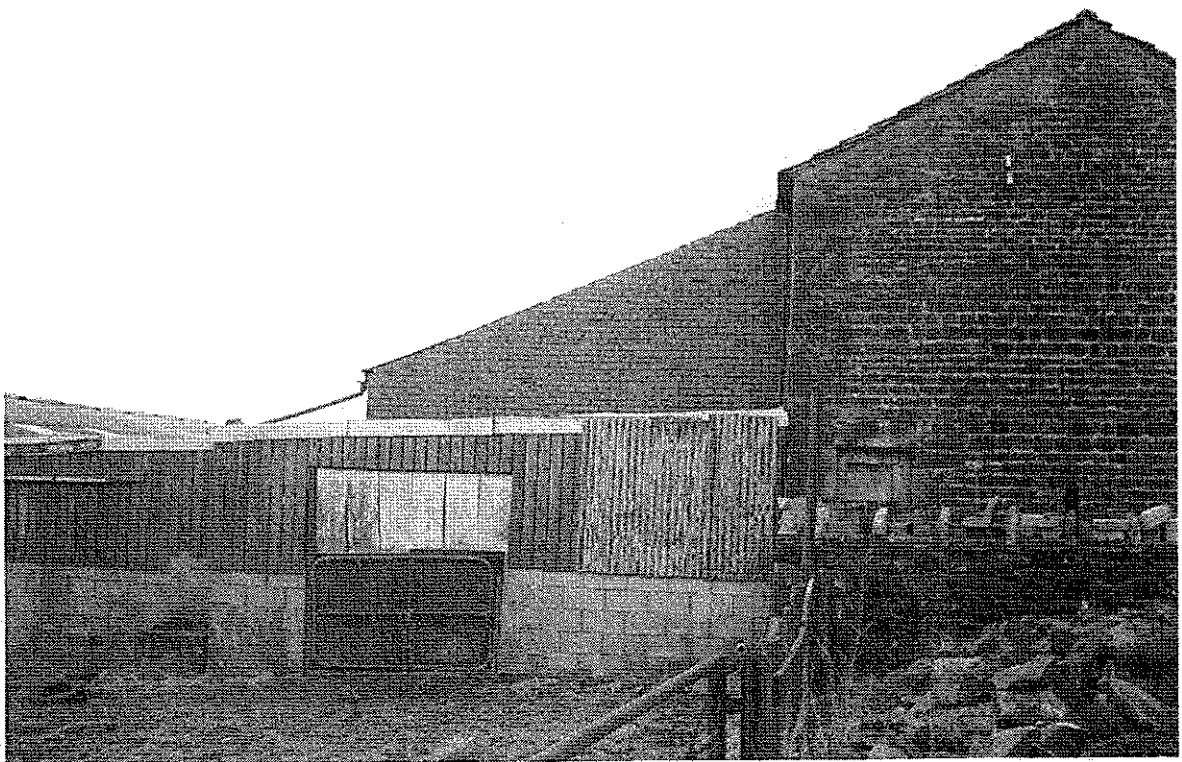
Photograph No. 6

The modern red brick lean too construction that can be seen in photograph number 6 show numerous areas of settlement and cracking and is generally in a very poor state.

Inspections of the existing foundations are required to determine if built off suitable ground bearing capacities.

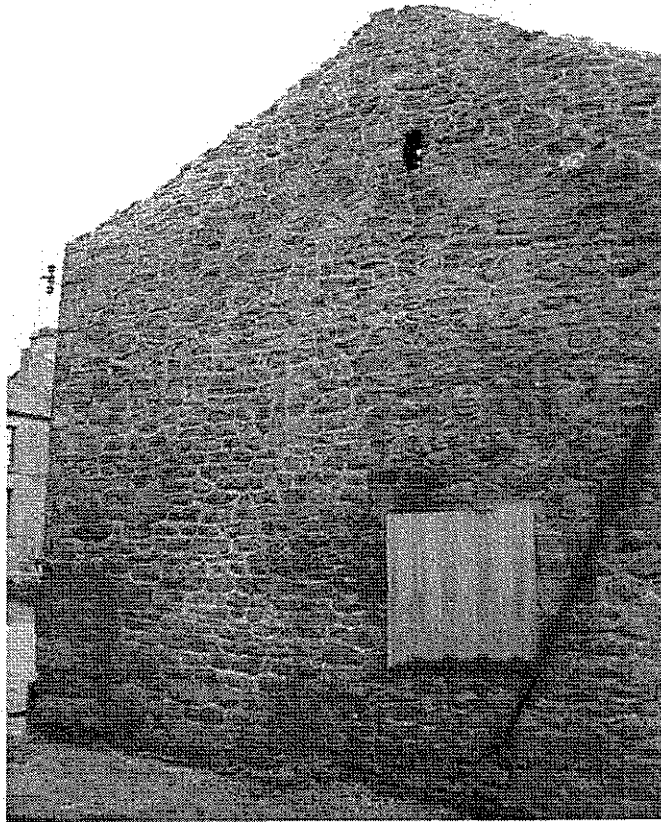
Photograph No. 7

The original barn wall as seen in photograph number 7 is reasonably plumb and in good condition externally showing no real signs of excessive movement or large cracking. The internal finish of the existing barn wall as seen in photograph number 10 can be seen to have large areas of render missing.

All lintels to openings to be replaced with new stone lintels to external face and Catnic lintels to internal masonry as per manufacturer's details and specifications.

All areas require the existing pointing to be removed and replaced. Any loose stonework must also be replaced as necessary once the pointing has been removed with stone work to match; this should be carried out both externally and internally

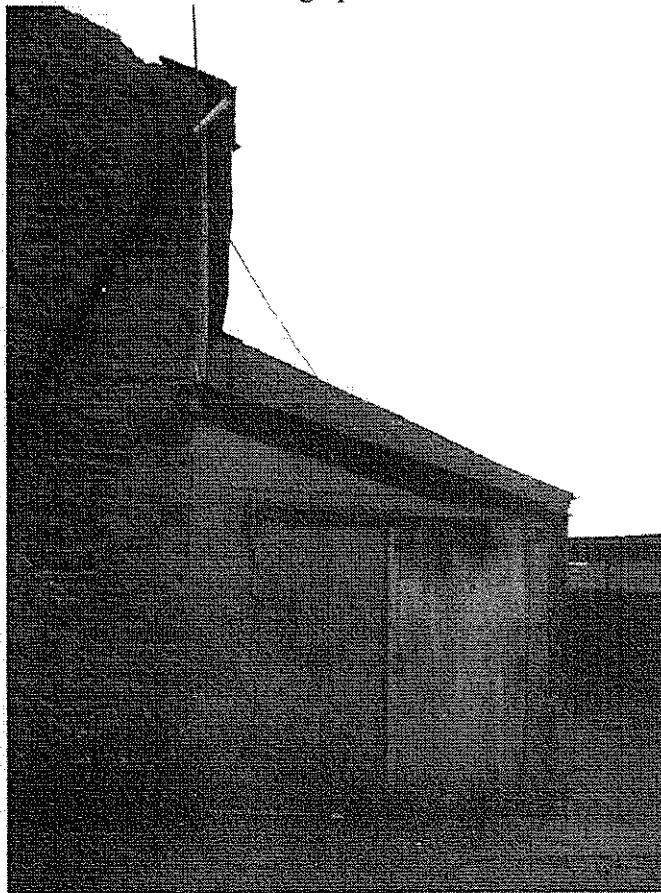
Photograph No 8

The two modern rendered and red brick lean too constructions that can be seen in photographs 8 & 9 respectfully show numerous areas of settlement and cracking and are generally in a very poor state.

Inspections of the existing foundations are required to determine if built off suitable ground bearing capacities.
